**BASIC DESIGN STUDY REPORT  
ON  
THE PROJECT FOR THE URGENT REHABILITATION  
OF  
MARKHAM BRIDGE  
IN  
THE INDEPENDENT STATE OF PAPUA NEW GUINEA**

March 2007

JAPAN INTERNATIONAL COOPERATION AGENCY

CHODAI CO.LTD.

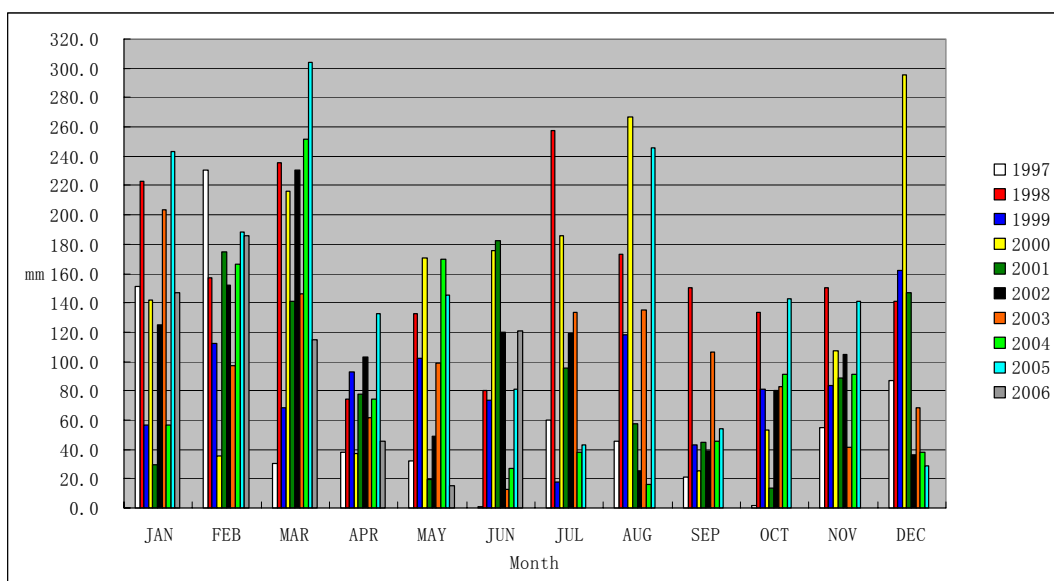
Figure 1-1 The monthly precipitation data  
for the last decade from the observatory in the Nadzab airport

The periphery of the Markham Bridge is situated near the seacoast and has high humidity and constant rain all year around. In the study period, the monthly precipitation data for the last decade could be obtained from the meteorological observatory in the Nadzab airport located at the suburbs of Lae and in Markham river basin and is shown in Figure 1-1. The high water levels during and after the construction period were calculated by using the data below and conducting hydrological and hydraulic analysis. According to Figure 1-1, the high rainfalls from January to March, in July, and in August can be pointed out as a significant tendency. Since the precipitation in flooding is important for analyzing the high water levels, the data of the maximum rainfall per a day was adopted for the design calculation.

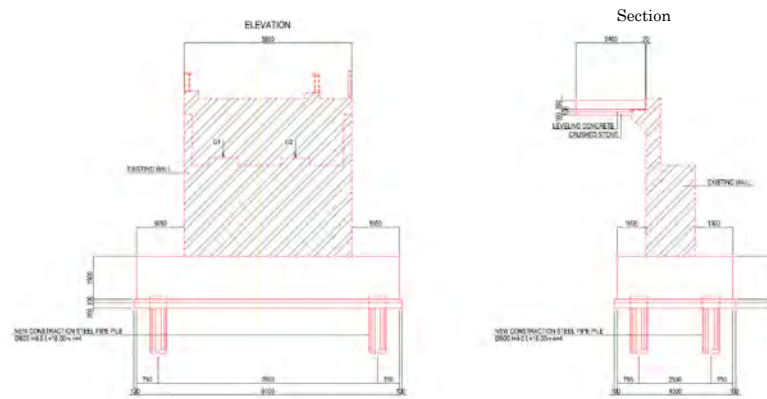
Four steel piles and a concrete slab at the basement are added for the abutment repair work. The approach slab is constructed using pre cast concrete to minimize the delay to traffic.

Figure 2-1 General View of Abutment 1

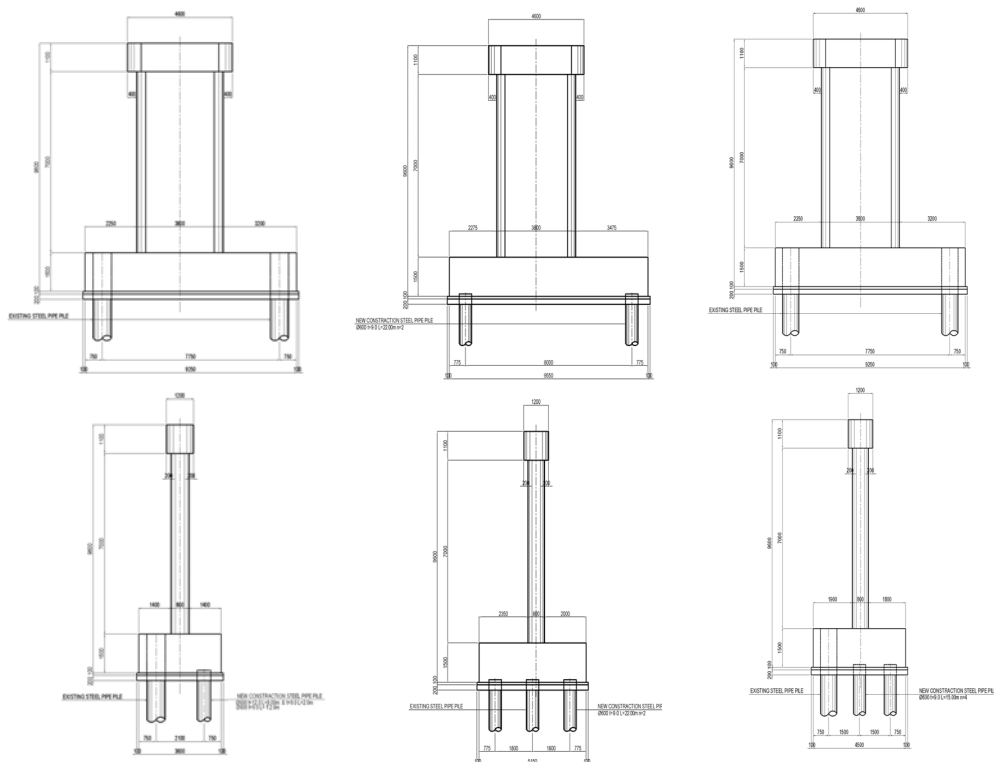
The pier pile caps are to be constructed 2.0m under the existing river bed. The 600mm diameter steel piles in the temporary support piers are to be recycled as a part of the permanent foundation for the new piers. The pier column is a wall type, the same as the existing piers.

Figure 2-2 General View of Piers

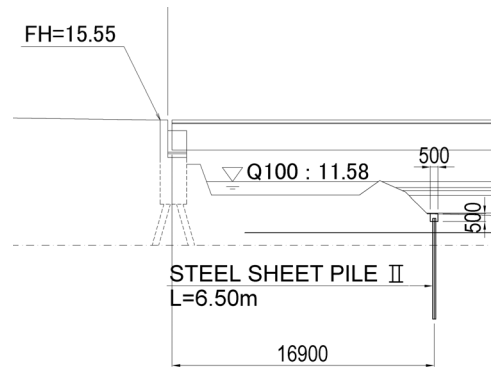
The concrete blocks, which AusAID used for the urgent repairs, will be used for the repair of bank protection. A steel sheet pile foundation will be constructed for the bank protection to avoid scouring of the foundation by the river flow.

Figure 2-3 Profile of the Bank Protection Steel Sheet Pile Foundation

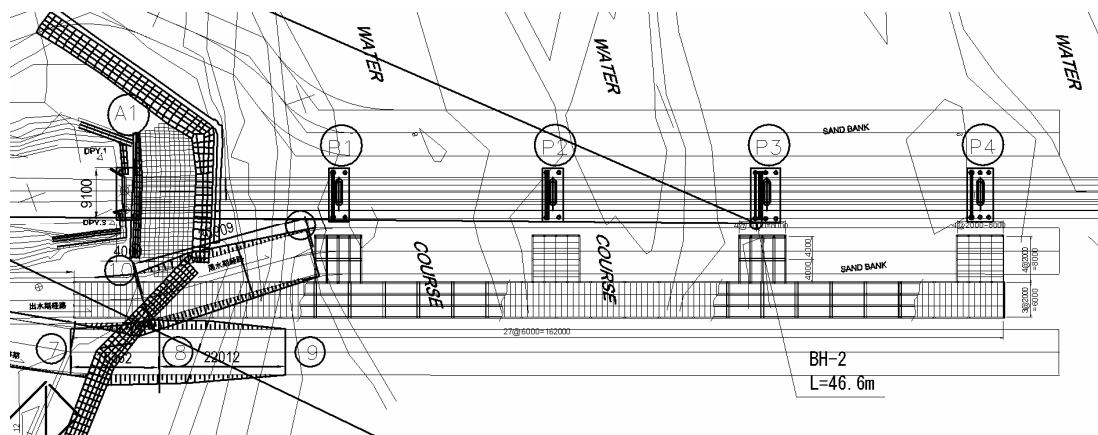
Figure 2-7 Temporary Staging

The removal of the existing piers and piling shall be carried out from April to July by changing the river flow. (Figure 2-6) Steel sheet piling and construction of the temporary staging are to be carried out in August. (Figure 2-7)

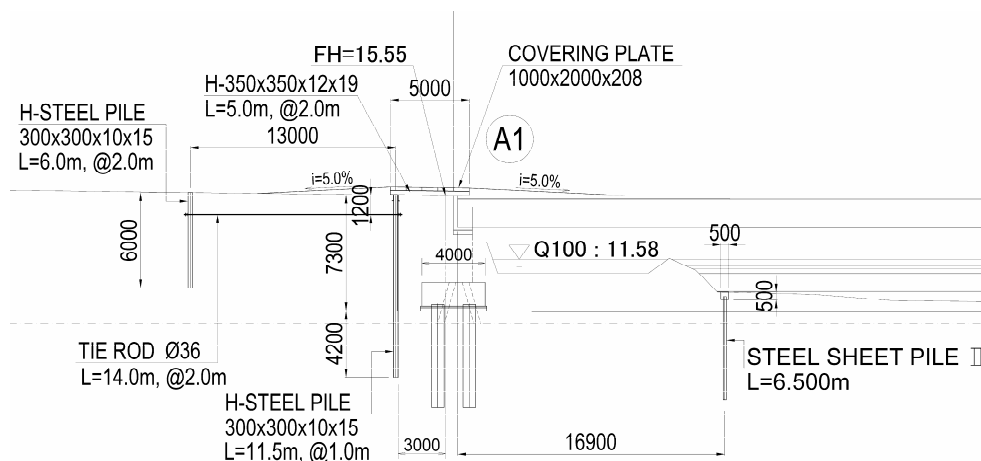
A temporary bridge will be installed behind the abutment during the construction and a combination of piles and sheet piles are used to support the embankment of the approach road. The profile of the construction of the abutment is shown in Figure 2-8

Figure 2-8 Profile of the Construction of Abutment
