## 10.2 Bridge Loading Test

The loading test on existing bridge is carried out for the purpose of the evaluation of the load carrying capacity and the durability of fatigue for steel member by measuring the deformation and stress of bridge under the actual loading on existing bridge. These results of the tests are used one of the material for making a plan to repair or reinforce the bridge, after comparing the results between a structural analyses and loading tests.

The loading tests on existing bridges in this Project were carried out for the purpose of technical transfer about the loading test to engineers in university and private companies as well as counterparts in Costa Rica. The series of loading tests on existing bridges have been carried out by the study team together with the counterparts in Costa Rican using the latest measurement equipment.

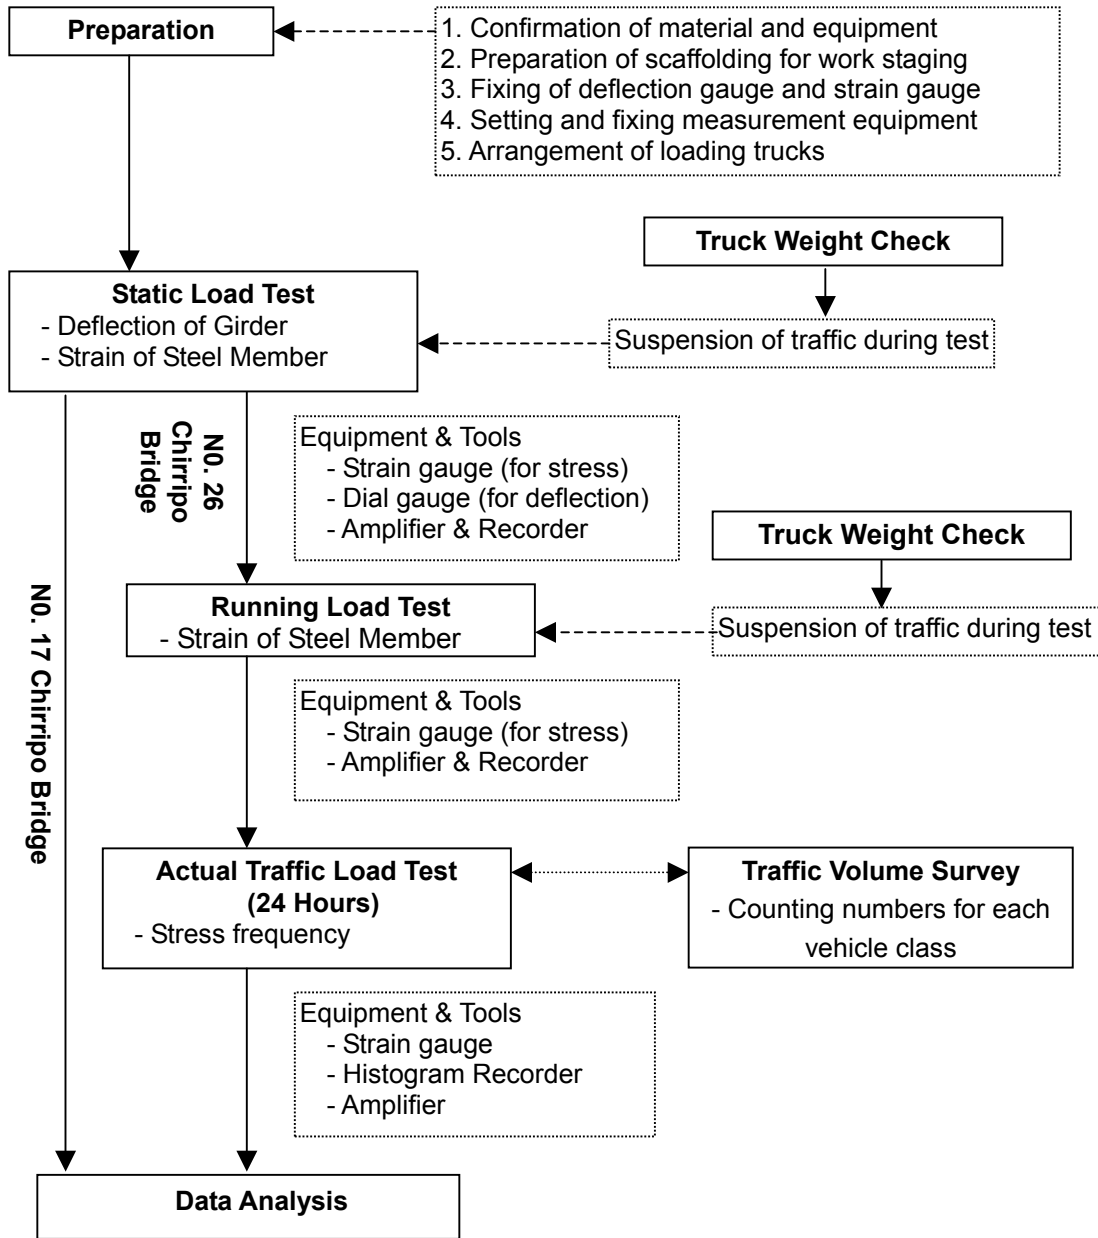
Figure 10.2.4. Loading Test Flow

The loading test flow is as shown in Figure 10.2.4.

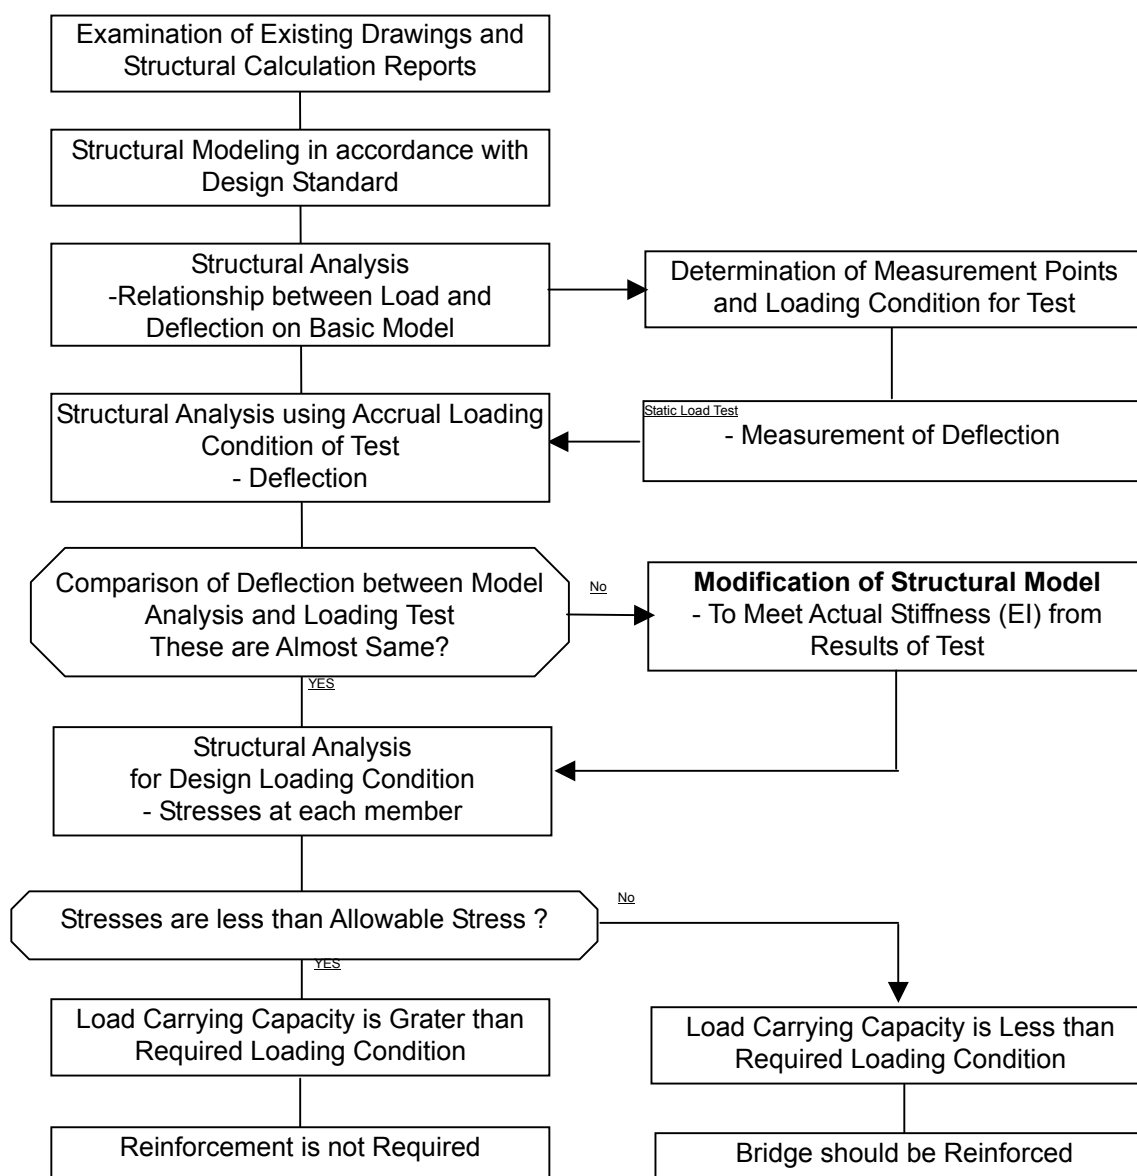
Figure 10.2.5. Evaluation Sequence for Load Carrying Capacity

The static load test has been carried out on the No.17 Chirripo Bridge to confirm the relationship between load and deflection of the main girder. The evaluation of load carrying capacity with the bridge loading test was proceeded in accordance with the sequence as shown in Figure 10.2.5.

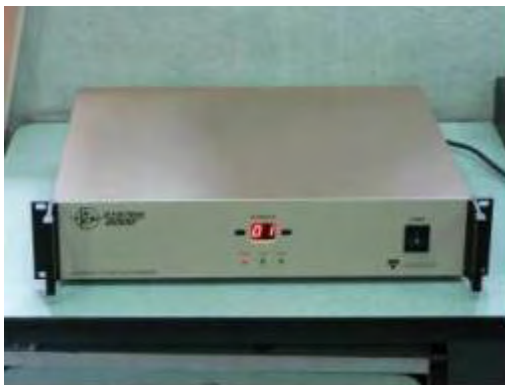
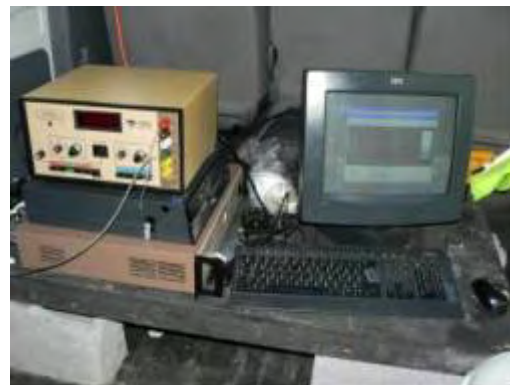
Figure 10.2.21. Data Recording System

The strain data was recorded with the data recorder, which was borrowed from one of the concrete suppliers in Costa Rica. This recorder has 15 channels to connect the strain gauges and has a capacity to read data 10,000 times per second.

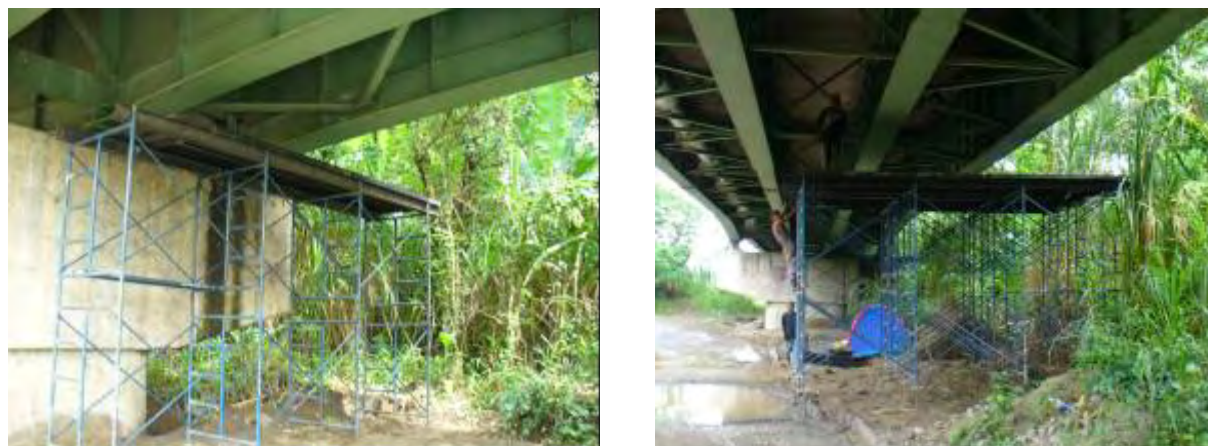
Figure 10.2.22. Scaffolding for Working Stage

The scaffolding for the stage of setting work yard was constructed under the bridge and the temporally electric power supply line, which can provide stable electric power to the measurement equipment and lighting system as shown in Figure 10.2.22.

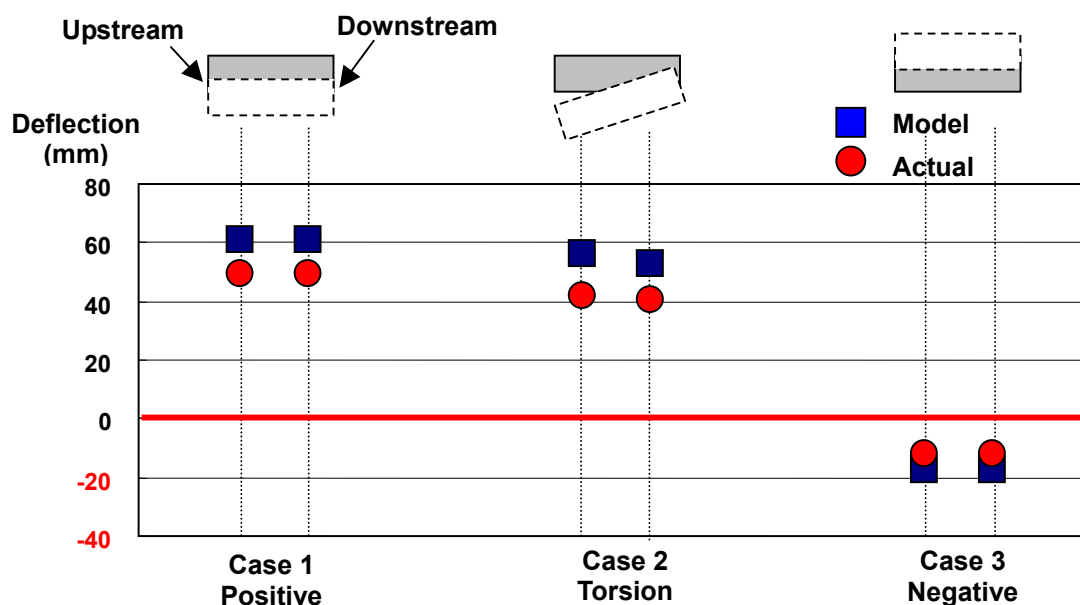
**Figure 10.2.28. Comparison of Deflection on No.17 Chirripo Bridge**

The results of deflection for the static load test on No.17 Chirripo Bridge were as shown in Table 10.2.12 and Figure 10.2.28. The deflections on the model were calculated by the structural model using the actual load conditions in taking account of position and weight of each axle of loading trucks.

Load Case	Upstream Side			Downstream Side		
	Actual (mm)	Model (mm)	Difference (%)	Actual (mm)	Model (mm)	Difference (%)
Case 1 Max Positive	+ 49.3	+ 60.6	81.4	+ 49.3	+ 60.6	81.4
Case 2 Torsion	+ 41.5	+ 55.1	75.3	+ 40.7	+ 53.6	76.0
Case 3 Max Negative	- 12.0	- 17.7	67.8	- 12.1	- 17.7	68.4

Therefore, the existing condition of the bridge main girder can be considered as followings;

- 1) The construction work satisfied the requirement of original design and/or specification. And the quality of main girder satisfies the requirement of original design.
- 2) In the girder, there are not any cracks or defects that lead decline of stiffness of the girder.
- 3) Decrease of elastic modulus of concrete caused by deterioration, such as carbonation, is not occurred

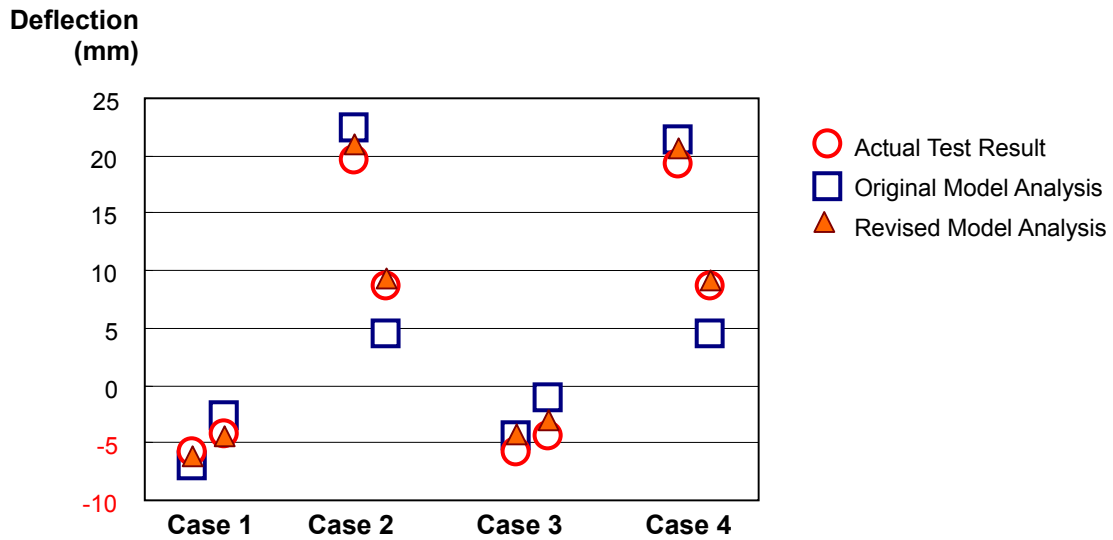
Figure 10.2.30. Comparison of Deflections Between Actual and Models

As paying attention to the differences between deflections of two girders, the structural model was revised by increasing the stiffness of the connection member between girders in taking account of the stiffness by the slab deck. The defections and stresses by the revised model become closer to the actual ones than by the original model as shown in Figure 10.2.30 and 10.2.31.

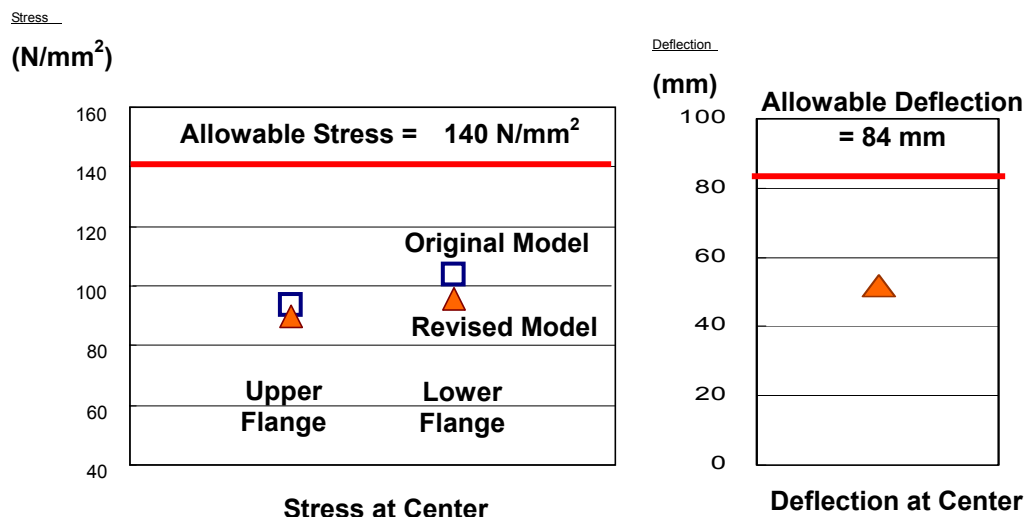
Figure 10.2.32. Stress and Deflection for HS20+25% by Revised

Based on the revised structural model, the deflection and stresses of flange were analyzed for the increased design live load HS20 + 25%. Both deflection and stress at the center of the span are smaller than the allowable ones as shown in Figure 10.2.32.

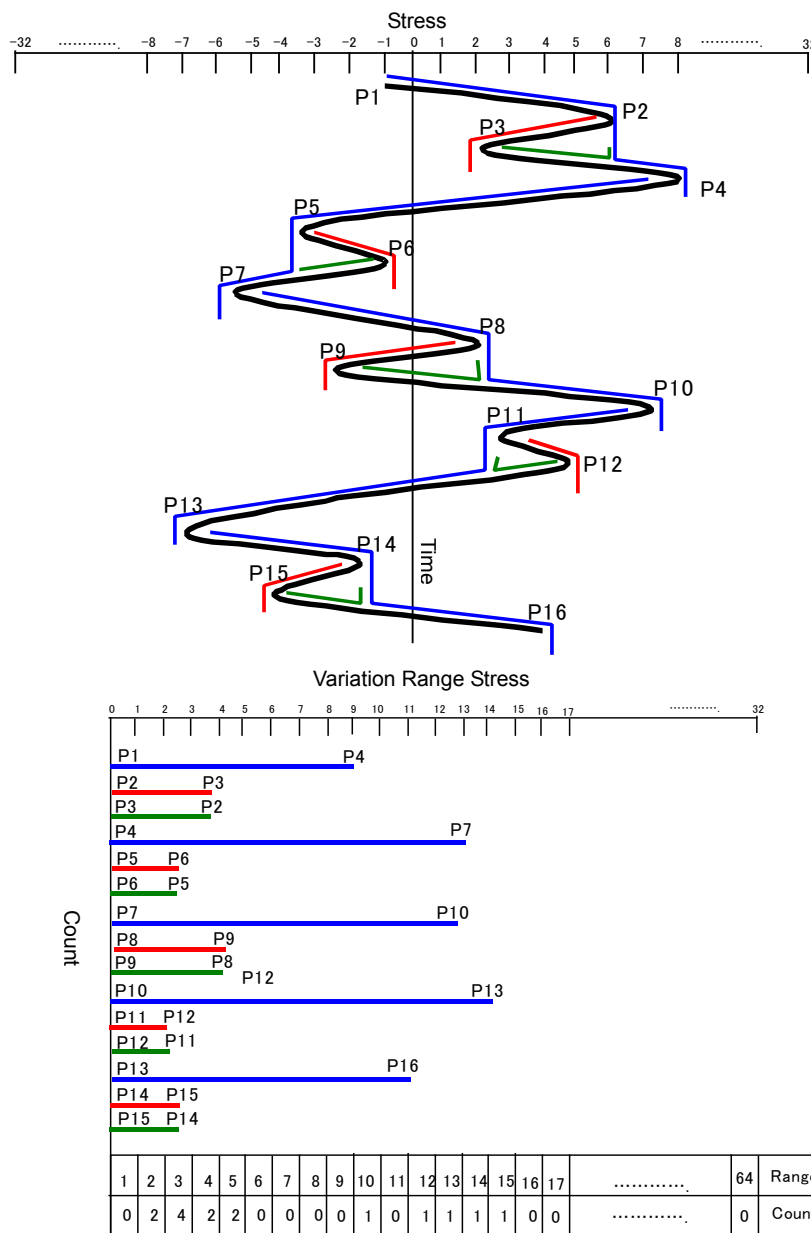
**Figure 10.2.35. Image of Rain Flow Method**

The Rain Flow Method is a method to transform the stress wave to the stress frequency distribution by attending a variation range of stress (i.e. a difference between maximum value and minimum value). The wave pattern is considered as a multiplex roof and the differences are counted like as that raindrops flow down from the root of all roofs as shown in Figure 10.2.35. The stress frequency distribution during test period is summarized to the repeated number for each variation rang.

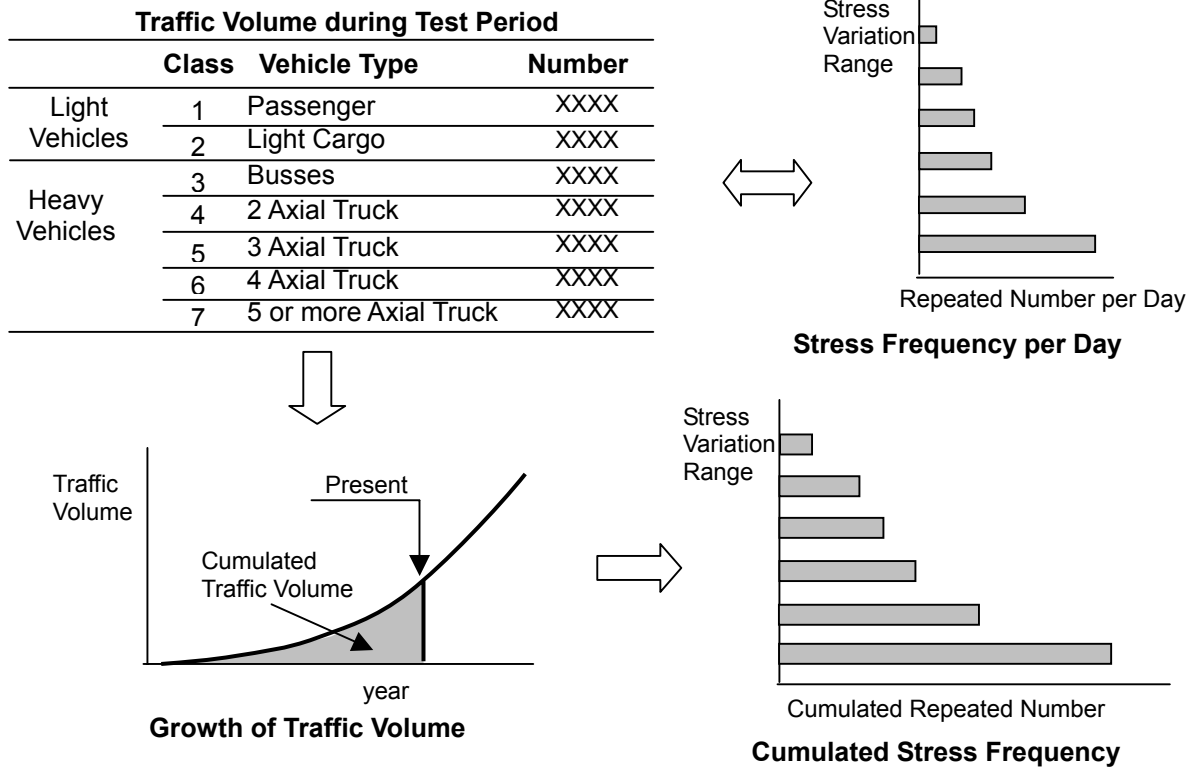
**Figure 10.2.36. Cumulated Repeated Number**

The cumulated repeated number for each stress variation range can be calculated based on the traffic volume observed during the test period and the traffic volume data for past years. The traffic volume used for the affection by fatigue.

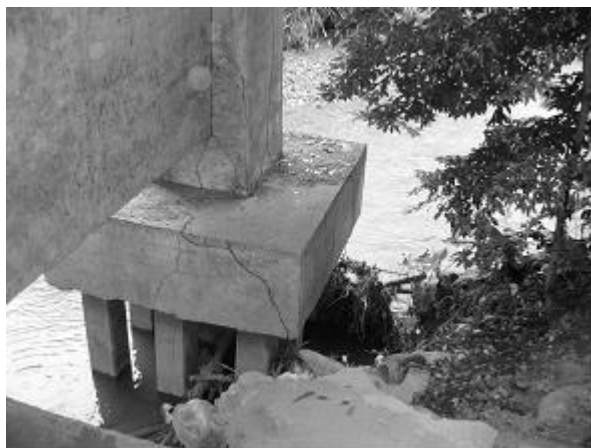
**Figure 10.3.1. Scoring of Riverbed on No.16 Nuevo Bridge**

No.16 Nuevo	1.2	<ul style="list-style-type: none"> <li>- Riverbed is scoured deeply whole width of river flow, not only in the area around bridge site but also wide area both upper and down stream sides.</li> <li>- Riverbed comes down about 6m from its original level at bridge site.</li> <li>- Piles of both piers are exposed by scoring.</li> <li>- Slope protection works in front of both abutments are broken by erosion.</li> </ul>
No.17 Chirripo	1.5	<ul style="list-style-type: none"> <li>- Slope protection of A2 abutment is eroded.</li> <li>- Riverbed is scoured with whole width.</li> <li>- Ordinary river flow area has been changed by the influence of quarries located at both up and down stream direction.</li> </ul>
No.19 Sarapiquí	0.5	<ul style="list-style-type: none"> <li>- Slope protection of A2 abutment is eroded.</li> <li>- Riverbed around P2 pier is scoured.</li> </ul>
No.20 Sucio	2.4	<ul style="list-style-type: none"> <li>- Riverbed is cover with huge rocks with more than 2 m diameter brought by flood. Damages caused by these rocks are found on pier.</li> <li>- Slope protection of A2 abutment is eroded by rain flow.</li> </ul>

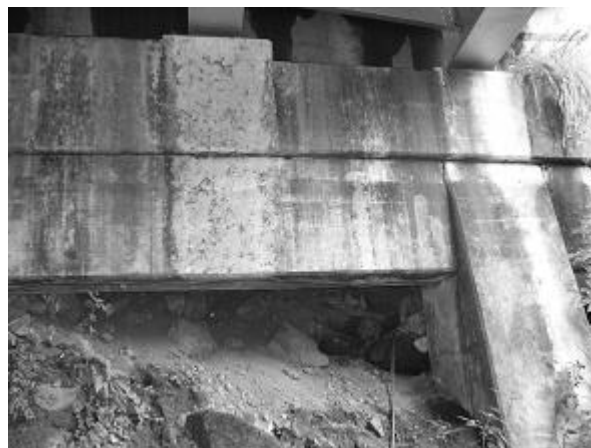
The erosions of backfill soil behind abutment are observed at many bridges, where, the pier type abutments are used. These erosions were occurred by the erosion of the slope protection in front of the abutment, which caused by floods or drain of rainwater around abutment. These erosions of backfill cause the settlements of road surface behind the abutment.

**Figure 10.3.2. Erosion of Backfill on No.12 Puerto Nuevo Bridge**

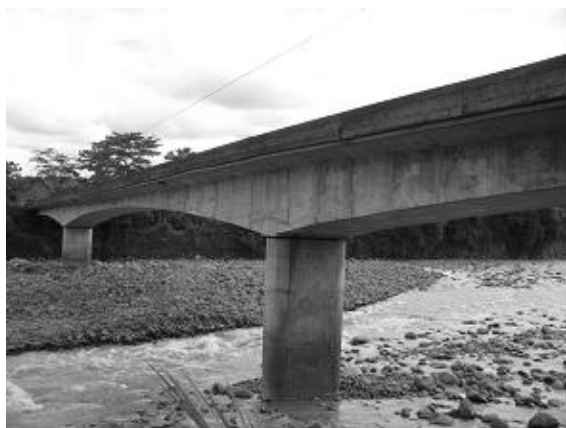
The flood flow velocity is very fast in the most of rivers, because the river profiles are very steep as shown in Table 10.3.1. At the bridges, such as No.17 Chirripo Bridge and No.20 Sudio Bridge, located on steep mountain area, large size of rocks are carried by flood and cover the riverbed as a deposit. These large rocks hit the piers and damaged them.

**Figure 10.3.3. Large Rock Deposit on No.17 Chirripo River Bridge**

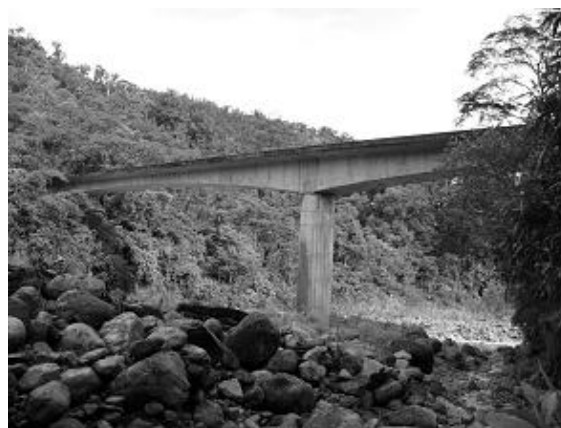
**Figure 10.3.4. Large Rock Deposit on No.20 Sucio River Bridge**
