## **14.5 Bridge Report System**

## CHAPTER 15 TOOLS FOR BRIDGE MAINTENANCE MANAGEMENT

## CHAPTER 16 TECHNICAL SUPPORT FOR ENVIRONMENTAL AND SOCIAL CONSIDERATIONS

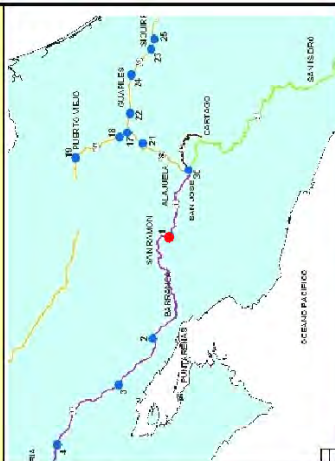
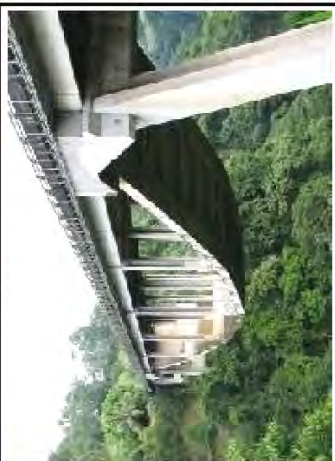
AÑO		1,940		Year								
TOTAL DE VEHICULOS		15,385		Car								
% DE VEHICULOS PESADOS		13.00		%								
RESTRICCIONES		POR CARGA		15.0		t						
RESTRICCIONES		POR ALTURA		4.5		m						
RESTRICCIONES		POR ANCHO		6.0		m						
DIMENSIONES												
ANCHO TOTAL		11.3 m		CALZADA		10.7 m						
ITEMS		1		2		3		4		5		7
W(m)		0.3		0.6		4.25		0		4.25		0.6
H(m)		0.49		0.35		0.24		0		0.24		0.35
W1		W2		W3		W4		W5		W6		W7
H1		H2		H3		H4		H5		H6		H7
CLARO LIBRE												
ALTURA LIBRE VERTICAL		SUPERIOR		INFERIOR		m		WAPROX		10.0		m
ANTECEDENTES DE INSPECCION												
DIA		MES		AÑO		INSPECTOR		TIPO DE INSPECCION				
4		10		2005		Gabriela Jorge		Routine Inspection				*
4		10		2000		Gabriela Jorge		Inventory Inspection				*
CRUZA SOBRE		2										*
ANTECEDENTES DE REHABILITACION												
DIA		MES		AÑO		ELEMENTOS		RESUMEN DE CONTRAMEDIDAS				
4		10		2005		PAVIMENTO		Debido al daño severo. Pavimentar sobrecapa				
4		10		2000		JUNTA DE EXPANSION		Cambiar debido al mucho desnivel de la junta de expansion

OBSERVACIONES												
Dificultar la inspección de sub estructura debido a la ubicación montañosa

This form presents the basic design data, deck geometry, clearance of road, and history of inspection and repair. Visual information including location map and panoramic view of bridge and the specific feature of the bridge are recorded in this form. The code for the location of a bridge, the bridge type and the type of pavement are instructed in the coding guide.

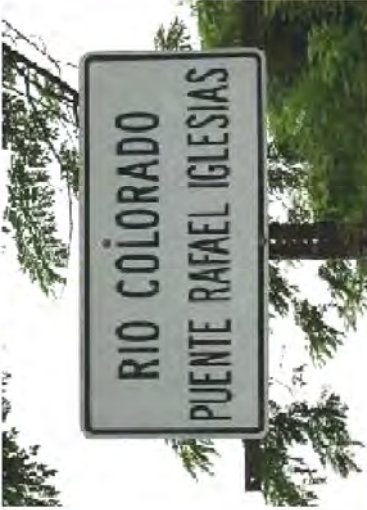
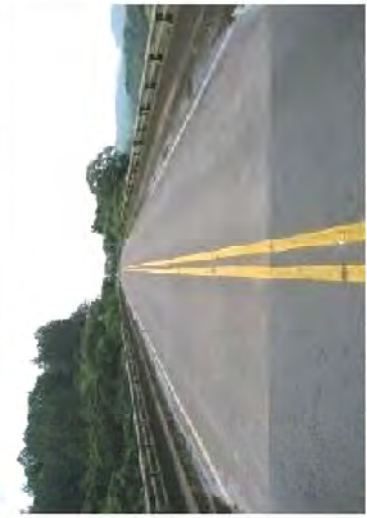
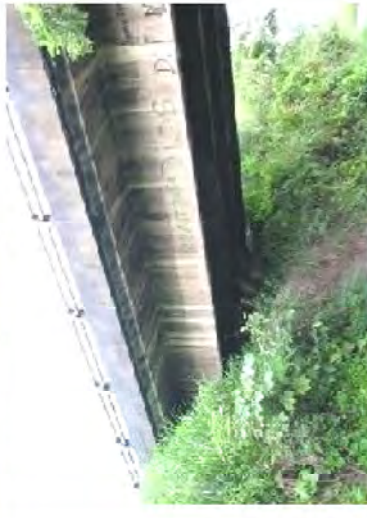
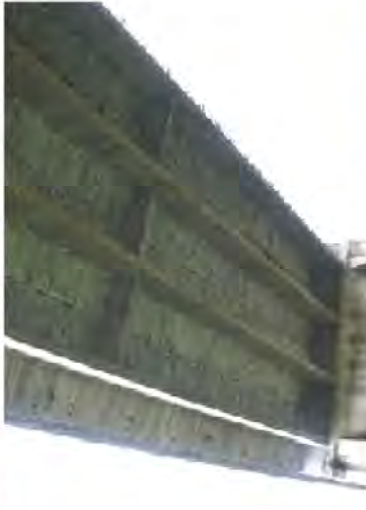
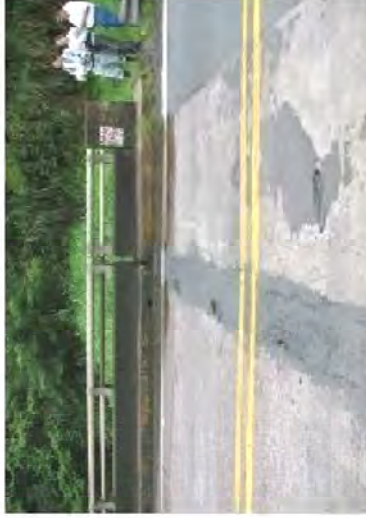
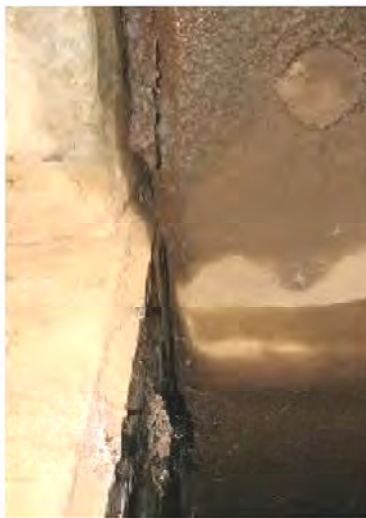
Form - 5 Photos of the Bridge

INVENTARIO BASICO DE PUENTES (FOTOS)												NO. 1 / 3						
NOMBRE DEL PUENTE	Colorado River		001		PROVINCIA	* ADMINISTRADO POR	Colorado		* UBICACION	No.	* UBICACION	No.	* UBICACION	LATERAL	DIA	MES	AÑO	
	No. DE LA RUTA	CLASIFICACION	Primary	* LOCALIDAD			CANTON	* LATITUD NORTE										12
KILOMETRO	35.756		km		DISTRITO	* LONGITUD ESTE	12	34	56.7	FECHA DE CONCLUSION DE CONSTRUCCION	31	3	1970					
No.	1	UBICACION	SEÑAL DEL PUENTE		No.	2	UBICACION	SUPERFICIE (PAVIMENTO)		No.	3	UBICACION						
NOTA

DIA	MES	AÑO	
No.	4	UBICACION	INFERIOR DE LA VIGA		No.	5	UBICACION	JUNTA DE EXPANSION		No.	6	UBICACION	APOYO			DIA	MES	AÑO
NOTA

Photos which show the typical feature of the bridge shall be recorded in this form. The inspector must provide 400 dot x 600 dot digital color photographs of each bridge for the bridge Inventory file. Photos on this form do not necessarily need to be updated when the inspection is carried out. However, when the major repair works or reinforcement works are carried out, the photos on this form shall be renewed. The following photos must be presented.

1. A photo with the name of the bridge on a record plate of a bridge or a road sign. In case the name of the bridge is not available on the bridge, the inspector should write the name of the bridge on a paper with a clip board and photograph it.
2. A view of the road way along a centerline of a road way. The direction should be in the increasing station direction and the general condition of the pavement on the bridge shall be observed.
3. A view of the elevation of the bridge which show major components of the bridge.
4. An underside view of the bridge such as the floor system of the bridge.
5. Upstream river views which should be taken from the bridge deck.
6. A weight limits sign or a notice sign for the bridge. The signs should be legible in the photos.

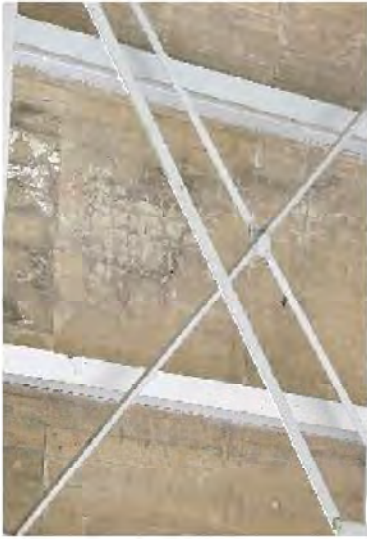
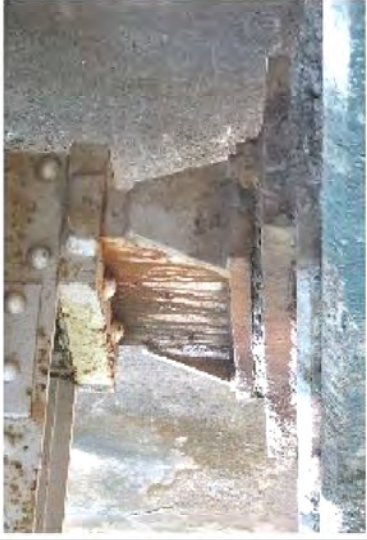
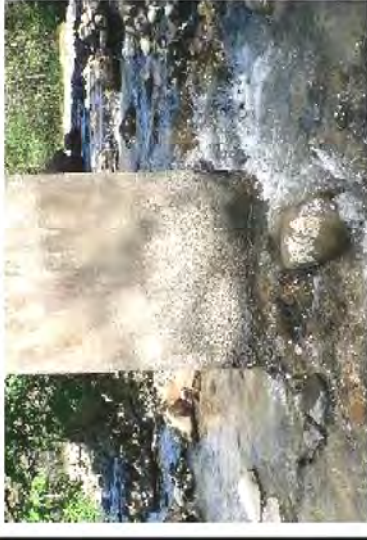
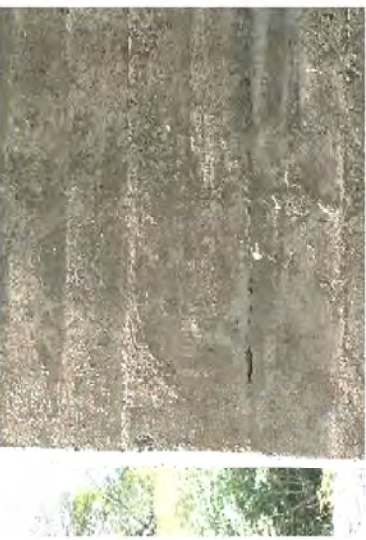
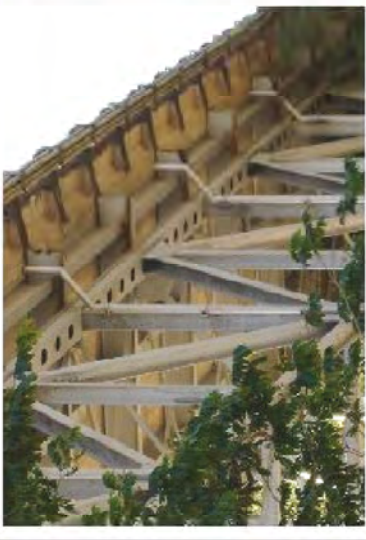
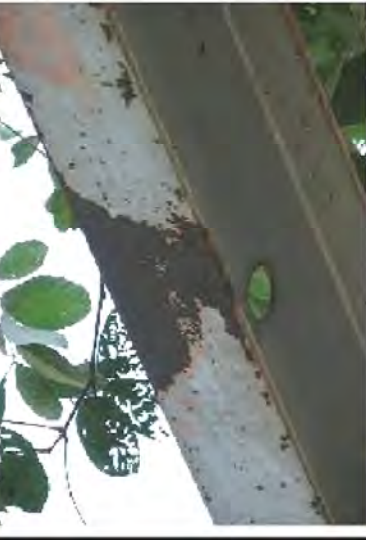
Form – 7 Photos of the Elements of the Bridge

INSPECTION DE PUENTES (FOTOGRAFIA)										NO. DE ESTRUCTUR		NO. 1 / 3					
NOMBRE DEL PUENTE		Colorado River		001		ADMINISTRADO POR		Colorado		DIA		MES		AÑO			
No. DE LA RUTA		1		CLASIFICACION		Primary		* LOCALIDAD		FECHA DE DISEÑO		31		3 1968			
KILOMETRO		35.756		UBICACION		km		* LONGITUD ESTE		FECHA DE CONCLUSION DE CONSTRUCCION		31		3 1970			
No.		1		UBICACION		DECK SLAB		No.		3		UBICACION		PIER			
NOTA

DIA		MES		AÑO		NOTA		DIA		MES		AÑO	
No.		4		UBICACION		PIER		No.		5		UBICACION		MEMBER OF RAMEN		No.	
NOTA

DIA		MES		AÑO		NOTA		DIA		MES		AÑO	
No.		5		UBICACION		MEMBER OF RAMEN		No.		6		UBICACION		MEMBER OF RAMEN		No.	
NOTA

DIA		MES		AÑO		NOTA		DIA		MES		AÑO	
No.		6		UBICACION		MEMBER OF RAMEN		No.		3		UBICACION		MEMBER OF RAMEN		No.	
NOTA

DIA		MES		AÑO		NOTA		DIA		MES		AÑO	
No.		18		UBICACION		PIER		No.		31		UBICACION		MEMBER OF RAMEN		No.	
NOTA

No.		31		UBICACION		MEMBER OF RAMEN		No.		3		UBICACION		MEMBER OF RAMEN		No.	
NOTA

The photos on this form should correspond to the Condition Rating on Form-6 and this form should be renewed when the inspection will be carried out. Not only should the photos of the elements of the bridge with major damages but also the bridge elements with no significant deterioration be recorded in this form. The photos in this form shall include

1. The expansion joints. If the joint is covered by the overlay pavement, the area where the expansion joint is supposed to exist should be photographed.
2. The bearings of the bridge. If there is not a bearing on a bridge, the boundary between a superstructure and a substructure should be photographed.
3. Underside view of a deck condition.
4. Underside view of a floor system.
5. The abutments of the bridge.
6. The approach embankment bound to the wing wall of an abutment showing slope erosions should be photographed.

7. Slope protection in front of the abutment
8. The piers of the bridge. Any scour or significant erosion that is present should be photographed.
9. If the pavement on the bridge is repaired by overlay, the thickness of the overlay of the pavement shall be examined and its thickness showing by a measure should be photographed.
10. The components with a major deteriorated condition. The photo should be taken of features which, in the opinion of the inspector, are unusual, non –standard, or poorly repaired.

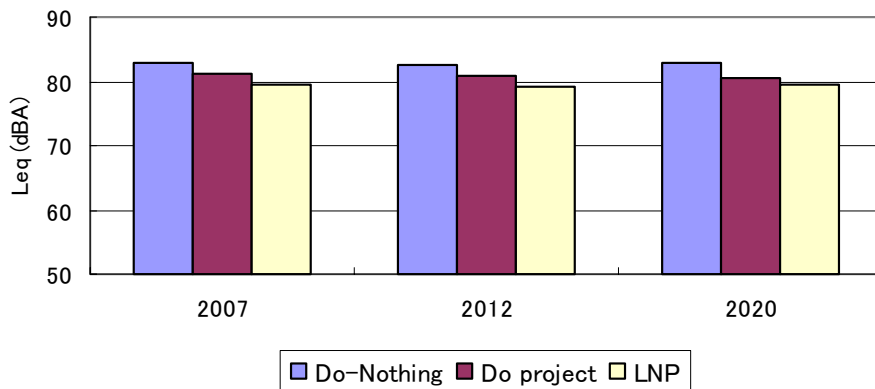
Note: Leq value under different scenarios are presented. "LNP" indicates Low Noise Pavement case

Figure 16.2.4. Noise Prediction Study Result
