JAPAN INTERNATIONAL COOPERATION AGENCY (JICA)  
EARTHQUAKE RECONSTRUCTION AND REHABILITATION AUTHORITY (ERRA)

# **THE URGENT DEVELOPMENT STUDY ON REHABILITATION AND RECONSTRUCTION IN MUZAFFARABAD CITY IN THE ISLAMIC REPUBLIC OF PAKISTAN**

## **FINAL REPORT I VOLUME 3 : SECTOR REPORT**

January 2007

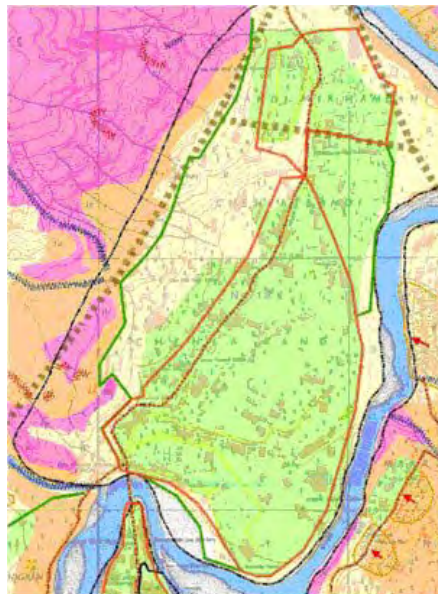
**Figure 1.3.1 A Zone**

Special consideration is needed for this area because there may be comparatively large ground motion when the Tanda fault slips. Comparatively large damage was reported in this area for the 2005 Kashmir Earthquake. The strike line of the fault is inflective, so this zone is enclosed from the north side and the west side by the surface faulting

- Special consideration of earthquake resistant design and construction is needed for lifeline structures such as water supply and electric power lines. Adopting flexible joints or some other special elements is possible for this purpose.

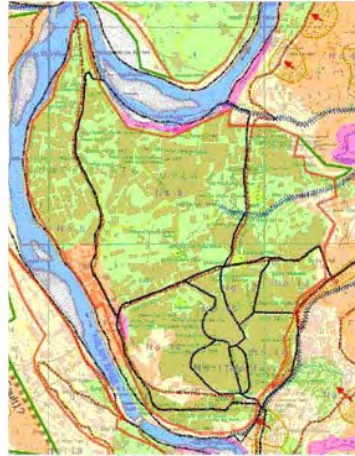
**Figure 1.3.2 B Zone**

In case of constructing buildings on cliffs, exceeding 3 m in height, it is preferable to avoid the constructing new buildings at the position where the horizontal distance from the bottom is less than twice the height of the cliff. If buildings are constructed in this danger area, protection work to prevent fall of the cliff and suitable measures to prevent the penetration of the cliff should be installed.

In case of buildings exceeding 3 m under the cliff, it is preferable to avoid construction of new buildings at the position where the horizontal distance from the top is less than twice the height of the cliff. (reference was made to the Japan ordinance in the above-mentioned description.)

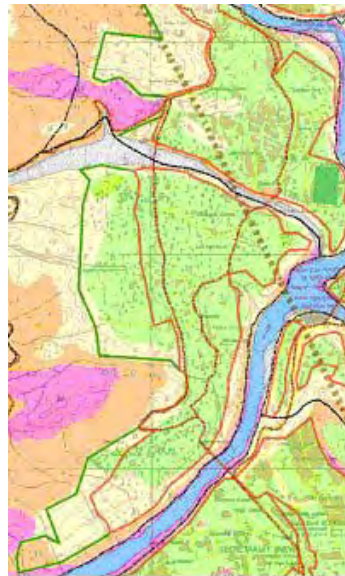
**Figure 1.3.5 E Zone**

- Hospitals, Schools (They are important for Urgent rescue and relief operations after an earthquake)
- Bridges (They are needed for access between a damaged area and other areas)
- Administration Buildings

Special consideration of earthquake resistant design and construction is needed for lifeline structures such as water supply and electric power lines. Adopting the flexible joints or some other special elements is possible for this purpose.

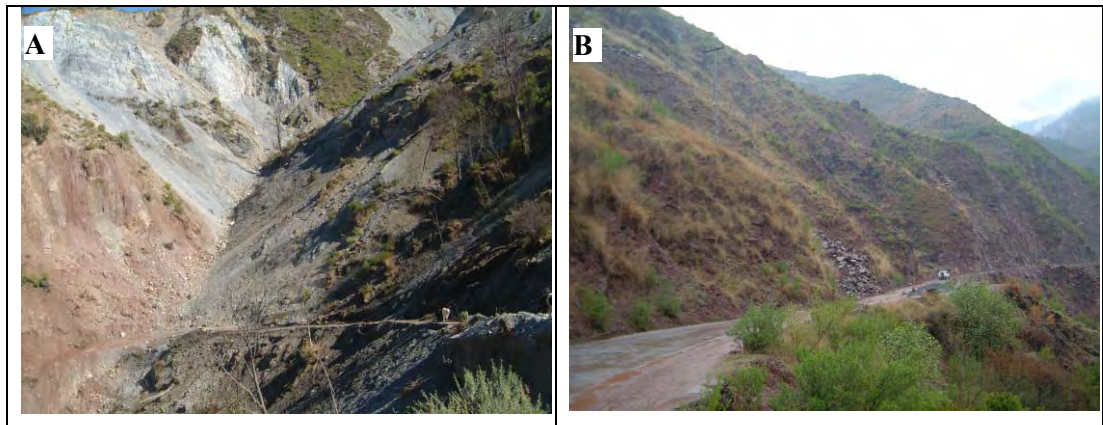
**Figure 2.2.3 Rock Mass Collapses occurred on (A) Limestone and (B) Sandstone and Shale**

Various sizes of rock mass collapses are distributed primarily on the steep rock outcrops of limestone, sandstone and shale that are strongly jointed and cracked. After rock mass

collapses, the exposed rock faces are mostly deteriorated into CL class and locally into D class rock mass (Figure 2.2.3 A and B).

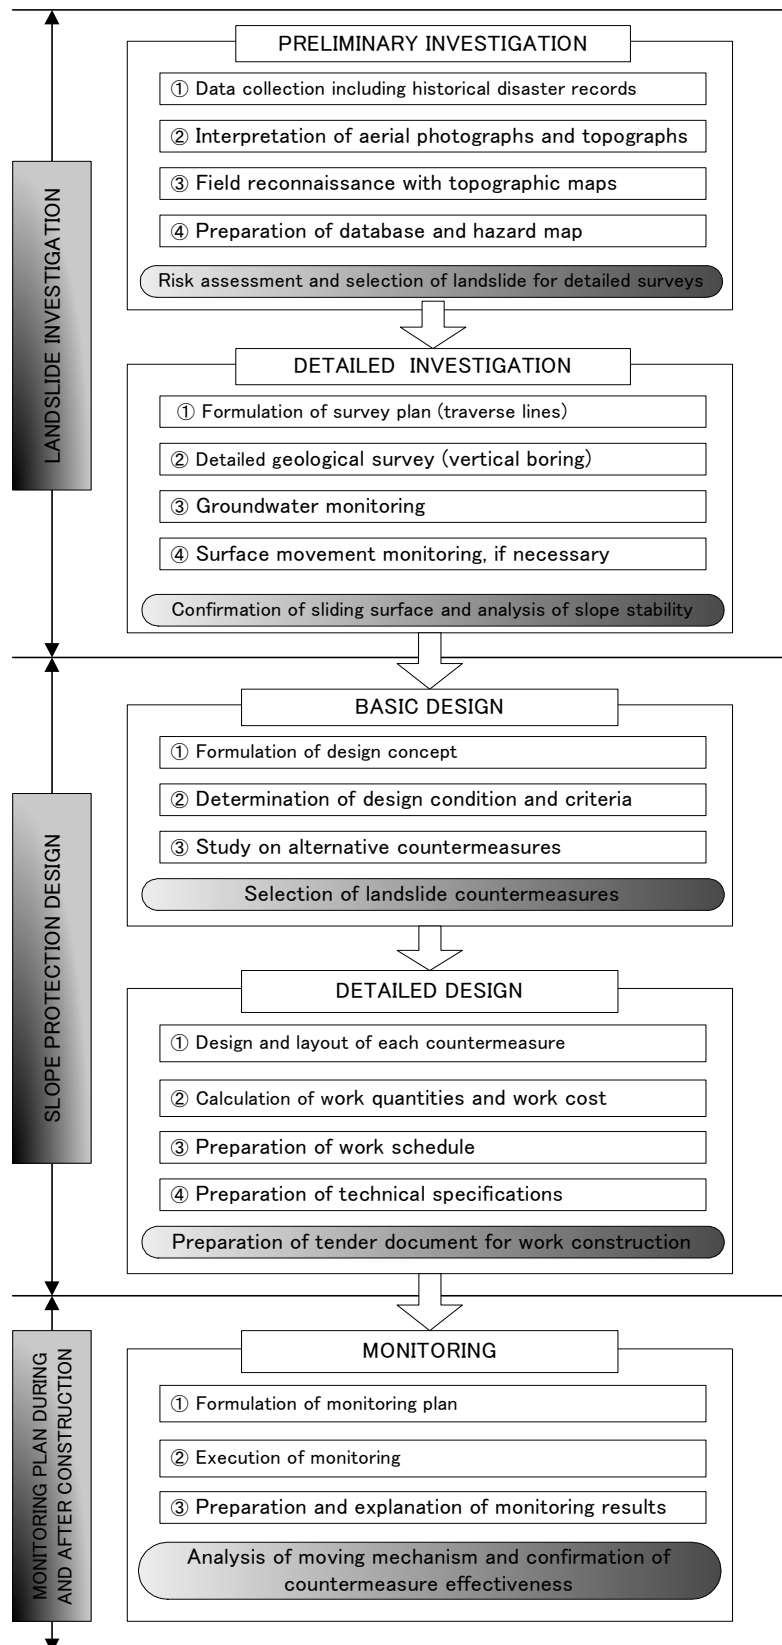
**Figure 2.3.2 General Flowchart for Landslide Investigation and implementation of Preventive Measures**

Figure 2.3.2 gives the proposed procedures for landslide investigation and design of stabilization works. Table 2.3.2 shows various countermeasures and their applicability.
