6. REHABILITATION AND RECONSTRUCTION OF SOCIAL INFRASTRUCTURE

6.1. Review of Existing Social Infrastructure in Muzaffarabad Municipality

6.3. Damage Inventory Survey

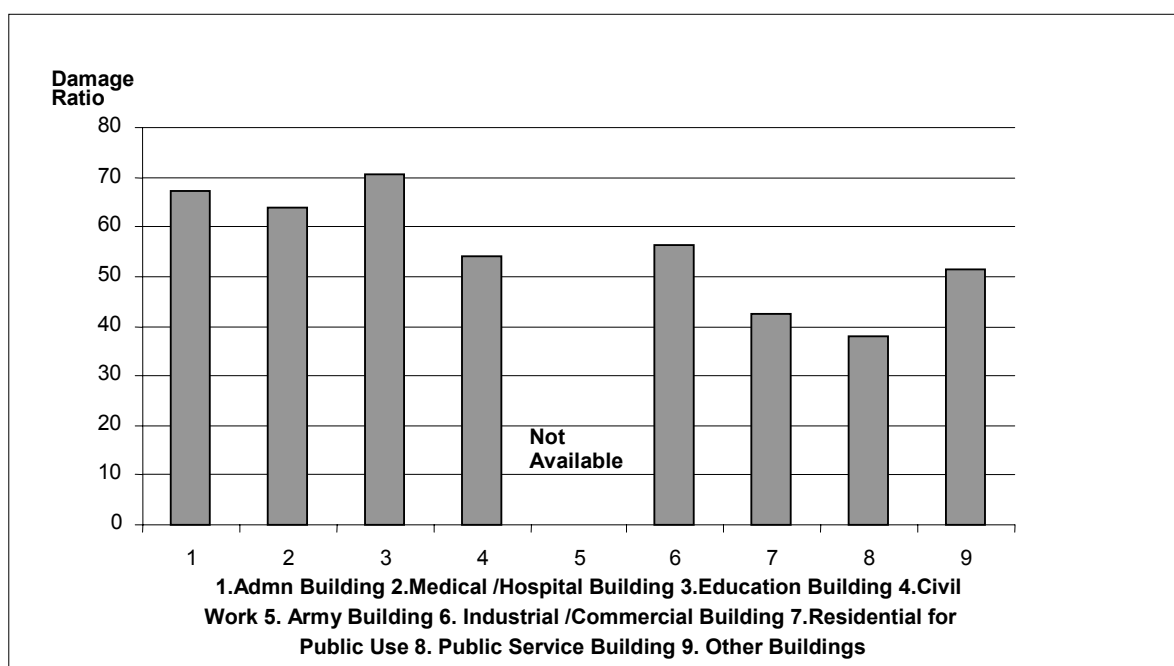
Figure 6.3.1 Damage Ratios of Government Buildings

The Study Team conducted the damage inventory survey for the government building structures in Muzaffarabad Municipal Area. Figure 6.3.1 shows the summary for survey

results of structure damages, location of damage buildings and area of building by visual inspection. Table 6.3.2 shows the damage ratio of existing building structures.

S#	Type of Building	No of Buildings Surveyed	Demolished	Damaged	Damage Ratio
1	Administration Buildings	33	11	22	67.34
2	Medical / Hospital Buildings	5	2	3	63.67
3	Education Buildings	35	17	18	70.5
4	Civil Work	5	1	4	54
5	Army Buildings	N.A.	N.A.	N.A.	N.A.
6	Industrial / Commercial Buildings	8	2	6	56.24
7	Residential for Public use	12	2	10	42.5
8	Public Service Buildings	27	5	22	37.96
9	Other Buildings	20	4	16	51.49

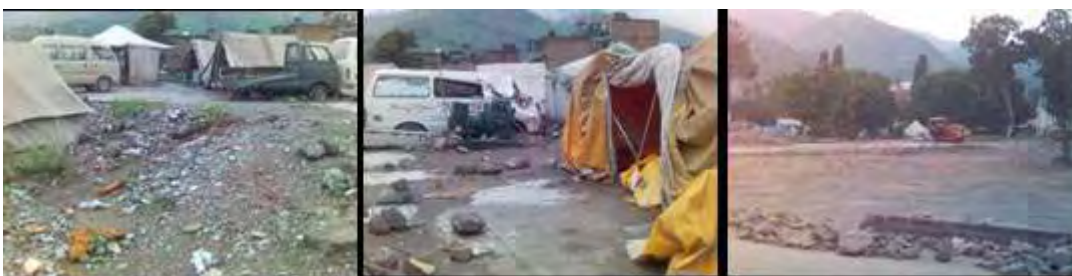
Photo 1

Photos 1 & 2 show the temporary hospital on the site of completely collapsed DHO/Civil Hospital. Photo 3 shows the site of completely collapsed CMH.

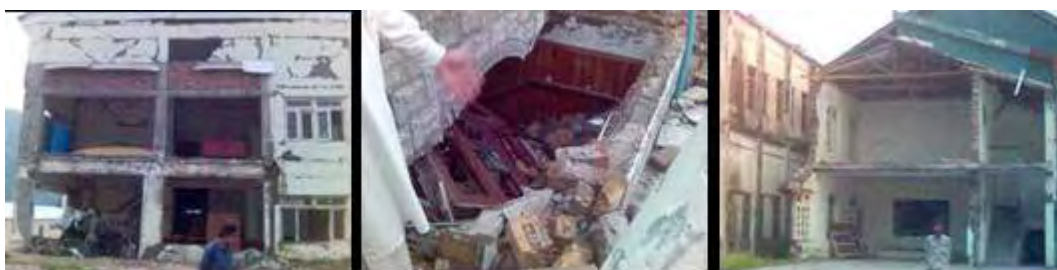
Photo 4 shows the existing condition of Government Boys College, Eidgah Road.

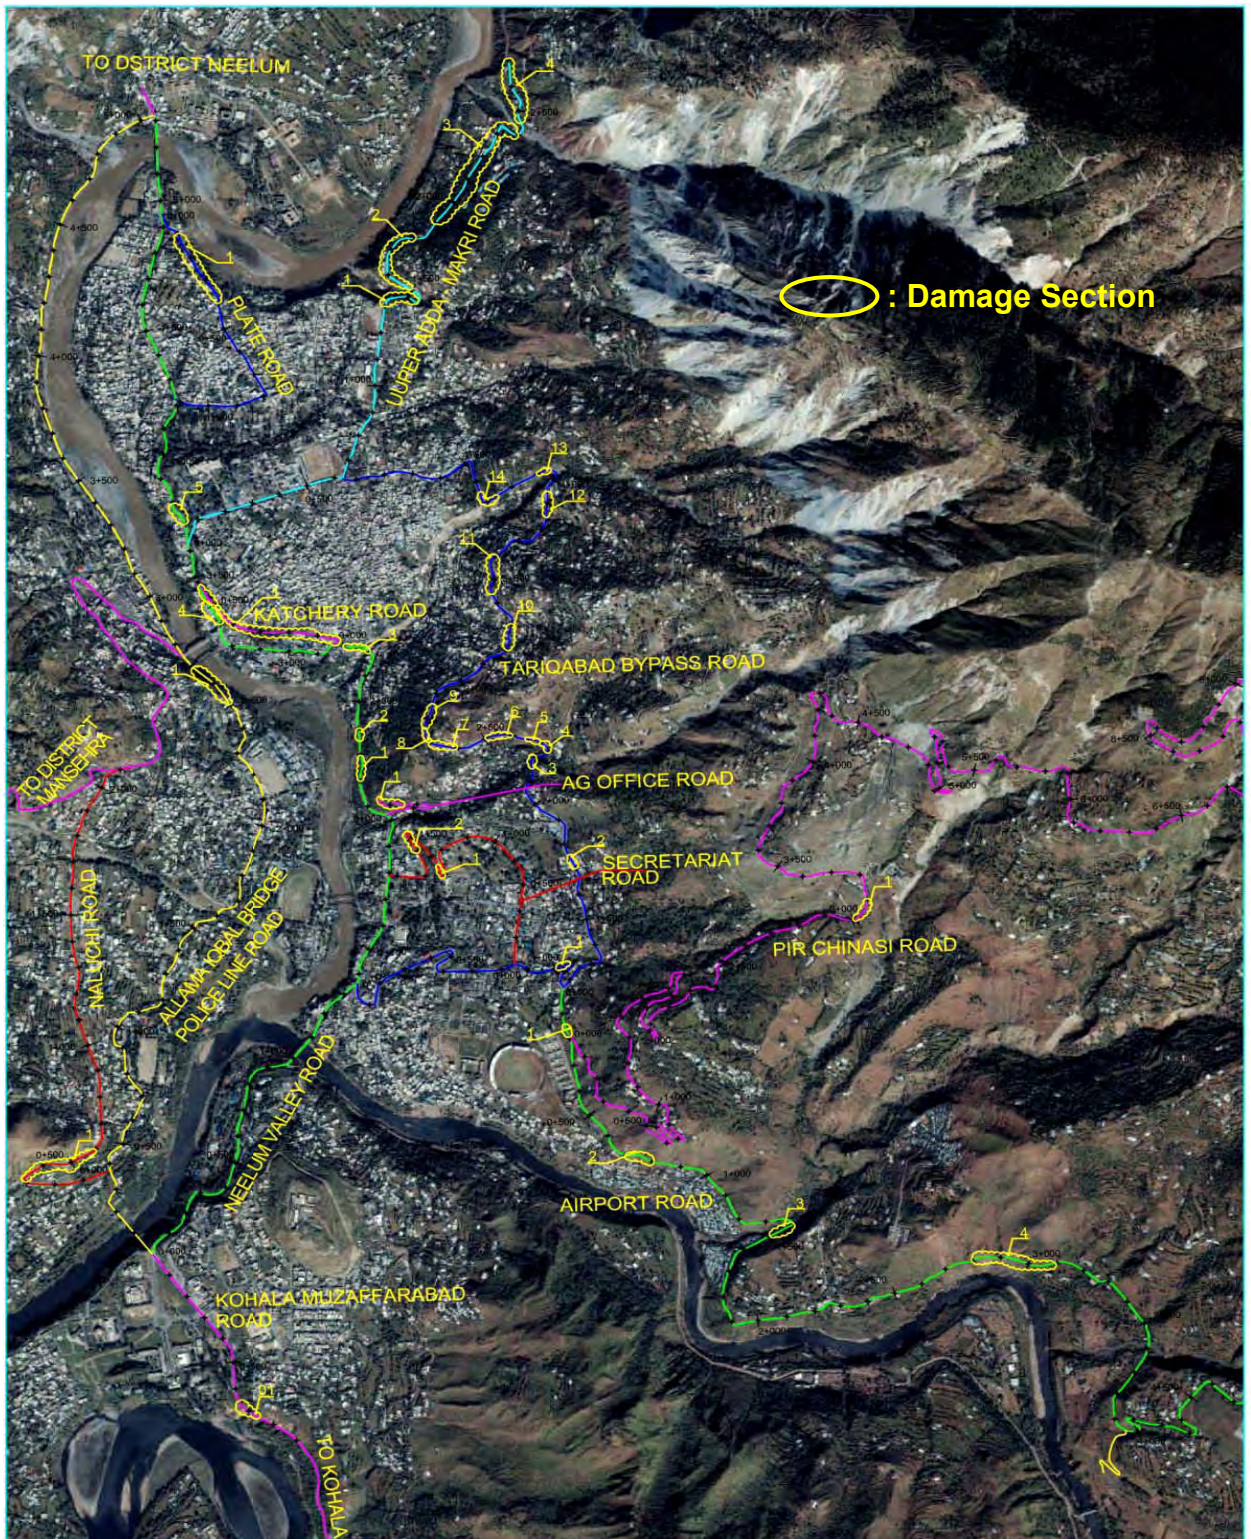
Figure 7.2.1 Road Damage Sections in Muzaffarabad City

3	1+400	1+500	100	Retaining wall on valley side and slope collapse on hill side.	under progress of retaining wall work on valley side.
		Total :		250		
Pir Chinasi Road	1	3+000	3+100	100	Retaining wall.	
Accountant General Office Road	1	2+250	2+350	100	Retaining wall, road shoulder and part of carrageway on valley side, and slope collapse on hill side.	
Secretariat Road	1	1+300	1+350	50	Retaining wall on hill side.	
	2	1+500	1+600	100	Road shoulder on valley side, and slope collapse on hill side.	
		Total :		150

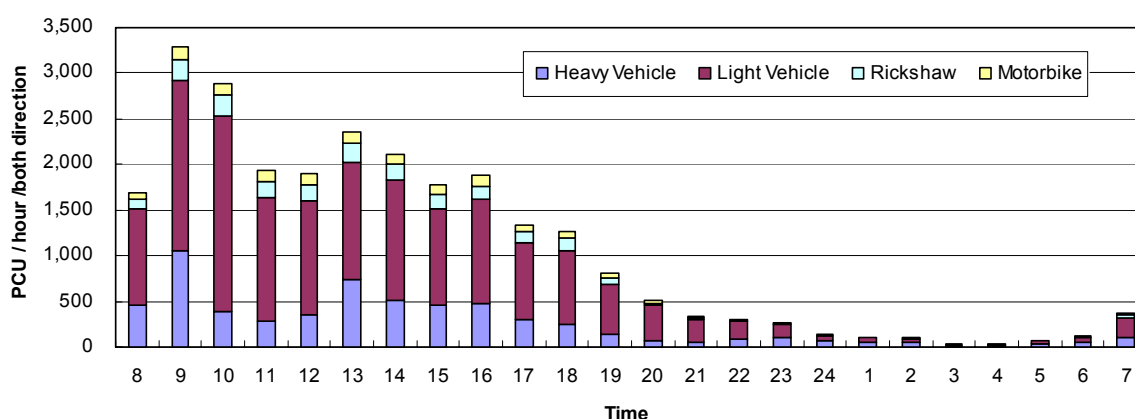
Figure 7.4.1 Hourly Traffic Volume Distribution (unit: PCU) (1/2)

[Domal Bridge of Muzaffarabad City Side : Neelum Valley Road]

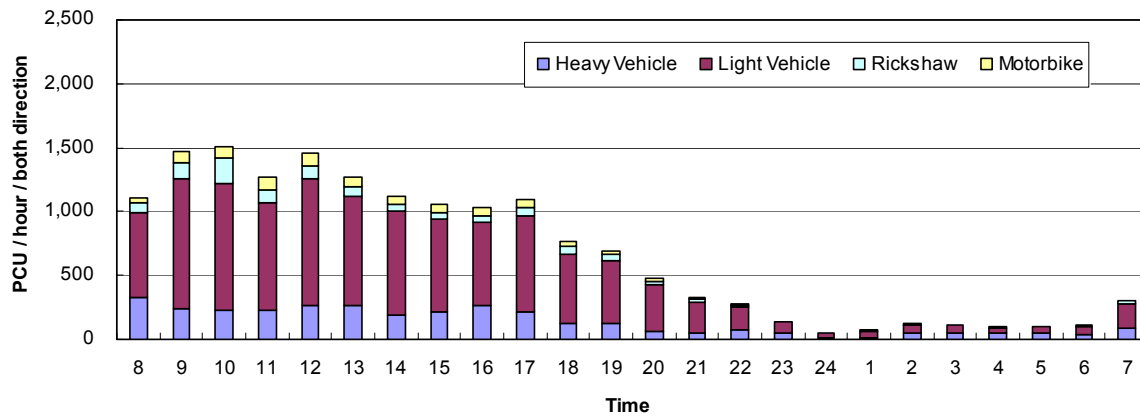
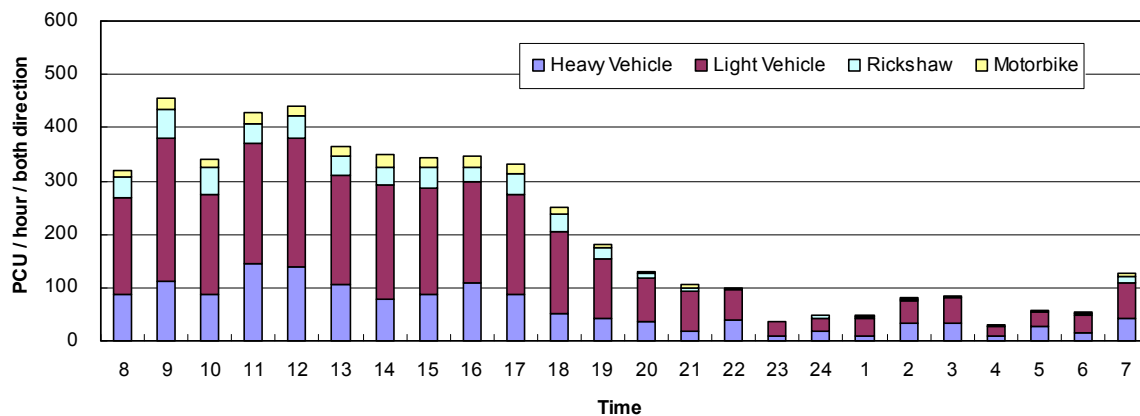
Figure 7.4.2 Hourly Traffic Volume Distribution (unit: PCU) (2/2)

[Domal Bridge of Kohala Side : Kohala-Muzaffarabad Road (S-2)]

[Beginning of Jhelum Valley Road]

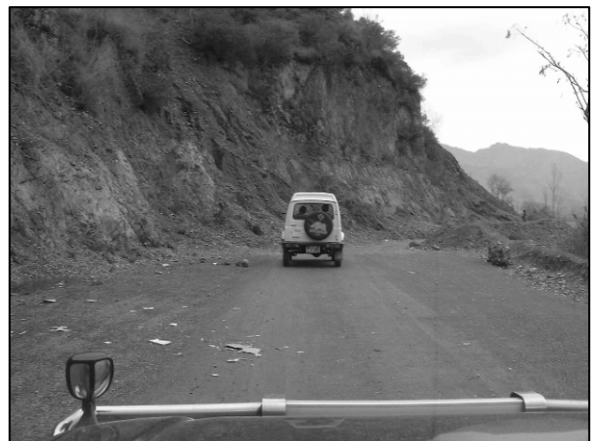
Naluchi Road is to connect with New Naluchi Bridge. The road has a climbing section of approximately 300 m long that was damaged when the earthquake struck causing rock-fall and slope slippage. It was vulnerable to this kind of damage because the road was constructed by cutting weathered bedrock (see Photo-1). It should be foreseen that the weakness of cutting slope would cause transport interruption by slope collapse because of the risks posed by not only

Photo-1 Slope condition on Climbing Section of Naluchi Road

earthquakes but also heavy rainfall. Therefore, the said climbing section will require measures against slope slippage and rock-fall. Figure 7.5.3 shows the samples of slope protection methods and countermeasure for slope collapse.

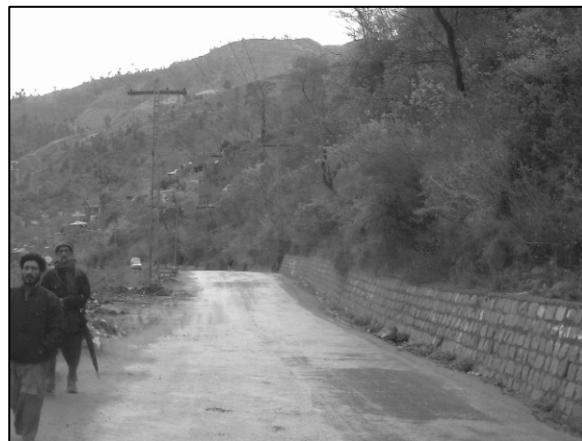
Through the survey conducted by the Study Team, a high hazardous state was confirmed along Chela Bandi Bridge – Alama Iqbal Bridge Road (see Photo-2a). Therefore, a detailed landslide hazard assessment and appropriate protection measures are necessary prior to the construction of this bypass road.

Photo-2a Landslide Hazardous Place in Chela Bandi Bridge - Alama Iqbal Bridge Road

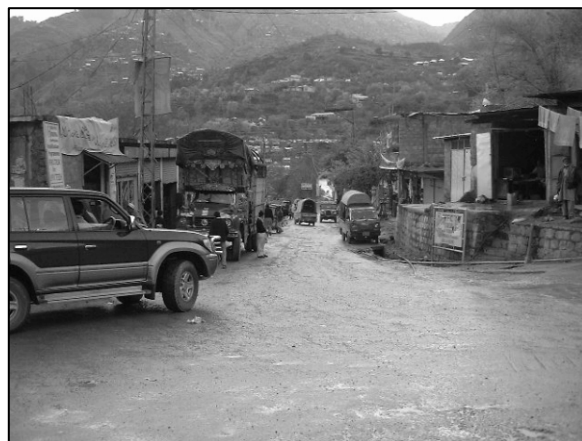
The road width at the intersection of Chela Bandi Bridge – Alama Iqbal Bridge Road and Neelum Valley Road is 4.5 m. and this narrow width is a bottleneck (see Photo-2b). To cope with the traffic demand, the widening of this intersection is proposed based on the appropriate traffic demand forecast survey.

Photo-2b Intersection of Chela Bandi Bridge - Alama Iqbal Bridge Road and Neelum Valley Road

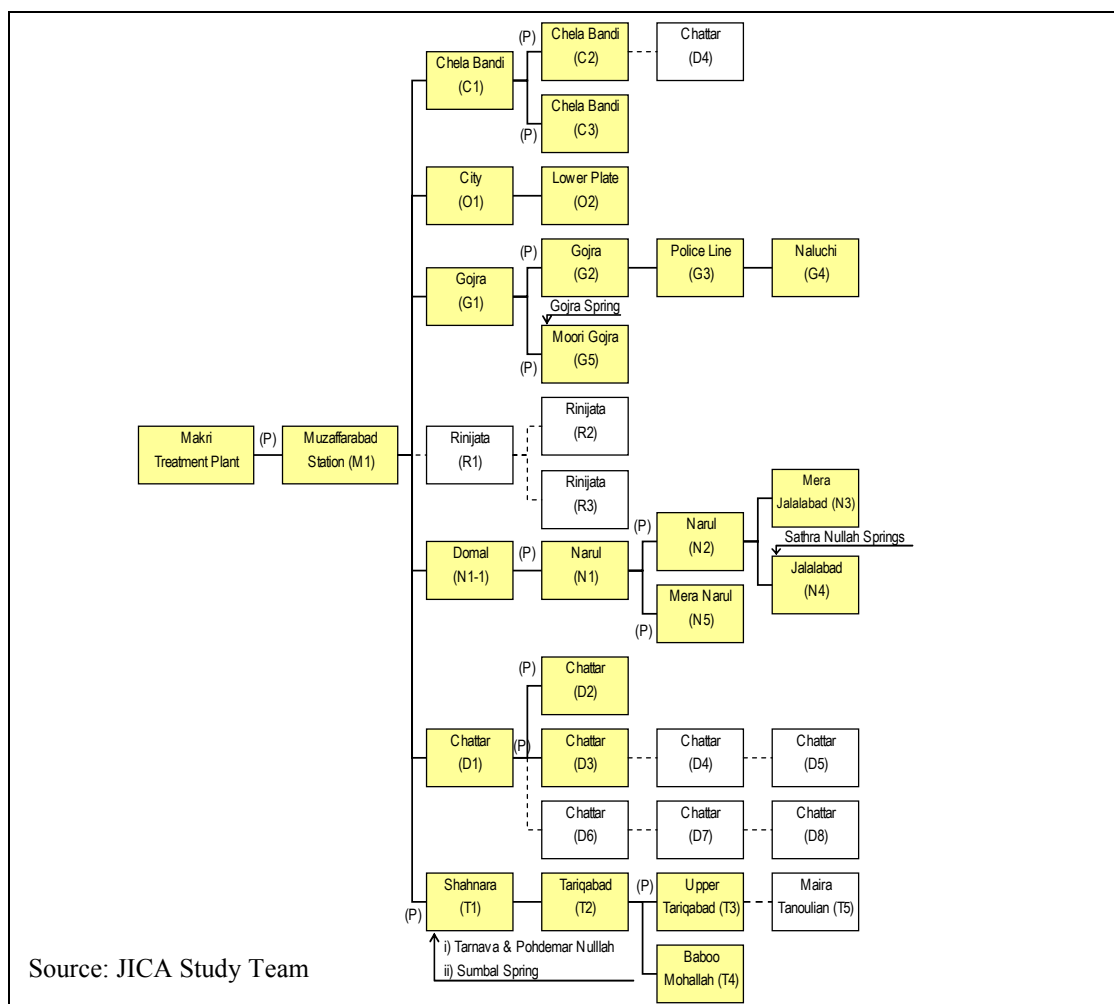
Figure 8.1.1 Diagram of Existing Water Supply System

Public Health Engineering Division (PHED) of Public Works Department (PWD) is responsible for water supply in the municipal area. Main raw water is obtained from the Neelum river which flows in north and south direction in the city. Pumped raw water from the Neelum river is treated at the Makri water treatment plant (WTP) located at the north of the old city, then pumped to M1 storage tank at the east of the old city. The Makri WTP has a treatment capacity of 4.0 million gallons per day (MGD). From M1 storage tank, the treated water was transmitted by gravity and pumping to other distribution tanks dispersed in the municipal area as shown in the figures below.

- Note 1: (P) means transmission by pumping.
 2: Yellow colored cells mean facilities specified in the pre-feasibility study for the Greater Water Supply Scheme Muzaffarabad Phase II.
 3: Colored cells mean facilities additionally indicated in a PHED location map of the water supply system in the city. Those facilities may obtain the raw water from springs and streams.

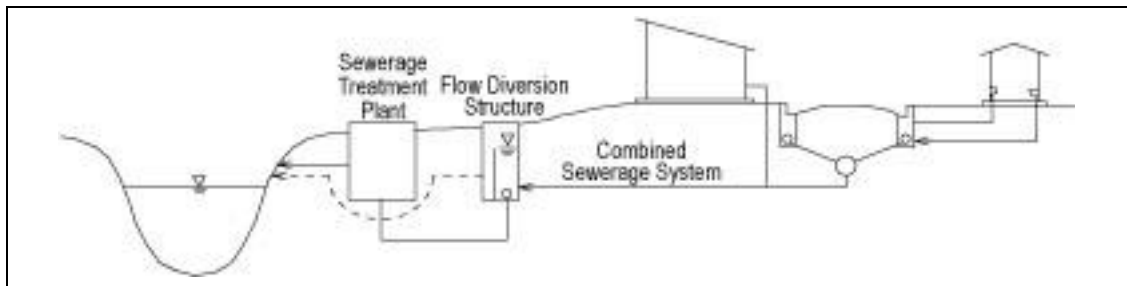
Figure 8.2.1 Combined Sewerage Collection System

Treatment process shall be primarily formed by septic tanks. In the urban promotion areas with relatively high population density, the feasibility study shall be required to examine the necessity and feasibility of a new central treatment system. The new central treatment system shall be connected to the existing sewerage pipelines by interceptor as shown in the figure below.

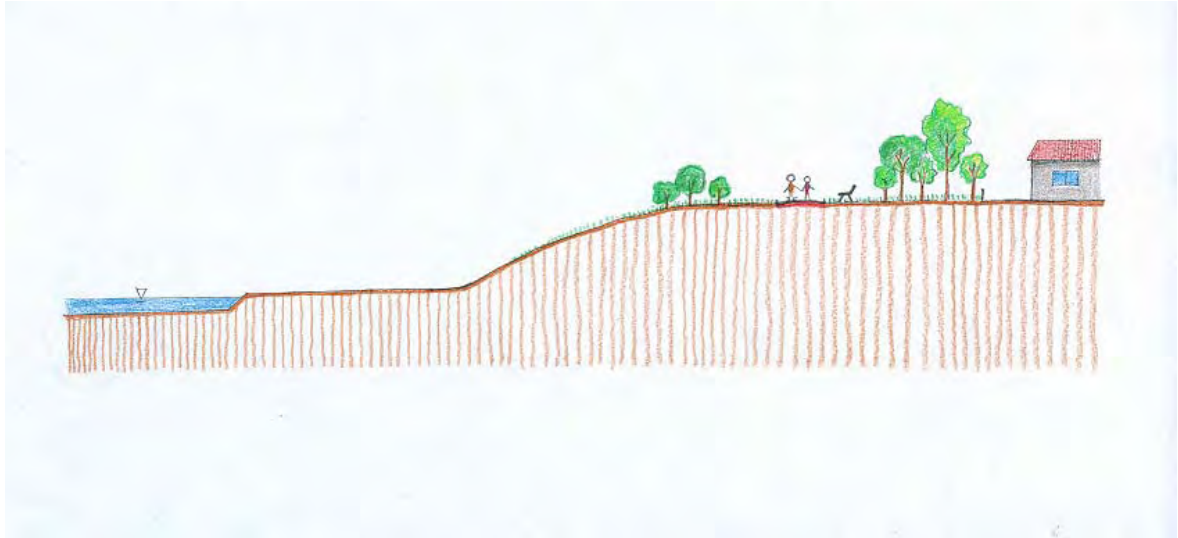
Figure 9.3.1 Example of Green Space with Footpath beside a River

Green spaces are established along a river for recreation and protection from flood. Especially, green spaces must be established along a small river which has danger of mud flood by land slide. In the green spaces, footpaths are established for comfortable walking. The example of green spaces is shown in the Figure 9.3.1.

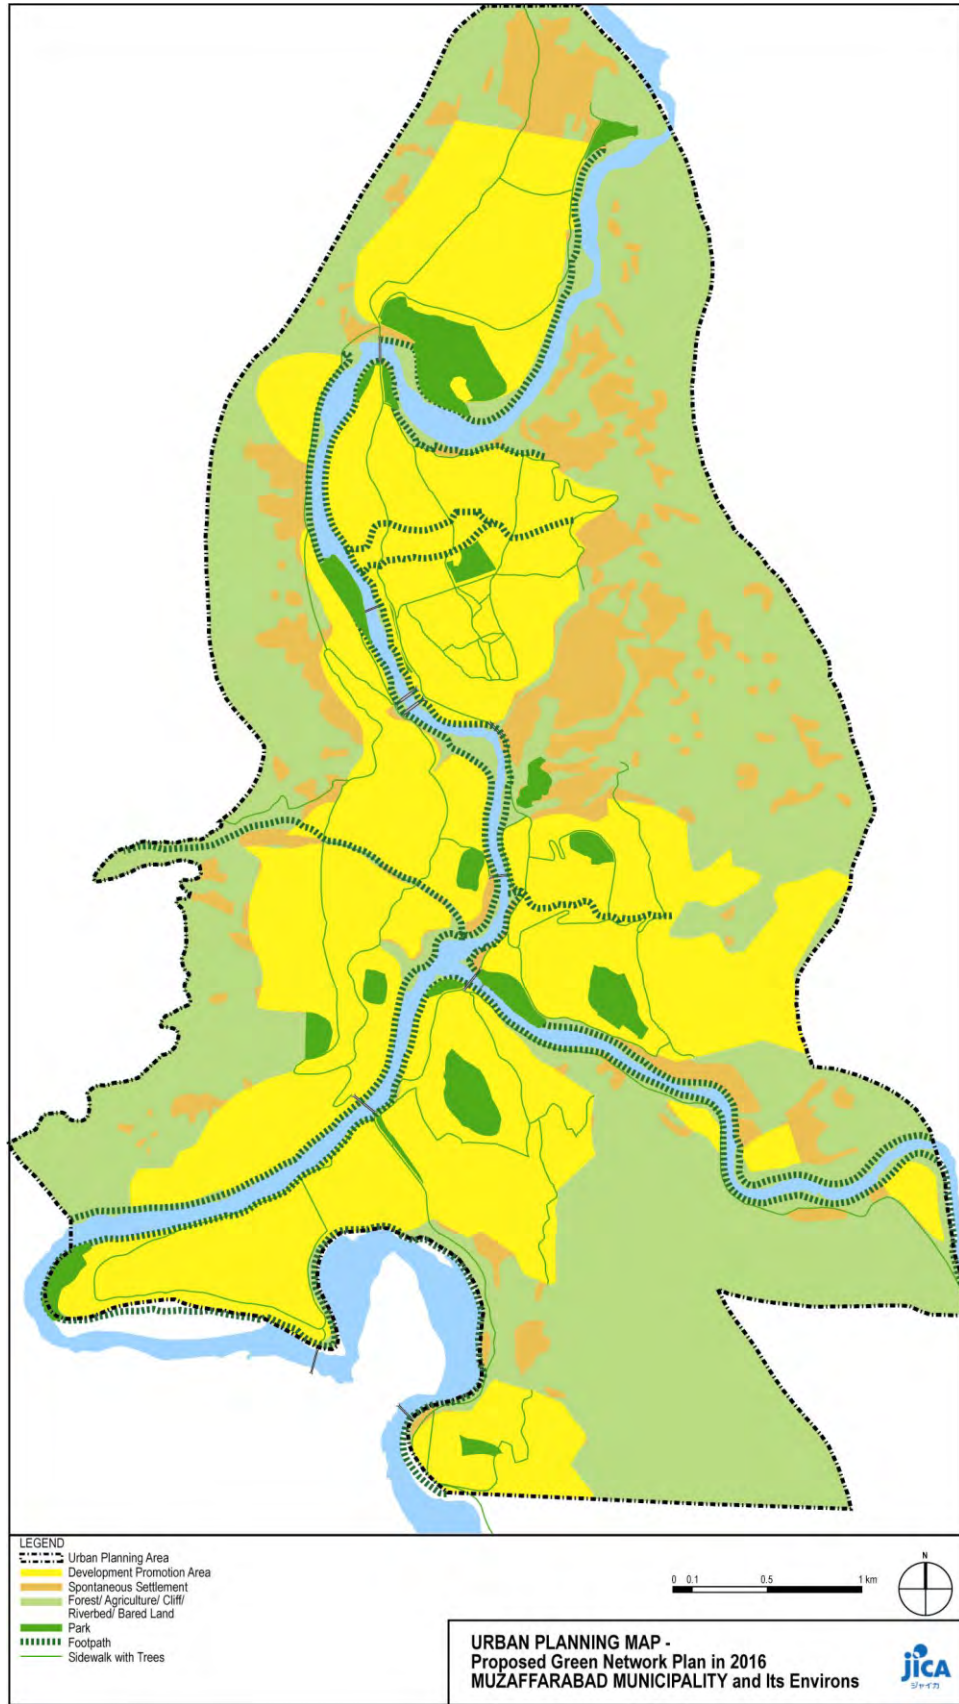
Figure 9.4.1 Park and Green Space Network

Based on the basic policies and the concept, the park development plan is proposed as it is shown in Figure 9.4.1. The areas are shown in Table 9.4.1.

Park area per person in urban promotion zone is 4.5 m²/person in 2016, and park area per person in whole city is 4.4 m²/person in 2016. The current condition is 2.3 m²/person in whole city, therefore, it is higher than current condition in whole city.

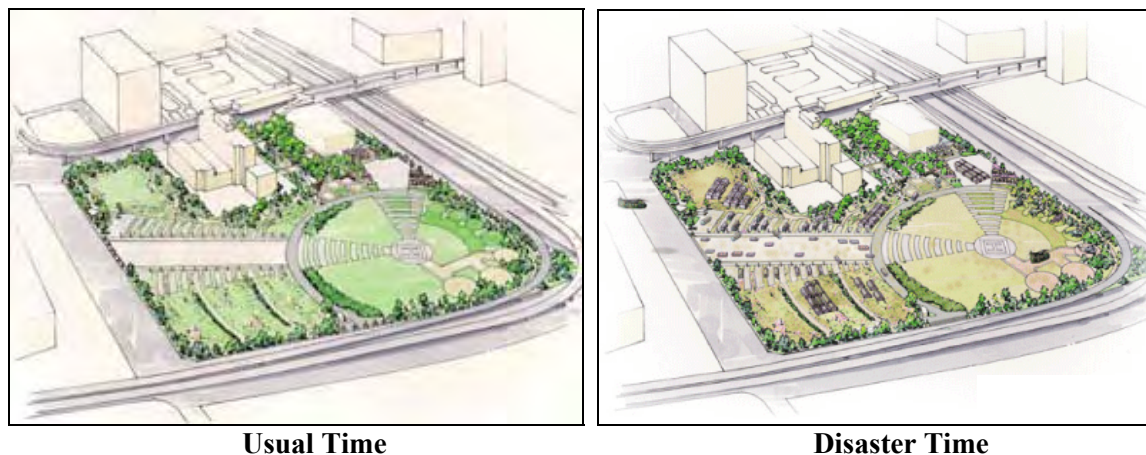
Figure 9.5.1 Image of Park for Disaster Prevention

A Park for disaster prevention can be used as a normal park in usual time, and it changes to the park which has functions for works against disaster when disaster occurs. Image of the conversion is shown in the figures below.
