## B. Collection and Transportation:

## B2. STUDY FOR THE MASTER PLAN

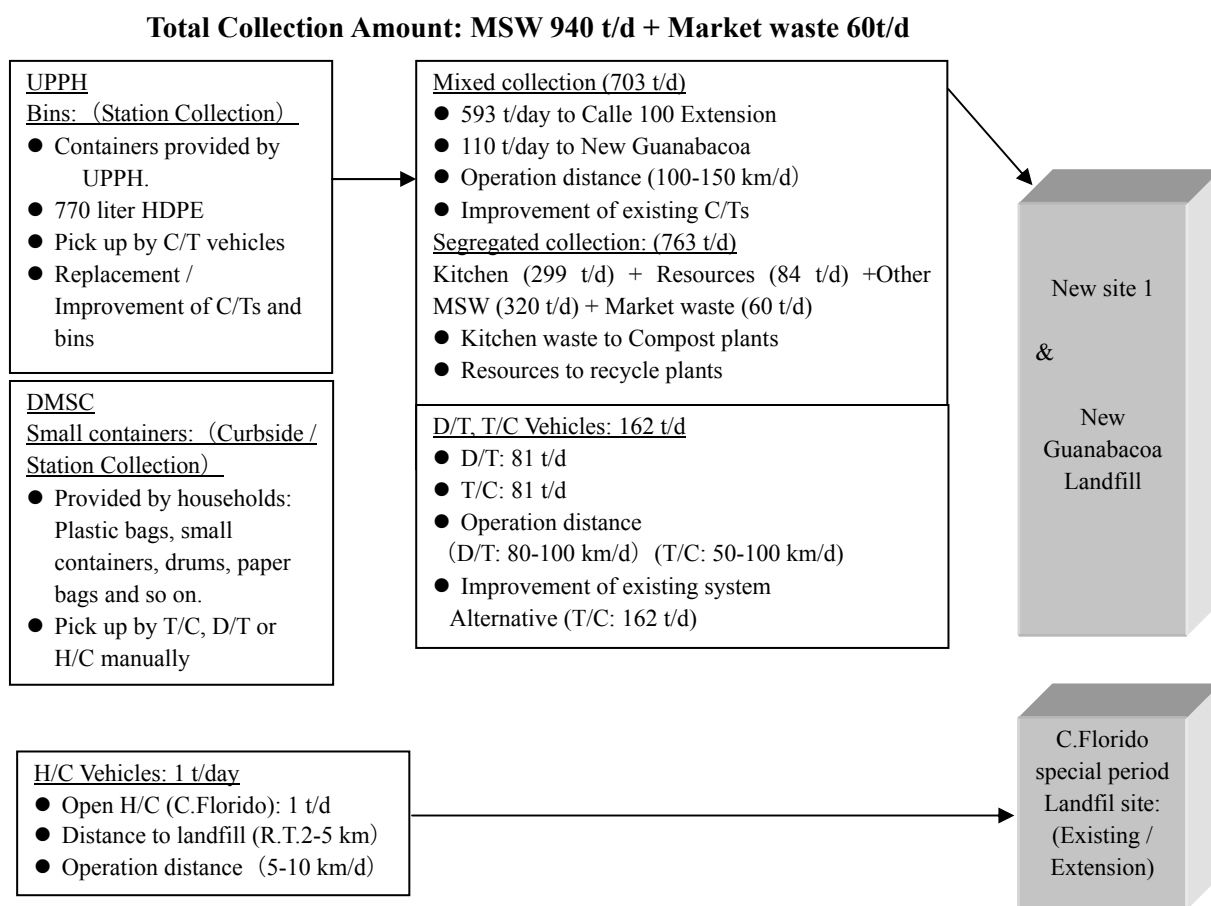
**Figure 1 Future Collection and Transportation Systems**

However, when the M/P was finalized for the F/R in March 2007, these future planning conditions for the M/P were changed with the assumption that no investment for the construction of New Guanabacoa landfill and Calle 100 Expansion landfill or for closure of existing landfills is taken in 2006 and 2007. This means existing landfills will be used until 2009 when new landfill sites will be constructed. The new transportation program is described in Table 3 and Figure 1. Table 4 shows the allocation of waste amounts for each disposal site in 2007 and Figure 2 shows the new transportation routes. Table 5 and Figure 3 show the new routes in 2015. The total amounts of MSW to be collected from UPPH's bins and bags in DMSC areas are estimated as shown in Tables 4 and 5.

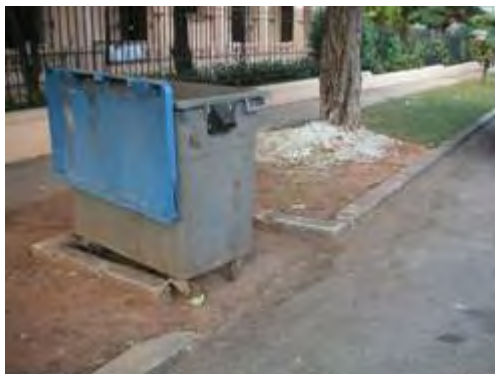
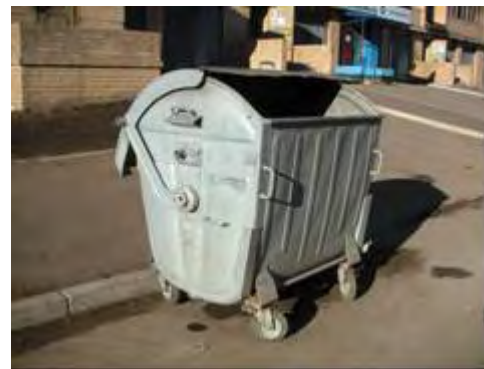
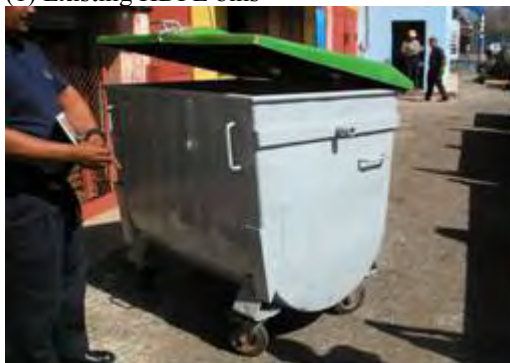
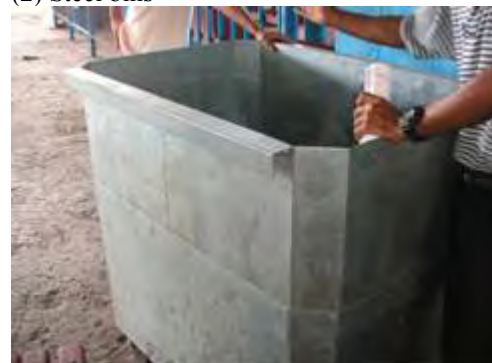
Figure 5 Typical Bins (770 liters)

(1) Existing HDPE bins

(2) Steel bins

(3) Prototype of metal bin (not galvanized) by local manufacture

The selected collection system uses 770 liter waste storage bins, being the same as the existing ones. One of the alternatives is door-to-door collection using plastic bags. However, that would cause there to be many waste bags on the street before collection and waste bags spoil the city's beauty. Also, too many plastic bags would be scattered around the disposal site. Existing bins are made of HDPE and they are damaged from handling by crew and/or predatory attacks by residents. It is difficult to repair damaged HDPE bins, so UPPH has to replace damaged bins with new ones every year. UPPH wants to replace them with steel bins, because the latter can be repaired easily and it is possible to manufacture them in Cuba. If every bin in the City is replaced with a steel bin, UPPH can repair them in its own workshop. This system is sustainable for Havana City.

- Adopt 770-liter steel collection bins. UPPH will repair damaged steel bins at its own workshop and will save on procurement costs.
- All existing bins will be replaced within 10 years.

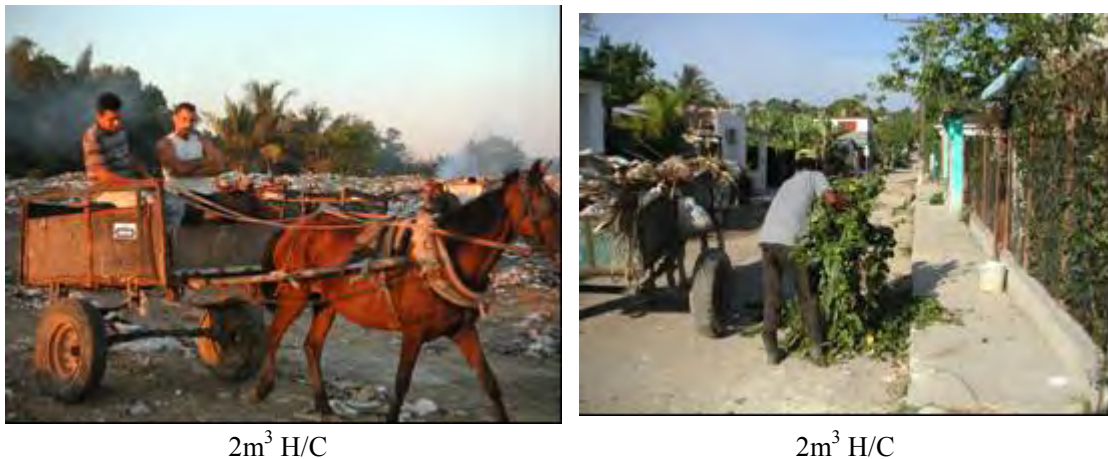
Figure 10 Typical Existing H/C Vehicles

There are six DMSC offices in rural areas. H/C vehicles collect 0.06 tons/hr/unit, the speed is about 1.5 to 2.0 km/hr, and they haul waste into special period landfill sites. Special period landfills will be closed by 2006, and then MSW will be transferred to New Site 1 and New Guanabacoa landfill. The new sites are further away than the special period landfill sites, so this suggests that the H/C system cannot be used for transportation as of 2007. DMSC has to introduce a new collection system in this area. Typical H/C vehicles are shown in Figure 10.

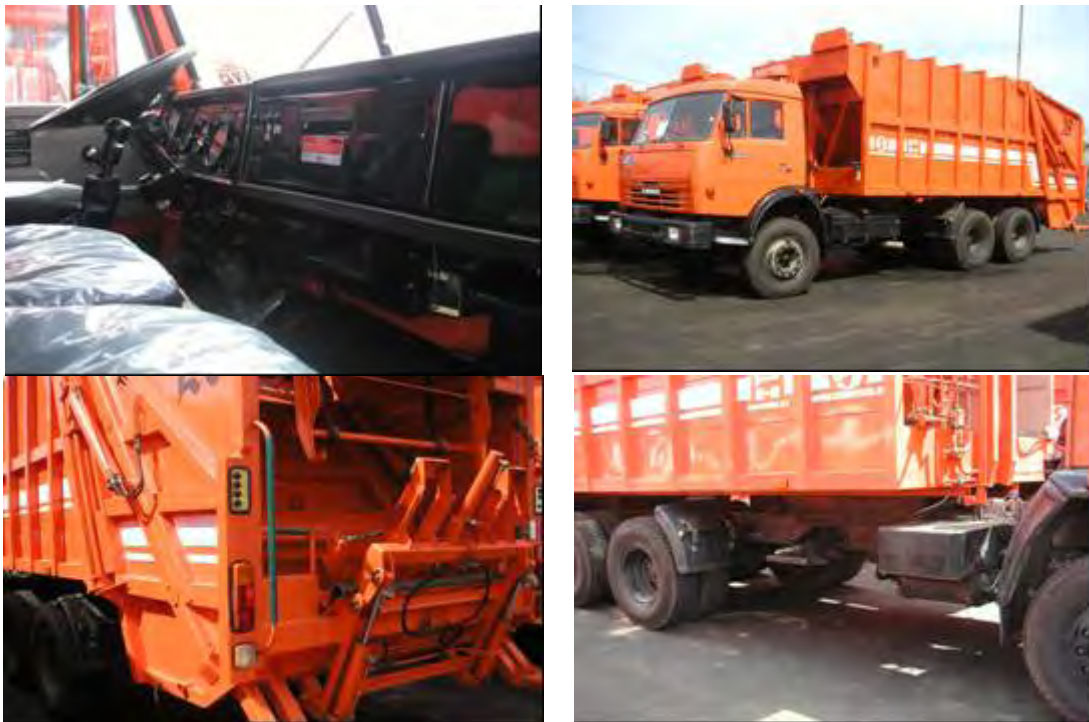
**Figure 13 Typical New C/T Vehicles Imported from Russia (KAMAZ)**

Introduction of a C/T collection system instead of the H/C collection system will improve not only the collection efficiency, but also transportation capability. The system does not require transfer stations, so the land for closed sites can be used for other purposes. In the collection areas with low population density, the collection efficiency for T/C is expected to be 1 ton/hour/unit according to the data from the time and motion study. This value is adopted to calculate the required number of T/C and small and medium size C/T vehicles in suburban areas. If working time for collection and transportation would be limited to 8 hours, the maximum collection amount would be 6 ton/day/unit. Therefore, Option B selects 12 m<sup>3</sup> C/Ts with an estimated capacity of 5 tons (actual data shows the capacity of 18 m<sup>3</sup> C/T was 7.5 tons). The replacement has to be done by 2007 before special period landfills are closed. However, UPPH would like to keep the traditional collection system with H/C. To meet their request, the H/C collection system, one ton/day, can be kept in service areas near the Campo Florido landfill site. Typical C/T vehicles are shown in Figure 13.

New 18 m<sup>3</sup> C/T with lifting equipment from Russia (2005)

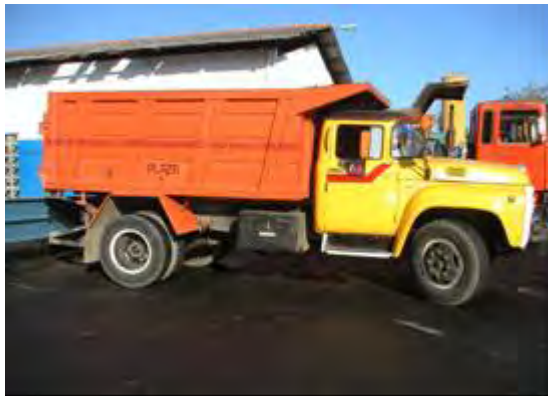
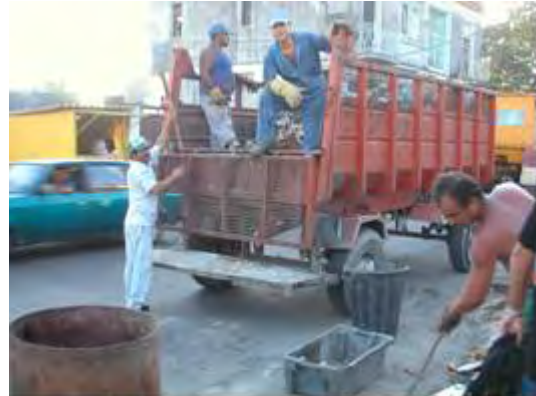
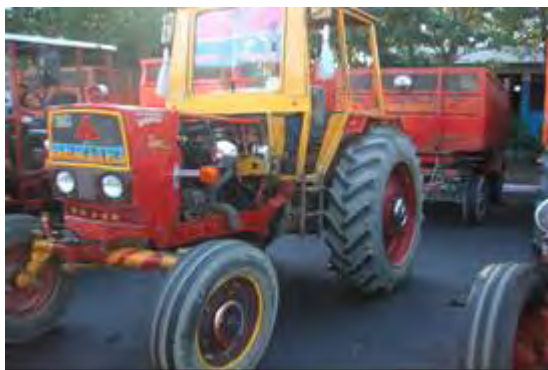
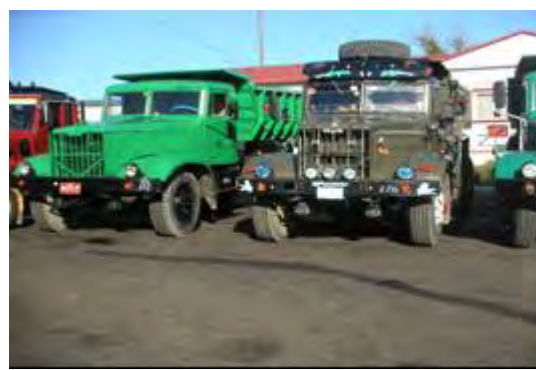
**Figure 14 Typical Existing Conventional Vehicles**

if the existing system can use domestic tractor-driven carts, then it has a future. This idea is in keeping with the basic policy of the plan. Therefore, the T/C collection system is adopted as the collection system in suburban areas. The total number of required T/Cs is 122 in 2015 but 62 units already exist in DMSC. Typical conventional vehicles are shown in Figure 14.

10 m<sup>3</sup> D/T (Imported)

15 m<sup>3</sup> T/C (locally made)

Old T/C (Russian)

T/D (Russian)

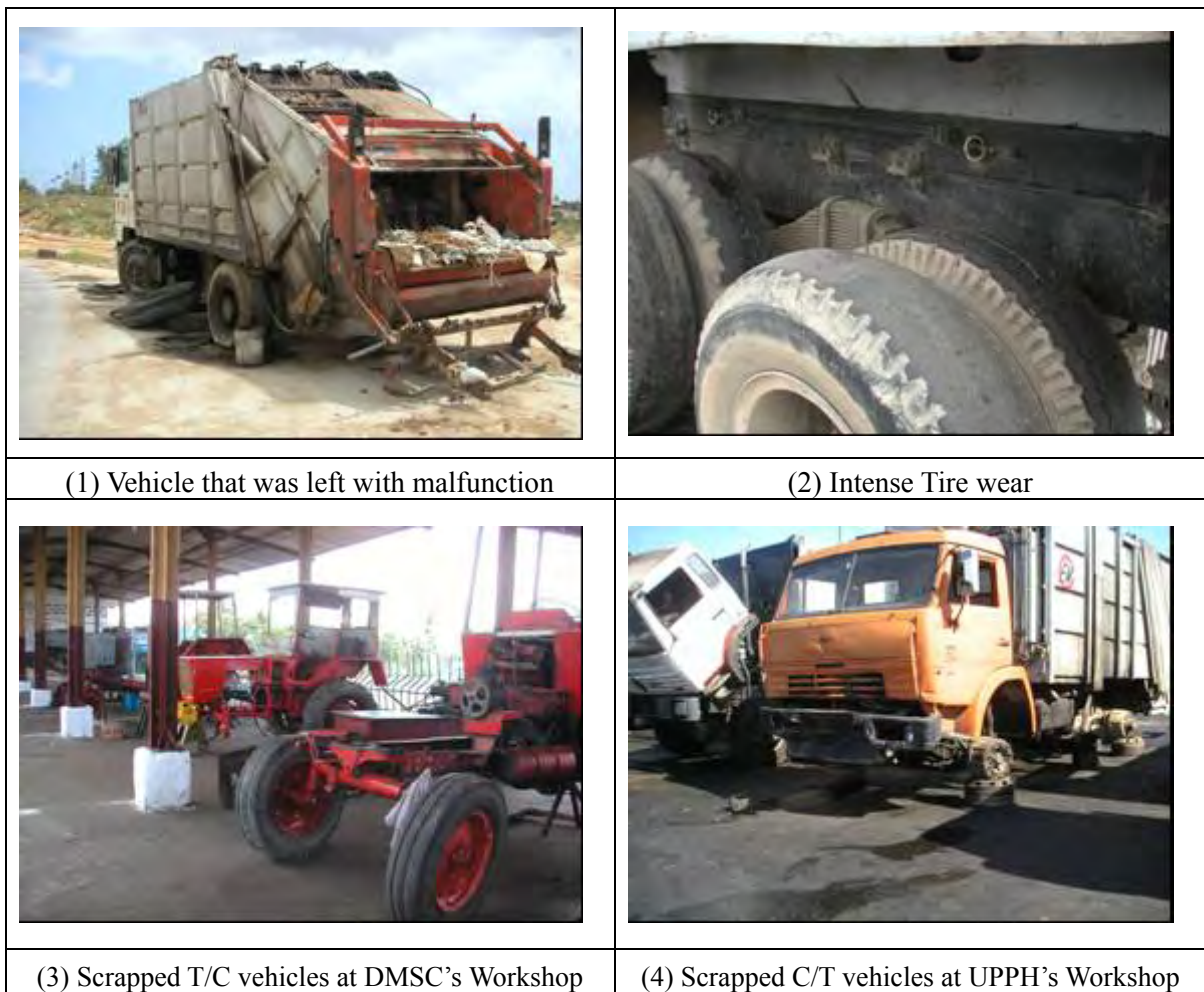
**Figure 5 Typical Condition of Collection Vehicles**

C/T collection vehicles are more likely to face mechanical troubles 4 to 6 years after procurement, particularly damage to brakes, engines, hydraulic systems and rusting of the body depending upon whether the model uses common maintenance parts, as shown in Table 13. The condition of secondhand vehicles imported in 2002 and 2003 is described in Table 14.

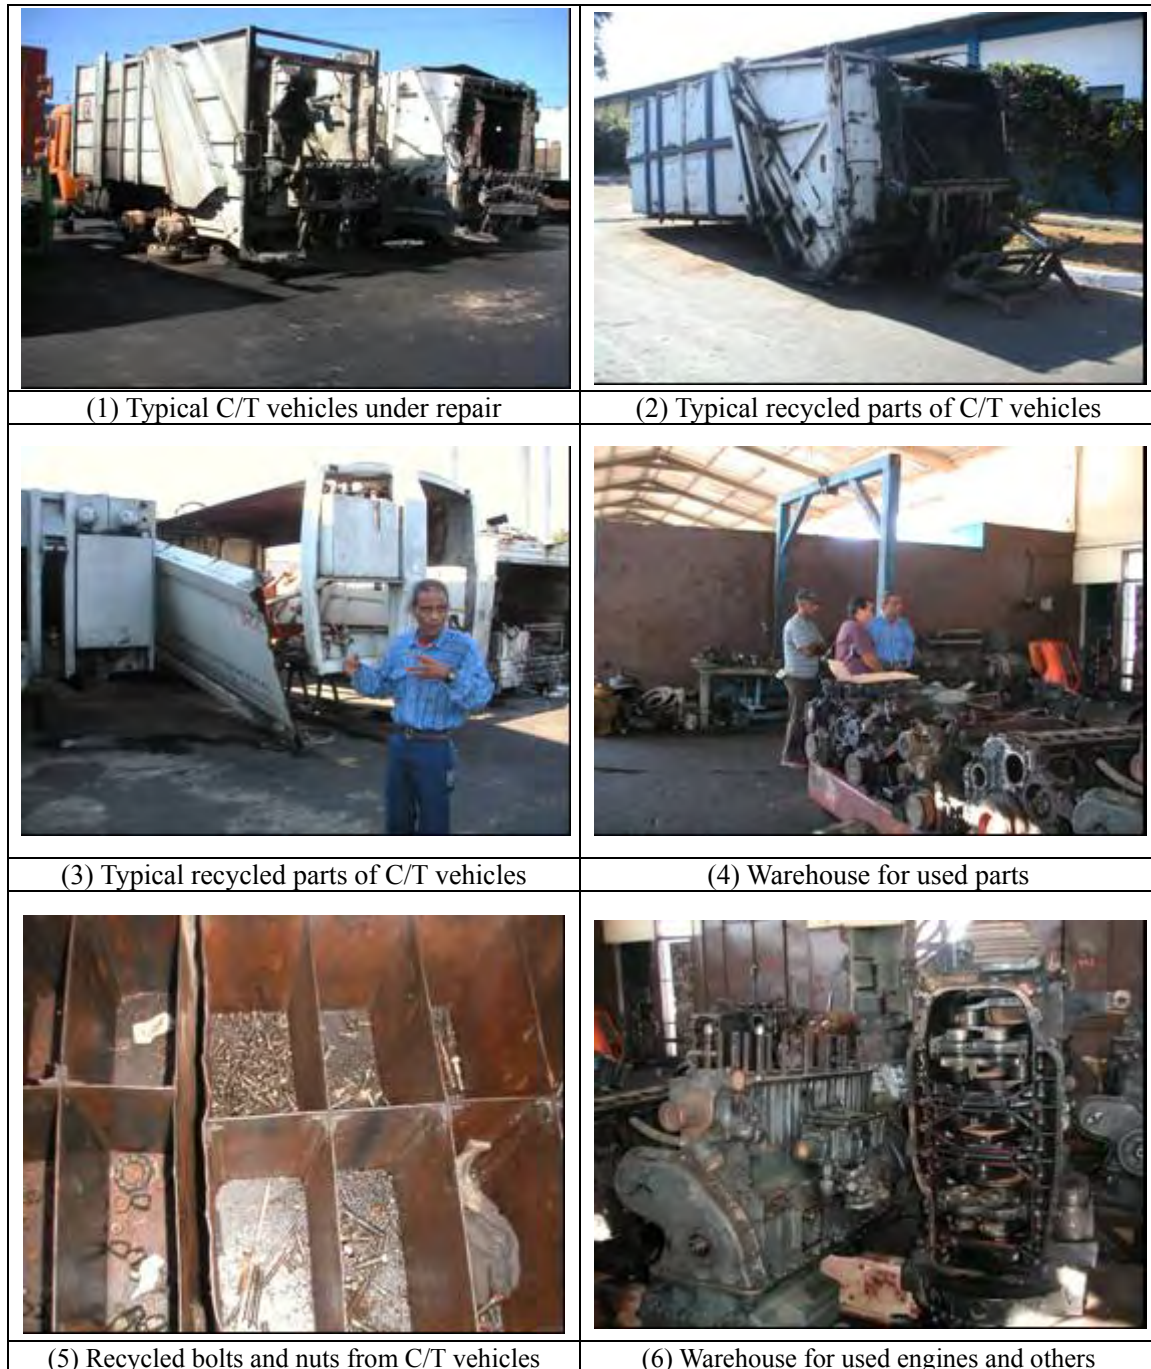
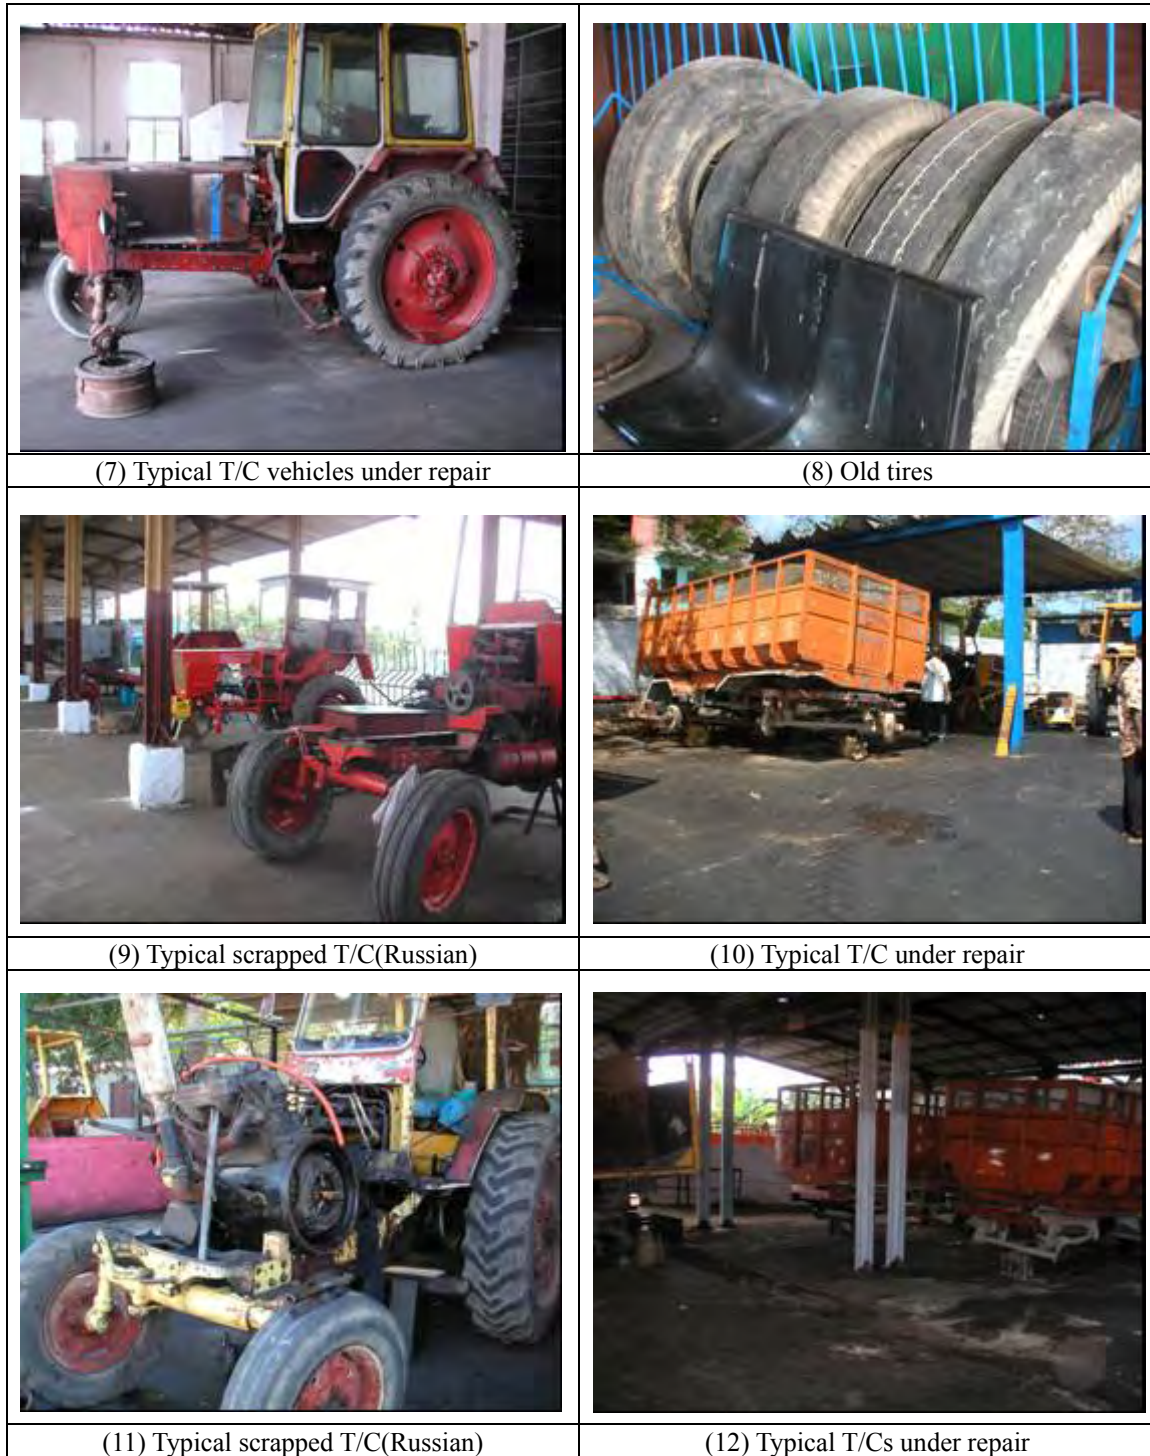
Figure 6 Typical Recycled Parts (1/2)

The most useful recycled parts are gearboxes, differential shafts, dynamos and bodies and so on but not oil seals, bearings, and gaskets. However, the use of recycled parts shortens the mechanical life span of the vehicles and reduces their reliability.

Residual scrap is conveyed to the relevant industries where it is compressed into a small lump before melting. Scrap tires are delivered to recapping factories or buried at the Ocho Vías landfill site. Typical recycled parts are shown in Figure 6.

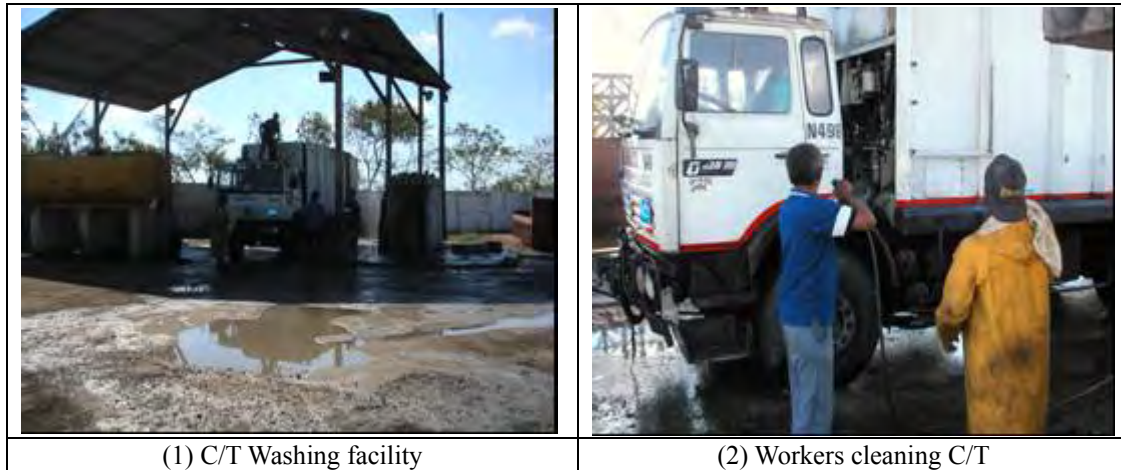
**Figure 8 CT Washing Facility**

The equipment consists of a washing nozzle, water pressure pump and water tank. Washing takes about 20 minutes and is done manually. Basically, the compactor trucks are washed every day.

A typical C/T washing facility is shown in Figure 8.

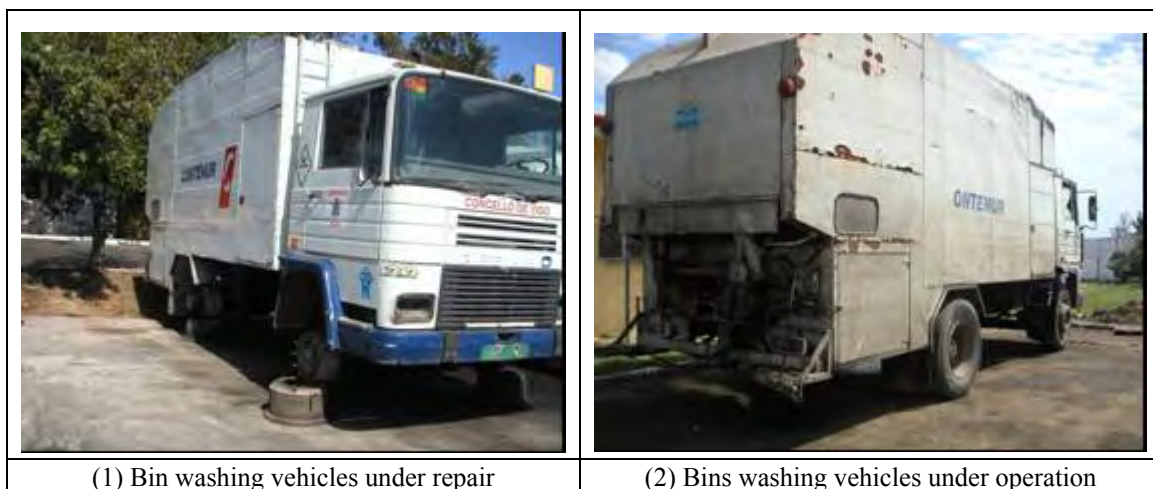
**Figure 9 Typical bin-washing vehicles**

There are two bin-washing vehicles, but one of them is out of order. Bins are taken inside the washing cabin by means of a lifting device. Water is sprayed automatically.

Bin washing takes about 2 to 3 minutes and the washing capacity is 100 to 150 bins per day. Typical bin-washing vehicles are shown in Figure 9.
