FEASIBILITY STUDY

6.1 General

6.3.1 Kennon Road Km 232 (Region CAR)

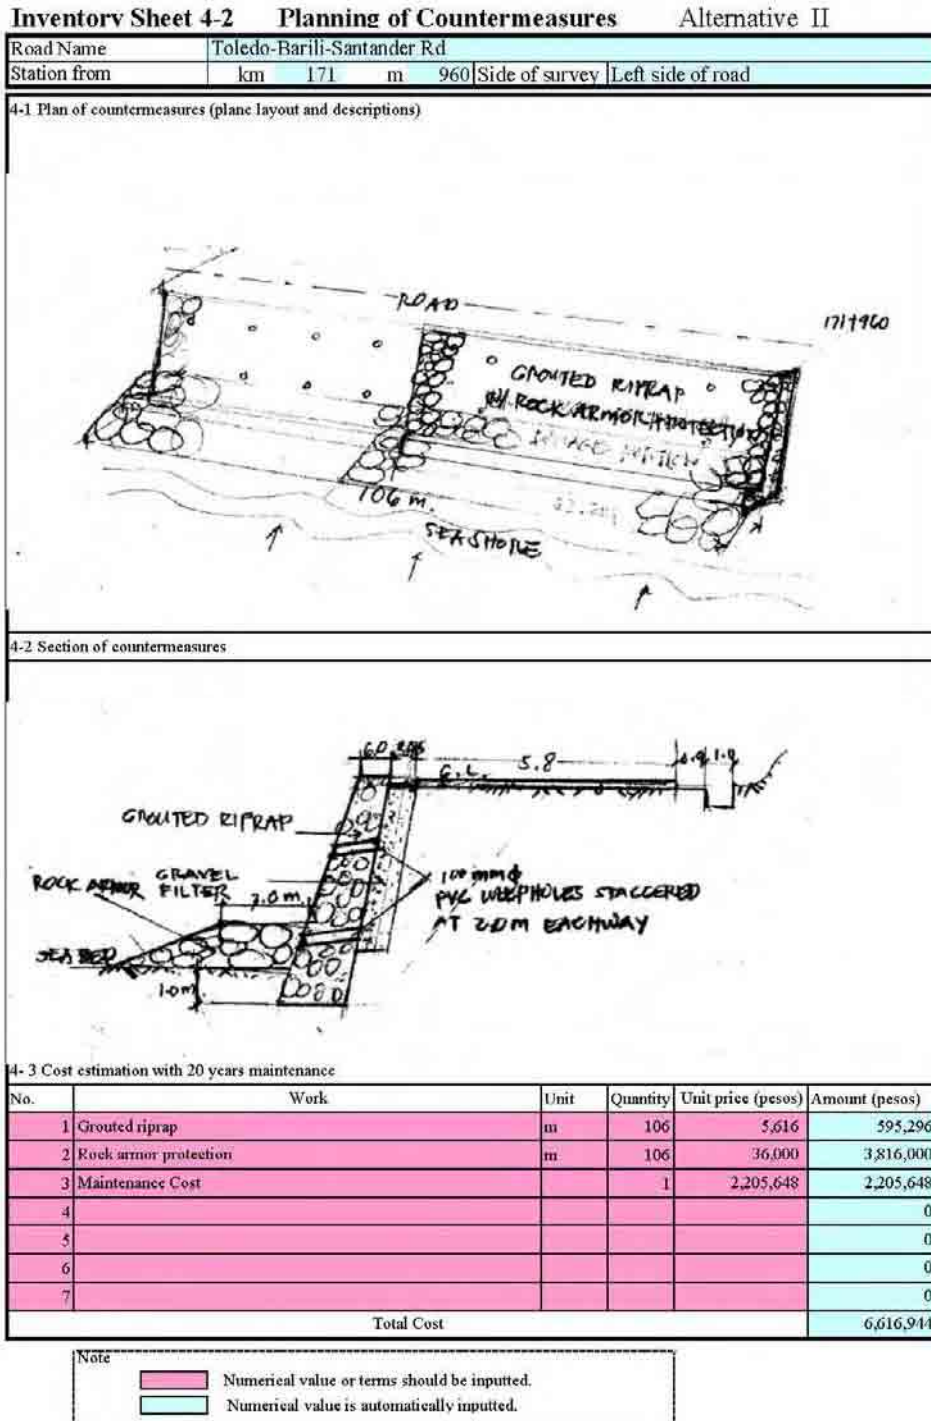
Figure 5.49 Example of Inventory Sheet 4-2: Planning of Countermeasure Alternative II for Coastal Erosion

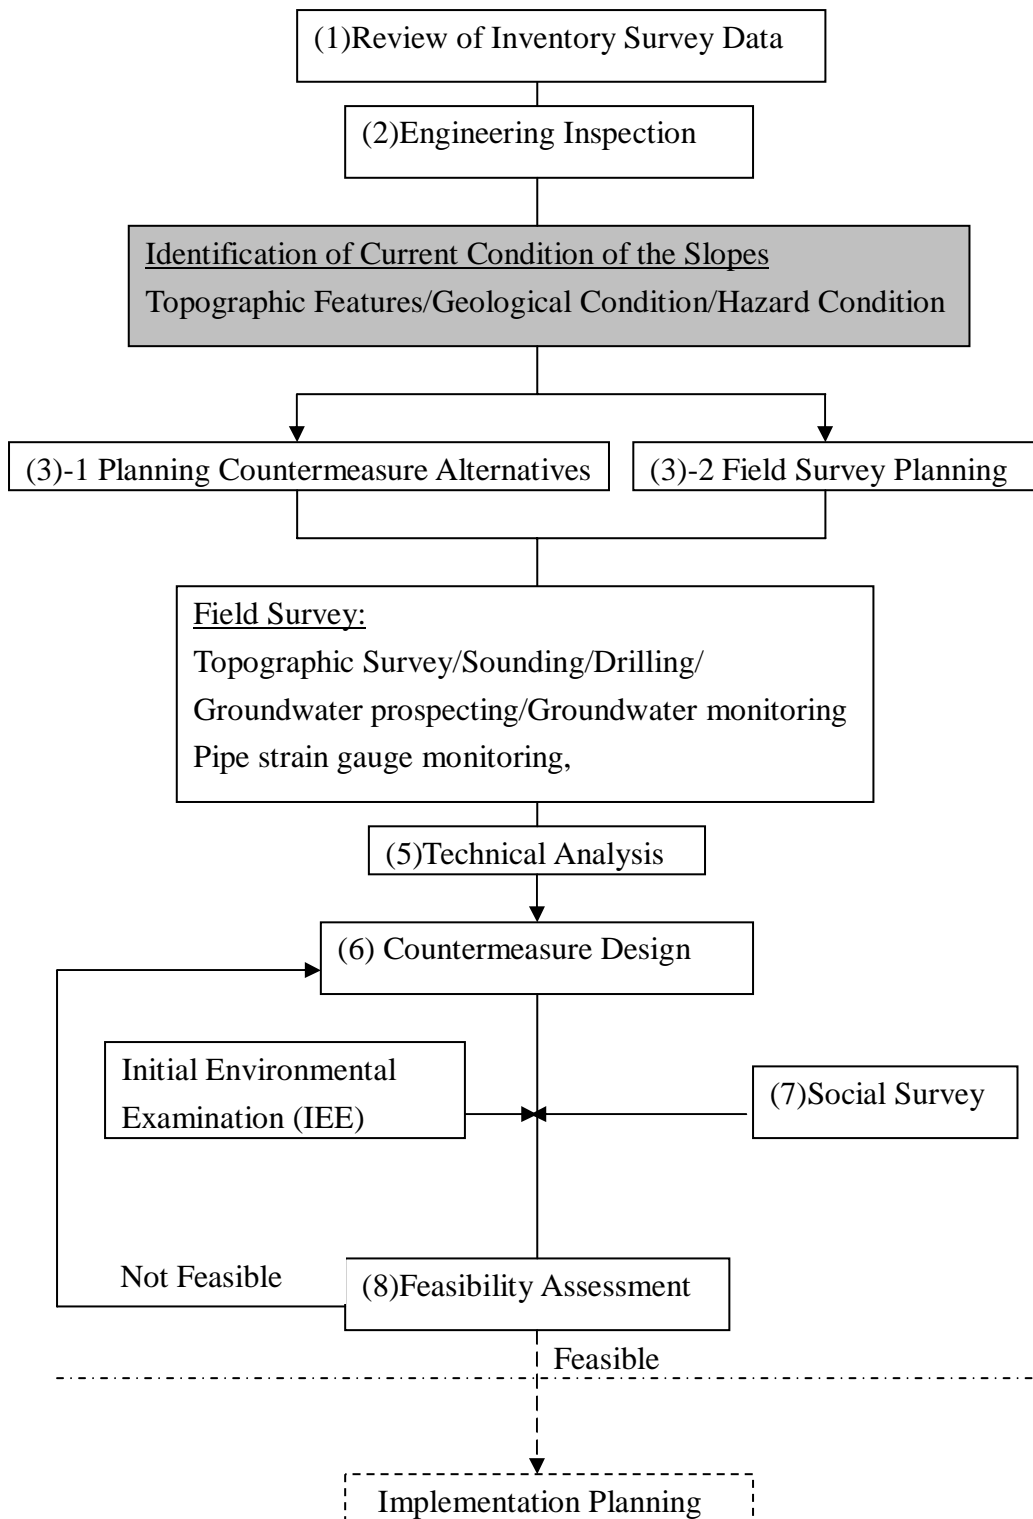
Figure 6.3 Flow of Feasibility Study

The feasibility studies undertaken in this study have been carried out as model studies in the process of the work flow shown in Figure 6.3. This same work flow can be applied in the actual feasibility studies that will be conducted after the formulation of the “Risk Management Plan for Nationwide National Highways.” Work item No.2, “Engineering Inspection”, which is the identification of the current condition of the slopes, is very important in the feasibility study from the viewpoint of engineering judgment. In this stage it will influence the procedures and the results of the feasibility study. Therefore, road engineers and geotechnical engineers of the study team worked together in the field to

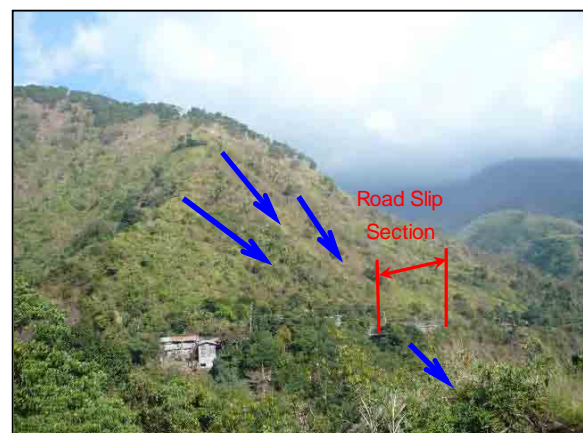
Photo 6.2 Surface water flowing from behind the mountain

- Surface waters from rain from the back of the mountain gathered towards the road slip section as shown in Photo 6.2.
- The groundwater to be distributed in the terrace deposit increased because rainfall water was concentrated in the slip section.
- Since the collapsed grouted riprap was not provided with sufficient drainage facilities such as weep holes and drain

filters in the back fill, excess pore water pressure formed behind the riprap.

- Also, the embedment of the riprap wall foundation looks unstable and did not resist the the ground water pressure. These factors caused the retaining wall to collapse and consequently, the road slip occurred.

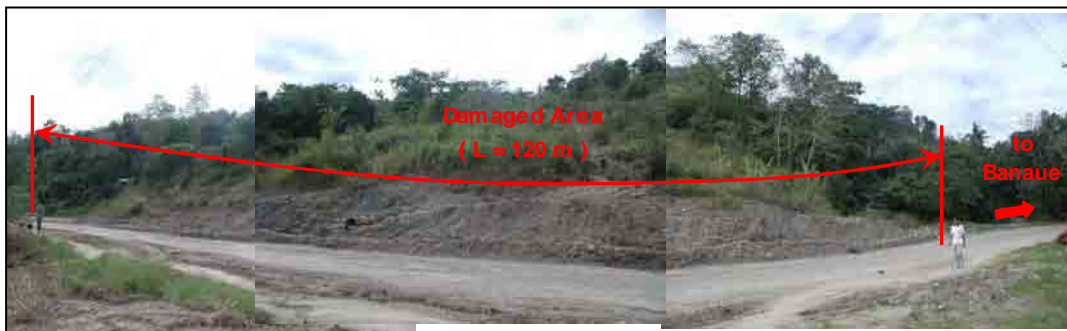
Photo 6.3 Front View of Damaged Section (Lagawe-Banaue Road Km 301)

This disaster was classified as a Landslide (LS). According to the District Engineering Office, the slope has collapsed repetitively over the past decades. Every time a landslide covered the road, it was simply removed to reopen the road to traffic. The length of the damaged section is approximately 120 m, as shown in Photo 6.3.

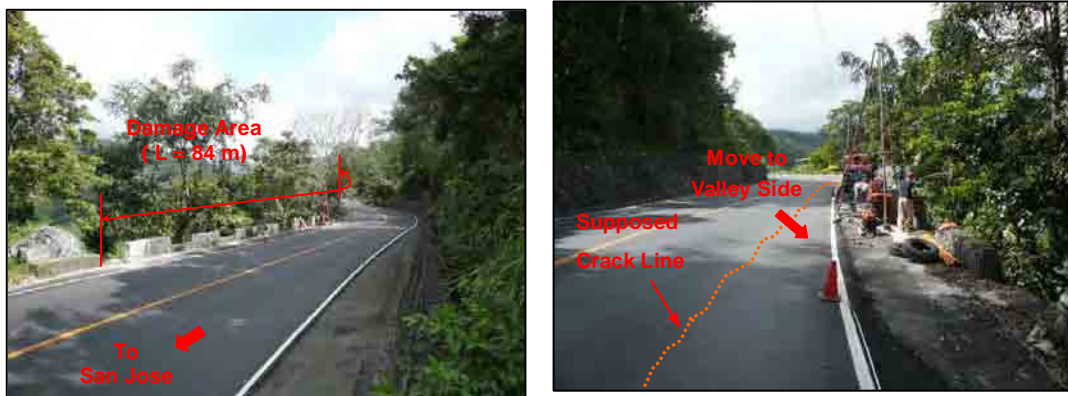
(a) Overview

(b) Supposed Crack Line

Photo 6.4 Conditions of Dalton Pass (Km 211)

This disaster was classified as the Road Slip (RS). According to the District Engineering Office, cracks on the pavement surface were observed several times in the same area, and the current pavement surface was over-laid in 2005 due to the cracks. The length of the damaged section is 84 m, as shown in Photo 6.4.
