PART 2 ANALYSIS OF NATURAL ENVIRONMENT

DP 2.1 Hydrology and Meteorology

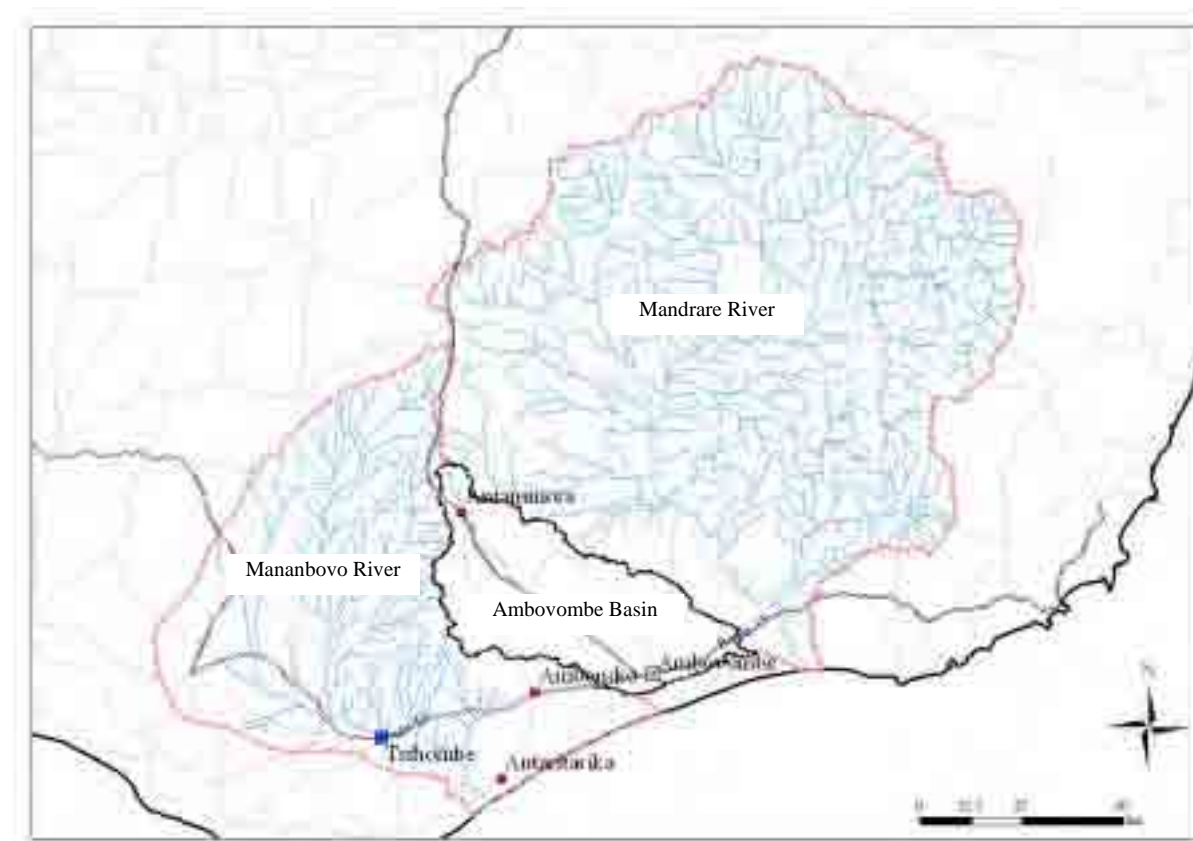
Figure 2.1.2-1 River systems around the Study Area

Around the Study Area there are two large rivers. One is the Mandrare River flowing in the east, and the other is the Mananbovo River flowing in the west. Ambovombe Basin is located between these two rivers and there are no river flowing continuously throughout the year flowing out to the sea within the Ambovombe Basin, and river flows can only be observed during the wet season. Figure 2.1.2-1 shows the river system around the Study Area.

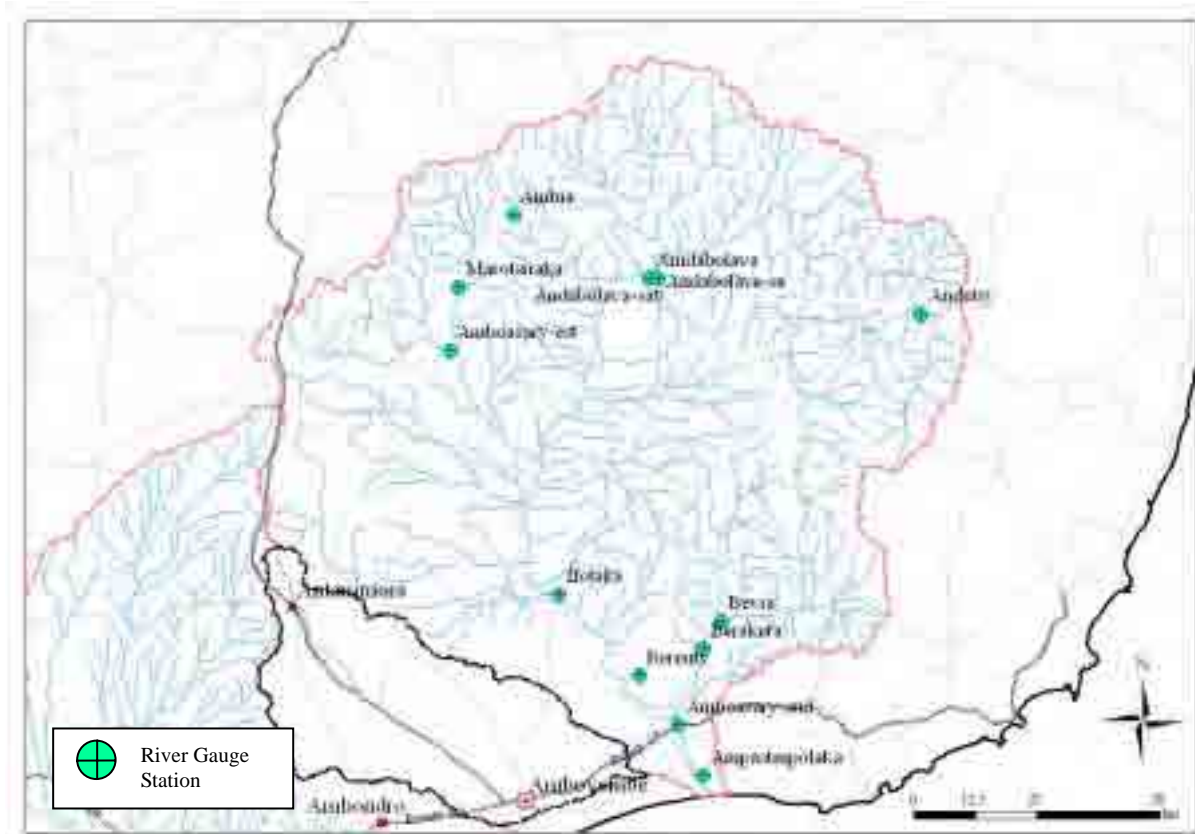
Figure 2.1.2-2 Location map of River gauge station within the Mandrare River basin

The Mandrare River is 270 km in length and has around 13,000km² of contributory area. The average altitude of the river basin is around 400m above sea level. The river flow can be observed throughout the year due to much amount of precipitation. Figure 2.1.2-2 shows location map of river gauge stations within the basin. Table 2.1.2-1 shows list of river gauge stations and the available period of the observed data.

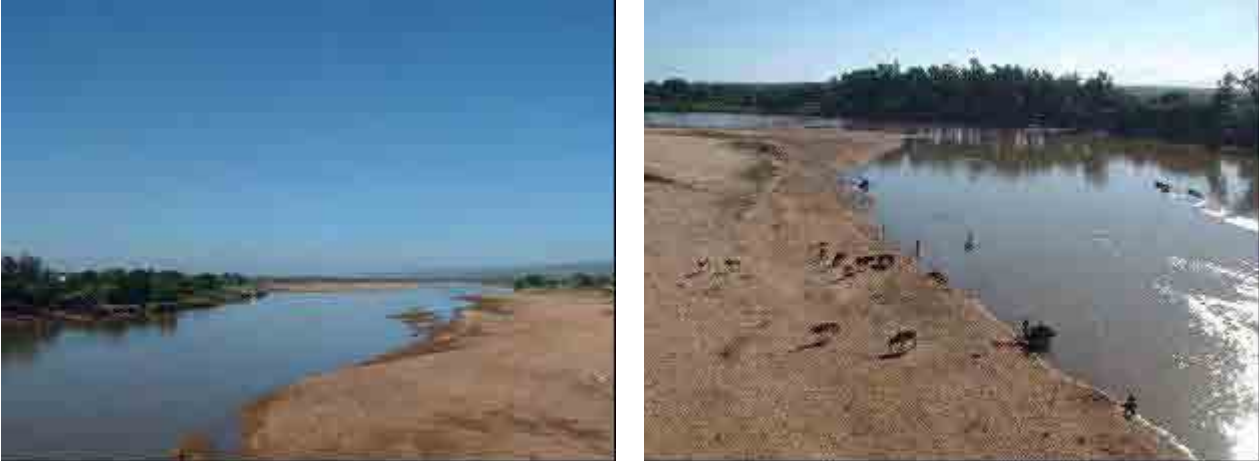
Figure 2.1.2-4 Picture of the Mandrare River (middle of May, 2005)

From the figure it can be seen that even in the dry season there are certain amount of discharge in this river. Figure 2.1.2-4 shows the picture of Mandrare river which was taken in the middle of May at Amboasary.

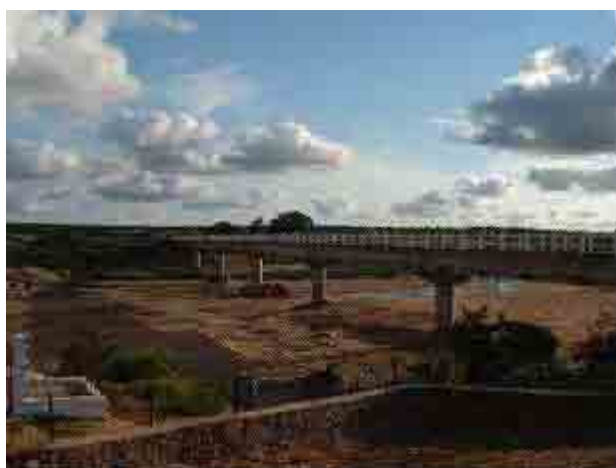
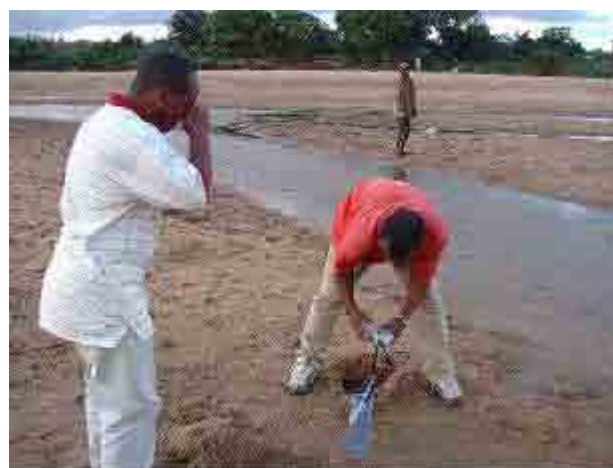
Figure 2.1.2-7 Picture of the Mananbovo River (end of April, 2005)

In the dry season, when river discharge becomes zero, people dig river bed to get water from the river.

From the figure it can be seen that in the dry season there are only little discharge in this river. Figure 2.1.2-7 shows the picture of the Mananbovo River which was taken in the end of April 2005 at Tsihombe.

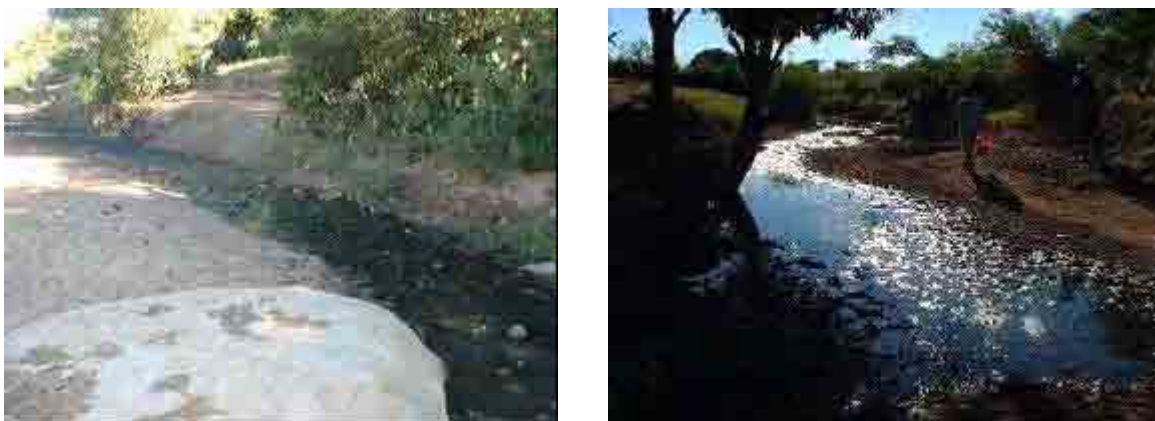
This point is located in the headstream of the River. At this point, several seepages were seen along the River. Figure 2.1.2-9 shows the condition of this point. According to the local people, they can obtain water from this river throughout the year.

Figure 2.1.2-9 Picture of the Bemanba River (Andranolalika)

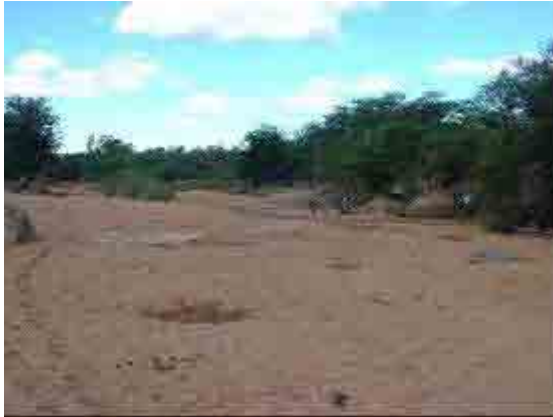
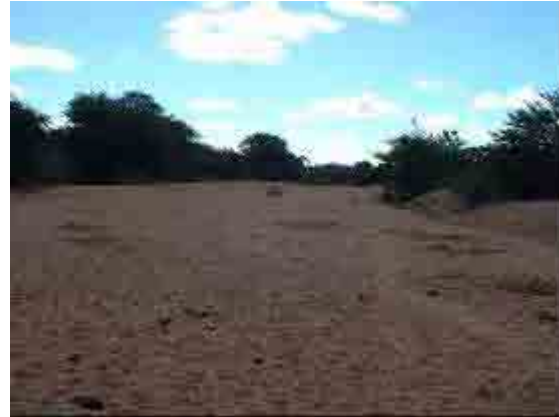
This point is located in the middle of the River. At this point, there are also several seepages along the River. Figure 2.1.2-10 shows the condition of this point. According to the local people, during the dry season, people get water from a dug hole in the river bed 1.5m deep. During the rainy season, after heavy precipitation, large stream flow appears and run off to the downstream rapidly.

Figure 2.1.2-10 Picture of the Bemanba River (Antanimora)

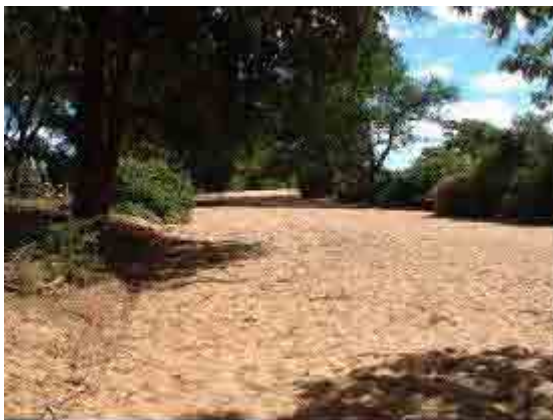
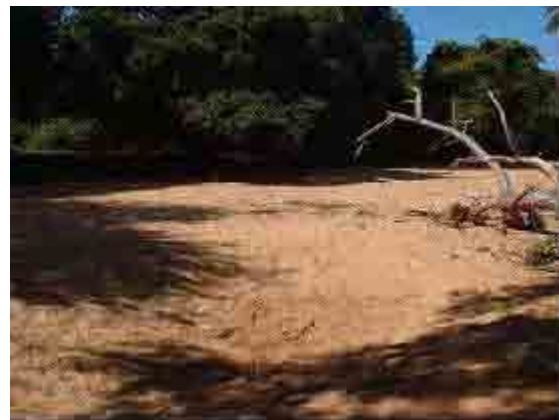
This point is located in the downstream end of the River. At this point, there are no seepages along the River. Figure 2.1.2-11 shows the condition of this point. According to the local people, people can obtain water only from the neighboring well. Discharges occur only after heavy precipitation.

Figure 2.1.2-11 Picture of the Bemamba River (Manave)

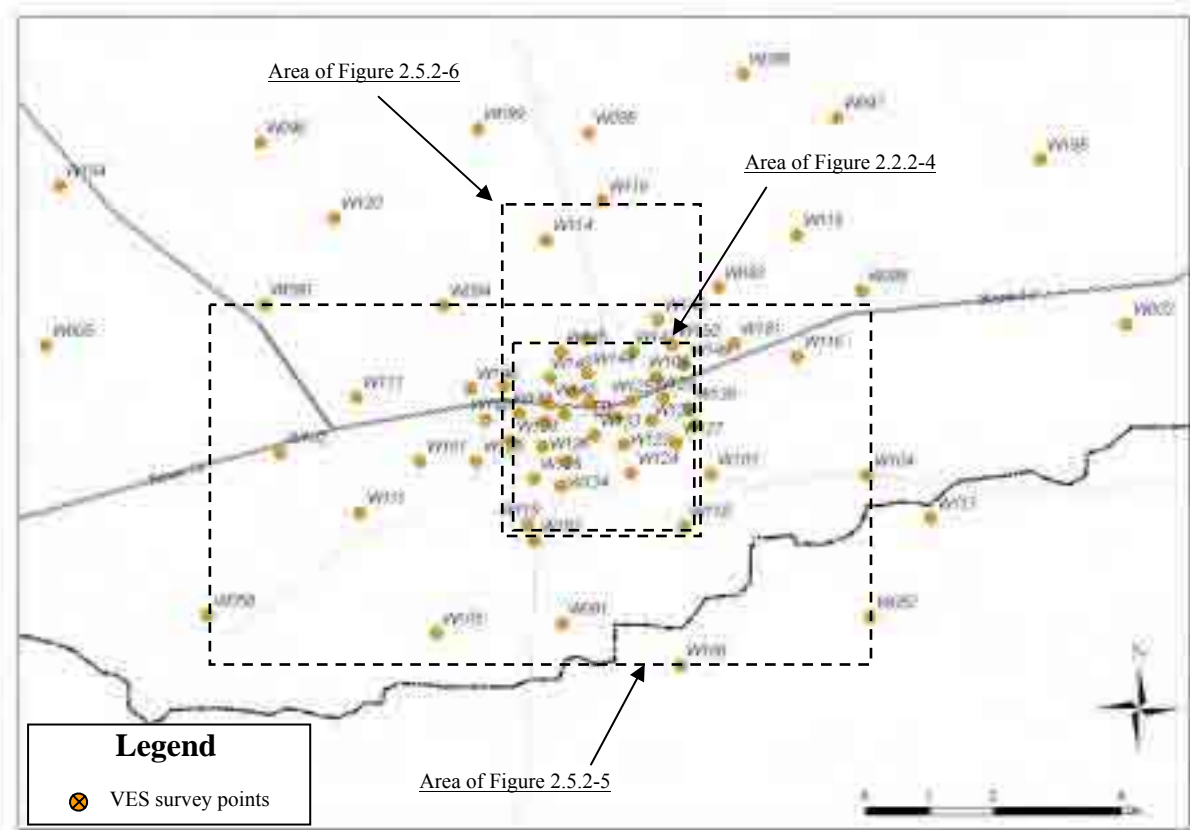
Figure 2.2.2-3 Enlarged view of VES survey points in the center of the Ambovombe Commune

Figure 2.2.2-3 shows enlarged view of the location of VES surveyed points in the central part of Ambovombe Commune.

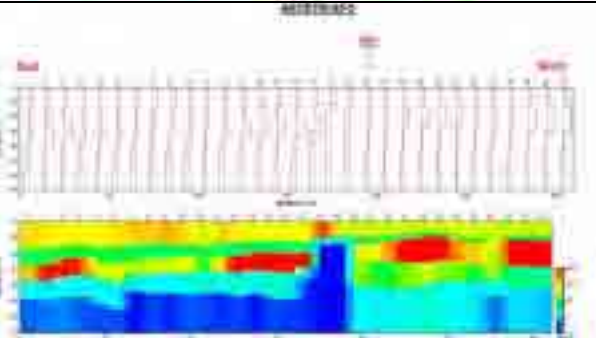
<p>T-11 (W169) Antetikafo Resistivity changes from 10 to 500 (ohm-m) from the surface. At the deep part, low resistivity layer, less than 10 (ohm-m), distributes. High resistivity layer, 500 (ohm-m), is interpreted as sandy gravel layer.</p>

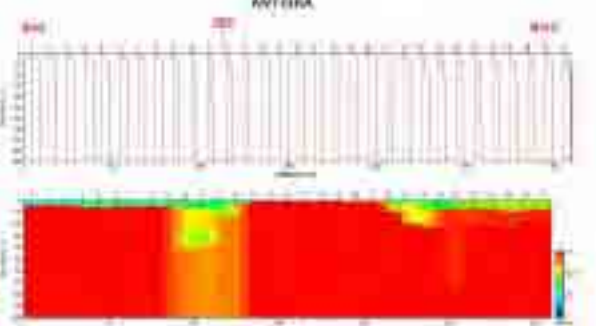
<p>T-12 (W170) Antsira At both ends of the traverse line lays 10 - 50(ohm-m) of surface layer to 5m, and beneath this layer lays high resistivity layer measuring over 500 (ohm-m) to the deepest point. In the central area, outcrop can be seen. 9-13m from the start point has relatively low resistivity compared to the surroundings, which can be interpreted as difference of crack development or effects of fault zone.</p>

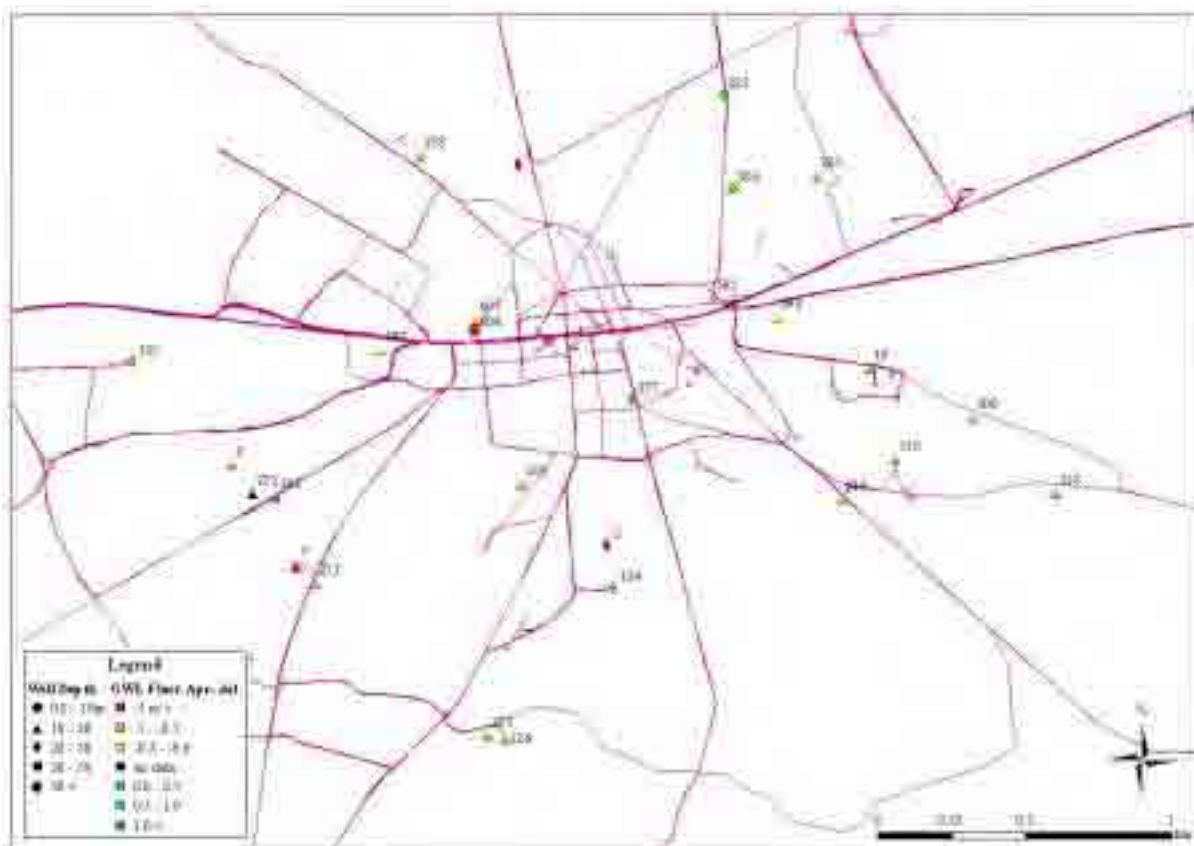
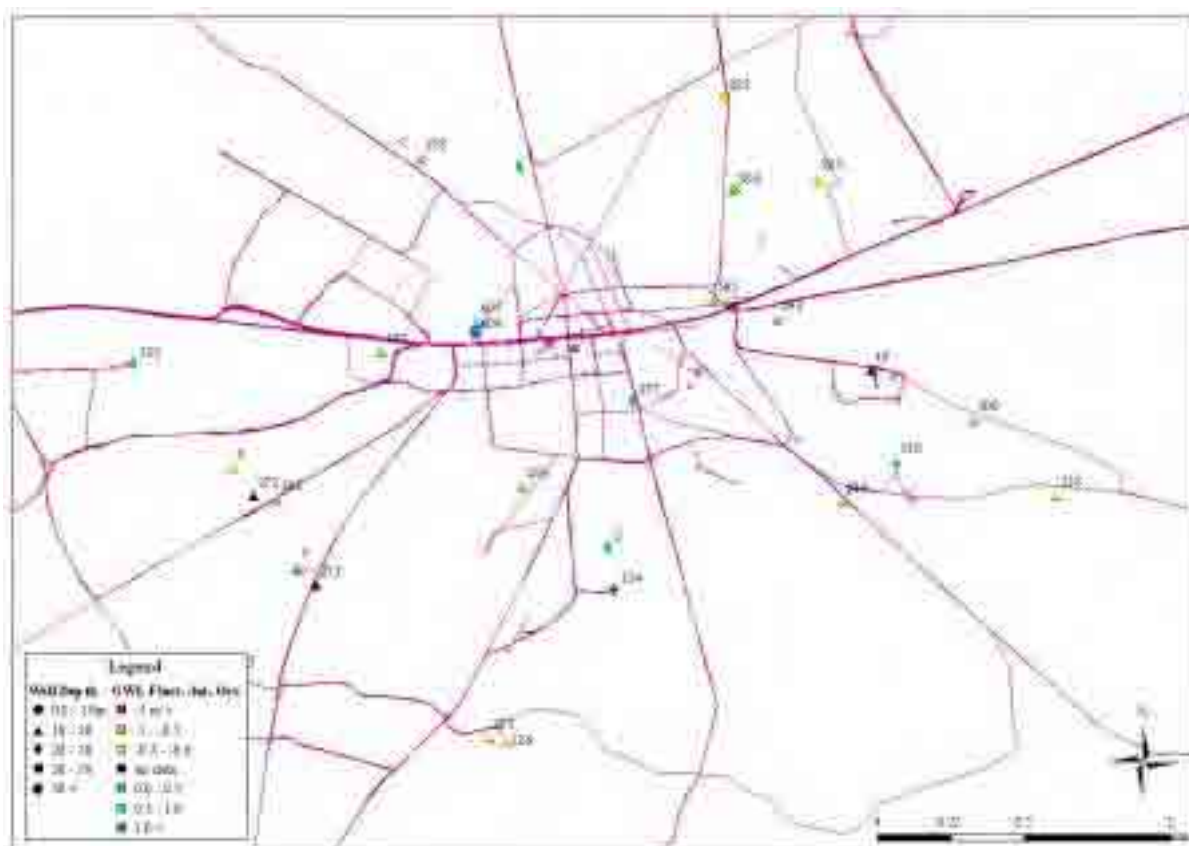
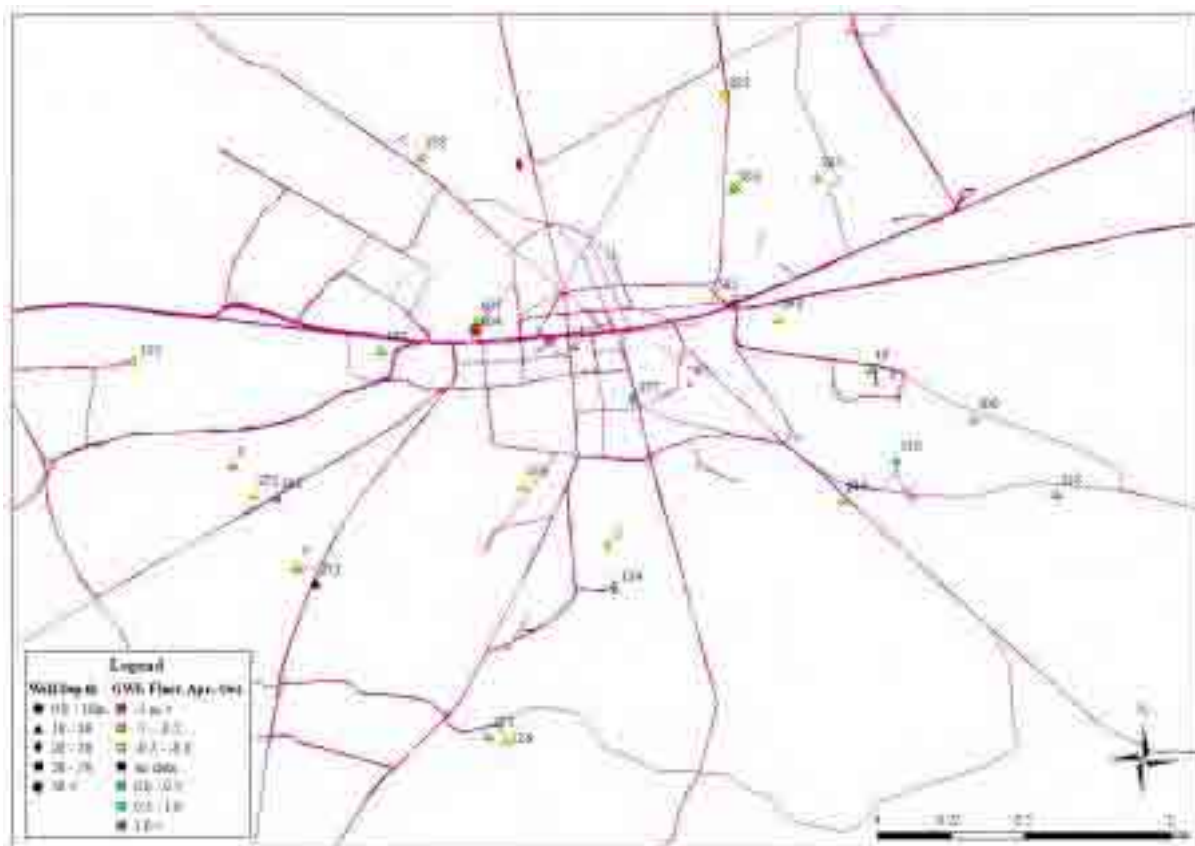
Figure 2.3.4-3 (a) Groundwater level fluctuation distribution map (from April to July)

Figure 2.3.4-3 (b) Groundwater level fluctuation distribution map (from July to October)

Figure 2.3.4-3 (c) Groundwater level fluctuation distribution map (from April to October)

Figure 2.3.4-3 shows distribution of groundwater level fluctuation in the study area from April to October. According to the Figure 2.3.4-3 (c), in Ambovombe area, the monitoring wells with uprising characteristic seems mainly located in eastern part, and wells with lowering characteristics seems mainly located in western part between April and October, 2005.

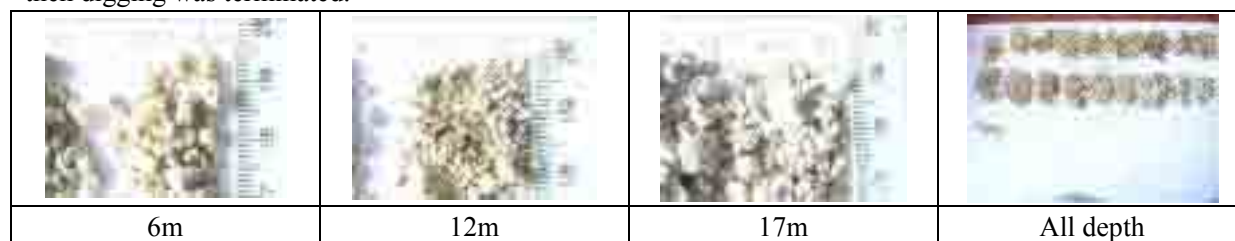
The formation is cemented with clay, silt and calcium as like rock. The major grain is angular gravel/sand of quarts. The block of cutting is hard to break at the state of dry, but it melted immediately once it was dipped into water. This indicates primary cementing material is silt. Calcium exists at the most of formation, but as a tiny particle. Clay exists from 5 to 10m where color of formation is green, but with much of silt. Existence of calcium was check by hydrochloric acid.

Water was struck at 19.6 m in this breccias sandstone. Water is salty with a conductivity of 10,350 μ S/cm, then digging was terminated.

Figure 2.6-1 Drilling sample of P003
