## CHAPTER 4 EROSION SOURCES AND SEDIMENT YIELD FROM THE WONOGIRI DAM WATERSHED

### 4.1 Erosion Sources of Sediment Deposits in the Wonogiri Reservoir

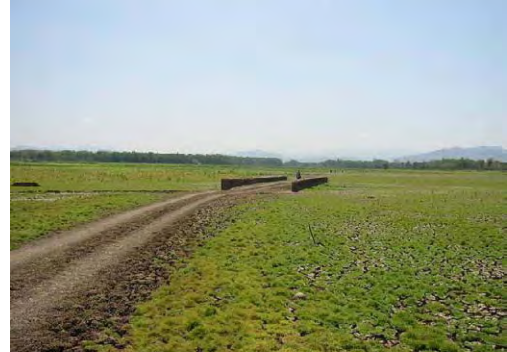
Sediment Deposits at the old bridge on the Reservoir Arm of Alang River

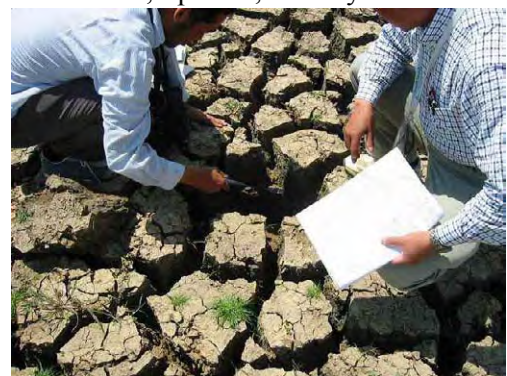
Silt/Clay Sediment Deposits in the Reservoir

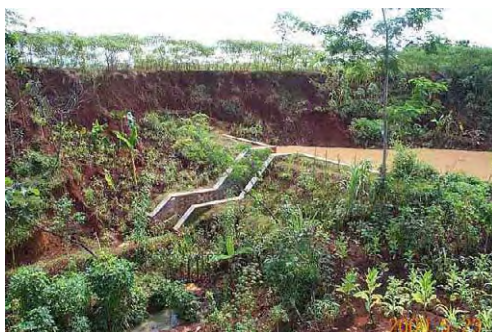
**Large Gully Plug in Keduang Area**

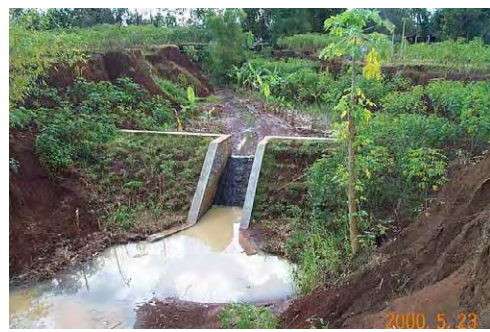
**Large Gully Plug in Keduang Area**

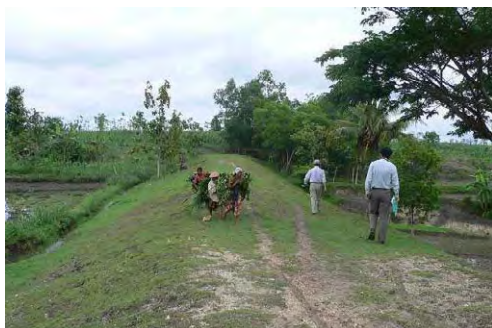
**Check Dam in Alang Area**

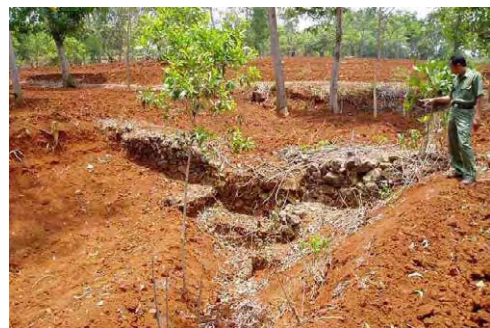
**Small Gully Plug in Keduang Area**

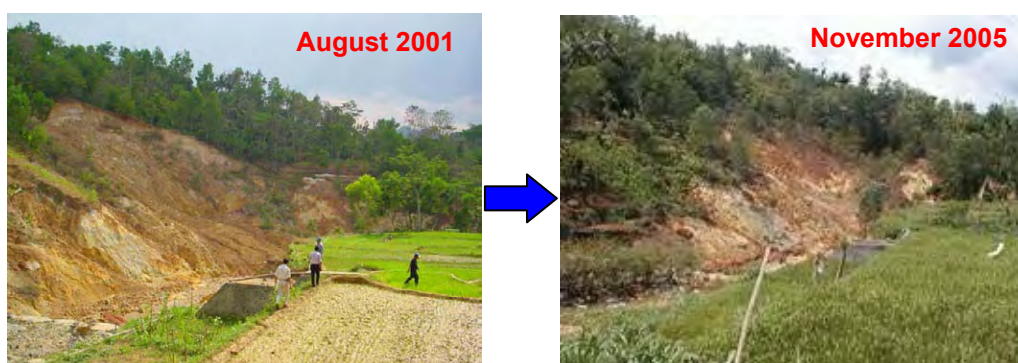
As for landslide, a total of 25 sites were observed through field investigation and the total erosion volume from landslides is estimated at around 10,300 m<sup>3</sup>. Although a few of them are still active, they are small as a whole. The number of sites is largest in the Keduang, but they are of relatively small scale. On the other hand, large scale landslides are observed in the Tirtomoyo watershed. Photos in the next page, which were taken in August 2001 and in November 2005, compare the state of the largest landslide on the Tirtomoyo River at different times. It seems that this landslide is being stabilized as its vegetation is being recovered. Under the Study, it is assumed that annual gross erosion over the Wonogiri dam watershed is around 10,300 m<sup>3</sup> applying the estimated total erosion volume from field investigation, assuming that from now on small scale landslides will continue to occur.

**Comparison of Largest Landslide at Different Times on Tirtomoyo River**

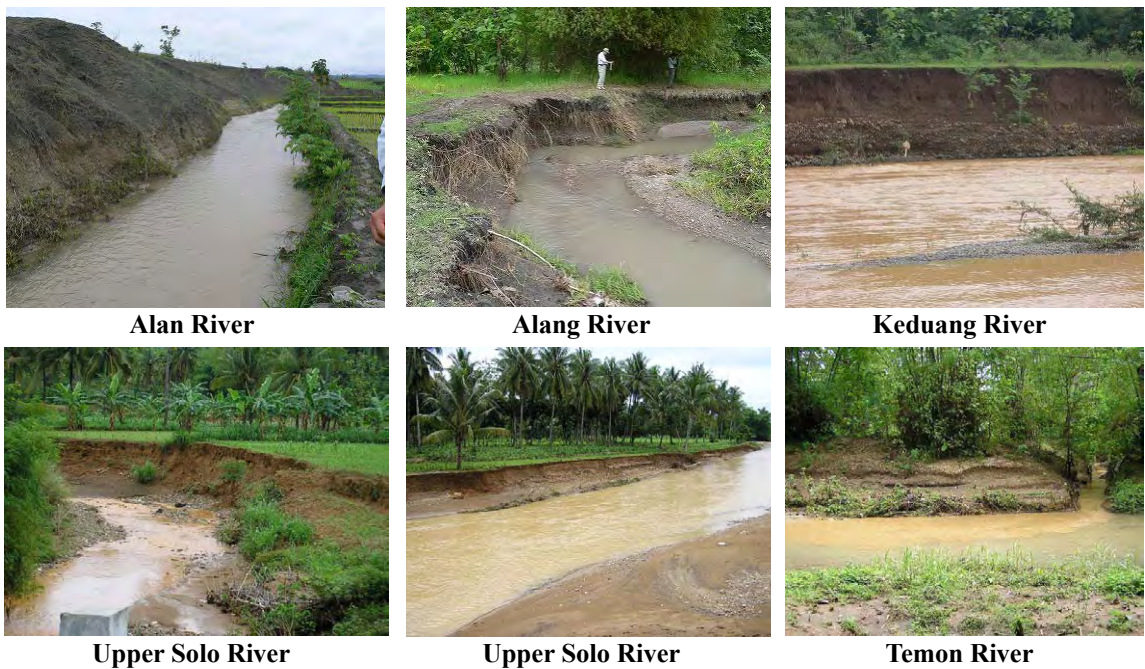
Figure 4.3.2 Location Map of Riverbank Erosion

photos are shown in Figure 4.3.2. As seen, locations of existing bank erosion are widely distributed over the Wonogiri dam watershed. Progressing bank erosions occur mainly at i) meandering stretches in the main stream ii) confluence points with small tributaries, and iii) downstream bank of river structures such as bridge and irrigation intake.

Most active bank erosions are observed in the Alang River which flows through the large river terrace over the lower land. Along the river terraces there are many small tributaries and the drainage canals causing erosion. Most of terrace deposits seem to be easily eroded by small flush floods. Typically the erosion occurs at the foot of the bank and could cause larger scale bank failure.

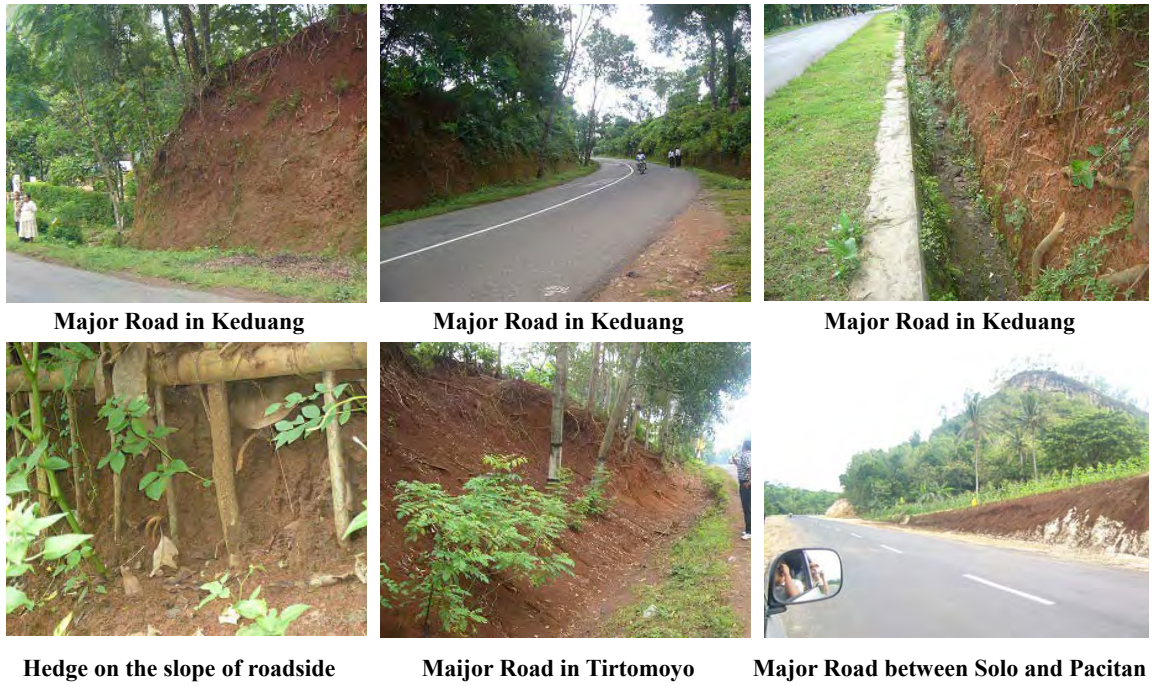
Figure 4.4.2 Location Map of Roadside Slope Erosion

The locations of existing roadside slope erosion are investigated for major and local road networks over the Wonogiri dam watershed. The identified locations together with field photos are shown in Figure 4.4.2.

The roadside slope erosions are distributed throughout the entire basin, especially on the steeper slopes of excavated sections. Though sheet erosion is a dominant for the erosion of roadside slopes, slope failures occur in some areas. Protection works by masonry and blocks normally exist on the road slopes in urban areas. Where the excavated roadside slope is gentler, the slope is protected from erosion by covering grasses. Both the protected slopes and gentler slopes were neglected for the estimation.

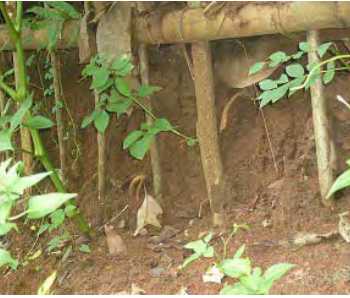
Hedge on the slope of roadside

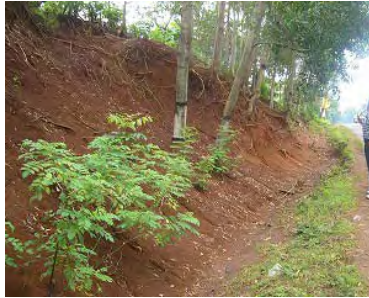
Major Road in Tirtomoyo

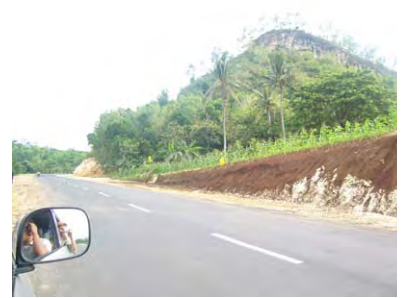
Major Road between Solo and Pacitan

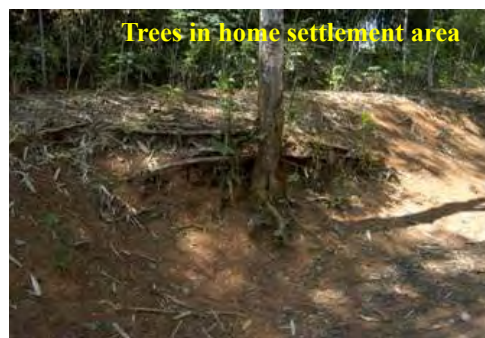
- i) The main sources of soil erosion are upland fields with no terraces which extend over steep (over 10% in gradient) mountainous areas in the upper streams of the Keduang, the Tirtomoyo, the Upper Solo, the Alang and the Ngungganhan. Also deterioration of bench terrace lands becomes one of the most important factors for acceleration of soil erosions.
- ii) Relevant to soil erosions, the home settlement area which occupies about 22% of the total catchment area, features considerable area of upland fields composed of non-terrace and ridge terrace, mainly for cassava cultivation. In case of the Keduang river basin, a lot of rivers run from north to south and deeply dissect the lands. The home settlement area is located at the

back and both sides are generally dissected by rivers. So the slope of the home settlement areas is steep, often over 20%. A lot of roots of the trees are apparent in the home settlement area due to soil erosion.

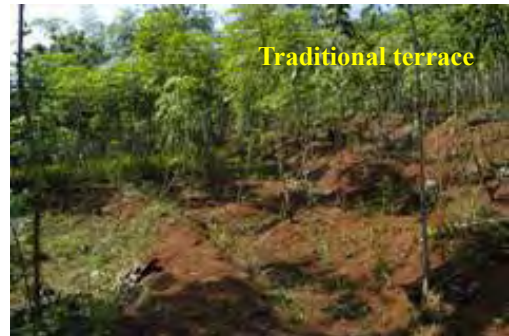
iv) About 50% of the total upland field area is covered with bench terrace even though about 80% of the total terraces are poor due to fairly low or no maintenance. The remainders is covered with traditional terraces, ridge terraces, non-terraces, composite of ridge terrace/non-terrace and complex of composite and traditional terrace. Especially, most of the upland fields extending over the steep mountainous areas in the upper reaches of the main rivers in the Wonogiri dam watershed and the most

critical upland field areas which are considered as the most serious potential areas for producing sediment yield, are not in bench terraces. Most of these upland fields are covered by traditional terraces, ridge terraces, non-terraces, composite of ridge terrace/non-terrace and complex. Such improper terrace conditions result in acceleration of soil erosion in these critical areas.
