**EMERGENCY STUDY ON THE PLANNING AND SUPPORT
FOR BASIC PHYSICAL AND SOCIAL INFRASTRUCTURE
IN JUBA TOWN AND THE SURROUNDING AREAS
IN THE SOUTHERN SUDAN**

SUPPLEMENTARY REPORT

OCTOBER 2007

**KATAHIRA & ENGINEERS INTERNATIONAL
JAPAN ENGINEERING CONSULTANTS CO., LTD.
KOKUSAI KOGYO CO., LTD.**

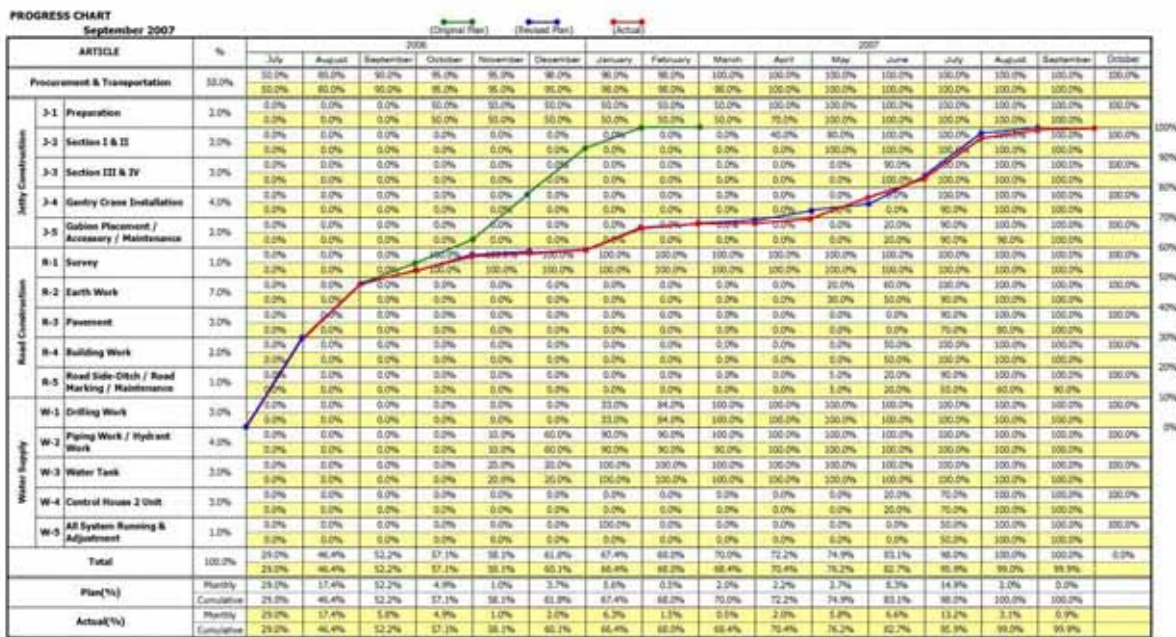
Figure I.4-1 Work Progress Chart

From late June, cement/lime stabilization works were also started along first section between Sta. 0+020 m and 0+420 m, followed by section between Sta. 0+420 m and 0+680 m with cargo handling yard beside the Jetty from late July after compaction of above described problematic sections were confirmed, although such stabilization works were repeatedly interrupted by sudden heavy rain, and caused additional repair works and further delay of other remaining works, such as double bitumen surface treatment works and road marking works which were rescheduled to be implemented during August 2007.

By the day of official handover ceremony dated 21 August 2007, which was scheduled based on the optimistic plan in June before heavy rainy season continued, DBST works were only completed in the cargo handling yard, followed by section between Sta. 0+420 m and 0+680 m in late August, and section between Sta. 0+020 m and 0+420 m by mid September 2007.

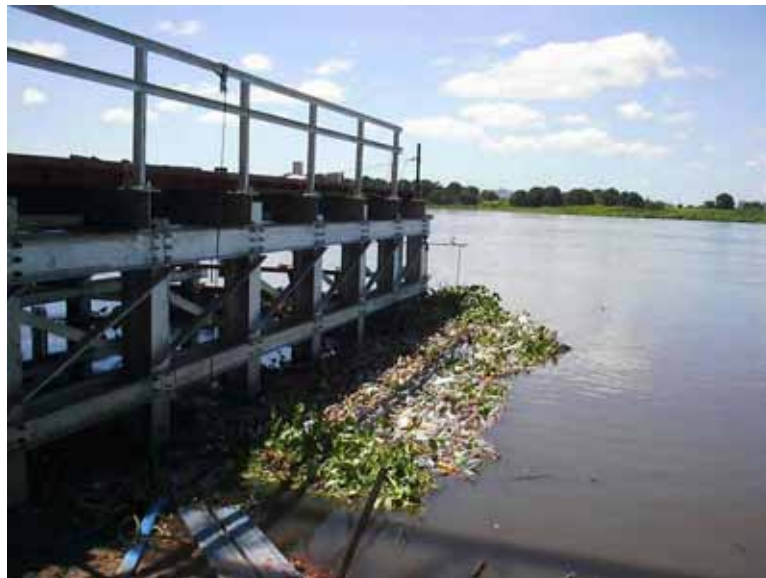
Current Situation of Floating Debris

In addition to above, installation of floating debris barriers is highly recommended to keep port facility clean from the floating debris which coming from upstream side of River Nile, meanwhile. Otherwise, periodical debris removal becomes critical issue in the course of operation and maintenance of jetty, although major portion of them are empty plastic bottles dumped everywhere in Juba Town, therefore improvement of public disposal collection system would be much more vital from the point of view of environmental consideration aspect.

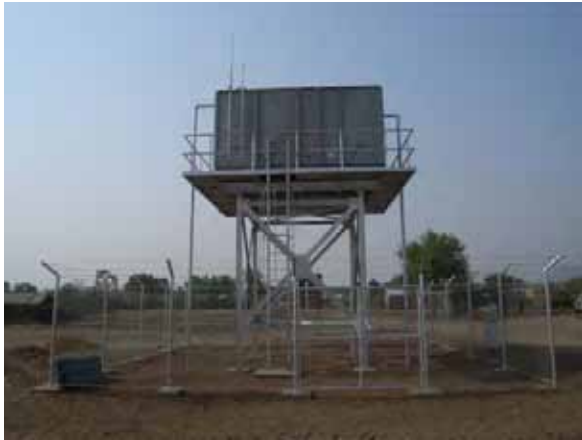
Completed Elevated Water Tank

When the water depth inside the elevated water tank reaches 1.8 m, the automatic shut off valve is triggered to stop the inflow of water. The water depth in the tank should be kept between 0.3

m and 1.8 m as the excessive outflow of water inside the tank may create air pockets inside the outlet pipe leading to the water distribution pipeline.
