**Technical Assistance**  
**For**  
**Reconstruction of Bridges Damaged**  
**by the 8 October 2005 Earthquake**  
**on the Jhelum Valley Road**

**Final Report**

**February 2008**

**NIPPON KOEI CO., LTD.**

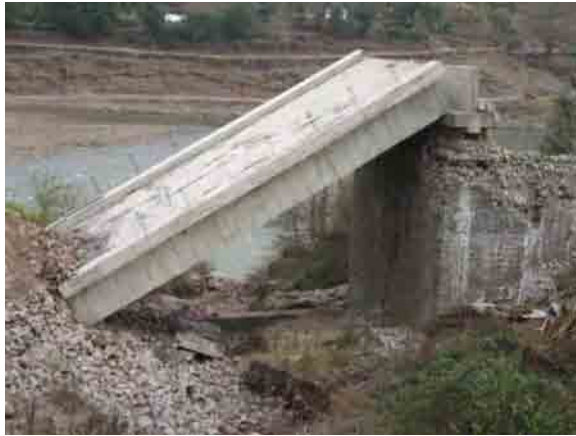
The old bridge damaged by the earthquake

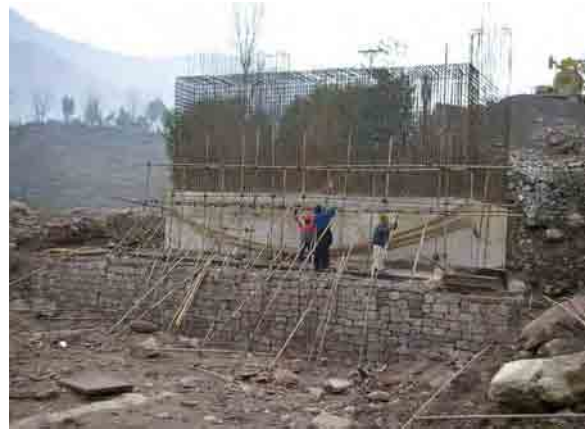
An abutment under construction

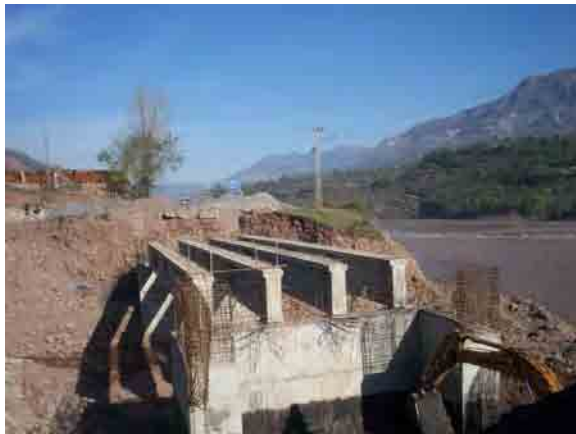
PC girders erected

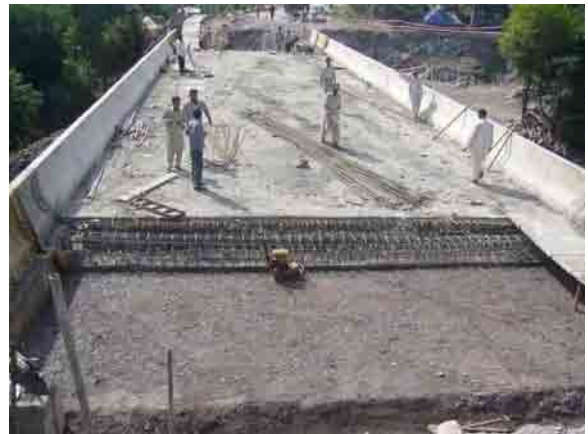
Super structure constructed

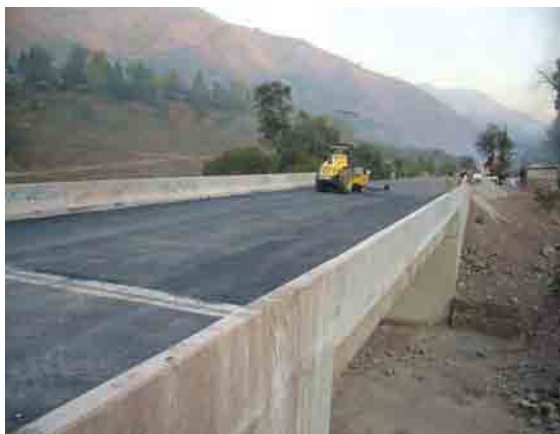
Asphalt pavement on the bridge

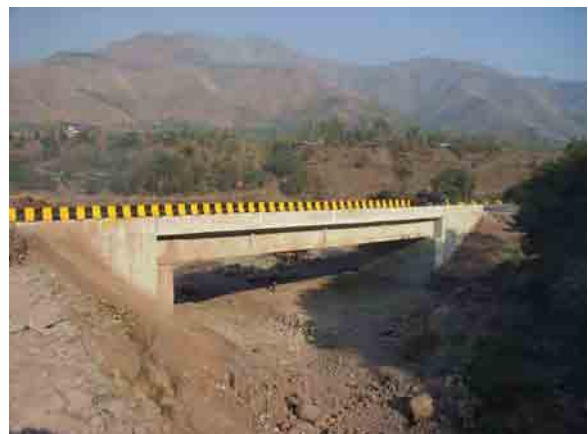
Bridge completed

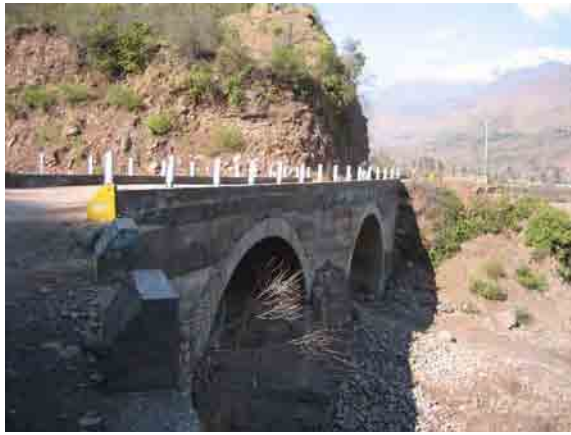
The old bridge damaged by the earthquake

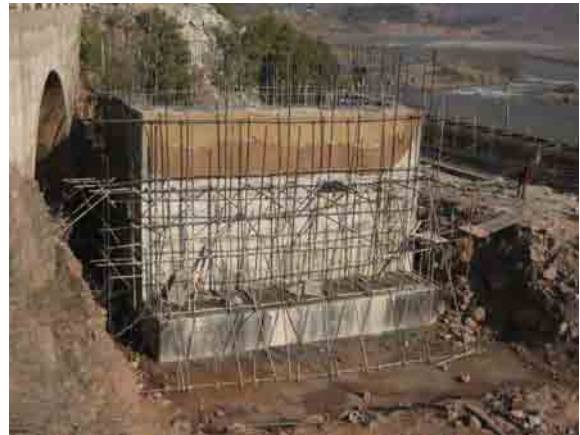
An abutment under construction

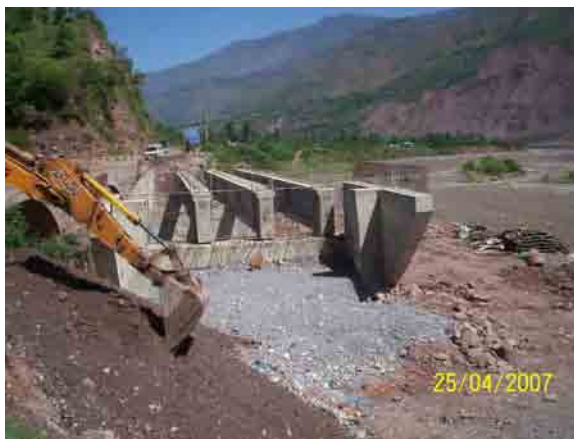
PC girders erected

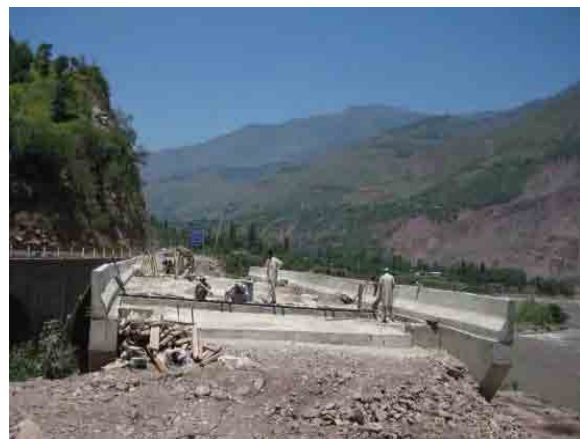
Super structure constructed

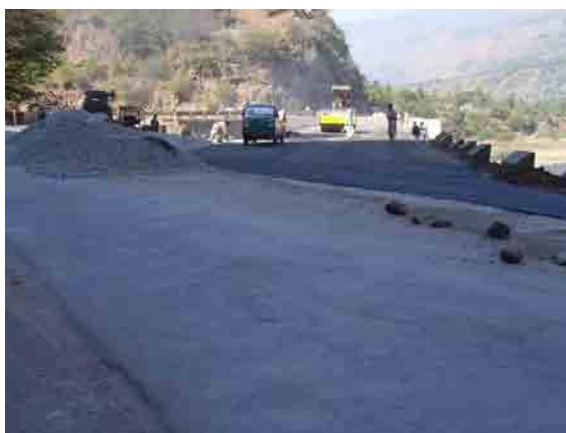
Asphalt pavement on the bridge

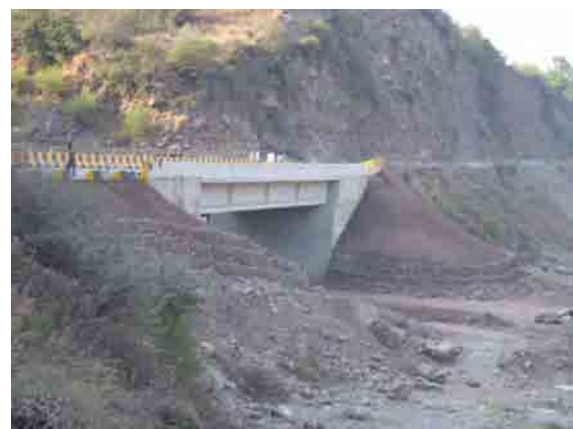
Bridge completed

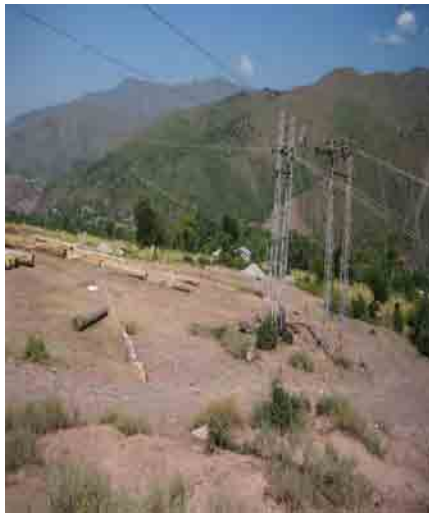
Top of the slope before cutting

During the construction stage, however, excavation of the slopes revealed that it consisted of loose stiff clayey soil with sub-angular boulders having diameter between 0.3 to 2.0m at the top step of the cut slope instead of the hardened and well-cemented gravelly soil. For such loose stiff clayey soil with sub-angular boulders, Mortar Spray Work is not applicable and the Crib Works should be selected as the countermeasure for slope stabilization in consideration of the frequent rock falling due to erosion of the soil surface.

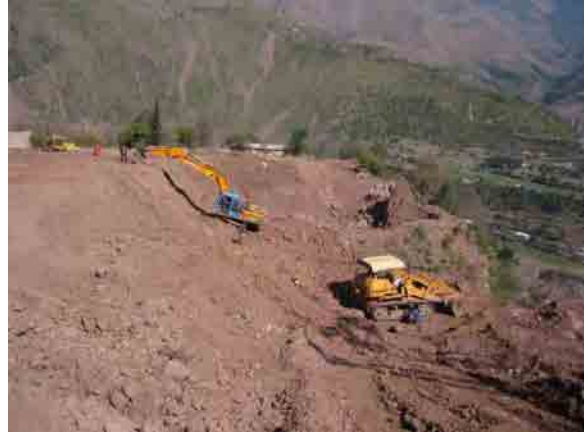
Sloping work under cutting

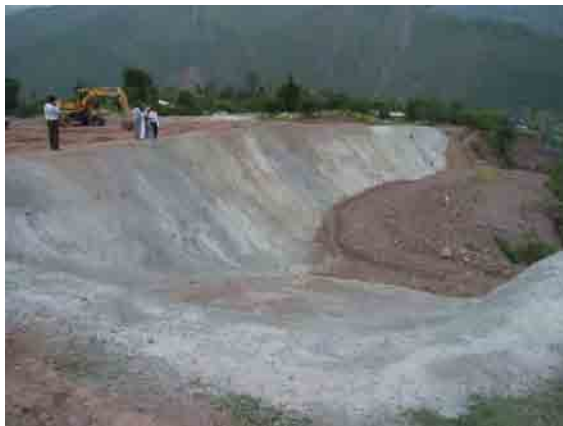
Slope protection (Mortar spray), completed

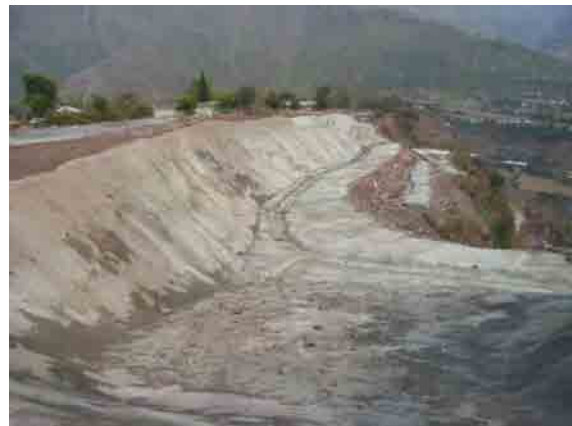
Mortar spray and Concrete cover work

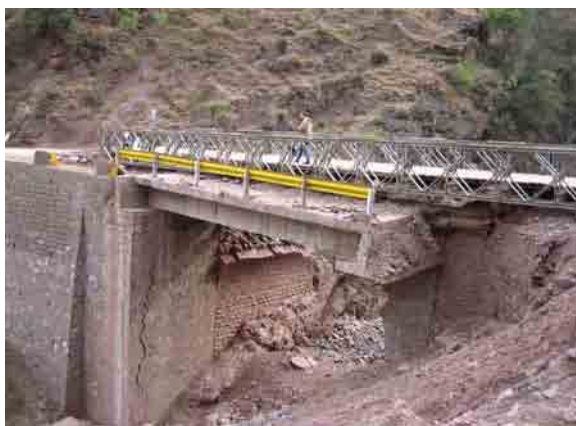
The old bridge damaged by the earthquake

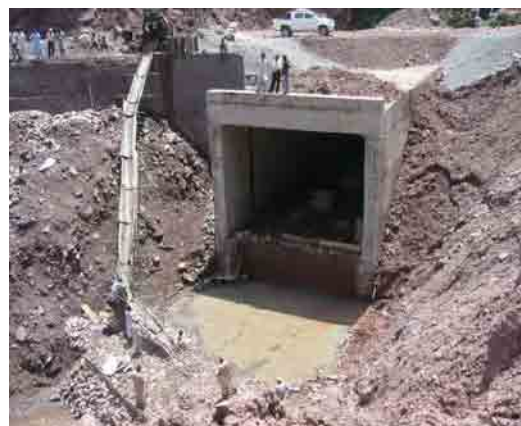
Box-culvert, completed

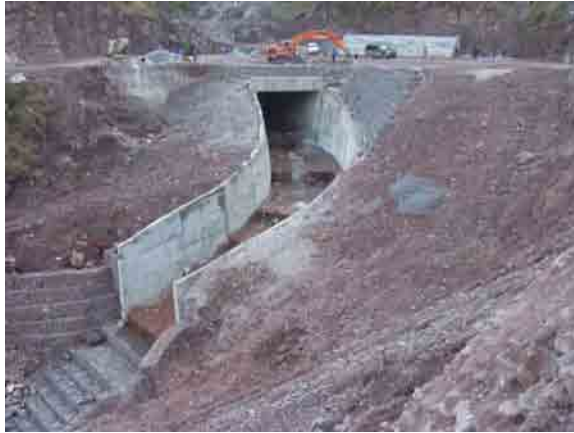
Log chute, under construction

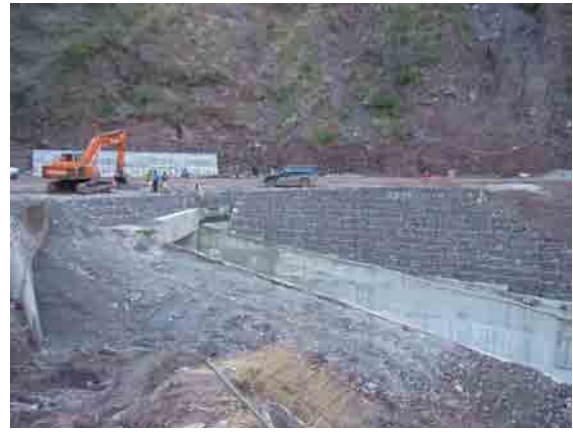
Road works, embankment protected by gabions

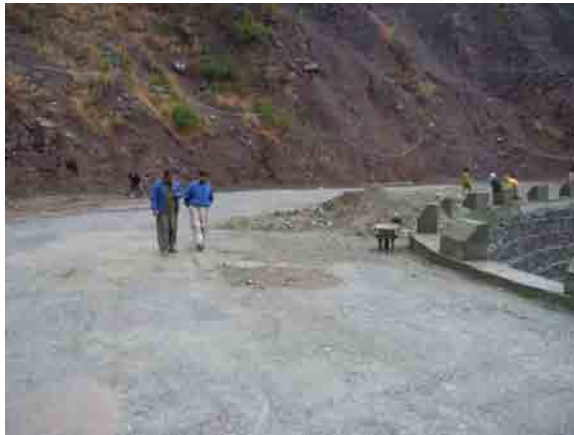
Base cause laying

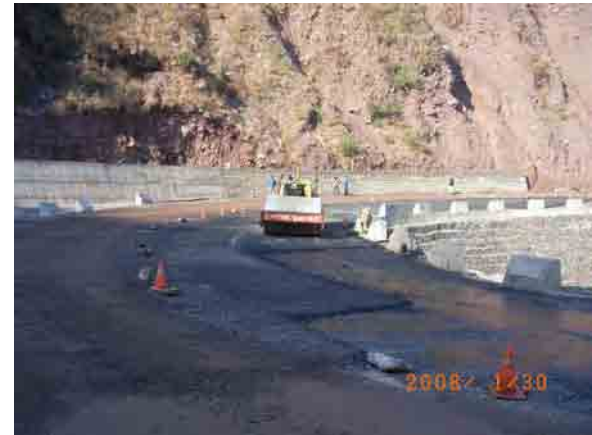
Pavement works

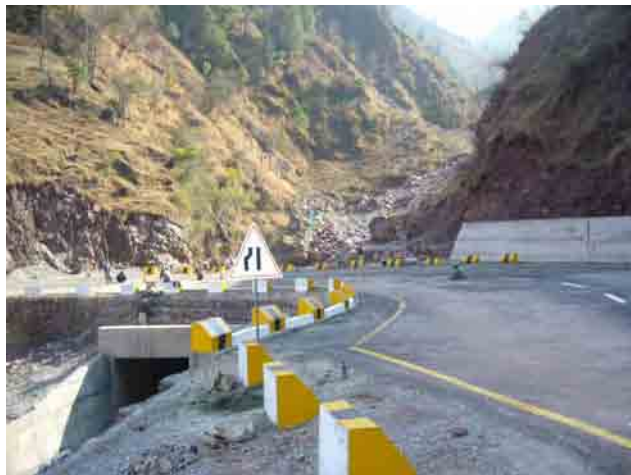
No.3 Bridge site, completed

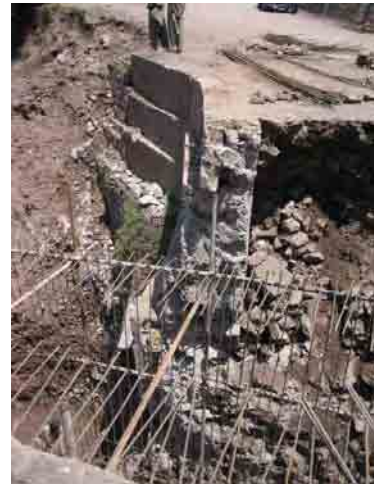
Demolishing work

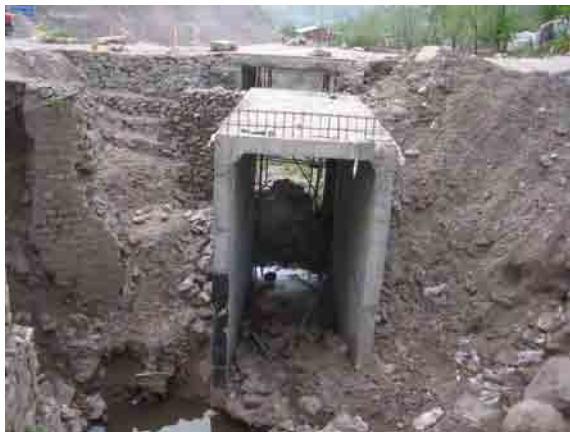
Box-culvert, completed

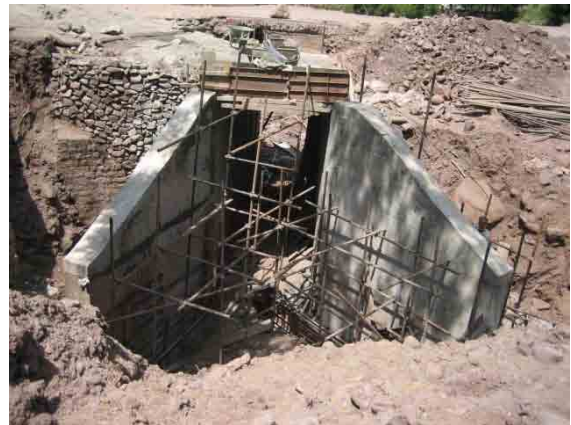
Wing wall under construction

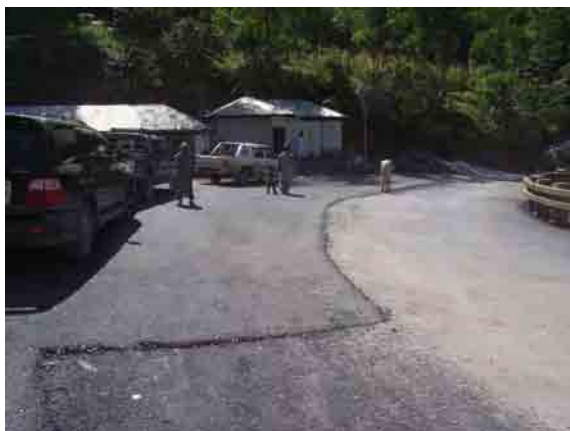
Pavement work

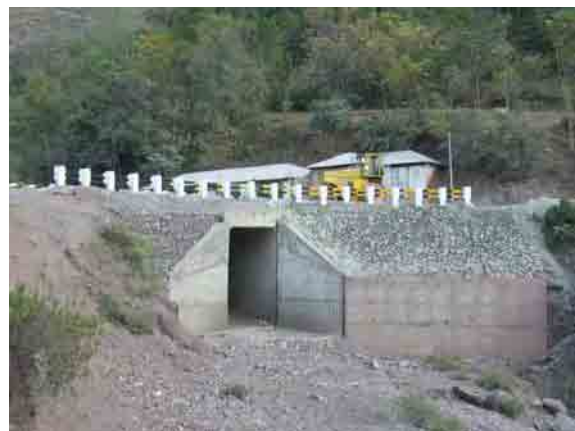
No.4 Bridge site, completed

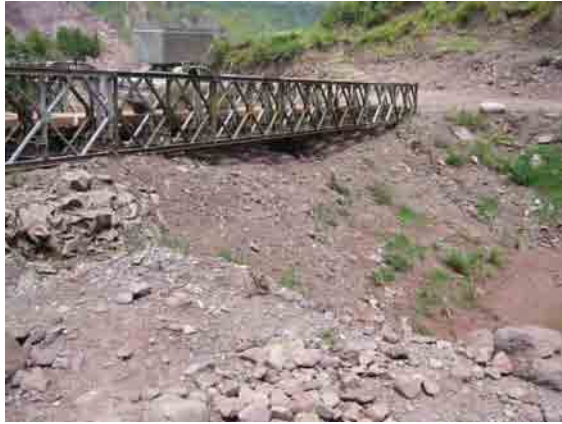
Old bridge damaged by the earthquake

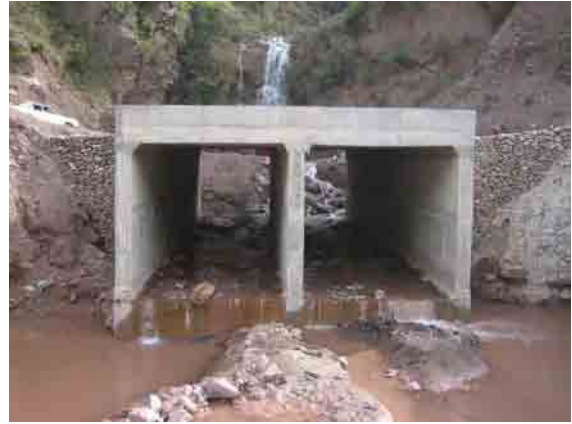
Box-culvert, completed

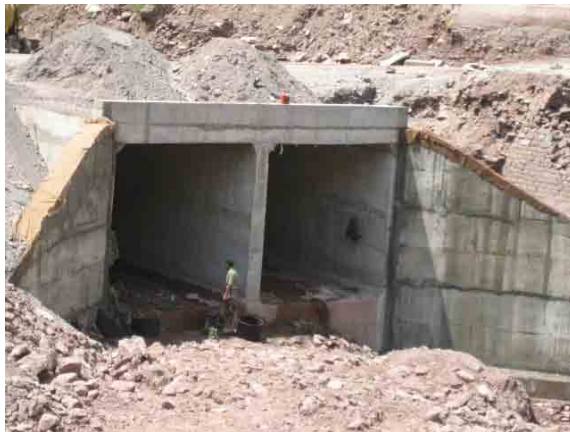
Wing wall under construction

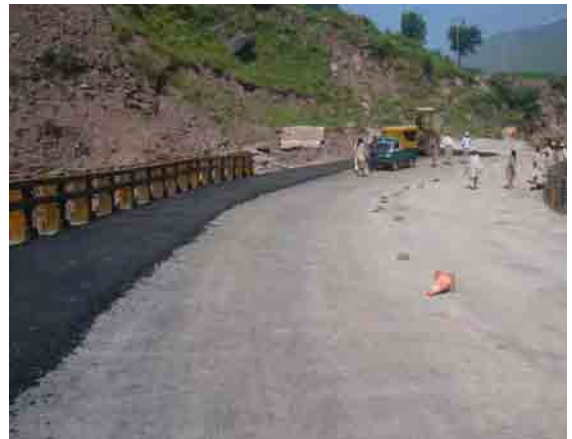
Asphalt pavement work

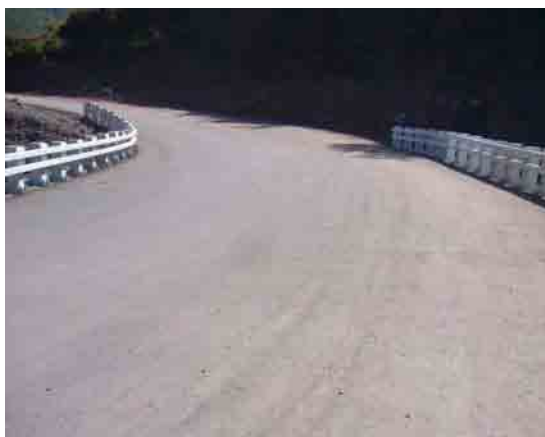
Asphalt pavement, completed

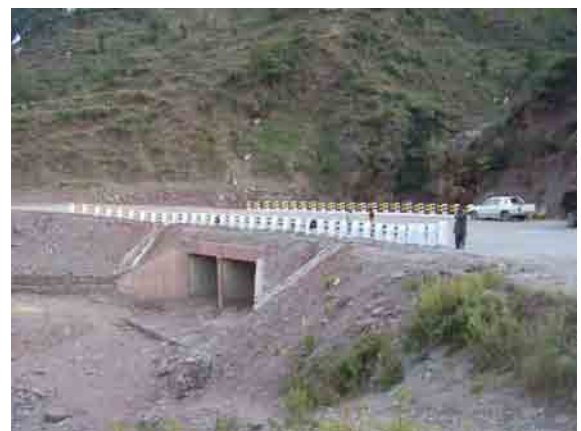
No.5 Bridge site, completed
