CHAPTER 3 SOCIO ECONOMY AND CITY DEVELOPMENT

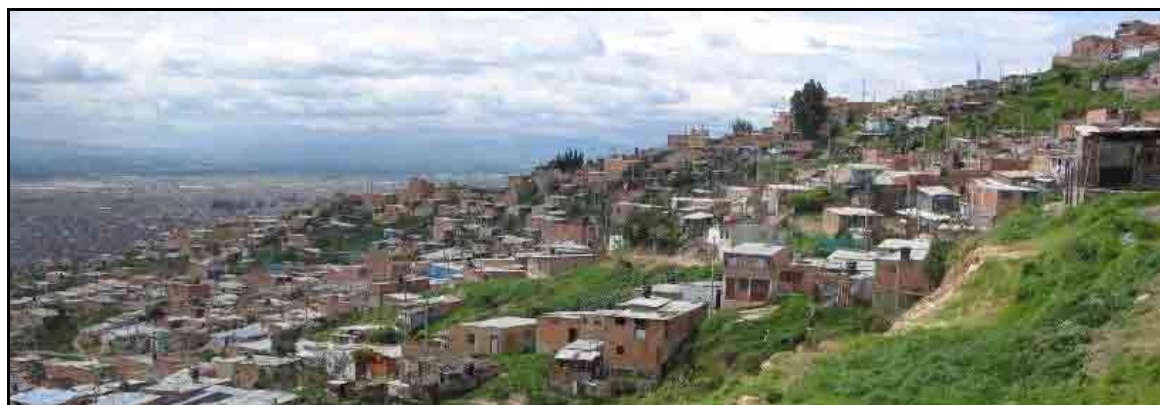
Photo 3-1 Typical Pattern of Urban Expansion

Management of closure processes of quarries are lack of strict compliance. The land recovery plans have been difficult to enforce. Many old mining areas are just left as it is, and becoming target areas for new informal settlements. As shown on the following photos, the uncontrolled urban expansion with poor infrastructures can be observed in many places within the municipal territory, and this situation creates unfavorable living conditions (poor infrastructure such as lack of road, water supply and sewerage, facing hazards, etc.).

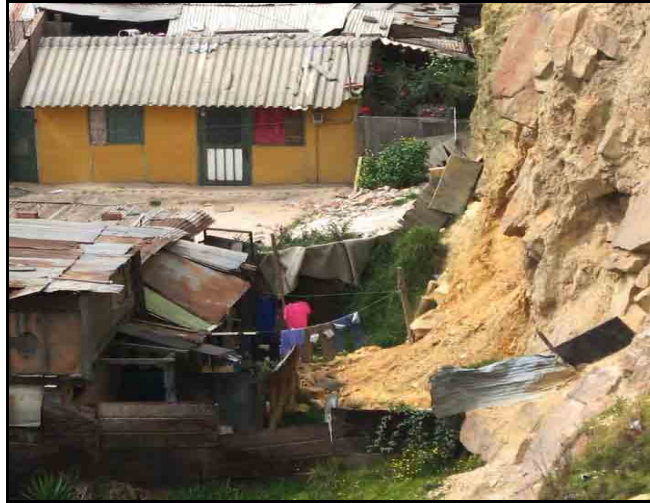
Photo 3-2 Homes Built in the Foothills Old Mine and Facing Landslide Hazards

With the permanent arrival of immigrants into the municipality, housing areas must be expanded. The land suitable for life has already been occupied and consequently only available spaces for immigrants under hardship conditions are the surroundings of the mining areas (quarries).

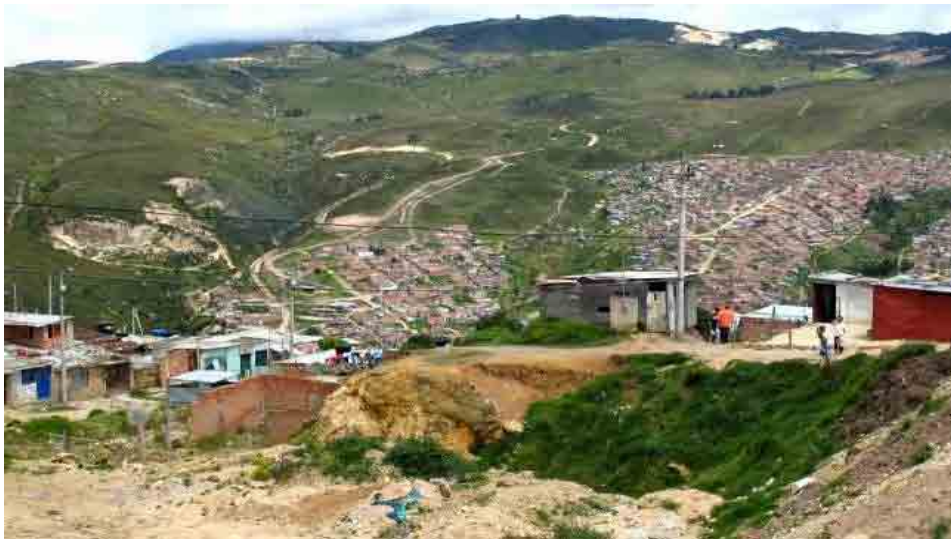
Photo 3-3 Neighborhoods Growth over Rural Hills

Photo 3-3 shows the case of Altos de Cazucá, an entire hill has been covered with many barrios in which more than 60,000 people live without any plan in terms of urban development.

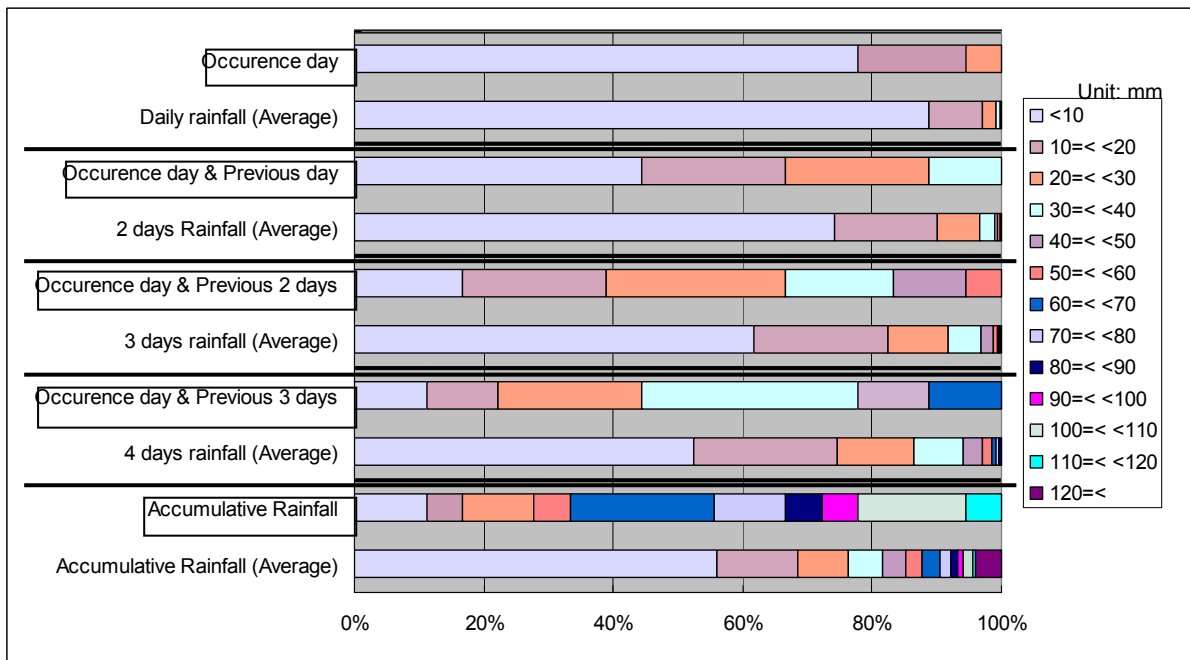
Figure 4-5 Various Rainfall Amount in Landslides Occurrence and Average Values in Juan Rey Station (EAAB)

From the following figure, the obvious differences of the tendency are not seen in the cases of occurrence day and daily rainfall (average), and occurrence day & previous day and 2 days rainfall (average). On the other hand, differences can be clearly found in case of accumulative rainfall, and can be recognized in 3 days and 4 days rainfall. DPAA already sets and uses the 3 days rainfall for the criteria in the current monitoring system. Therefore, analyses are undertaken using accumulative rainfall and 3 days rainfall (rainfall of occurrence day and previous 2 days).
