CHAPTER 6 FLOOD

6.1 Creeks in Study Area

6.4 Flood Analysis and Mapping

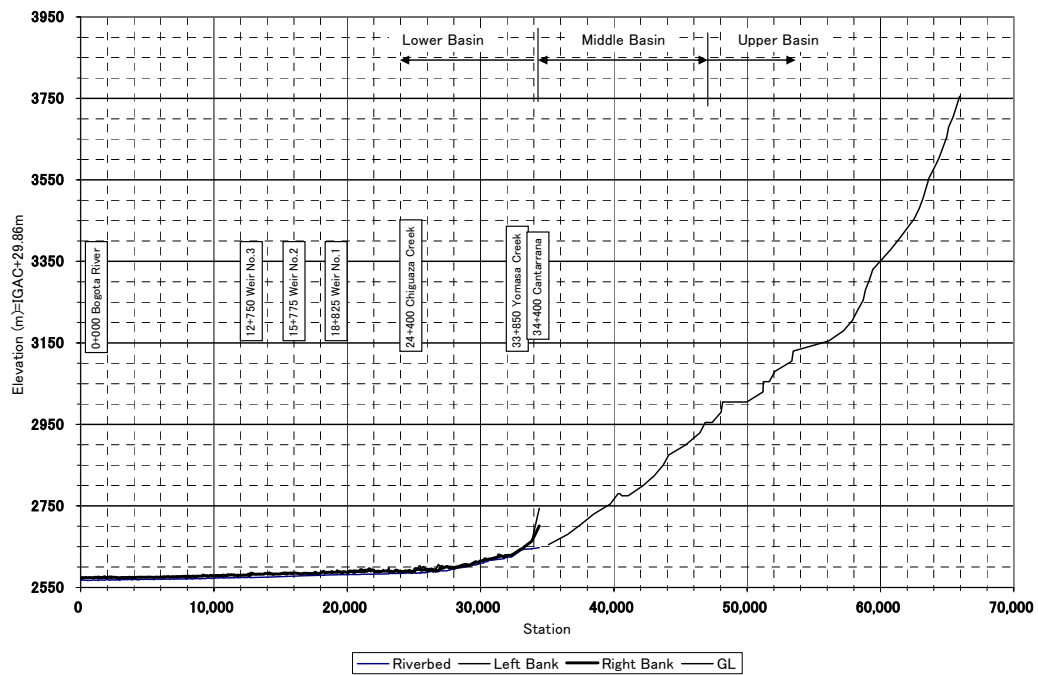
Figure 6-2 Longitudinal Profile of Tunjuelo River

The catchment area of the Tunjuelo River is 388.13 km², whose the highest point is 3,850 m and the lowest point is 2,536 m at the confluence to the Bogota river. The basin can be divided into the upper part, middle and lower part (Figure 6-2).

In the upper catchment there are the Chisaca river and the Curubital river. There is the La Regadera Dam at the confluence of those rivers. In the middle catchment, the Tunjuelo river is going down collecting other some tributaries to the Cantarrana Dam. The upper and middle part has the total area of 254 km² at Cantarrana Dam site.

The lower part can be defined for the reach from the Cantarrana to the Bogota river confluence. The lower catchment has eight (8) main tributaries such as Yomasa, Santa Librada, La Fiscala, Chiguaza (the right bank tributaries) and Botello, Trompeta, La Estrella and Limas (the left bank tributaries).

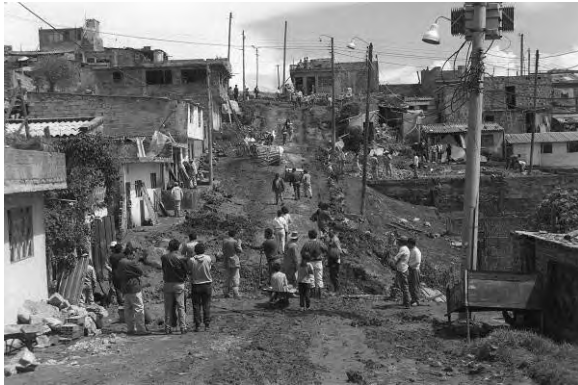
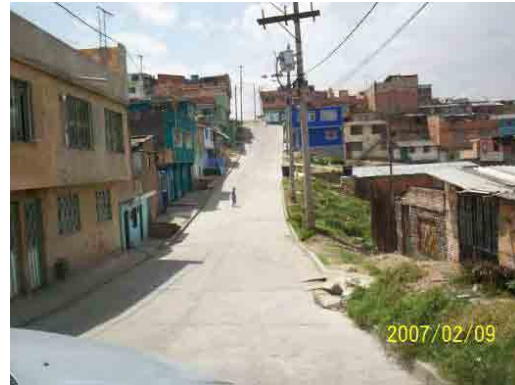
The most significant phenomenon in the 1994 event was the diversion from the bridge on *old highway to “Villavicencio”*. The resultant flash flood went to barrios Altamira, running on the streets among the blocks.

Photo 6-1 Affected Barrio Altamira (left: after May 19, 1994 source El Tiempo, right: Feb. 2007)

The area downstream of barrio Altamira suffered from the debris flow damage only in the creek and the limited riverine.

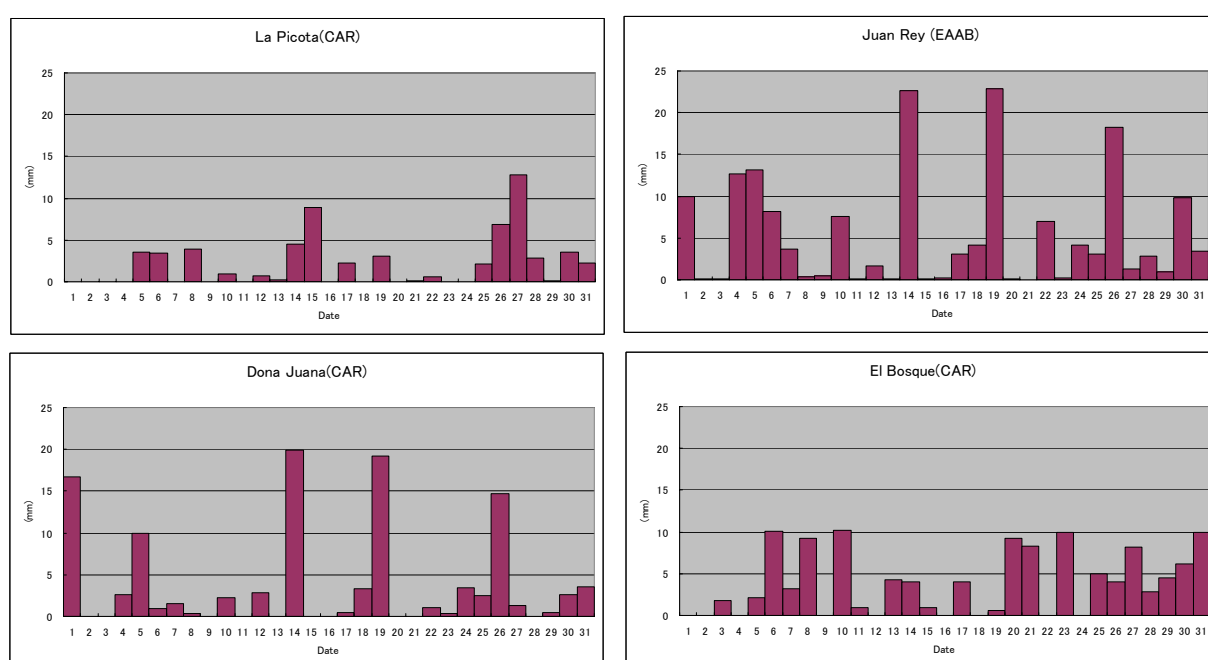
Figure 6-15 Daily Rainfall during 1 to 31 on May 1994

The following figures show the daily rainfall on May 1994 of the stations near Qda. Zuque. In Juan Rey (EAAB) and Dona Juana (CAR), around 20 mm a day was observed on May 19, 1994. Especially Juan Rey station (EAAB) which is the nearest to the Qda. Zuque had 22.9 mm on May 19 after it experienced the almost same amount of rainfall on May 14.

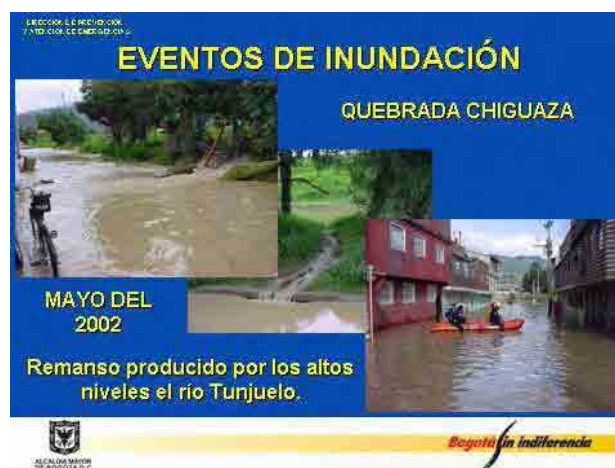
The inundation in the Chiguaza creek in May 2002 can be considered as one of the main flood disasters in recent years. The area near the Tunjuelo river confluence was seriously affected by flood water. As shown in Figure 6-16, it has been reported that the high water of the Tunjuelo river itself was the main cause of the inundation.

Figure 6-16 Presentation Material on May 2002 Flood by DPAE

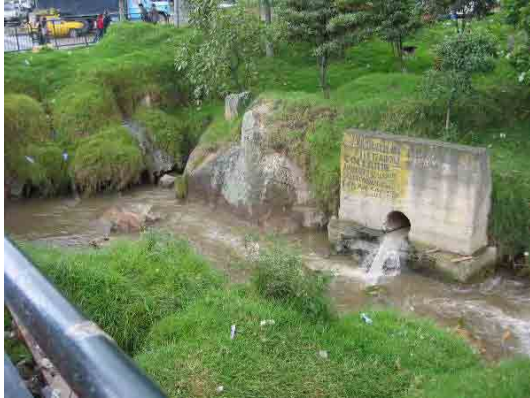
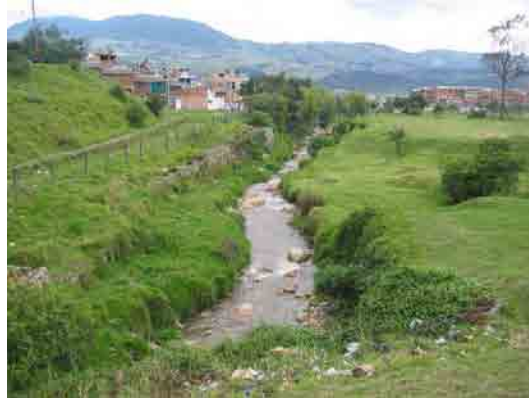
Photo 6-2 DPAE Monitoring Point 9 "Yomasa Creek"

In normal time DPAE does not do any monitoring activity for these points, however, in critical time, they are supposed to be monitored by Civil Defense or Firefighter based on the DPAE instruction.

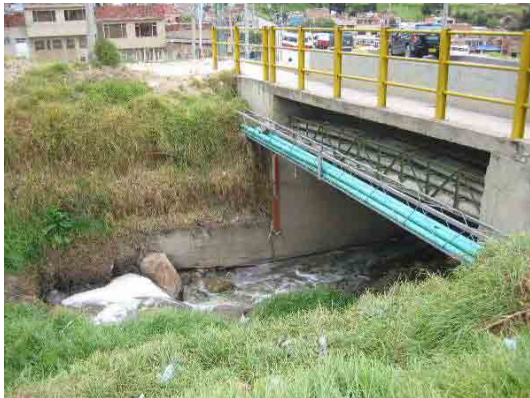
Photo 6-3 DPAE Monitoring Point 10 "DIANA TURBAY - LOS PUENTES"

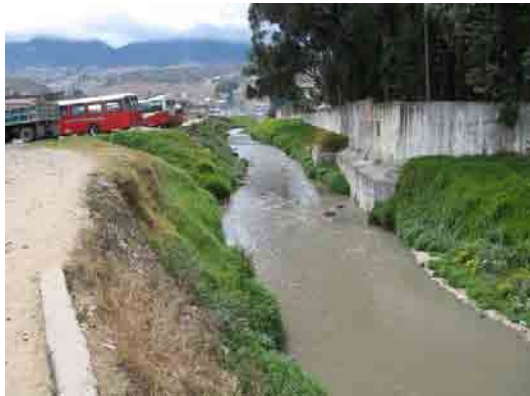
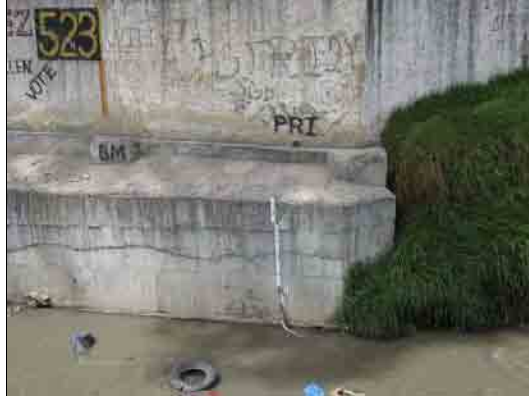
Photo 6-4 DPAE Monitoring Point 11 "PICOTA"

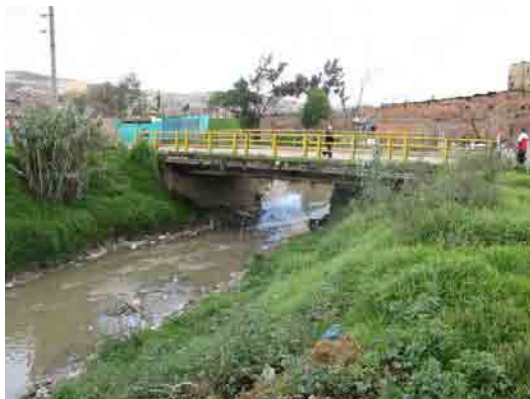
Photo 6-5 DPAE Monitoring Point 12 "PUENTE EL HOYO (Q. Chiguaza)"

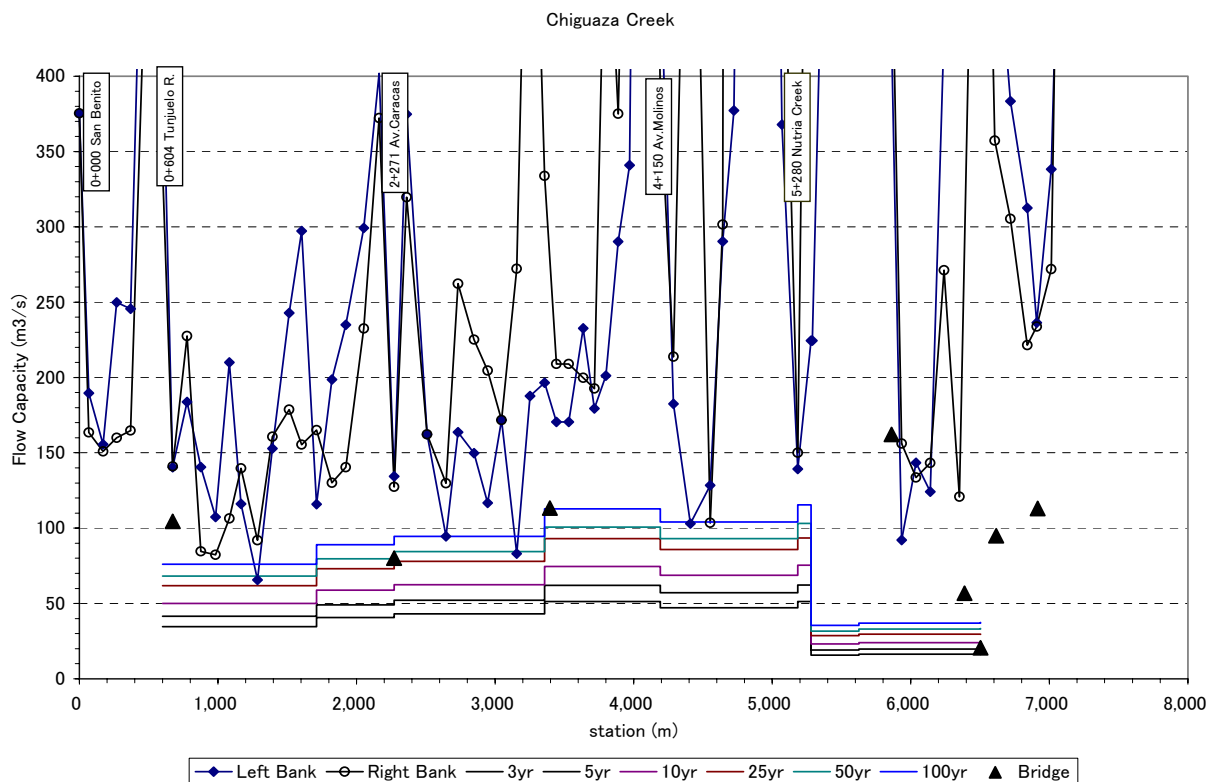
Figure 6-27 Channel Capacity and Probable Discharge of Chiguaza Creek

The creek has crossing structures such as bridge and culvert. Figure 6-27 also indicates the capacity of main crossing structure assuming without sedimentation. These structures have a sufficient capacity, however, the clogging due to sedimentation and garbage is easily to happen. In this sense, the critical points are selected as shown in Table 6-9.
