CHAPTER 10 COMMUNITY DISASTER PREVENTION ACTIVITY

10.1 Existing Community Studies in Soacha

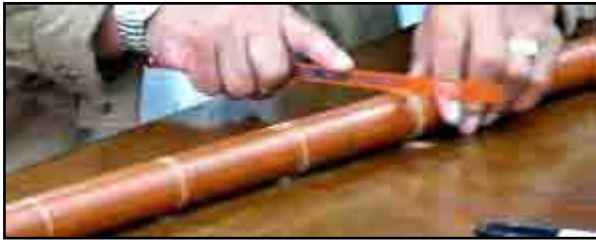
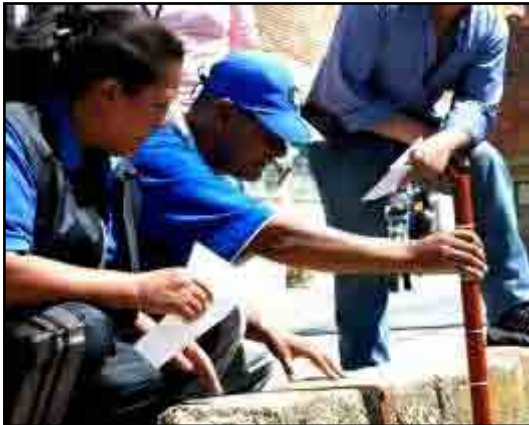
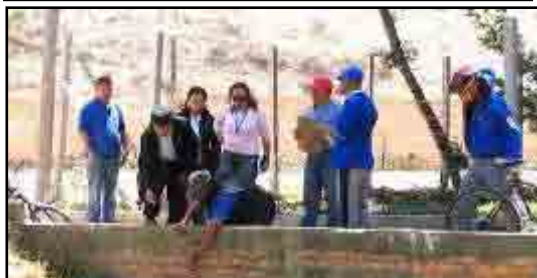
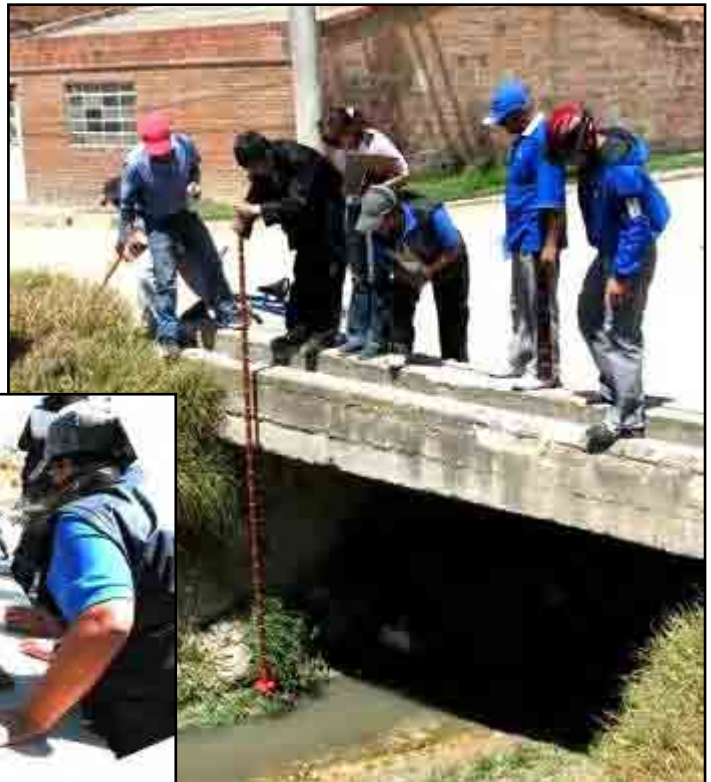
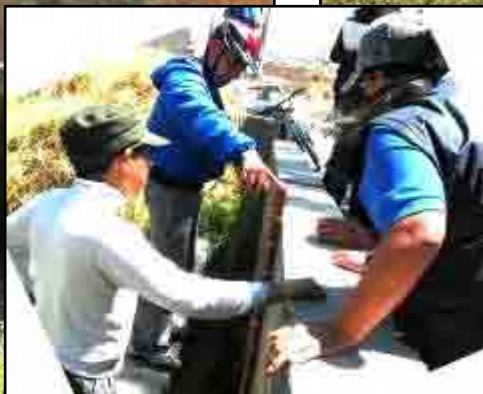
Photo 10-1 River Bed Monitoring Activity

Preparing the monitoring pole, carving an edge, each 10 cm. The pole is 3 m long.

Above: the length is written down in the register sheet. For example, in March 2nd the left side of the bridge located in Cien Familias measured 2 meters and 85 cm.

Left: They now take their chance to measure and write down the figures of the distance between the bottom of the river and the edge of the bridge marked in orange paint.

The first bridge is in Florida II Sector. People observe at first, while the exact point of monitoring is defined.

In five Bridges: Carrera 2A, Carrera 2Este, Carrera 4 Este, Carrera 7 Este, Carrera 9 Este, community leaders committed to take measurements, each two weeks. A field's training took place on March 2nd and the monitoring activity has continued each two weeks by these five community members. These five people have agreed to continue to monitor the river, although they requested support from other neighbors and leaders to take part of the observing and recording group. These observers belong to different barrios of the study area (Florida II, Florida I and Llano Grande).

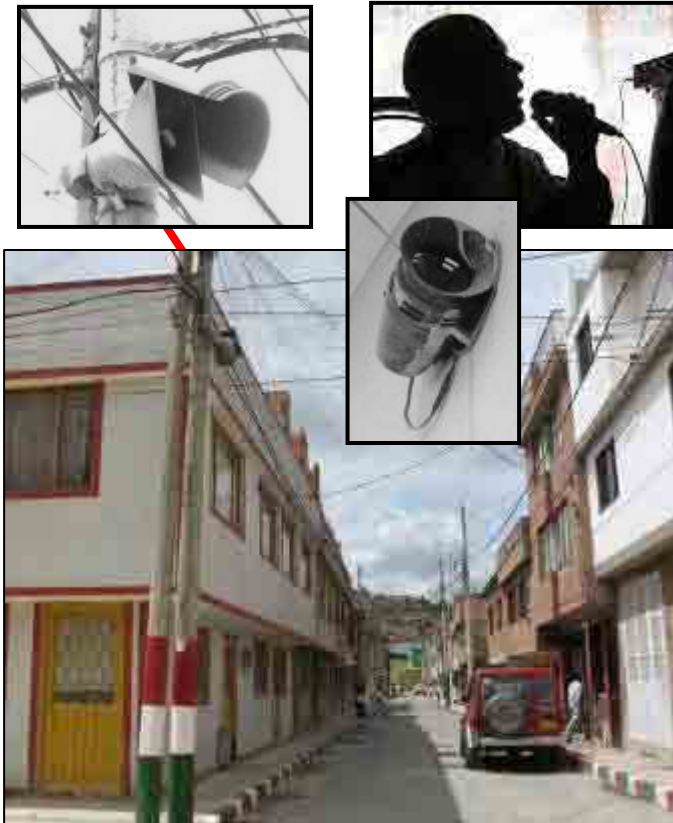
Photo 10-2 Present Speaker System

In La Florida II currently there is a community system used by the neighborhood association for announcing events or topics of community interest. This is the only barrio that has this kind of devices. The alarm system is broken. The speakers present distortions at 80 mts of distance which does not allow fully understand the message, due to its limited capacity.

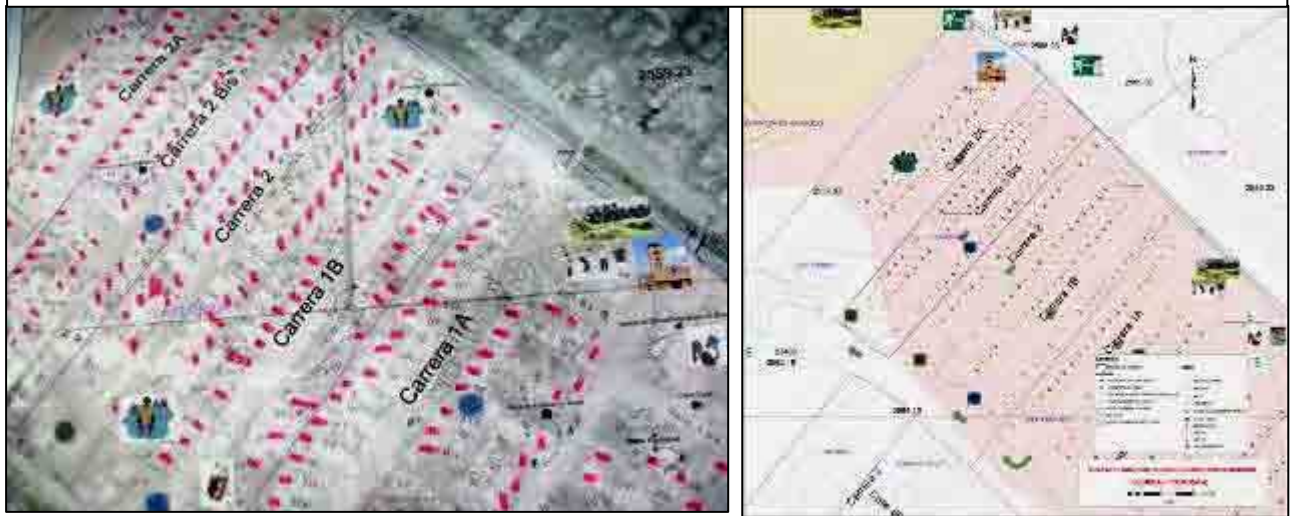
A walk around the streets to study the possible evacuation plan in each barrio was coordinated with Red Cross volunteers and the JAC leaders who visually explained the areas flooded during May 2006. The streets, routes and shelters were identified and inspected in Cien Familias, Florida II, Cohabitar and Florida I. Another field visit identified the number of floors and type of roof (flat with terrace or not). This data was added into the draft maps, (lower left) and later incorporated into the GIS data base for the Community Map (lower right GIS based draft map).

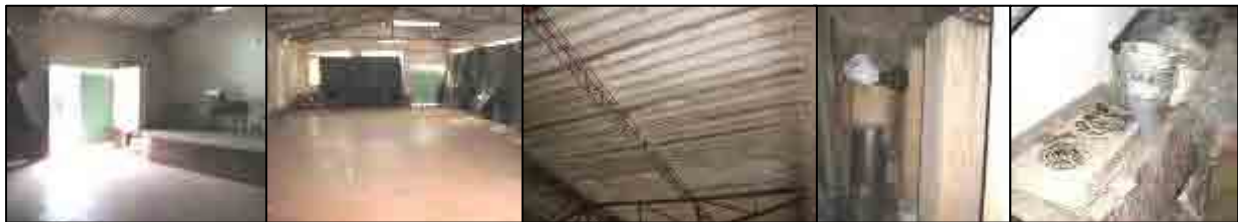
Photo 10-3 Community Center

The Community Center at Florida I is an ample space, used during May 2006, which can hold up to 300 people. Nevertheless roof leaks, windows, ventilation and illumination, in bathroom and kitchen area is key. This center is owned by the neighborhood association. The Alcaldía CLOPAD coordinator explained that a legal procedure needs to be written promptly in order to make the required investments. Signing an agreement with the JAC board stating the center plays a shelter role in an emergency is one pending task to be achieved by the CLOPAD..

In the case of Florida I, they do have a Community Center, but it is in no condition to shelter people for too long. Photos below are witnesses of the conditions of this place which needs repair.

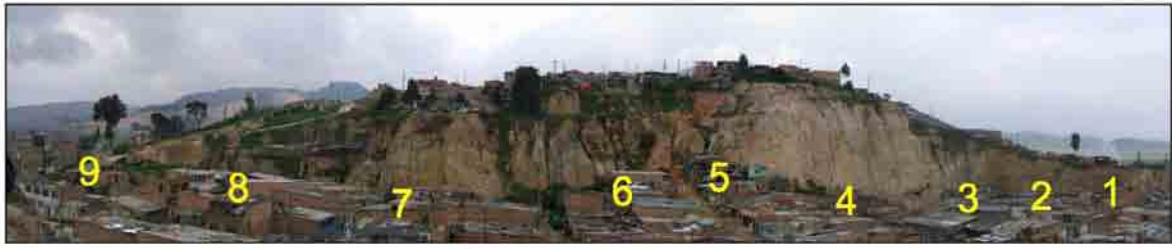
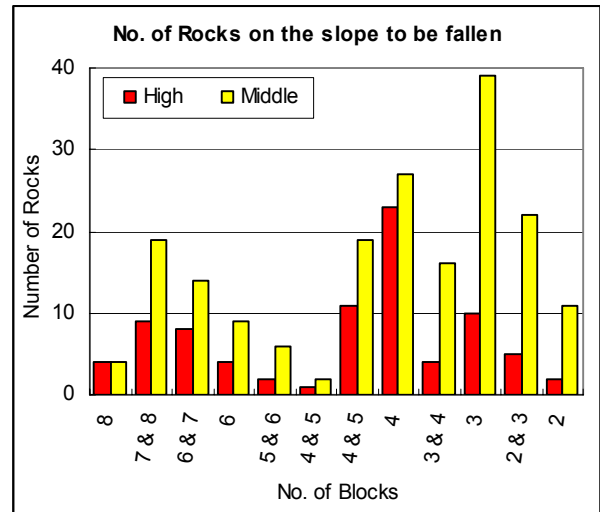
Figure 11- 4 No. of Rocks on the Slope to be Fallen by Blocks

The rocks on the slope which may fall in the future were investigated using stereo pictures as shown in Data Book 3. The rocks on the slope were classified into two (2) categories of: 1) high possibility of rock fall in the near future and 2) middle possibility of rock fall in future. According to this investigation, 271 rocks in total which may fall in the future were detected and the rocks classified high and middle possibility were 83 and 188 respectively. The result of the investigation is shown in Figure 11- 4.

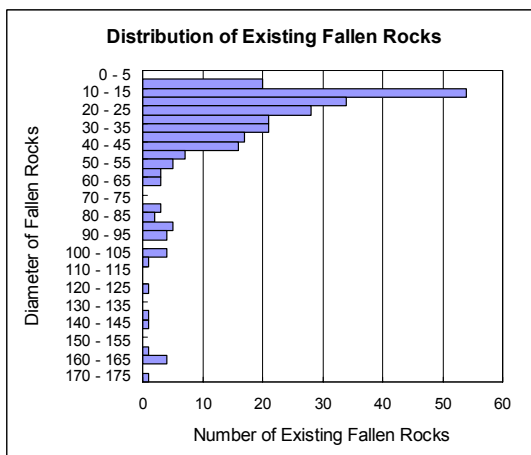
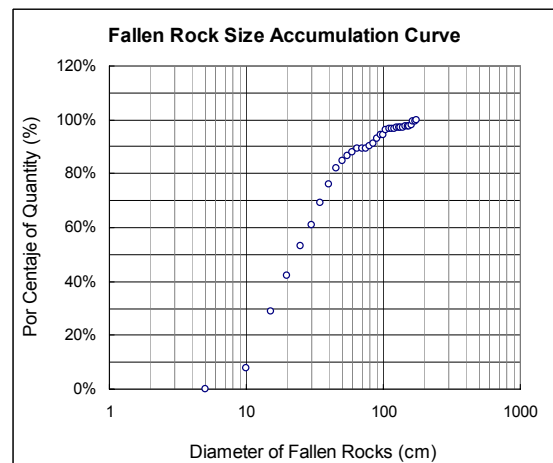
Figure 11- 5 Analysis of Size and Size Distribution of the Fallen Rocks

The form of measured rocks was variable; therefore the actual size of the rocks is converted to spherical form based on the estimated volumes. The size distribution of fallen rocks and rock size accumulation curve are shown in Figure 11- 5.

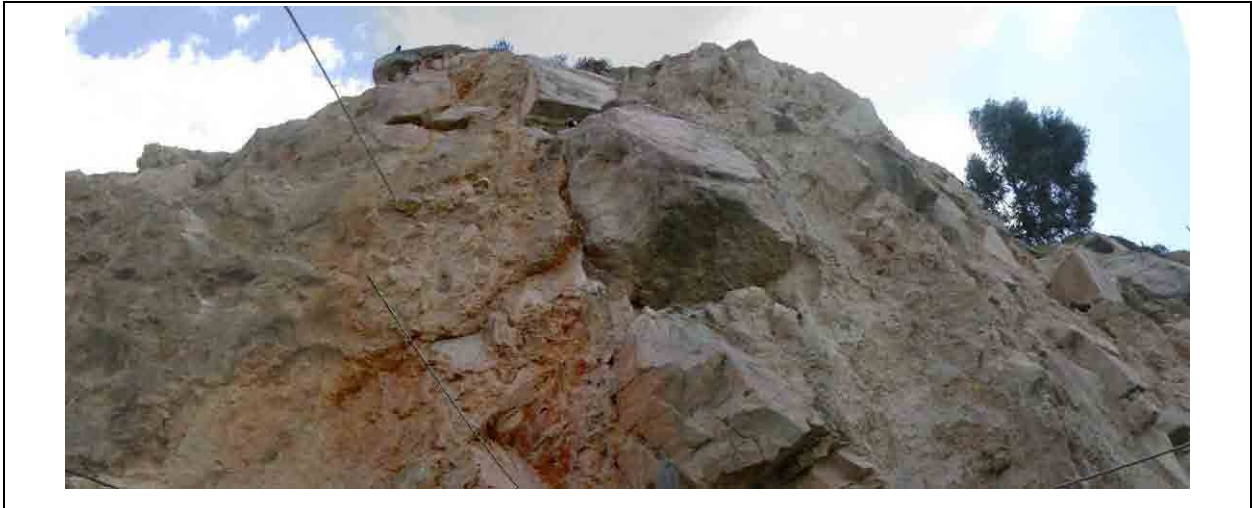
Figure 11- 11 Rocks supported by Deposits and Sediments in Street No.4 in El Divino Niño area

Many rocks are found out on the surface of slope in El Divino Niño area as shown in Figure 11- 11, and these rocks are supported by deposits and/or sediments between rocks. In rainy season, these materials which support the rocks is eroded by intense of rainfall, the disasters caused by rockfall are often informed. Therefore a conventional channel to minimize the erosion mentioned above is required on the top of slope in El Divino Niño area.

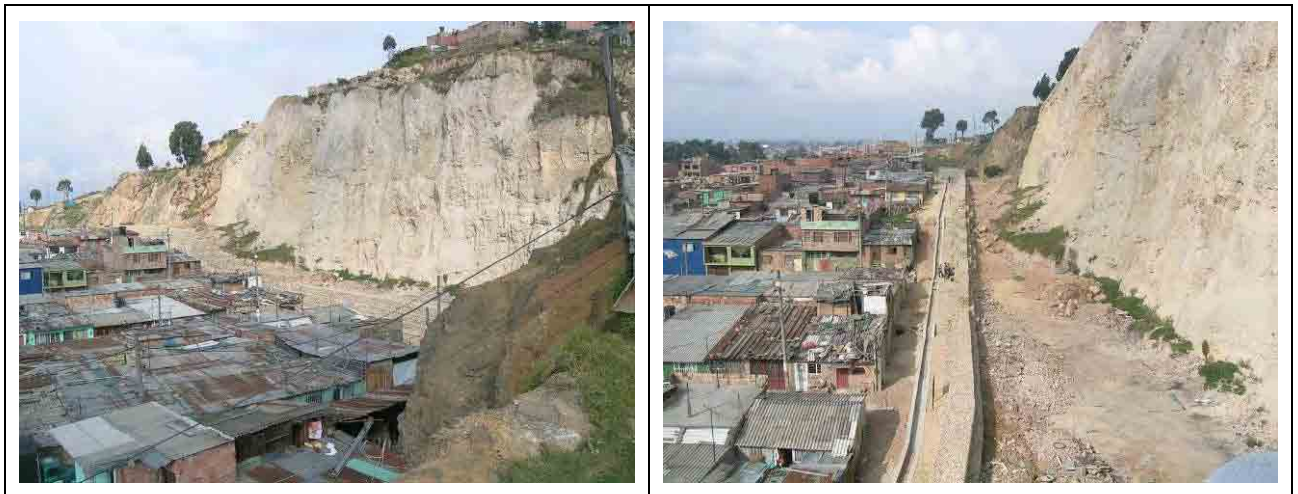
Figure 11- 17 General View of Temporary Works

- Installation of form work to avoid bulge out the gabion wall due to horizontal pressure by the stone
- Selection of the cobble stone to avoid aperture between stones
- Placing of the cobble stone in the gabion net to avoid aperture between stones

General view of the Temporary Works is shown as follow.

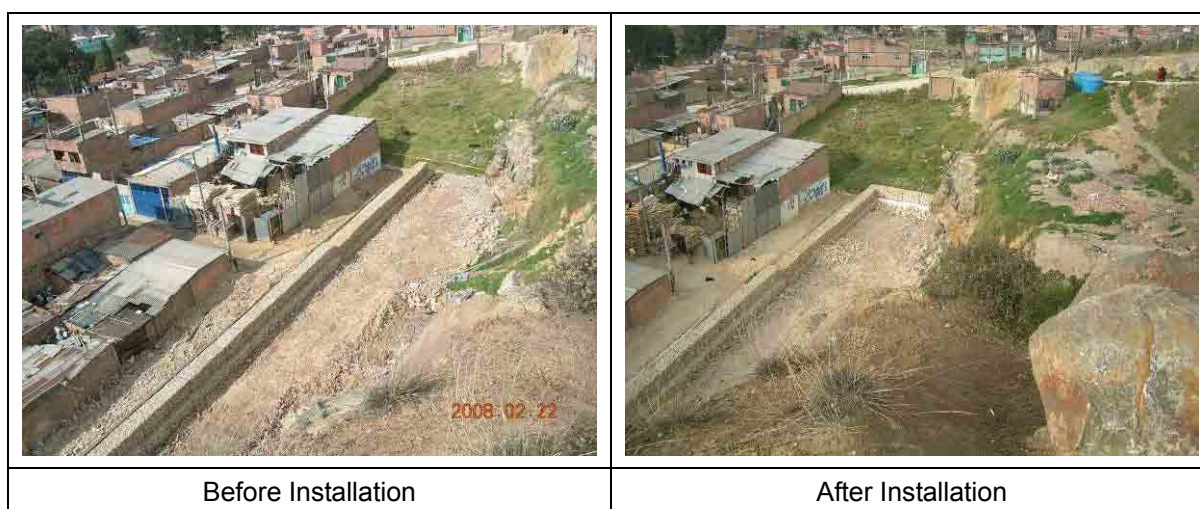
Figure 11- 19 Additional Protection Wall

In order to avoid new settlement from this place, the temporary protection wall with a length of 8.0m was considered in the 2nd Contract.

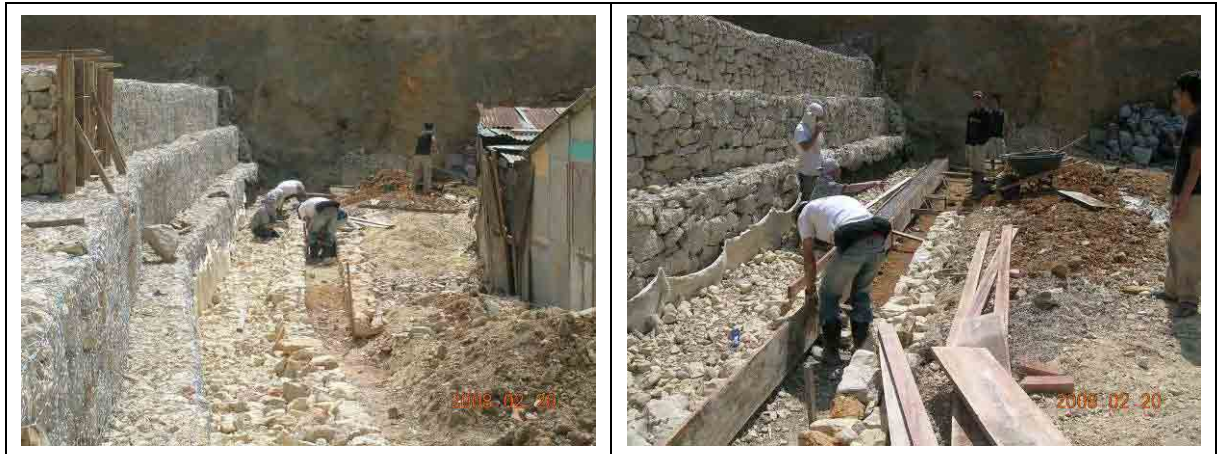
Figure 11- 20 Fixing of Cobble Stone by Concrete

Since rainwater from steep slope is conveyed to drainage channel through aperture of the gabion wall, the channel slope is made of dry masonry which guarantees infiltration of rainwater. And cobble stone with a diameter of 200mm is applied for dry masonry of channel slope. In the construction stage, it was found out that the channel slope made of dry masonry can not guarantee its stabilization in long term therefore top of channel slope was fixed with concrete.

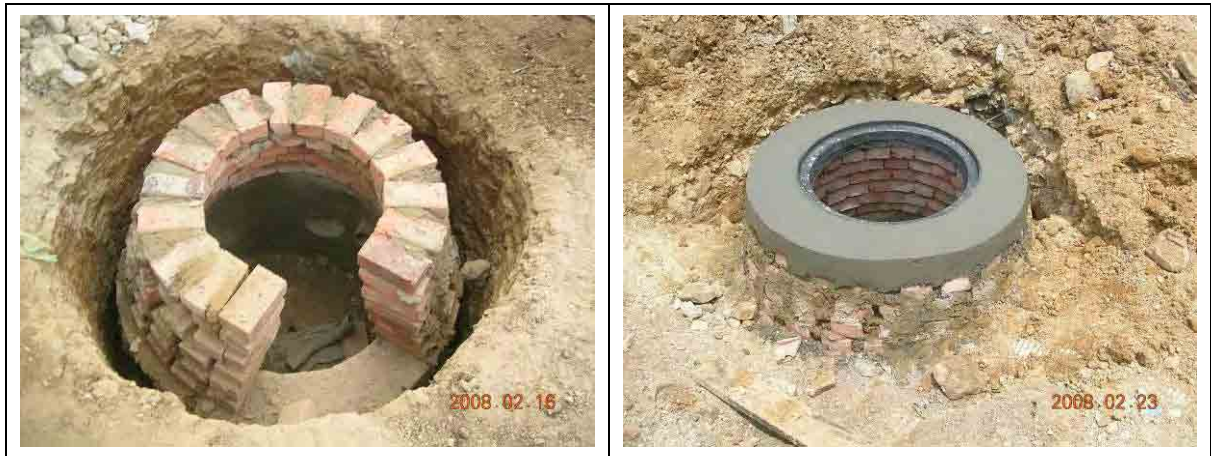
Figure 11- 21 Structure of Drainage Pit

Based on the community's information, location and diameter of existing pipe were confirmed by means of excavation works in the construction stage. From this investigation, the diameter of more than 6inches was confirmed between supervisor and contractor. Furthermore it was confirmed some streets have 2 to 3 drainage pipes. It is technically impossible to make some hole on the concrete pipe according to the number of existing pipe. Therefore the pit made of brick was applied in order to facilitate connection with the existing drainage pipe.

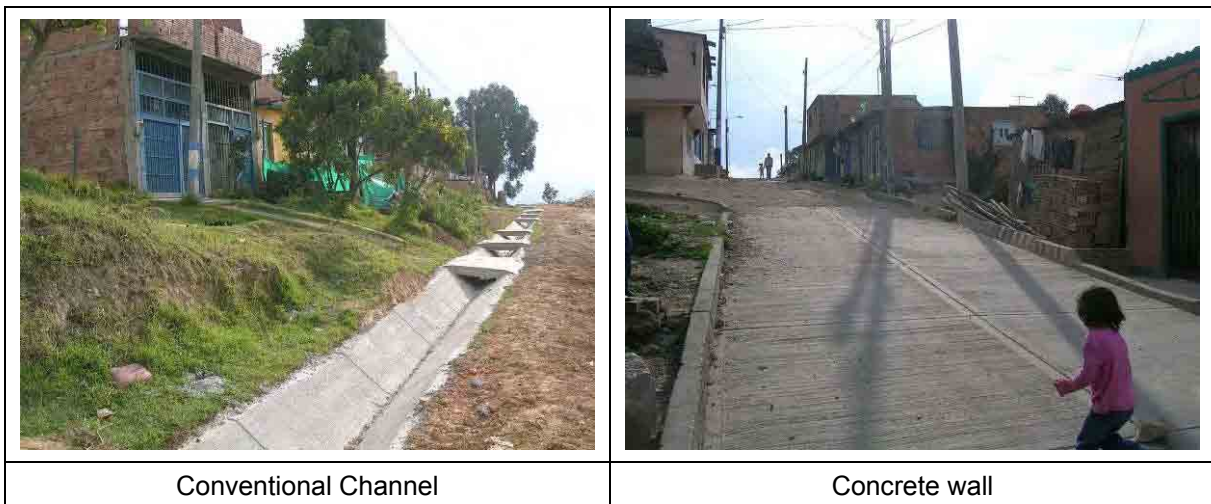
Conventional channel is installed in front of the houses therefore 10 foot passes were considered on the channel in original design. In the construction stage, it was confirmed that the number of houses are eight (8), which two (2) houses have their garage. Consequently a foot pass which has twice the size of width was installed to two (2) houses with garage considering passing of the car. For remaining houses, one (1) foot pass was respectively installed.

Conventional Channel

Concrete wall

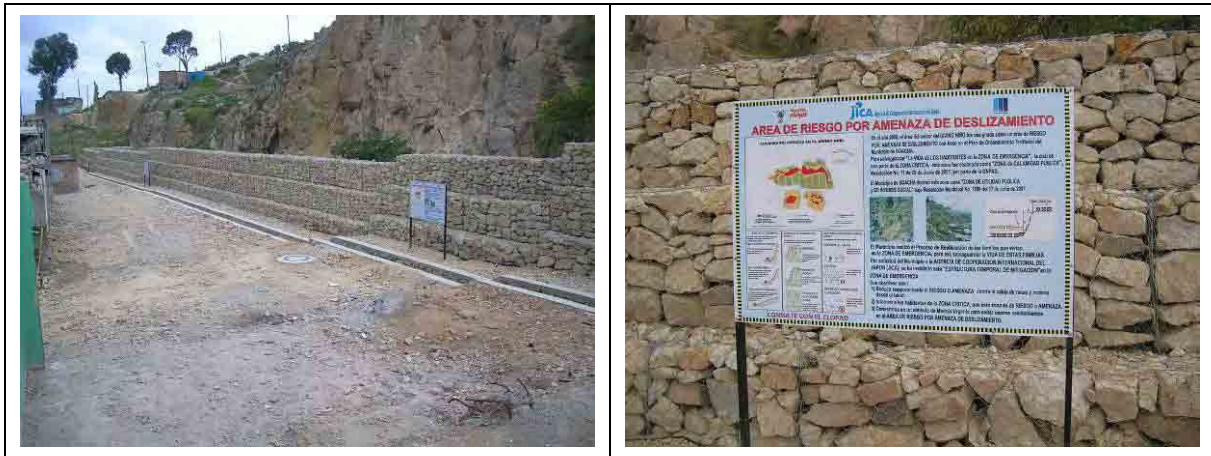
Figure 11- 23 Hazardous Sign Board

- Hazardous map with Critical Zone in El Divino Niño area
- Explanatory note of landslide and falling rocks
- Background of the Temporary Works
- Objectives of Temporary Works

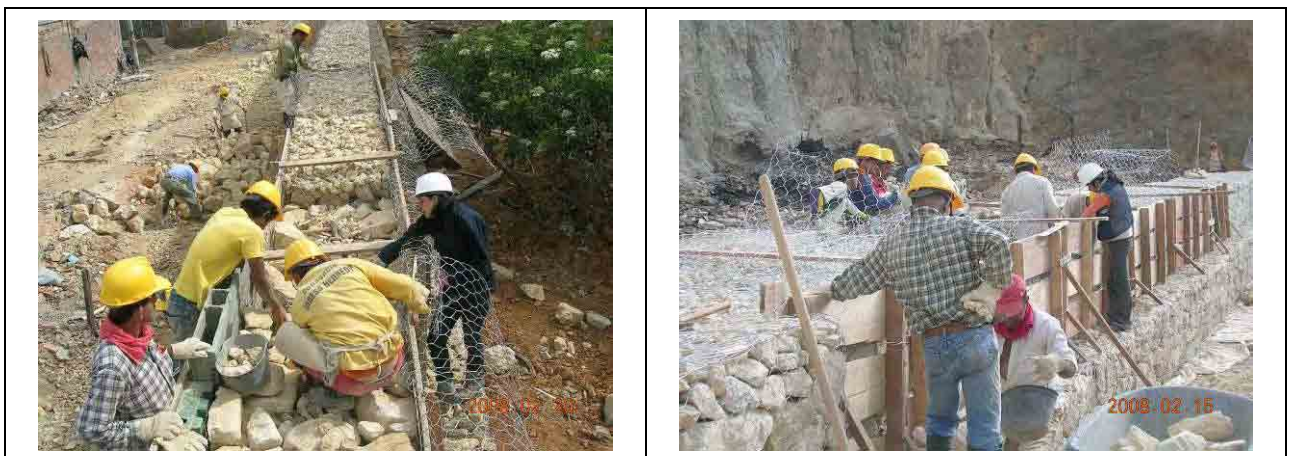
Figure 11- 24 Instruction by the Supervisor

The gabions in Colombia, two (2) sizes of stone are normally used. The large one is placed for face of gabion, and small one is for inside. If these stones are not good combination in the net, the face of gabion body is buggy due to horizontal pressure when form work is taken out. As the easy method to avoid this problem, the supervisor instructed the labor to fill small size stone in the aperture between the stones.

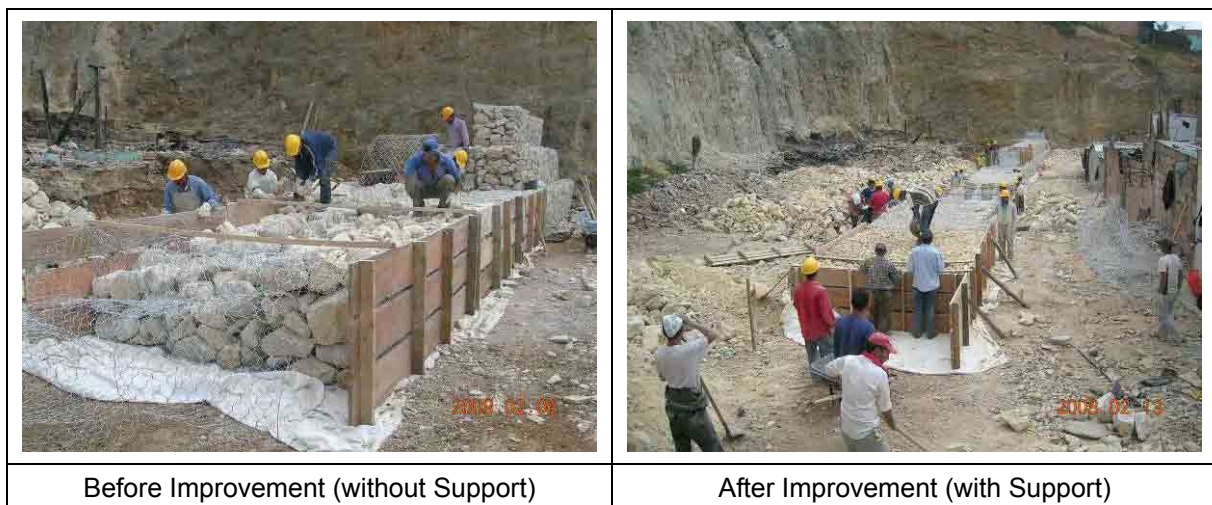
Figure 11- 25 Supporting of Form Work

instructed labors the point to fix of form work.
