# ANNEX

# 1 RELOCATION PROGRAM OF SOACHA MUNICIPALITY

## 1.2 Monitoring of Relocation Program by Soacha Municipality

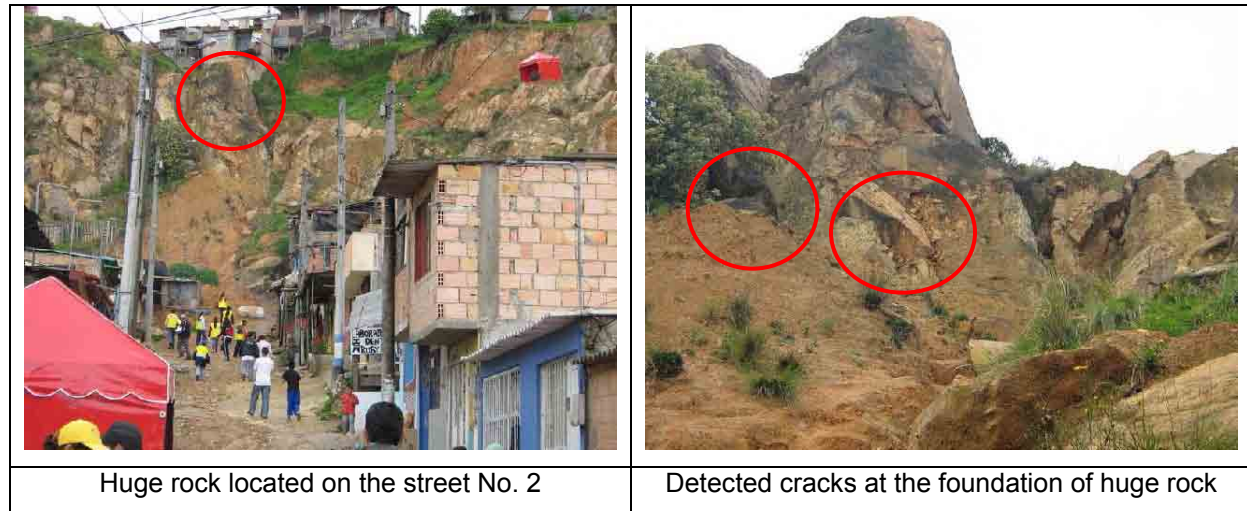
Figure 1 Location of Huge Rock and Detected Cracks

On 17 of May 2007, the Municipality received information that some cracks in the rocks which supported a huge rock were detected at the top of slope on the street No. 2 in El Divino Niño area. As in the opinion of the municipality, these cracks will immediately not affect the stability of huge rock; however this stability at present could not be guaranteed in the coming rainy season, so on the following day, 18 of May the Municipality called related organizations which are CAR, CREPAD, OPAD-CREPAD, National Police, Military and Fire Brigade in order to find out the method of urgent measure. At the same time 11 families who lived at residential blocks Nos. 5 and 6 around the street No. 2 were evacuated to the school in the area following the instruction of the municipality.

As the method of urgent measure, two (2) options which are 1) to remove directly the huge rock by heavy machinery and 2) to repair the cracks of supporting rocks by concrete were considered. The first option, which is removing of the huge rock was applied among related organizations due to period of the measure and procurement of the required material. So CREPAD started to investigate and measure the huge rock supported by rocks which has some cracks. The huge rock was estimated at approximately 96tons based on its form and general specific weight of rock. From this investigation, it was impossible to hoist directly the rock with crane or back-how which municipality possesses. Therefore following method was applied as urgent measure.

- excavate the material around the huge rock with back-how CAT 320L
- carry out the blast test in order to break safely the huge rock with white gun powder
- fix the huge rock by wire cable before blast works
- hoist broken huge rock with back-how at the top of slope after blast works

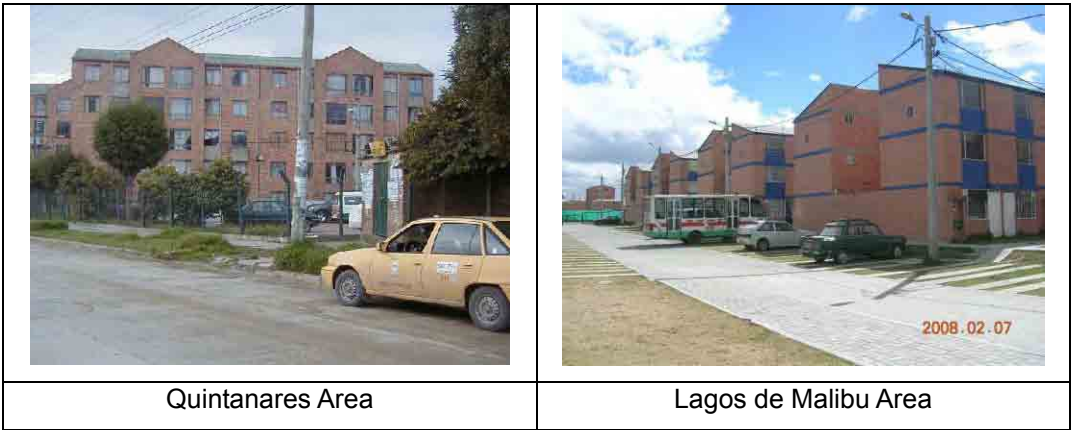
Figure 2 Site for the Relocation of Families

As the definitive area for relocation, Quintanares and Lagos de Malibu area were selected by the municipal administration. Quintanares area is for small scale families and Lagos de Malibu is for large scale families who have more than 8 persons.

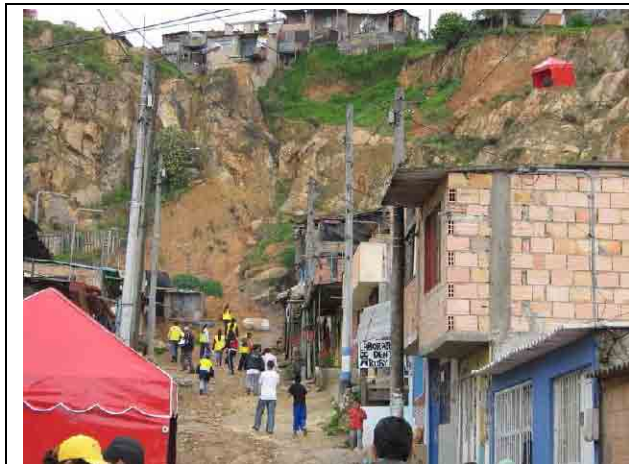
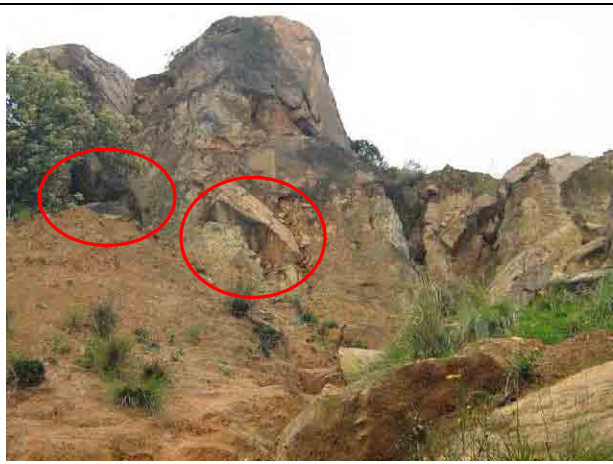
18/May/2007

The area is located at the slope of street No.2

Some cracks at the supporting rock were informed to Soacha municipality. It was estimated that the cracks of blocks affect the stability of huge blocks at upper part of the slope.

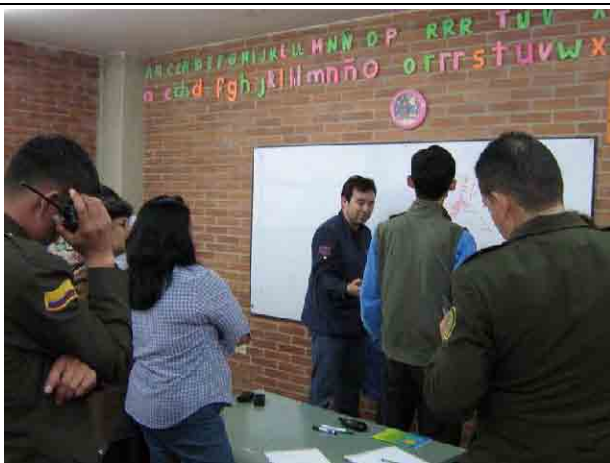
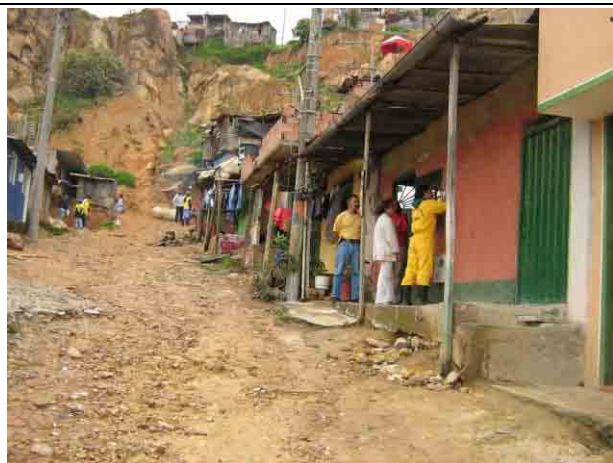
Discussion about the existing conditions and proposition of the countermeasures among the related organizations.

Evacuation of the residents who live at street No.2 by the Municipality.

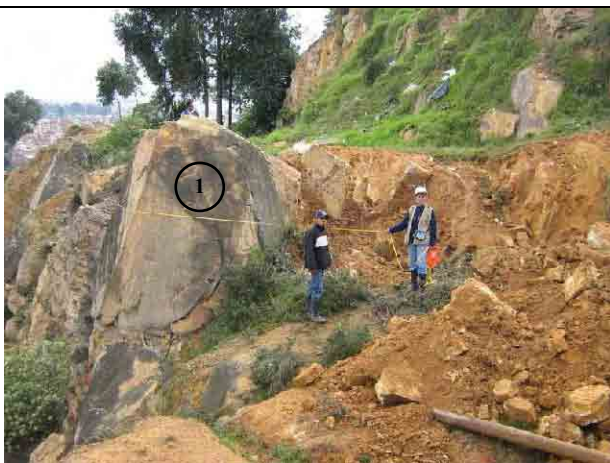
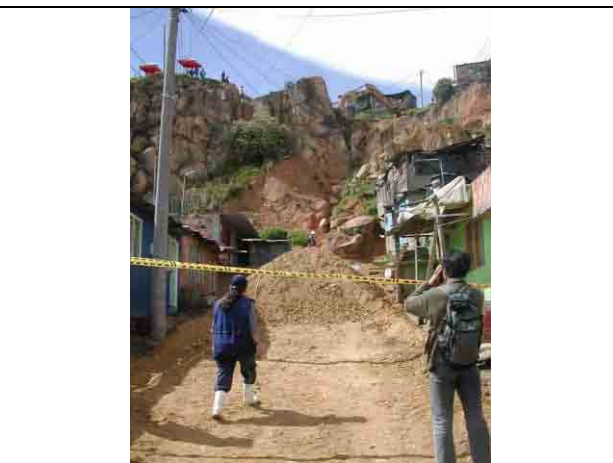
19/May/2007 Measurement of No.1 block by CREPAD

Installation of the earth wall in front of the slope at street No. 2

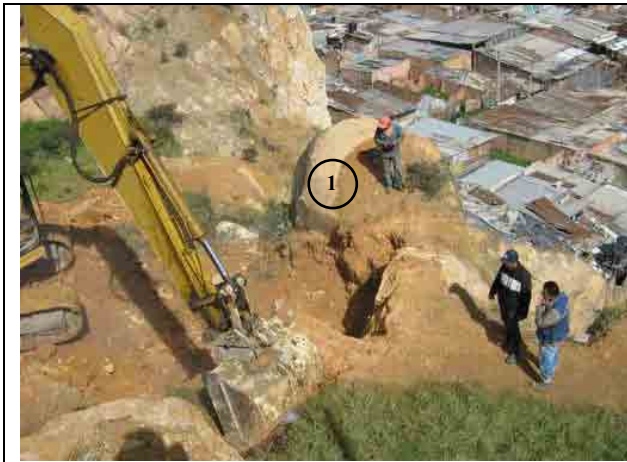
Excavation works behind the block No.1

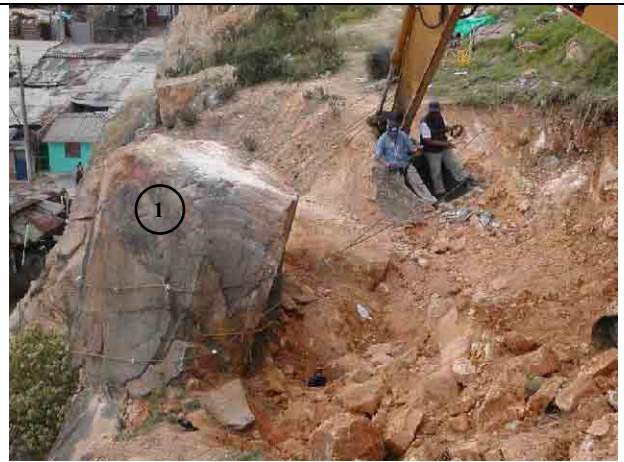
Wire net is fixed with wire rope

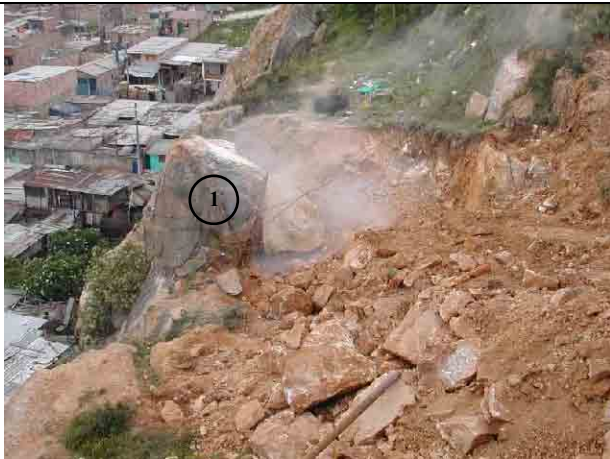
1st blast of block No.1 with white gun powder

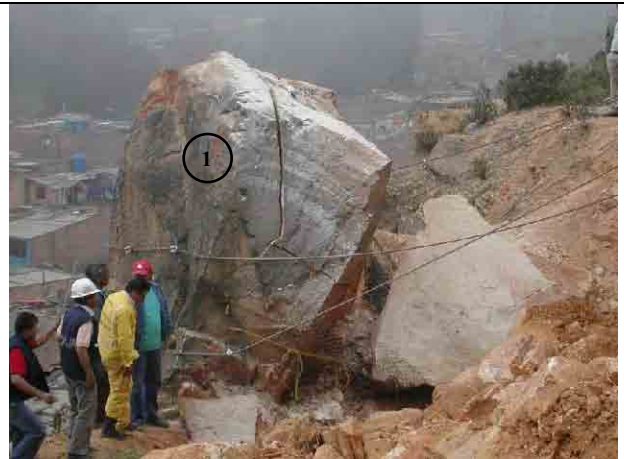
Cracks of block No.1 with 2nd blast

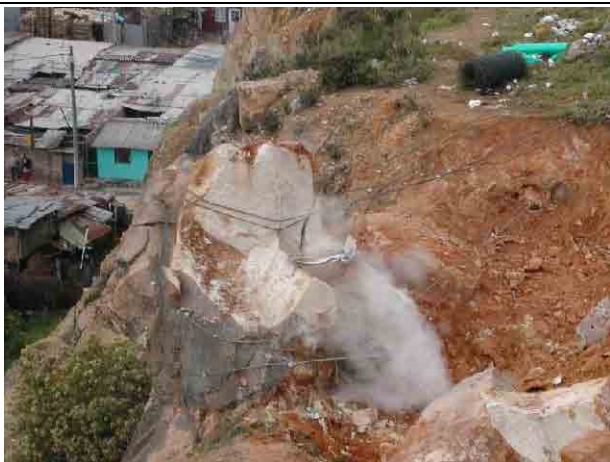
3rd blast of block No.1

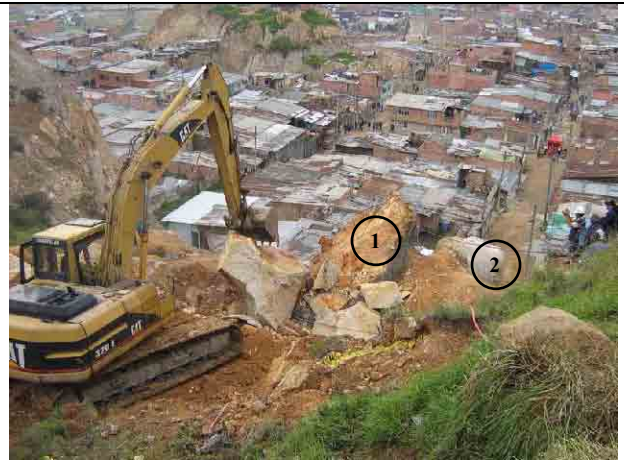
Remained pieces of block No.1 is removed with back-how

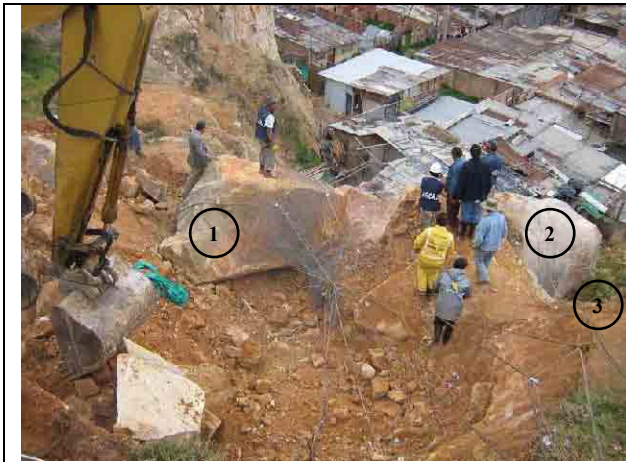
Termination of emergency measures for the block No.1

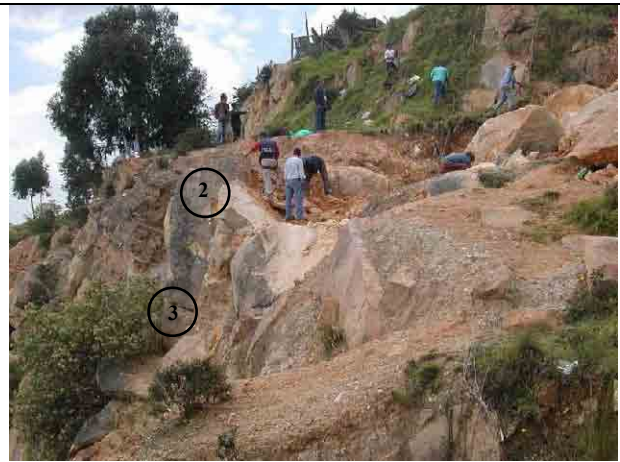
Site conditions after removing of block No.1

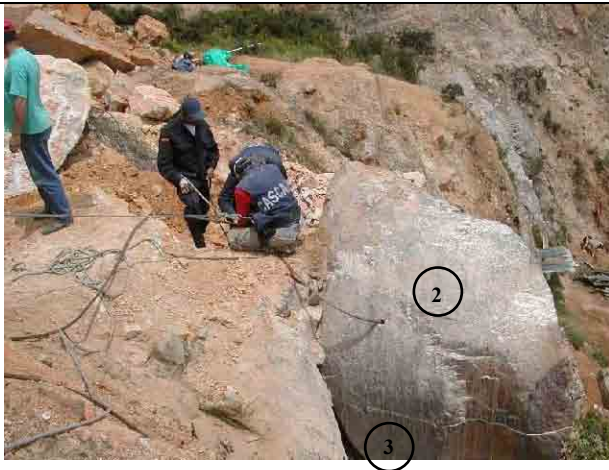
Installation of wire rope to blocks of No.2 and 3

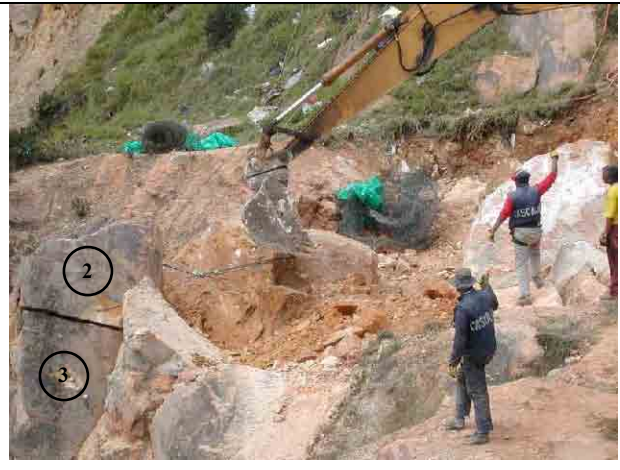
Removing of block No.2 after excavation of its back

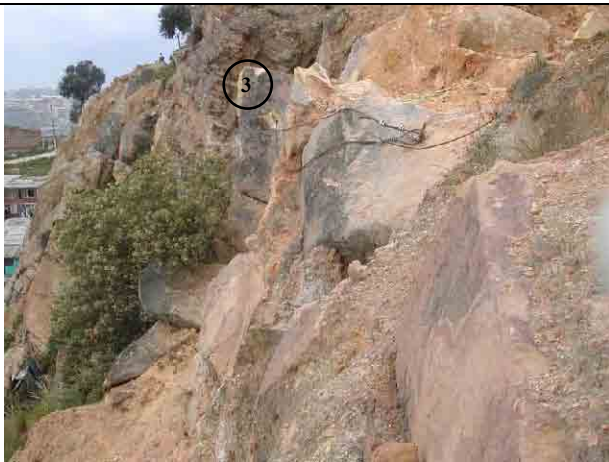
The block No.3 is fixed with wire rope

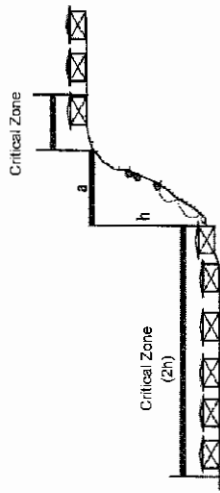
Figure 1 Rock fall/Slope Failure Critical Zone

In the study, the hazard map will be prepared based on the study on rockfalls and failures in the study area, El Divino Nino and Altos de Cazuca. The hazard map will show the Rockfall/Slope Failure Critical Zone (Critical Zone). The Japanese standard is applied to the decision of the Critical Zone (Figure 1). The Critical Zone is defined as the followings.

- Slope angle is not less than 30 degree, and slope height is not less than 5m
- Distance from the slope toe is within two times of height of slope.
- Critical area above the slope (will be proposed in the Study)

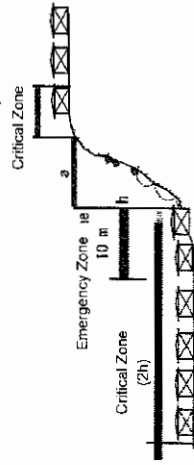
Figure 2 Emergency Zone

Accordingly, the Critical Zone shall be classified into two zones; Emergency Zone (the area within 10 m or 2 rows of houses from the toe of the slope, Figure 2) and the remaining (at the end of emergency zone and above the slope). In the relocation plan of Soacha municipality, this Emergency Zone shall be given the first priority.

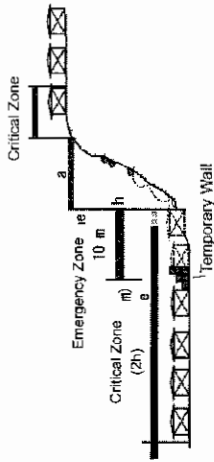
Figure 3 Example of Temporary Works

The Study Team will recommend temporary works such as temporary wall using gabions in the Emergency Zone after completion of relocation from the Emergency Zone. The execution of works may be done by the Study Team during the pilot project period.

The purpose of this temporary works is to reduce the damage by small-scale slope failures and rockfalls, but it does not secure the safety of remaining area. The detailed of locations of the works will be decided in the Study.
