SUPPORTING REPORT

S4

SOCIO – ECONOMY CONDITIONS

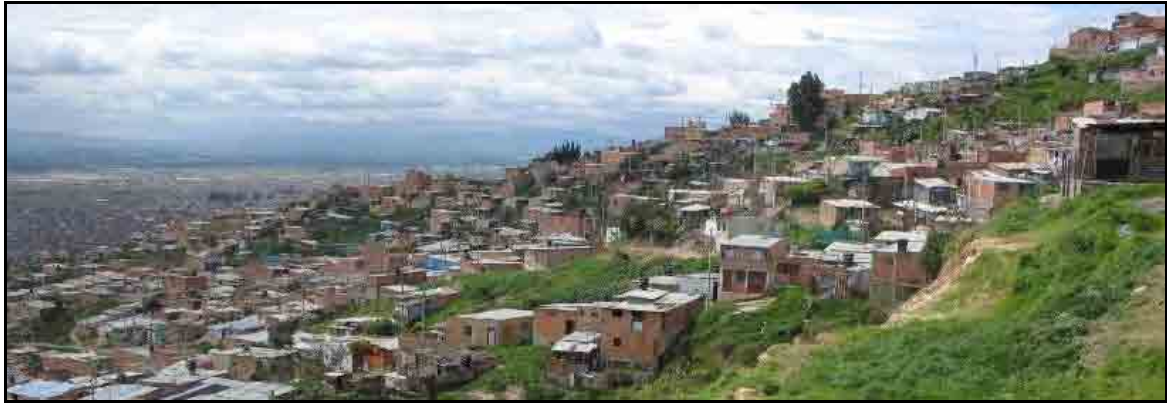
Photo S4-2-1 Typical Pattern of Urban Expansion

Management of closure process of quarries are lack of strict compliance. The land recovery plans have been difficult to enforce. Many old mining areas are just left as it is, and becoming target areas for new informal settlements. As shown on the following photos, uncontrolled urban expansion with poor infrastructures can be found in many places with in the municipal territory, and such situation creates the unfavorable living conditions (poor infrastructure such as lack of road, water supply and sewerage, facing hazards, etc.).

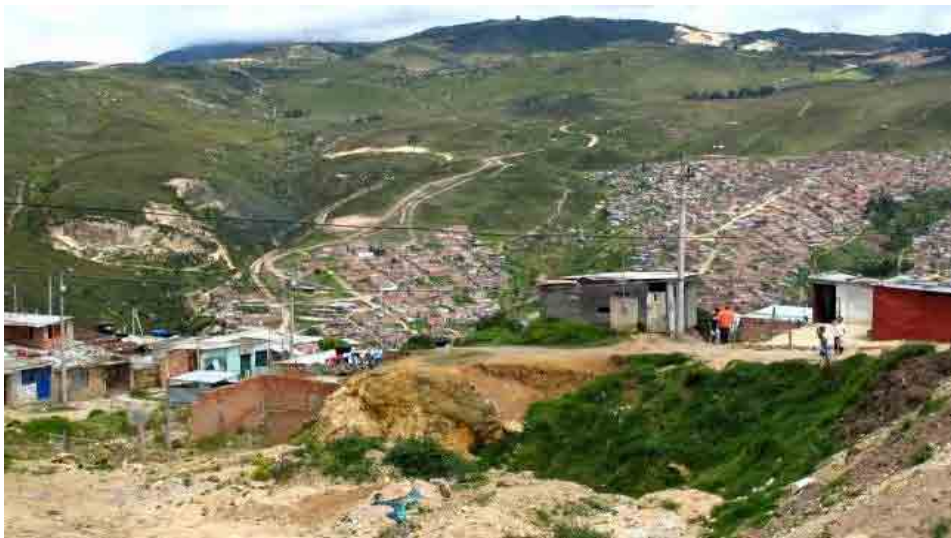
Photo S4-2-3 Neighborhoods growth over rural hills

Photo S4-2-3 shows the case of Altos de Cazucá, an entire hill has been covered with many barrios in which more than 60,000 people live without any plan in terms of urban development.

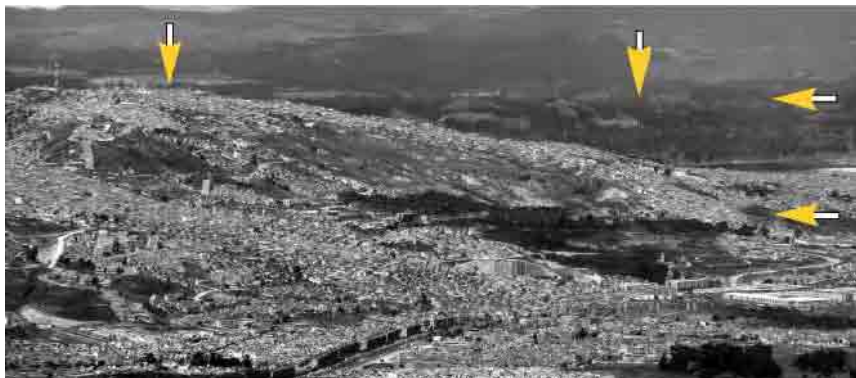
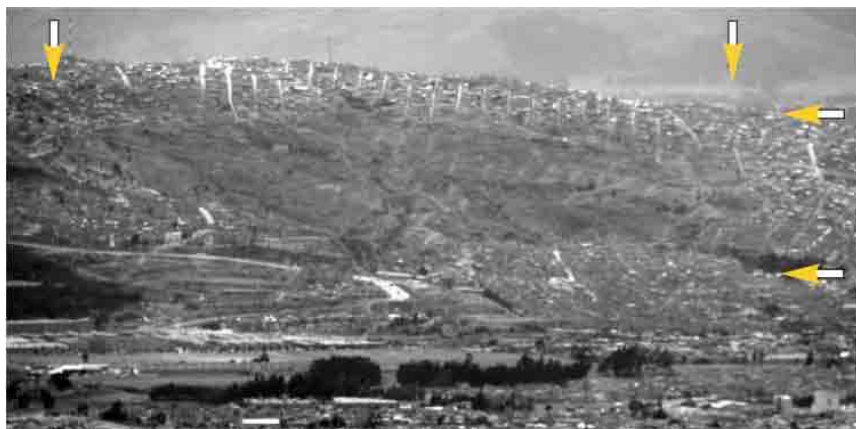
Photo S5-1-1 Panoramic Views of the Landslide

(a)  
from East  
Darker area at the center is the Landslide

(b)  
from Northeast  
Wasteland on the slope is the Landslide

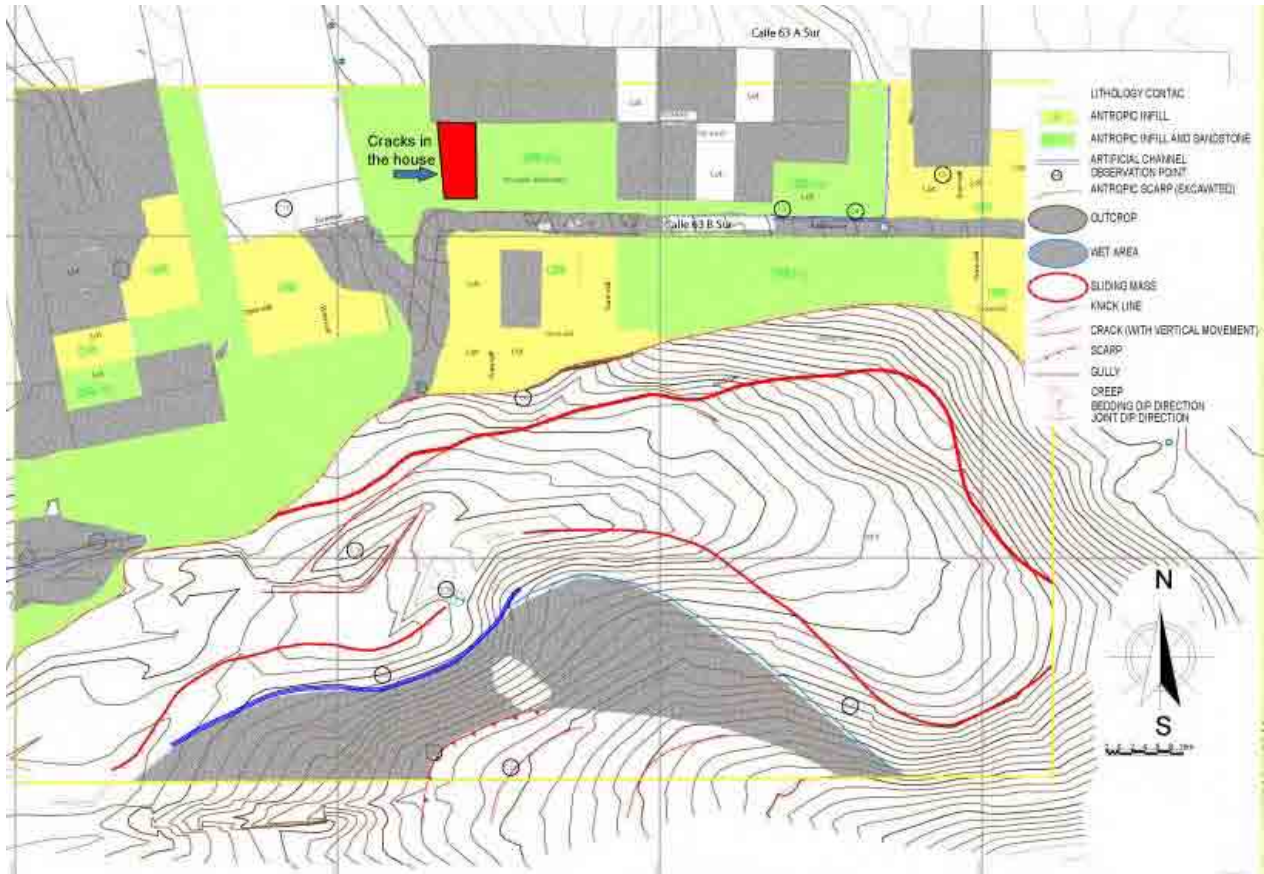
Figure S5-1-9 Geologic and Geomorphologic Features in Espino 1 Sector (the Landslide)

In south side and high part of sector (La Carbonera) important deformations are not observed, not continuous creeks with vertical displacement which indicate retrogressive movement of instability phenomena. Over south side and to lower part of the hill will be observed some dispersal traction cracks, not continuous and in parallel to scarp direction, which indicate local landslides production due to outcropping lithology, to the diaclasa planes and to the semi-vertical slope and in some cases negative of the slope. Inside landslides mass in 2000 (approximately) and posterior re-conformed is observed deformation of lineal works (concrete's channels), continuous creeks appearing and not continuous, water outcrop, deformation or lost of verticality in present vegetation; which indicate apparently re-activation of instability phenomena.

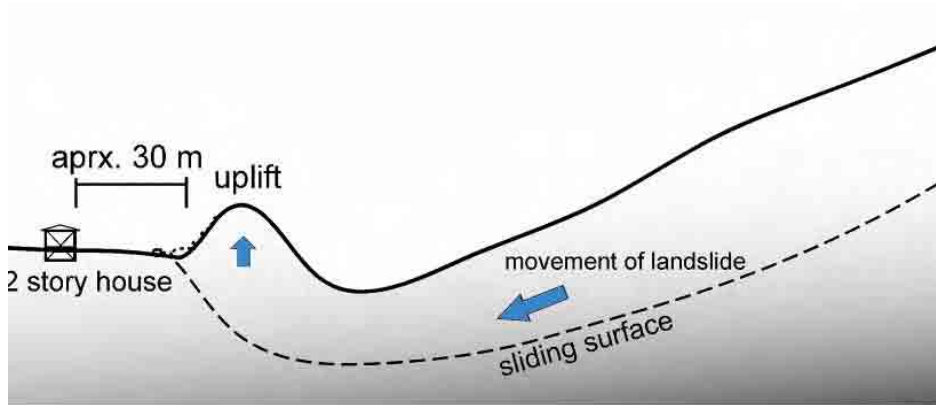
Figure S5-1-10 Supposed Mechanism of the Uplift

The uplift at Espino 1 probably rose by compression at toe of landslide as shown in Figure S5-1-10. The house which got cracks is close to the uplift, and the force of the landslide which lift the ground, could affect on the house. If the influence of the landslide on the house in the residential area is confirmed, the Landslide area (Phase I and II) should be reconsidered and be expanded.

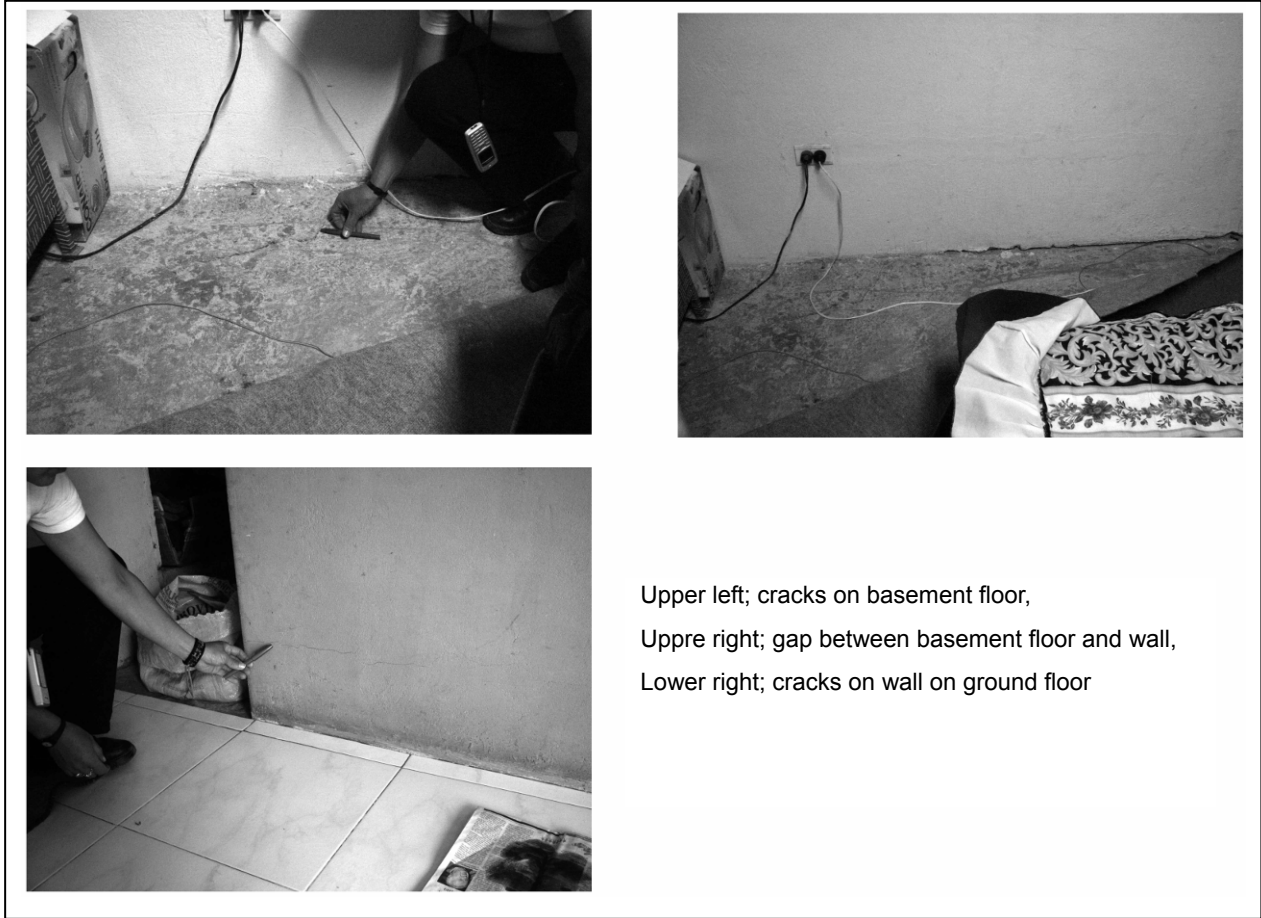
Photo S5-1-3 Deformations Found in the House

Upper left; cracks on basement floor,  
 Upper right; gap between basement floor and wall,  
 Lower right; cracks on wall on ground floor

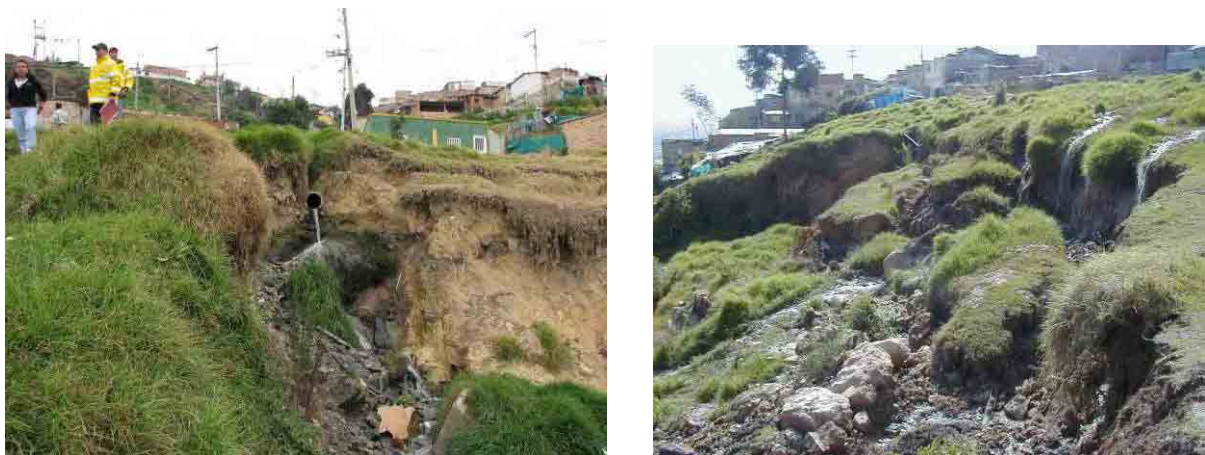
Photo S5-1-4 Water Flow into the Landslide

As remarkable thing in the survey, surface water which come from sewer flows into the Landslide area at all over the place. Water makes many channels and pools in the Landslide. It is easily understand that the water flow has a great influence on the Landslide. Figure S5-1-11 shows distribution of saturation in the Landslide. The figure also shows a lot of water overflows into the Landslide.

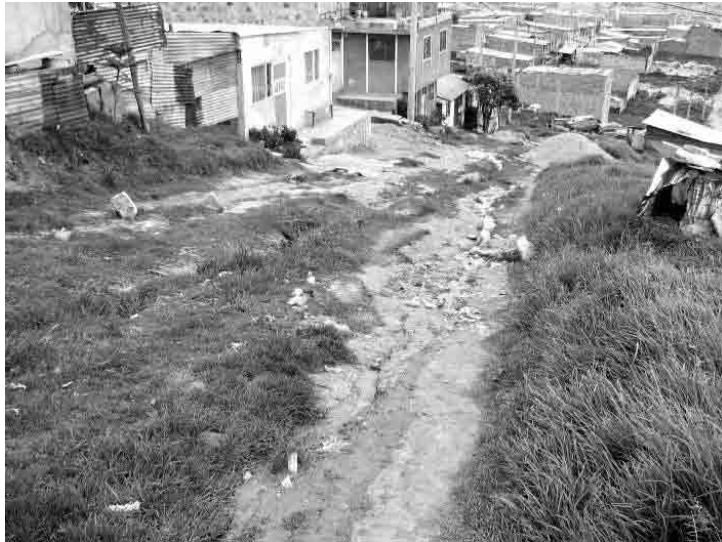
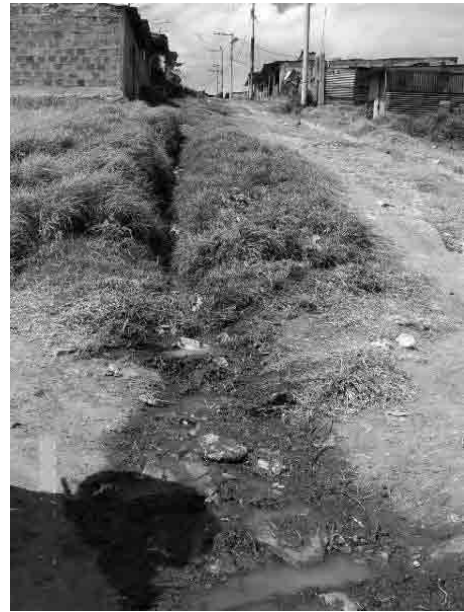
Photo S5-1-6 Poor Drainage in Phase III Area

Overflow many residents in Phase III mentioned indicate the drainage system in Phase III is inadequate. In heavy rain, water overflow from the drainage and surroundings of residential houses are sodden. The drainage system is inadequate in Phase III where locate above the Landslide means water on upper slopes flows into the Landslide. This situation has a bad influence for stability of the Landslide

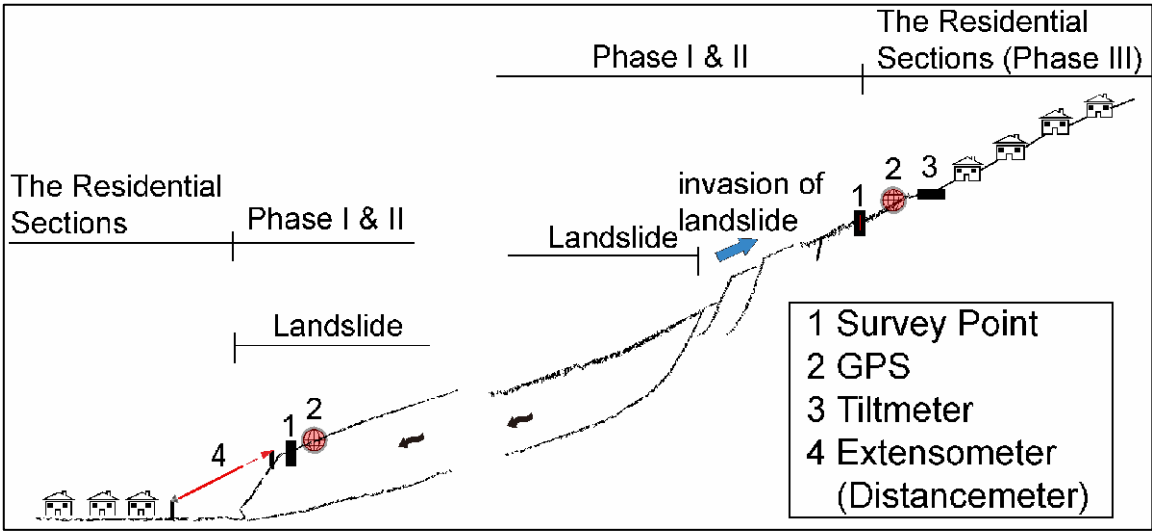
Figure S5-1-18 Example of Instrumentation along the Landslide and the Residential Area

Laser distance meter is recommendable for the area since it is not require any wire between the residential houses and the Landslide

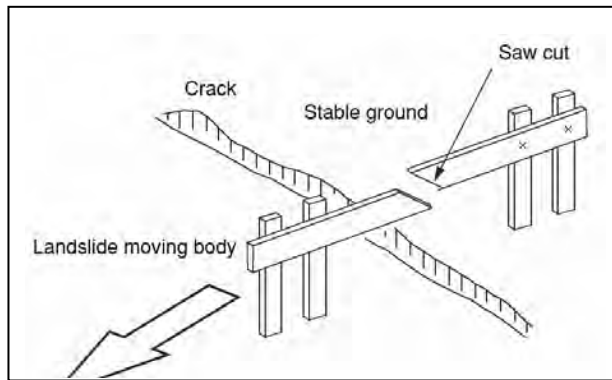
Figure S5-1-20 Simple Ground Crack Gauge

One of the simplest methods to determine landslide movement is a simple ground crack gauge. Installation of the crack gauge is to drive stakes across a tension crack along the direction of slide movement. Then attach horizontal board to the stakes, and saw through the board. Any movement across the tension crack can be determined by measuring the space between the sawed portions of the board.

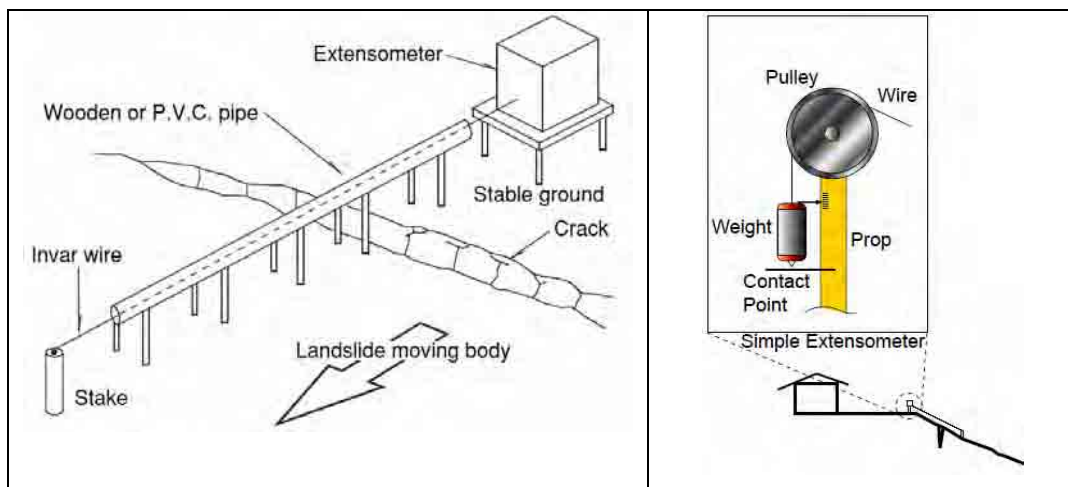
Figure S5-1-21 Extensometers

The extensometer is used to measure relative movement by comparing the extension of two points. the extensometers are generally installed across the main scarp, at transverse cracks and transverse ridges near the toe or front portion of the slide and parallel to the suspected slide direction. Measurements should be accurate to within 0.2 mm to 1.0 mm and the magnitude of the movement and daily rainfall data should be recorded to establish the relation ship between the measurable movement and the precipitation rate.

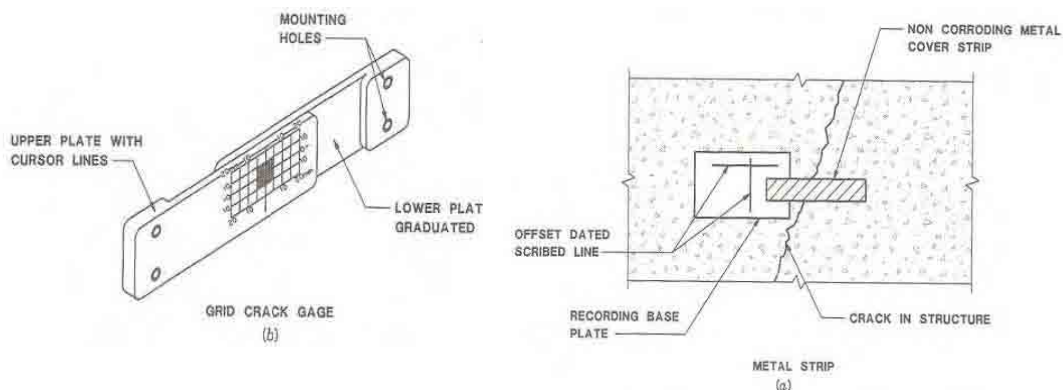
Figure S5-1-22 Simple Crack Gauge (for monitoring on structures)

When new deformation was found in a house, the house should be monitored. The crack in a house can be monitored simply by marker pen and ruler or by simple gauge as shown in Figure S5-1-22. For the monitoring on a deformed house, tiltmeter is also useful.

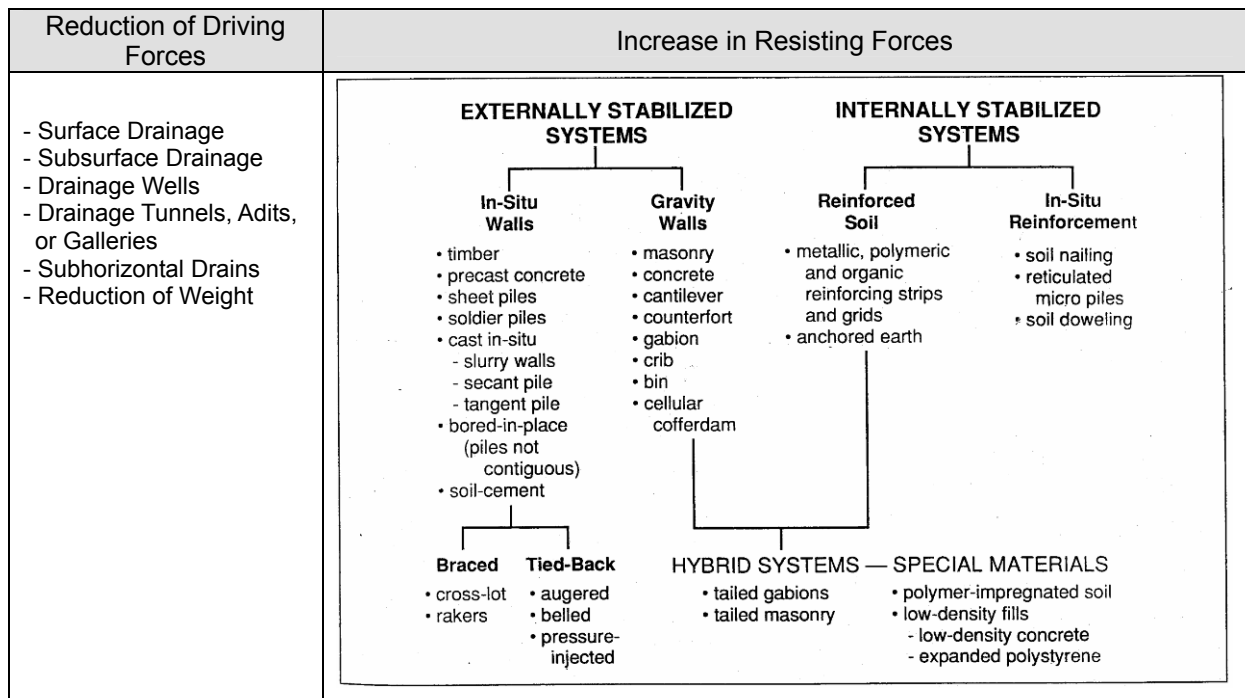
Figure S5-1-24 Stabilization Works (Turner 1996, Landslide)

Stabilization works are classified into two major categories, works for reduction of driving forces and works for increase in resistance force. In a large scale landslide like the Landslide, generally, method for reduction of driving forces is given to priority, since cost effectiveness for a large scale landslide is normally better than method for increase in resistance force. The only natural character of a slope that can be changed economically, and on a scale large enough to improve slope stability, is groundwater, because it can be drained by gravity. The alternatives to drainage are expensive regarding of a slope to reduce the gravity induced shear stresses with it, or equally expensive support measures to increase the resistance of the slope to these stresses. Hence the drainage of groundwater is a common component of slope design. The first thing we have to do as measure for the Landslide is to reduce the groundwater level, and prevent water penetration into the ground especially from sewer and rainwater.
