## **CHAPTER 16**

# **TECHNICAL SUPPORT TO OTRACO**

### 16-1 PRESENT CONDITION

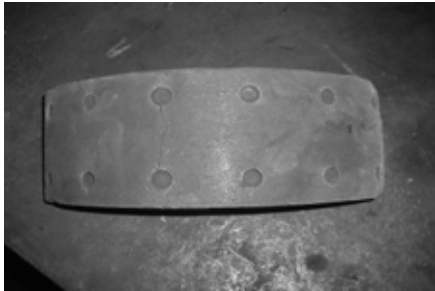
- Brake Lining

Genuine

At Present, problem in procurement of the spare parts arises at the time of delivery to judge whether they are appropriate parts (genuine parts) or not. Especially, there are inferior quality brake parts which may cause the increase of the breakdowns. Differences of regular

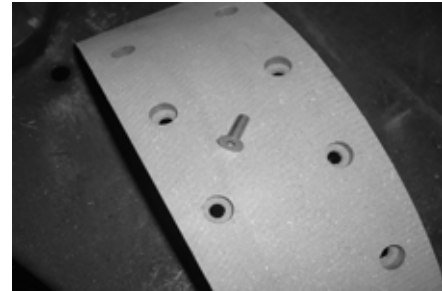
Non standard product

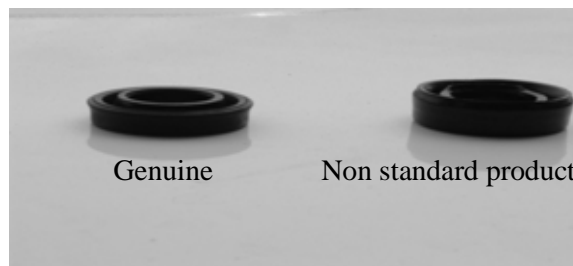
- Wheel cylinder cup

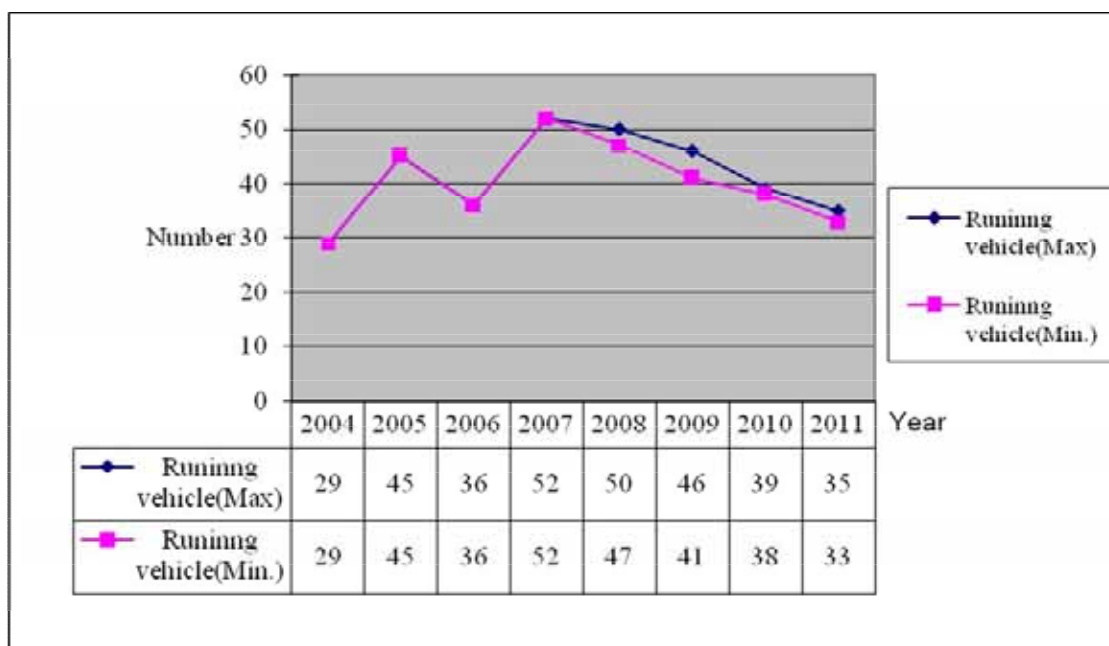
**Figure 16.1.6 Numbers of buses in the future**

It is observed that vehicle number decreased gradually every year by 4-15%, and based on the above data up to year 2007 it is expected that about 30% of the vehicles will be decreased in next five years.

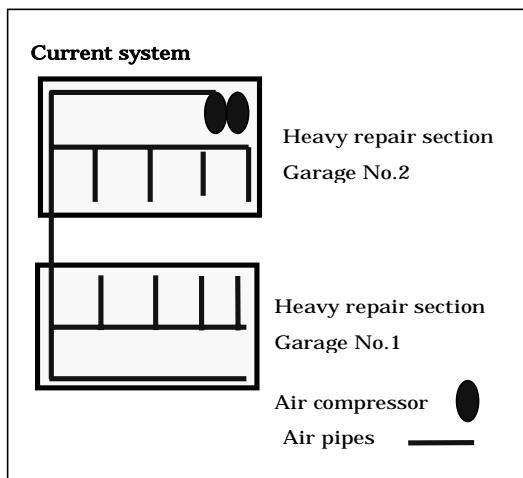
- Heavy repair garage

Existing air supply system

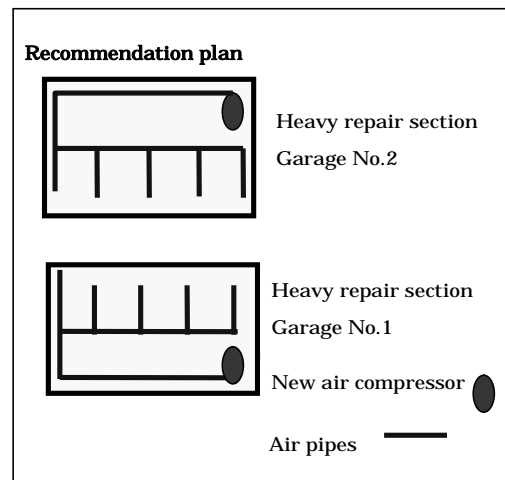
Recommendable air supply

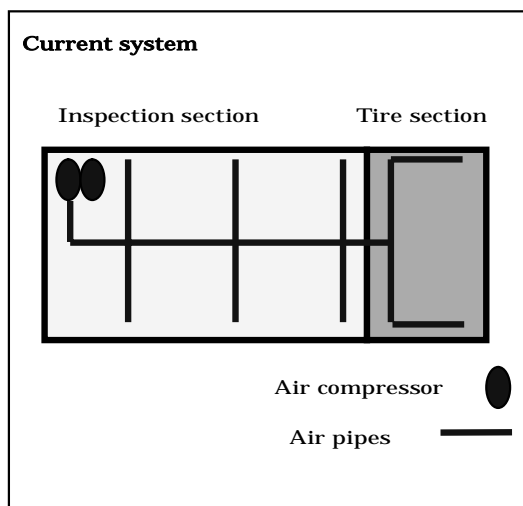
- Inspection yard

Existing air supply system

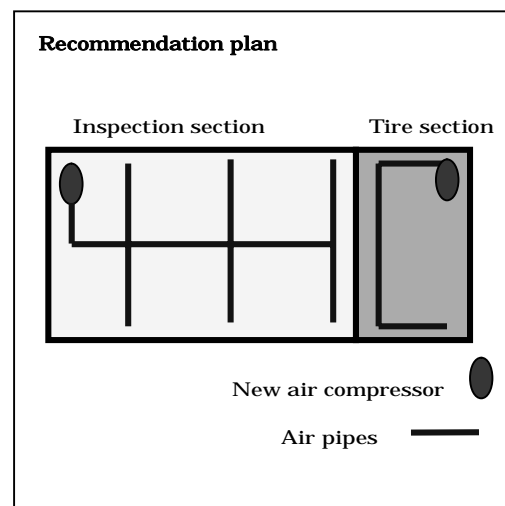
Recommendable air supply

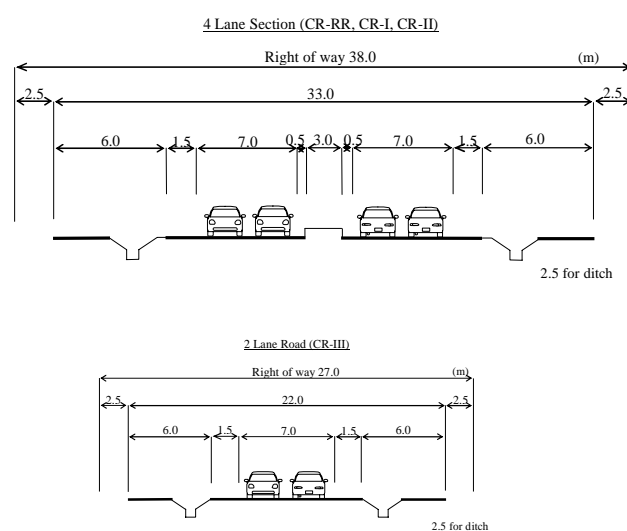
## Cross Section

Project Type	Road Development		
Project Name	New Construction of Coastal Alternative Route		
Project Objective	To reduce traffic volume to CBD area To enhance development in southern areas specifically for industrial functions To strengthen north-south corridor		
Executor	Ministry of Public Works and Equipments (MTPE)		
Location	Kinindo-Kanosha		
Beginning	RN No. 3	Ending	Ring Road
Length	7.4km	Width	27-38m
Lanes	2-4 lanes		
Present Traffic Volume in 2007		5,666/per 12 hour	
Traffic Volume Forecast in 2017		300 ~ 14,400 pcu/day	
Total Cost	19.1 billion Fbu	Cost per Length	2.5 billion Fbu

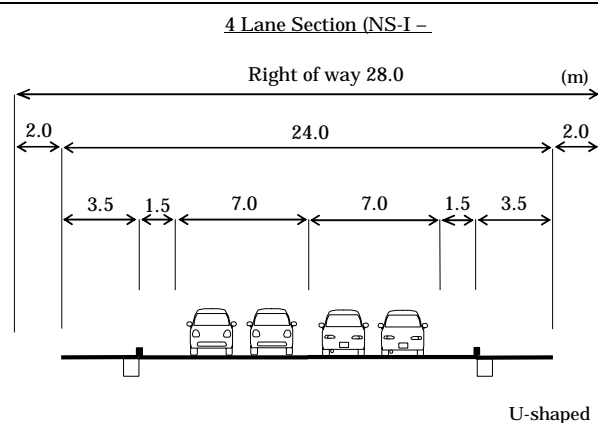
**Cross Section**

Project Type	Road Development		
Project Name	Improvement of North-South axis around CBD area		
Project Objective	To reduce traffic volume to CBD area To enhance development in southern areas specifically for industrial functions To strengthen north-south corridor		
Executor	Ministry of Public Works and Equipments (MTPE)		
Location	Rohero-Kinindo		
Beginning	Rohero	Ending	Kinindo
Length	4.6km	Width	28m
Lanes	4 lanes		
Present Traffic Volume in 2007	10,812/per 12 hour		
Traffic Volume Forecast in 2017	10,800 ~ 36,700 pcu/day		
Total Cost	10.6 billion Fbu	Cost per Length	2.5 billion/km

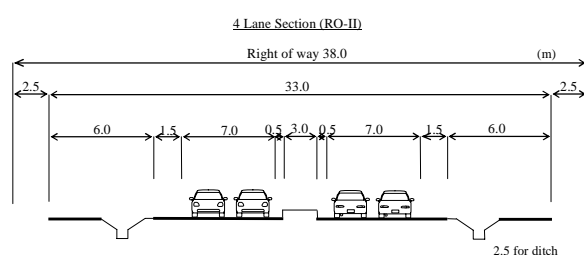
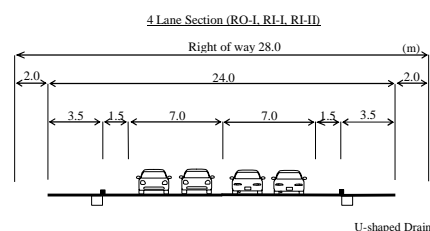
## Cross Section

Project Type	Road Development		
Project Name	Improvement of Ring Road		
Project Objective	To reduce traffic volume to CBD area Strengthen road network to future traffic demand		
Executor	Ministry of Public Works and Equipments (MTPE)		
Location	Ngagara-Rohero		
Beginning	Rohero	Ending	Kinindo
Length	6.9km	Width	28m
Lanes	4 lanes		
Present Traffic Volume in 2007	5,094-11,267/per 12 hour		
Traffic Volume Forecast in 2017	2,500 ~ 19,500 pcu/day		
Total Cost	17.2 billion Fbu	Cost per Length	2.5 billion/km

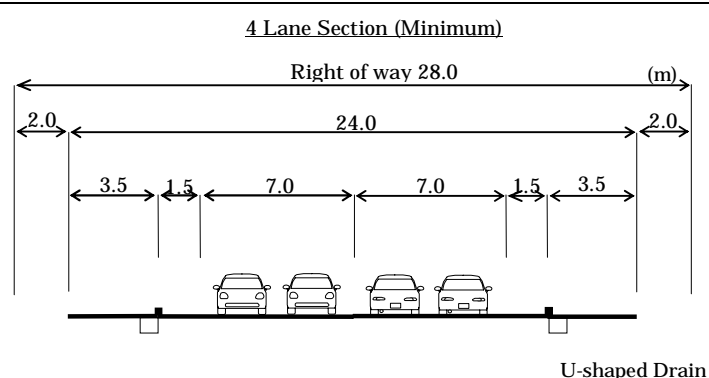
**Cross Section**

Project Type	Road Development		
Project Name	Widening of RN-7		
Project Objective	To reduce traffic volume to CBD area Strengthen road network to future traffic demand		
Executor	Ministry of Public Works and Equipments (MTPE)		
Location	Rohero-Musaga		
Beginning	Rohero	Ending	Musaga
Length	2.0km	Width	28m
Lanes	4 lanes		
Present Traffic Volume in 2007	11,267/per 12 hour		
Traffic Volume Forecast in 2017	14,000 pcu/day		
Total Cost	5.5 billion Fbu	Cost per Length	2.5 billion/km

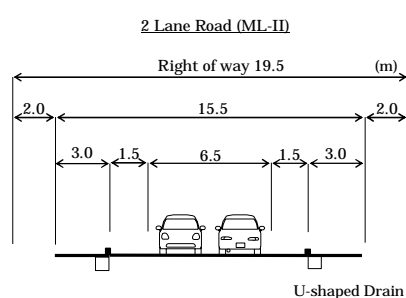
## Cross Section

Project Type	Road Development		
Project Name	New Construction of Missing Link		
Project Objective	Forming the Road network to traffic functions		
Executor	Ministry of Public Works and Equipments (MTPE)		
Location	Buyenzi-Ngagara, Bwiza-Gihosha, Rohero-Musaga		
Beginning		Ending	
Length	1.4km	Width	12-19.5m
Lanes	2 lanes		
Present Traffic Volume in 2007		/per 12 hour	
Traffic Volume Forecast in 2017		5,300-9,000 pcu/day	
Total Cost	4.9 billion Fbu	Cost per Length	3.5 billion/km

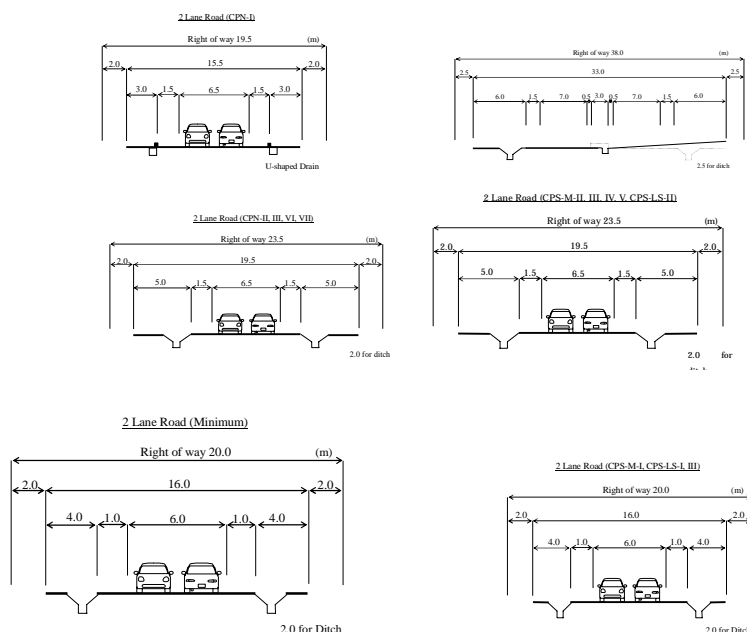
## Cross Section

Project Type	Road Development		
Project Name	City Plan Road Project at Northern and Southern Area		
Project Objective	Formulation of road network for the expansion of Bujumbura city		
Executor	Ministry of Public Works and Equipments (MTPE), Bujumbura City		
Location	Northern Area(Buterere, Kinama,, Ngagara, Gihosha) Southern Area(Kanosha, Musaga)		
Beginning		Ending	
Length	19.9km(Northern Area) 22.7km(Southern Area)	Width	22-23.5m(Northern area) 20-38.0m(Southern area)
Lanes	2 lanes		
Present Traffic Volume in 2007	/per 12 hour		
Traffic Volume Forecast in 2017	500-9,200 pcu/day(Northern area) 100-5,100 pcu/day(Southern area)		
Total Cost	39.0 billion Fbu(Northern area) 48.3 billion Fbu(Southern Area)	Cost per Length	2.0 billion/km(Northern Area) 2.1 billion/km(Southern Area)

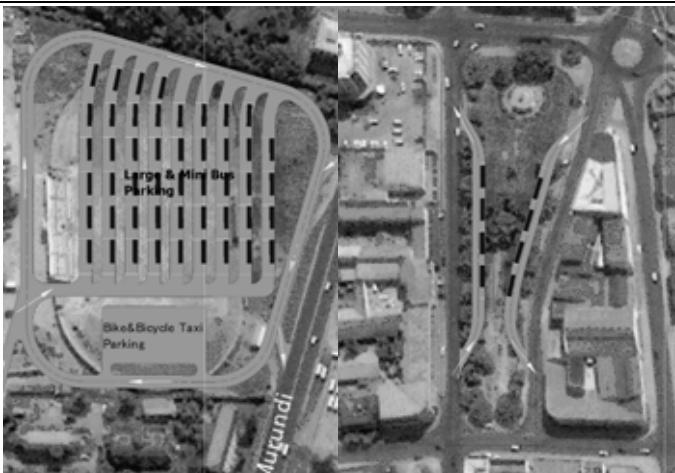
Design

Project Type	Bus Station
Project Name	New construction of City center busterminal
Project Objective	Reduction of traffic congestion Reduction of traffic accident Provision of easy and safety transfer at bus terminal
Executor	Ministry of Transport, Posts and Telecommunications, Bujumbura City
Location	Rohero
Area	30,600sq.m
Total Cost	2.4 billion Fbu
Location
