**IMPLEMENTATION REVIEW STUDY REPORT
ON
THE PROJECT FOR THE URGENT REHABILITATION
OF
MARKHAM BRIDGE
IN
THE INDEPENDENT STATE OF PAPUA NEW GUINEA**

September 2008

JAPAN INTERNATIONAL COOPERATION AGENCY

CHODAI CO.LTD.

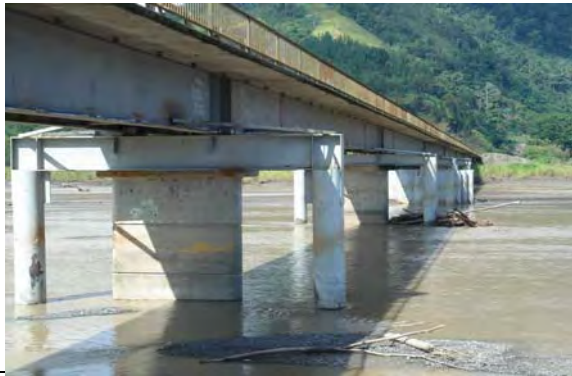
Photo-1 General View of Markham Bridge
View from the upstream on the Lae side

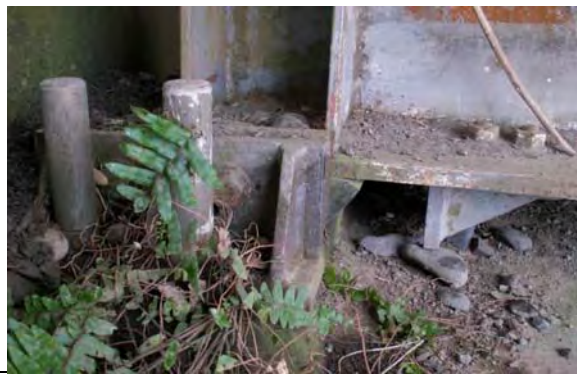
Photo-2 Bearing of A1 on the Lae Side
The girder almost comes off the bearing due to the backward displacement of A1

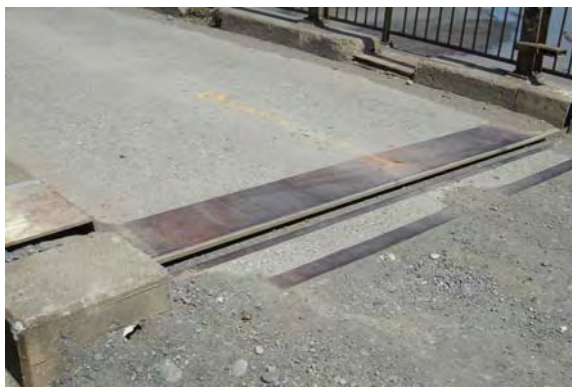
Photo-3 Expansion Joint on A1
The gap has widened due to the rotation of the abutment

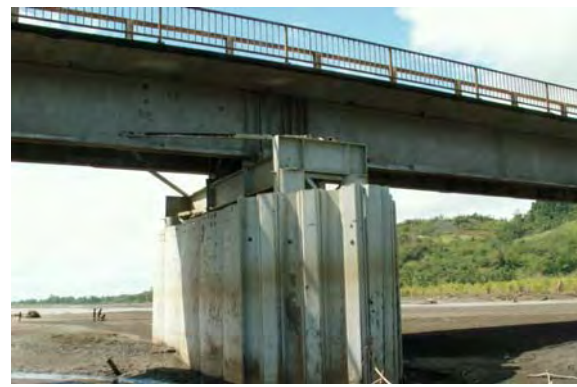
Photo-4 Repaired P3
View of P3 after a different repair from the other piers. This pier subsided due to flooding in March 2004

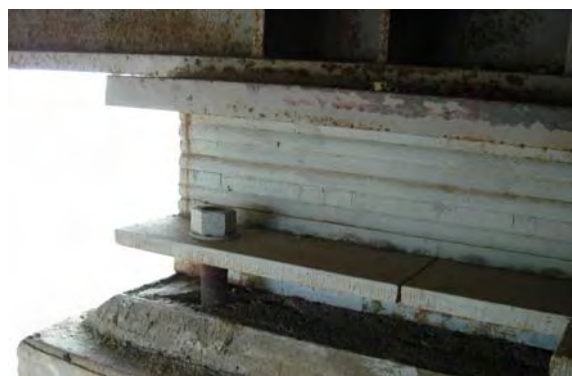
Photo-5 Elevated Bearing on P3
The bearing elevation was adjusted for subsidence of the pier by rubber pads.

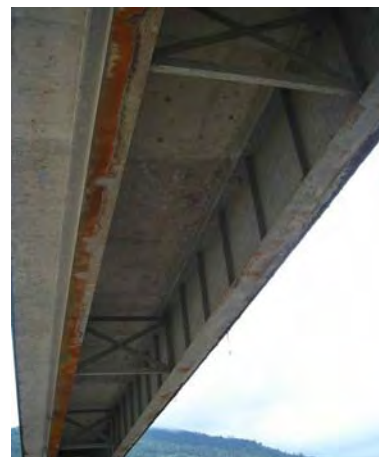
Photo-6 Corrosion of Steel Girder
The girder is partly rusted due a lack of maintenance over the last 30 years

Although almost no maintenance work has been carried out on Markham Bridge for more than 30 years after its completion, the structural members of the superstructure are relatively intact except for some corrosion. The pedestrian handrail, which is partly lost or damaged, can be reused after repair and repainting.

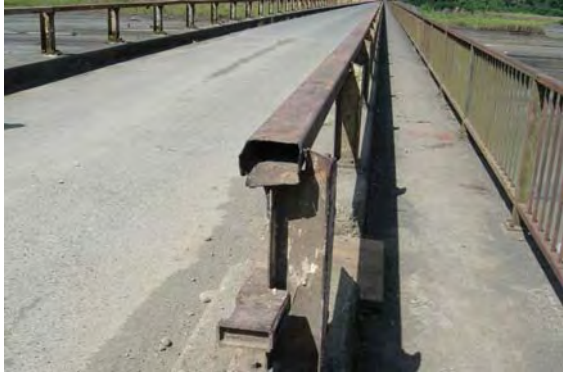
Photo-7 Damage to Guardrail

The guardrail is partly damaged and rusted but no corrosion was found.

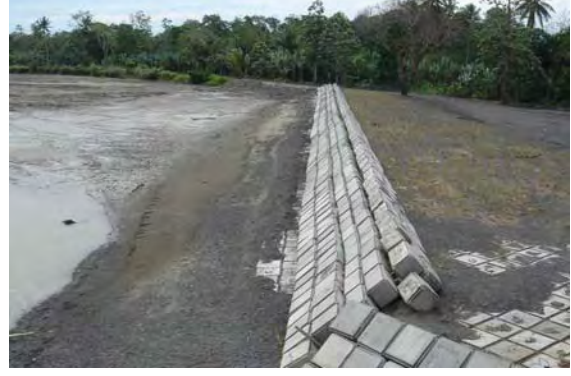
Photo-8 Revetment at Upstream on the Lae Side

Concrete blocks constructed by AusAID, Planned construction yard is shown on the right side. (August 2006)

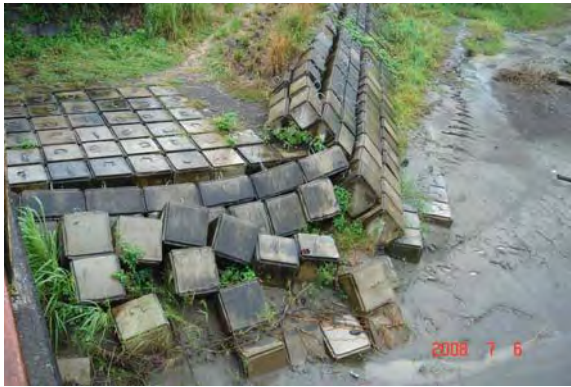
Photo-9 Collapse of Blocks downstream on the Lae Side. Condition in July 2008

At the Basic Design stage, six concrete blocks were found displaced but the damage of the revetment was not severe. However, at the Detailed Design stage, the extent of the displacement extended to the length of 73.2m and the width of 7.7m. Compared with the previous two site investigations, the extent remains almost the same but the displacement increased. Furthermore, some of the blocks sank under the riverbed. In addition, two panels of the handrail on the sidewalk side had been stolen. The bridge itself has not suffered from any additional damage. The planned construction yard was kept cleared without any illegal inhabitants.

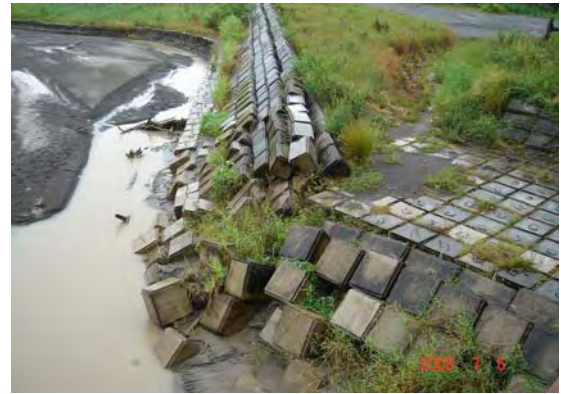
Photo-10 Collapse of Blocks upstream on the Lae Side.

Condition in July 2008. The collapse extended from that shown in Photo-8.

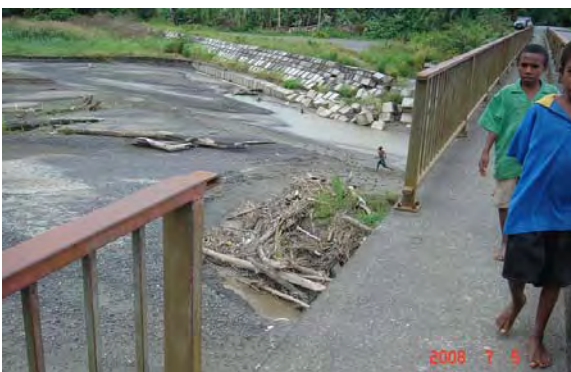
Photo-11 Missing Handrail Panels
Stolen panels.

At the detailed design stage, two panels had been found missing. This time, another two entire panels and a part of another panel were stolen. As a result, a total of five panels must be installed.

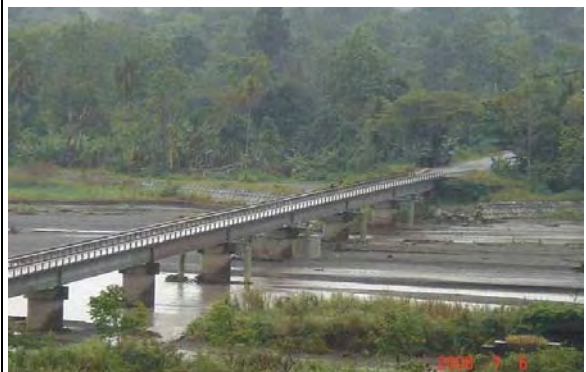
Photo-12 Distant View of Markham Bridge

View of the existing bridge from downstream on the Wau Side to the Lae Side (Bridge length=560m, of which 187m is subject to repair). July 2008

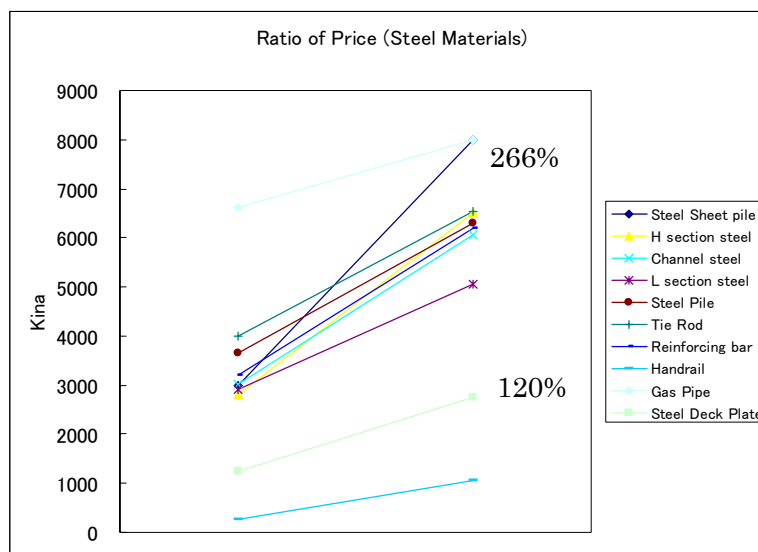
The cost of materials has skyrocketed during 6 months between October 2007 and March 2008, especially the cost of steel and fuel. Materials such as concrete and timber have increased in cost and some materials have considerably increased compared with the Basic Design stage and the Detailed Design stage. Figures 2-2 and 2-3 show the cost comparison of steel and concrete and asphalt, respectively. The price rise of steel sheet piles, road decking plates, concrete and mountain sand are 266%, 120%, 186% and 102%, respectively.

Figure 2-2 Change in Unit Prices of Steel Materials

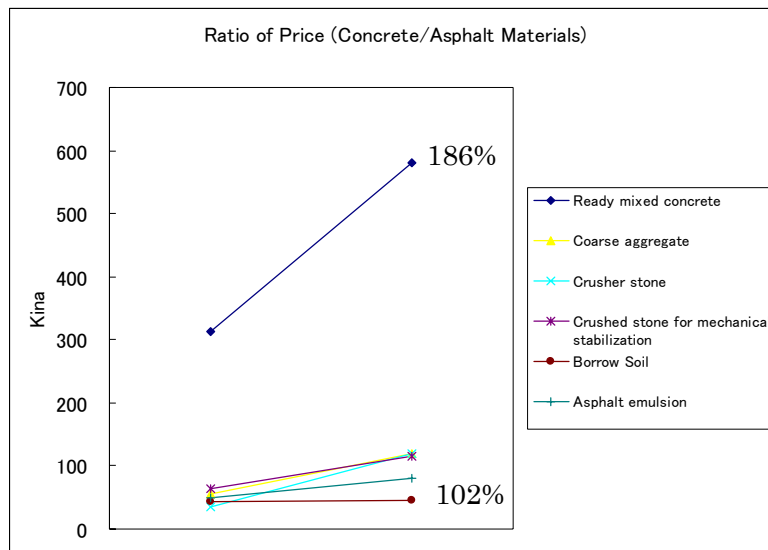
Figure 2-3 Change in Unit Prices of Concrete and Pavement

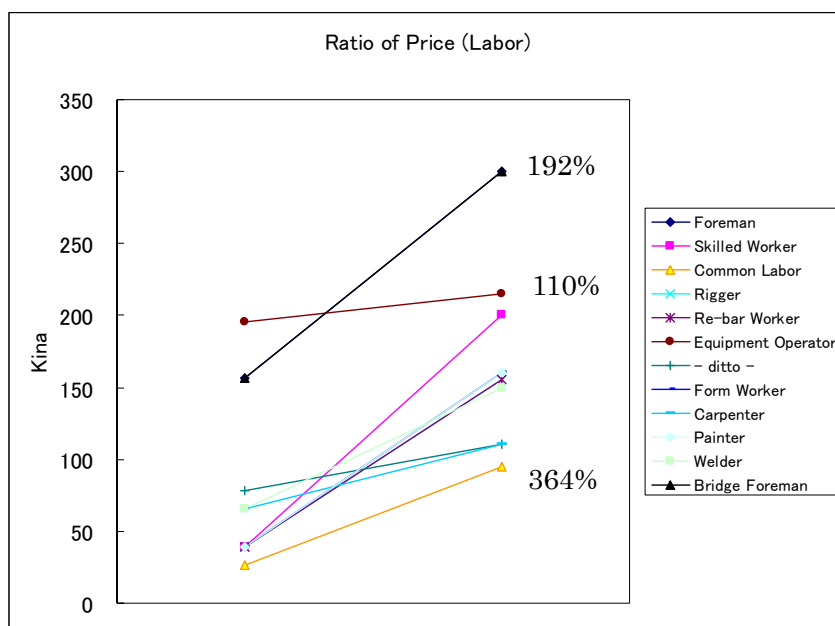
Common labor, for which special knowledge and/or experience are not required, is available in PNG although the unit cost has considerably increased as domestic prices increase. There is a shortage of skilled labor and the unit cost is increasing because quite a few skilled labors were hired by mining industry. As a result, skilled labors are often recruited from Australia, for whom welfare allowance such as commuting vehicle, housing, education and medical allowance must be added to the basic salary. Highly experienced skilled labors will be needed for the Markham Bridge project because of the work under unusual conditions. Therefore, submitted unit price was very high. Figure 2-5 compares the unit prices between the Detailed Design stage and the Implementation Review Study stage. As compared with the Detailed Design stage, the prices of a bridge special worker and a special driver increased by 192% and 110%, respectively. The unit prices of common labor, which were 26 Kina and 95 Kina at the Detailed Design stage and the Implementation Review Study stage respectively, increased to 364%.

Figure 2-5 Change in Unit Prices of Labors
