# BASIC DESIGN STUDY REPORT ON THE PROJECT FOR RECONSTRUCTION OF BRIDGES (PHASE III) IN THE KINGDOM OF BHUTAN

**NOVEMBER 2008**

# JAPAN INTERNATIONAL COOPERATION AGENCY

CONSTRUCTION PROJECT CONSULTANTS, INC. CHODAI CO., LTD.

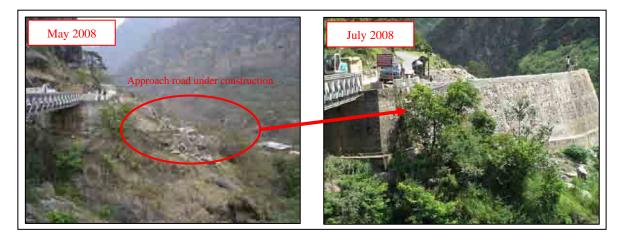
Fig. 2-10 Construction at Punatsangchu Dam and Approach Road

At the time of the Study, it was unexpectedly confirmed that approach road construction had started for the dam construction in the vicinity of the bridge abutment on the left bank of Lawakha Bridge. Unavoidably a new bridge will be constructed at a site that does not intervene with the approach road. A detour during the construction work would be secured by relocating the existing bridge the mountain side.
