5. Other Data and Information

5-2 Results of Surveying Investigation

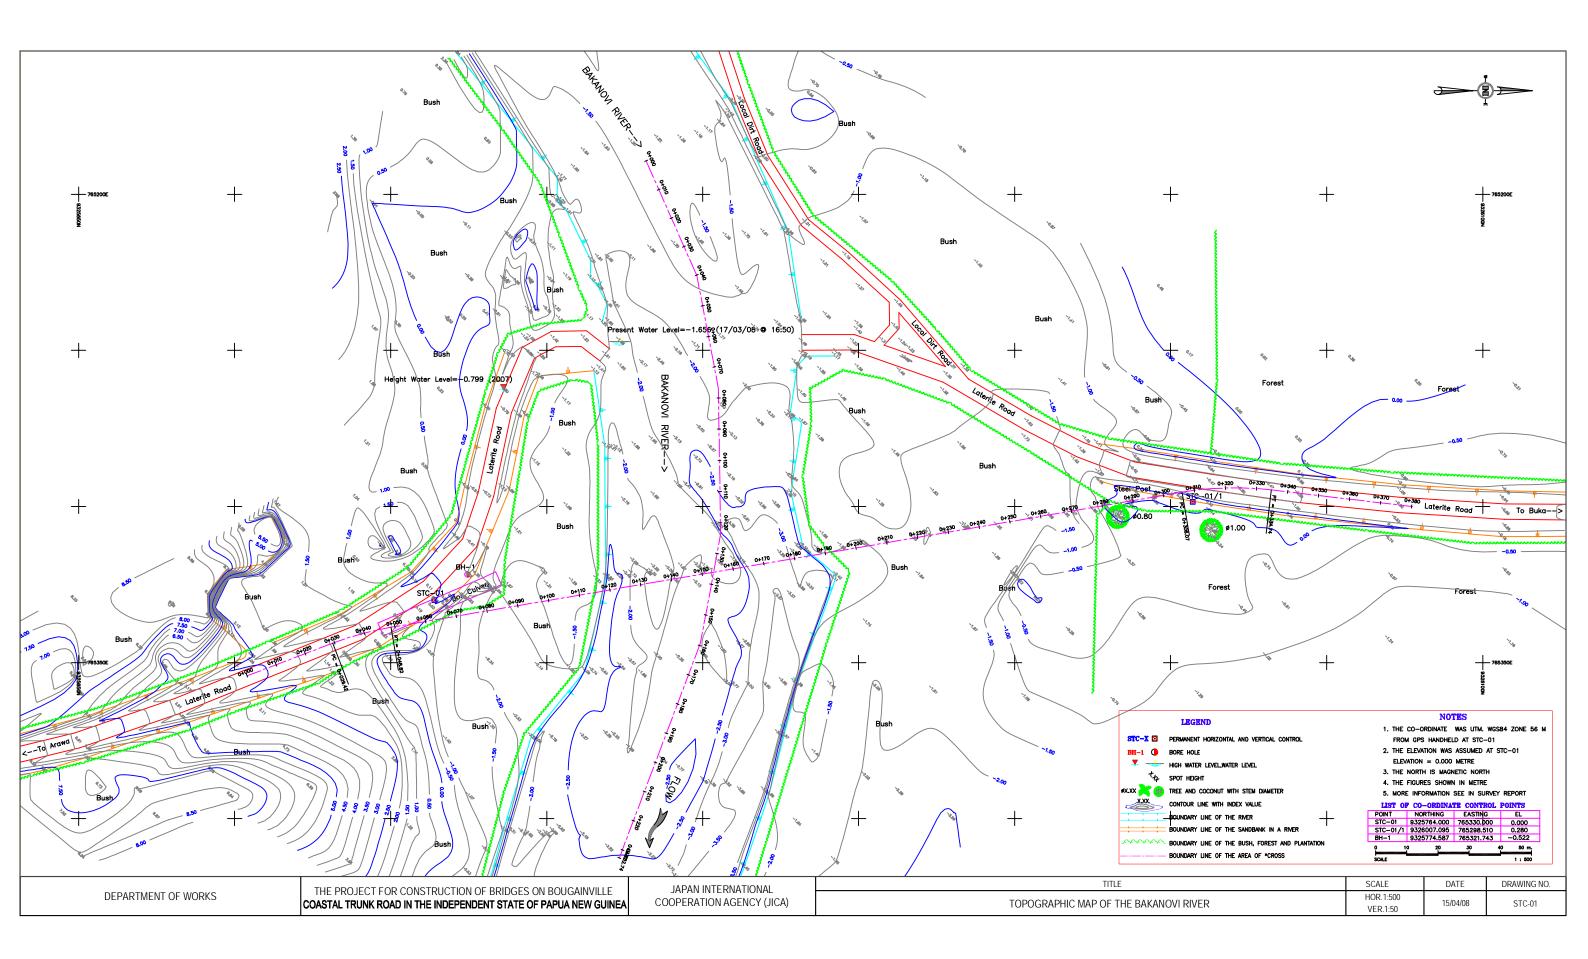
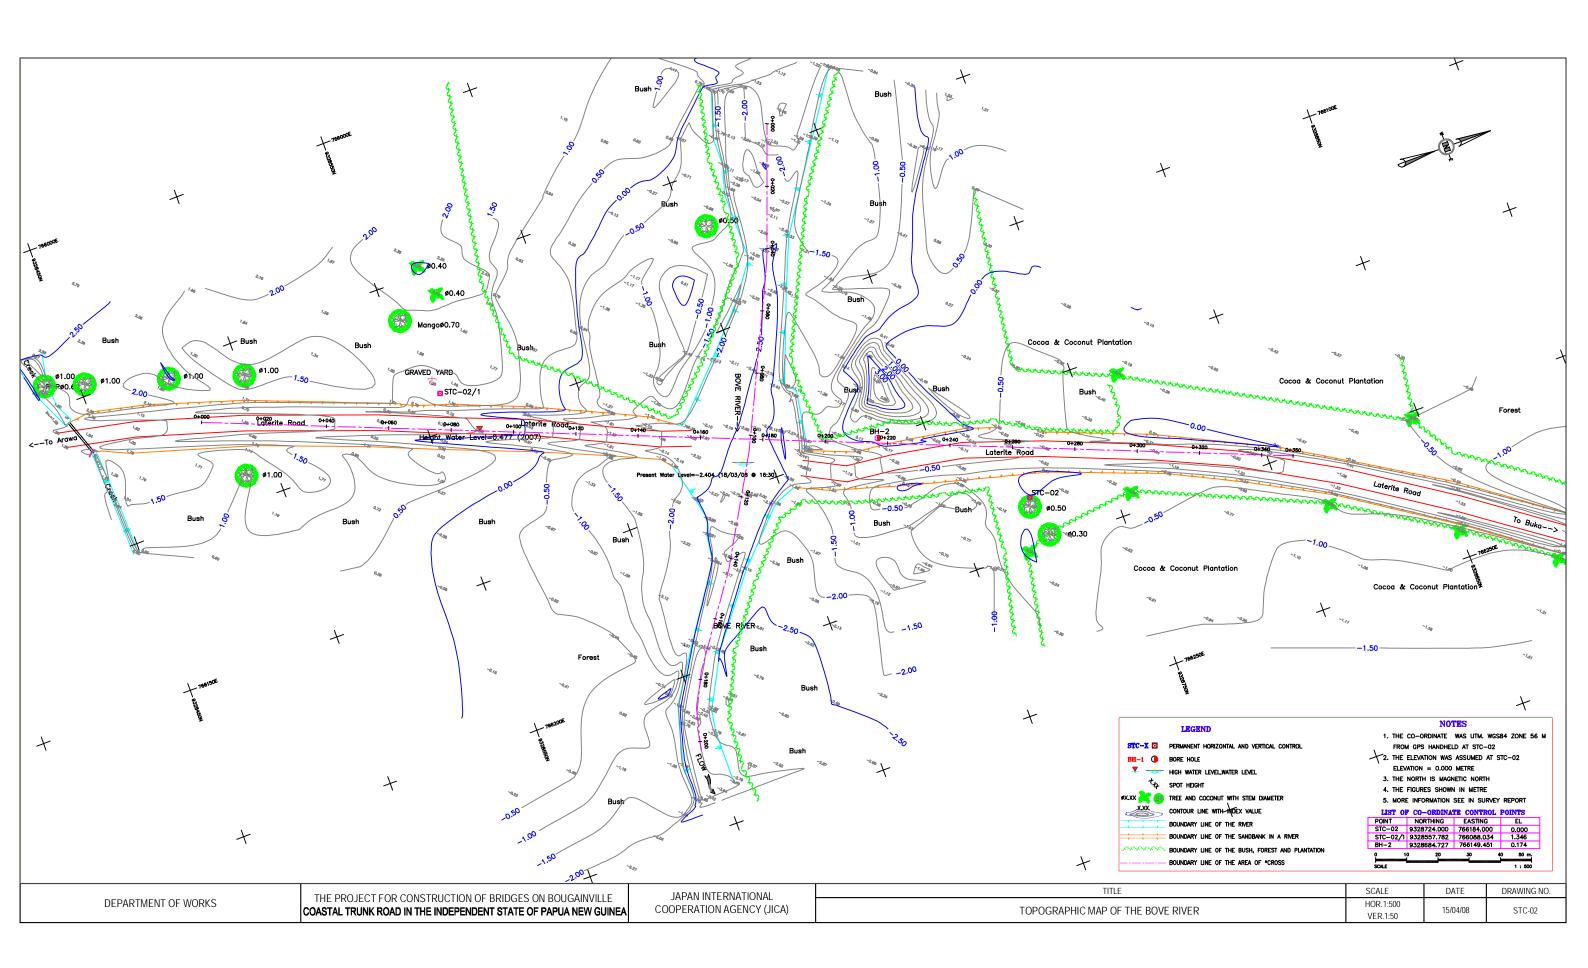
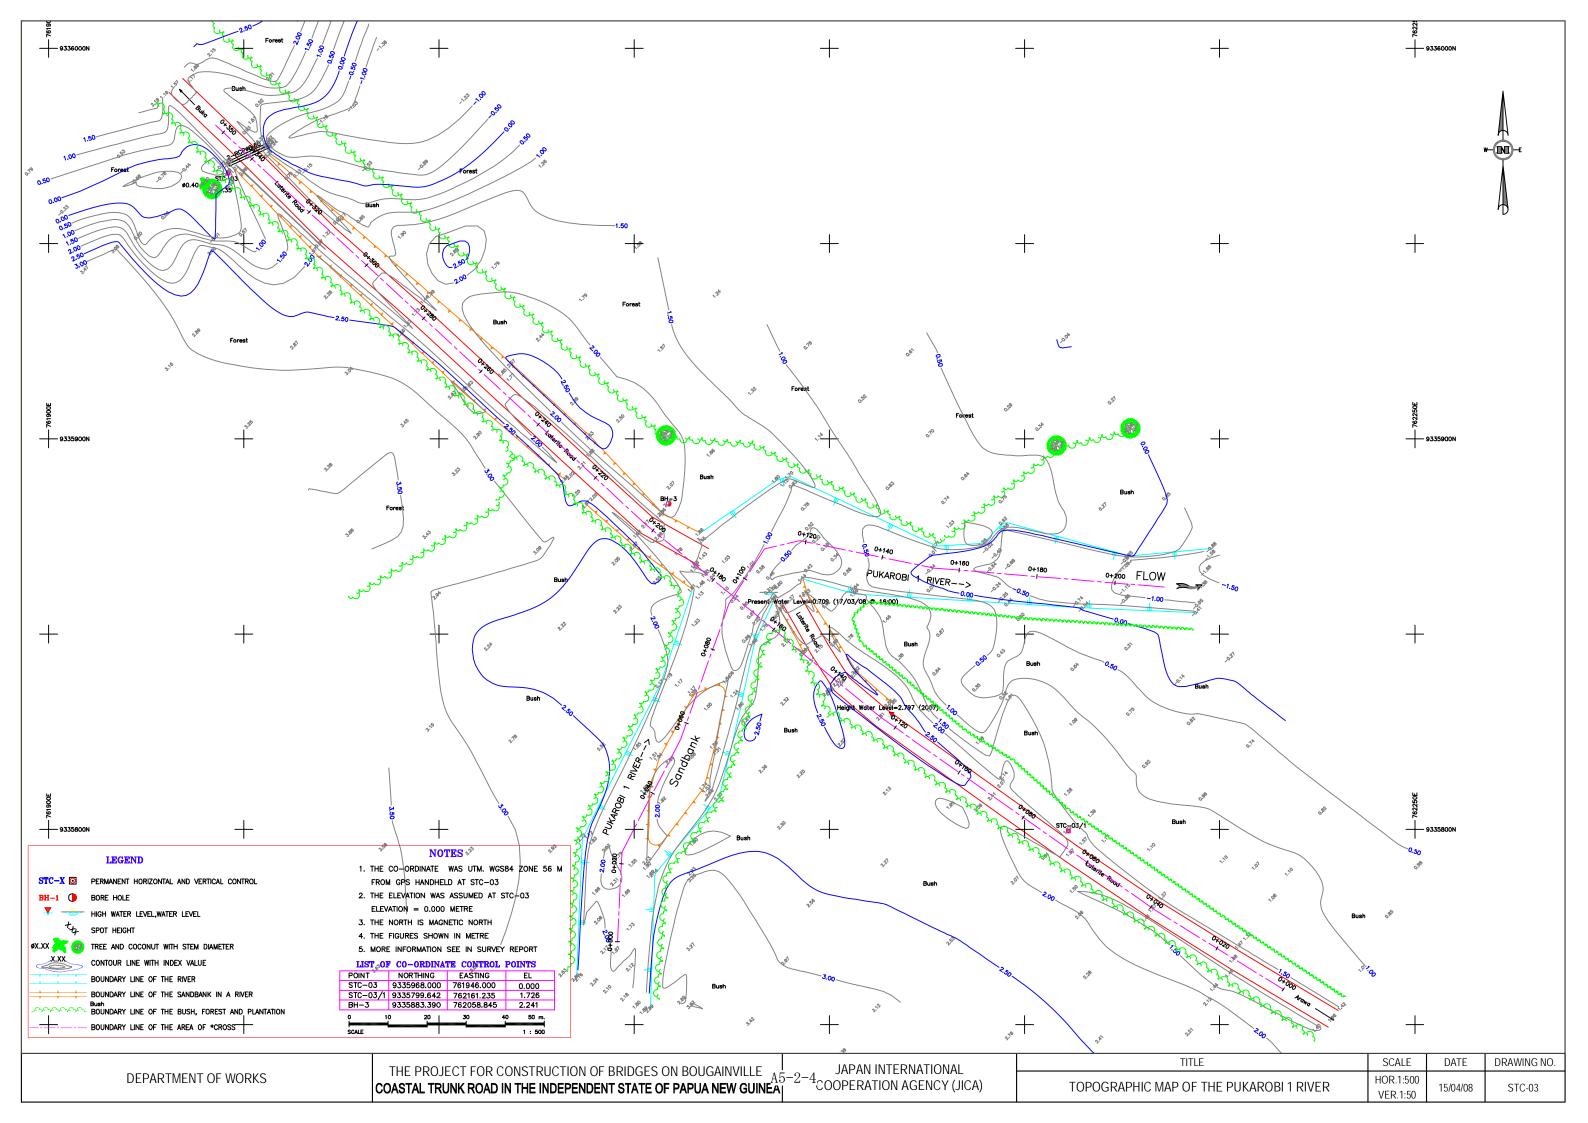
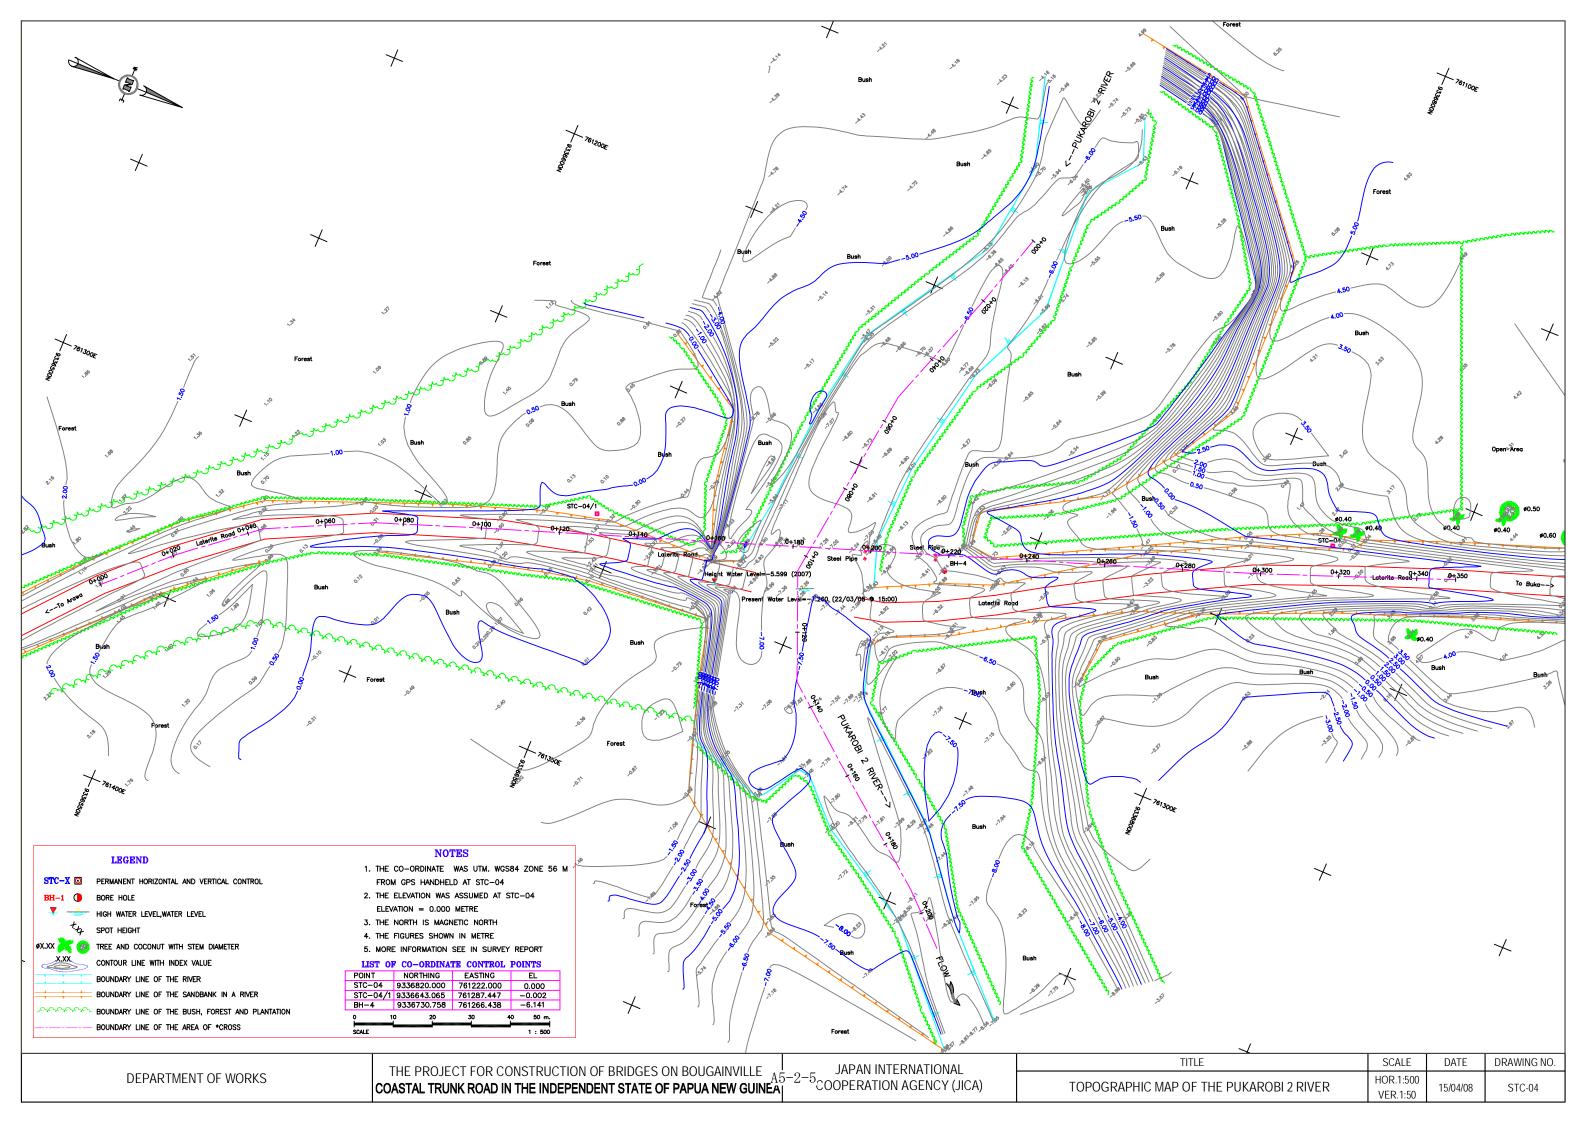
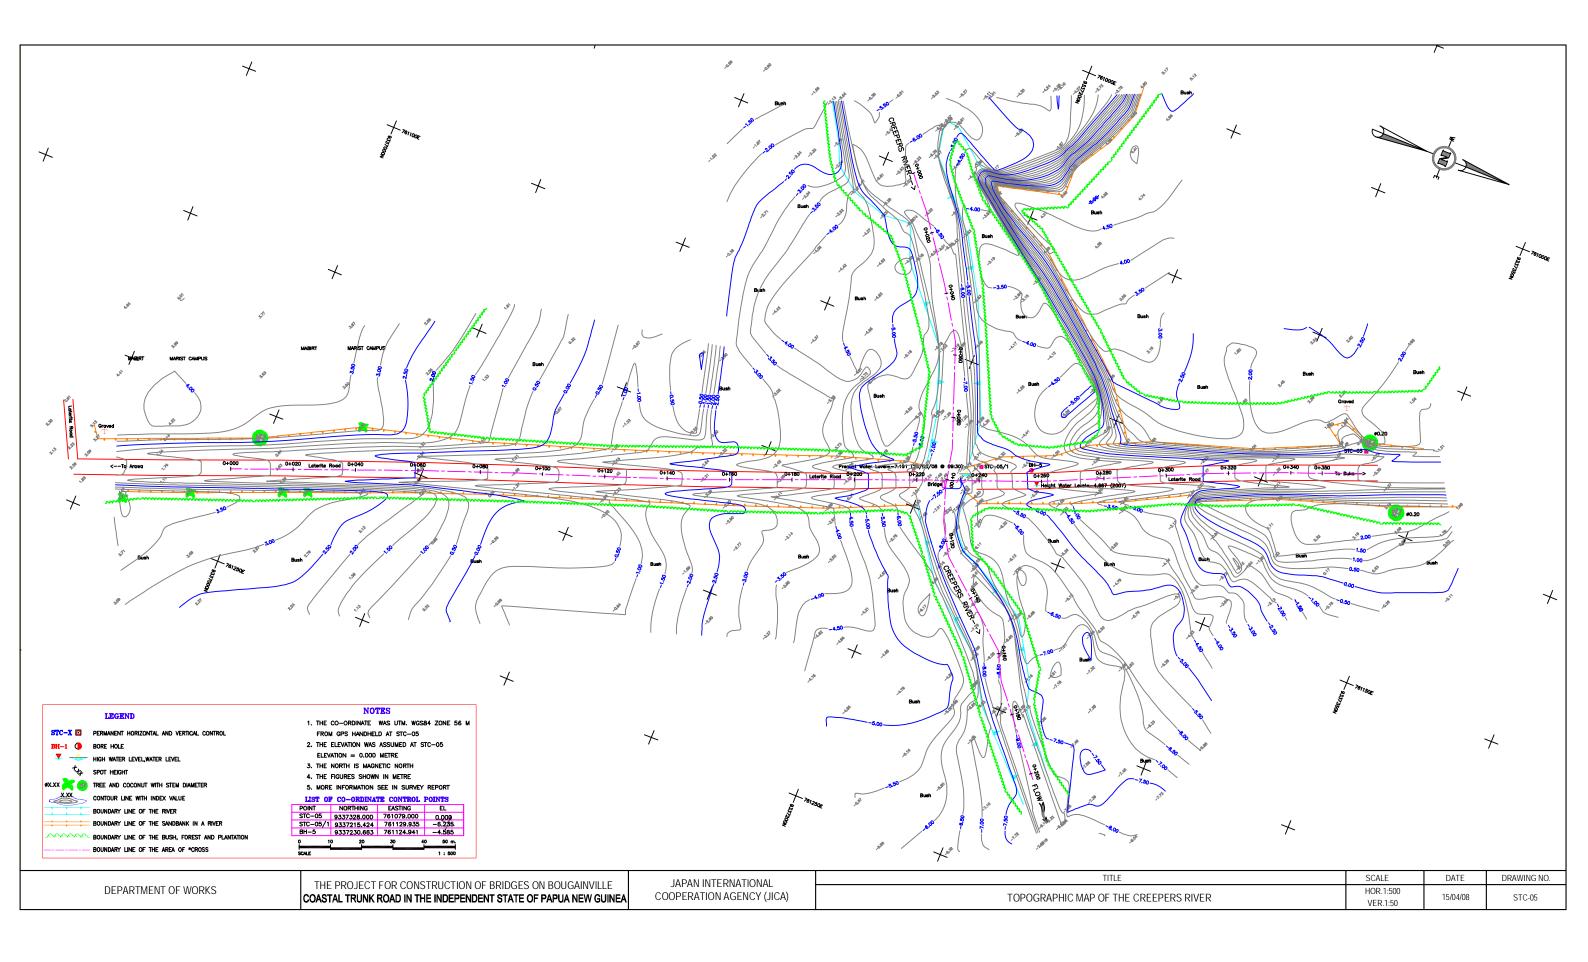
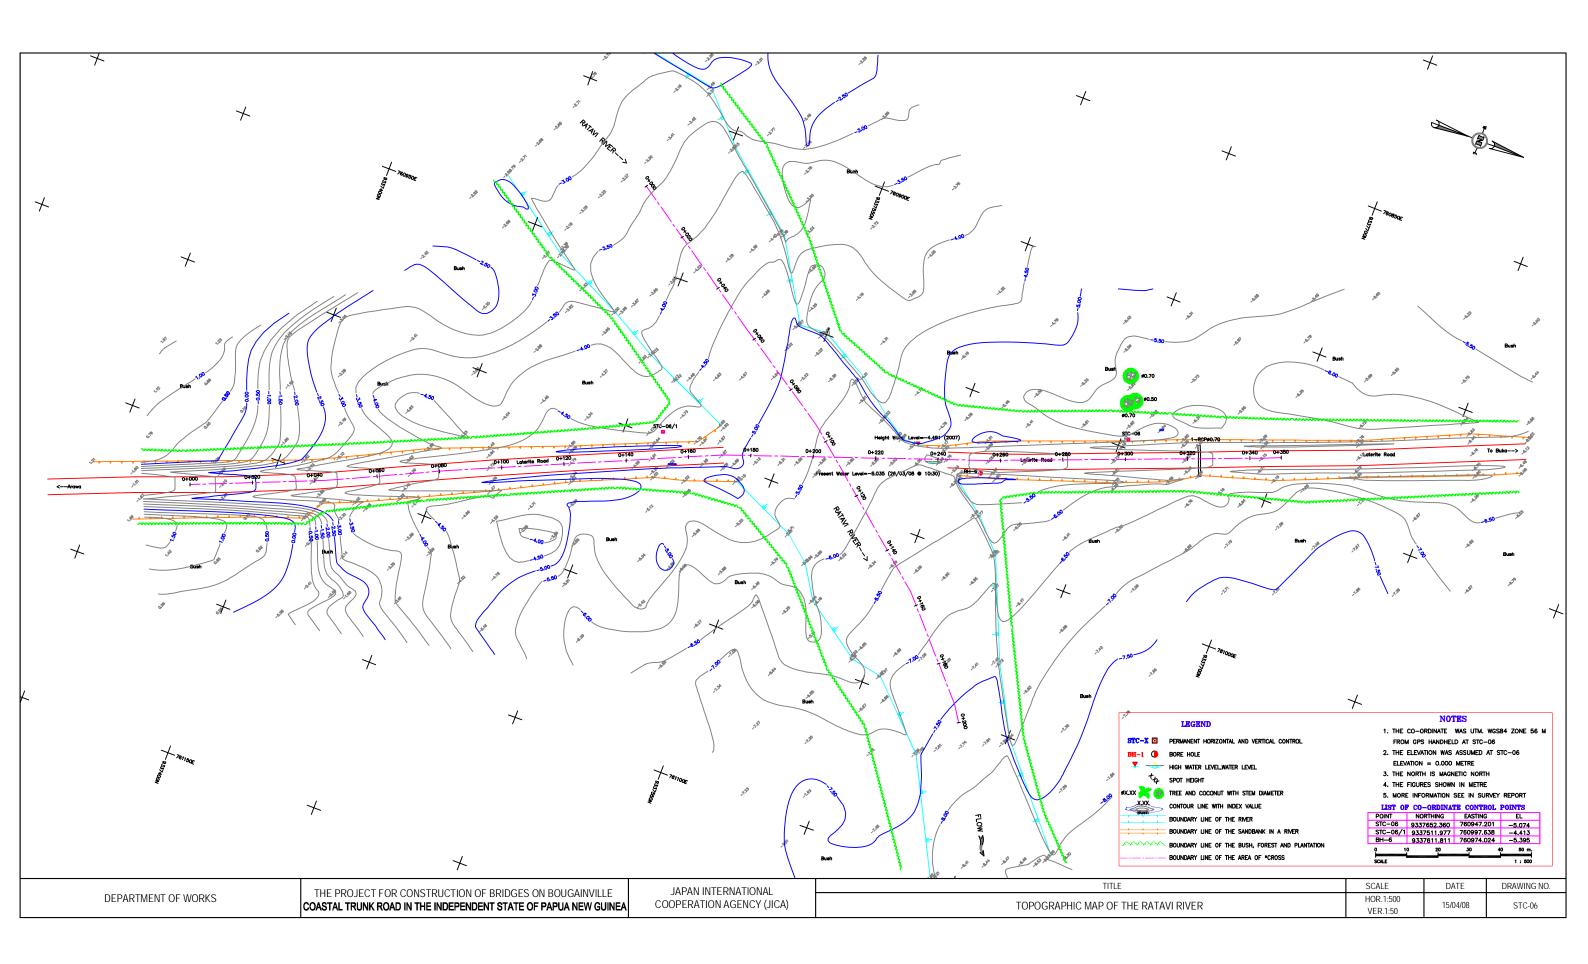
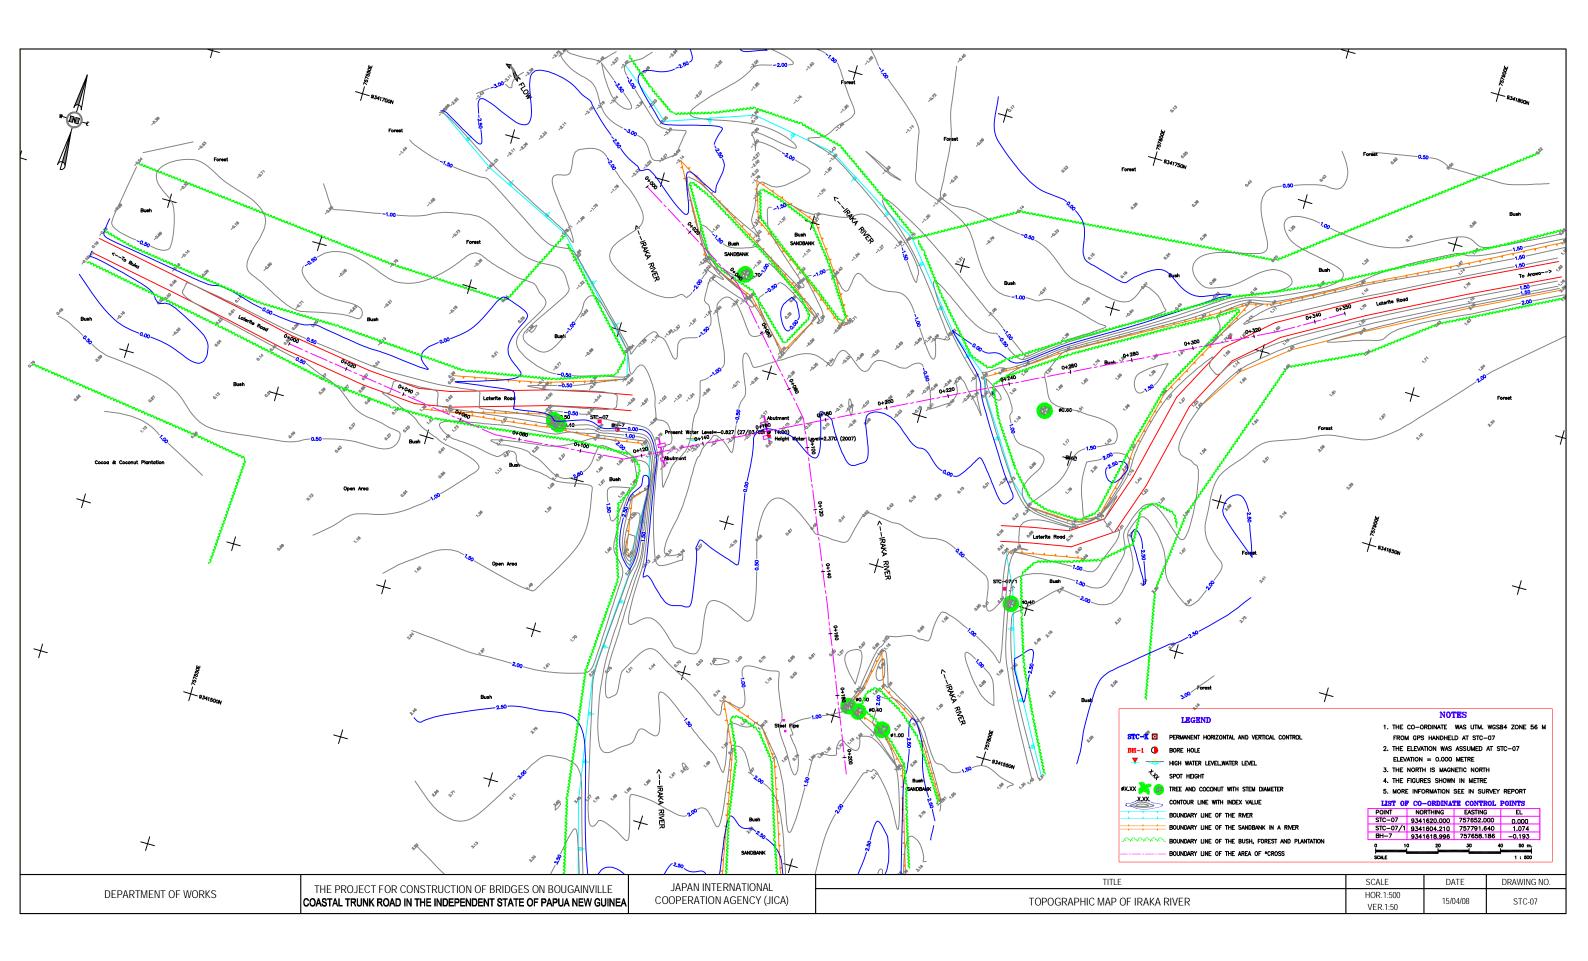
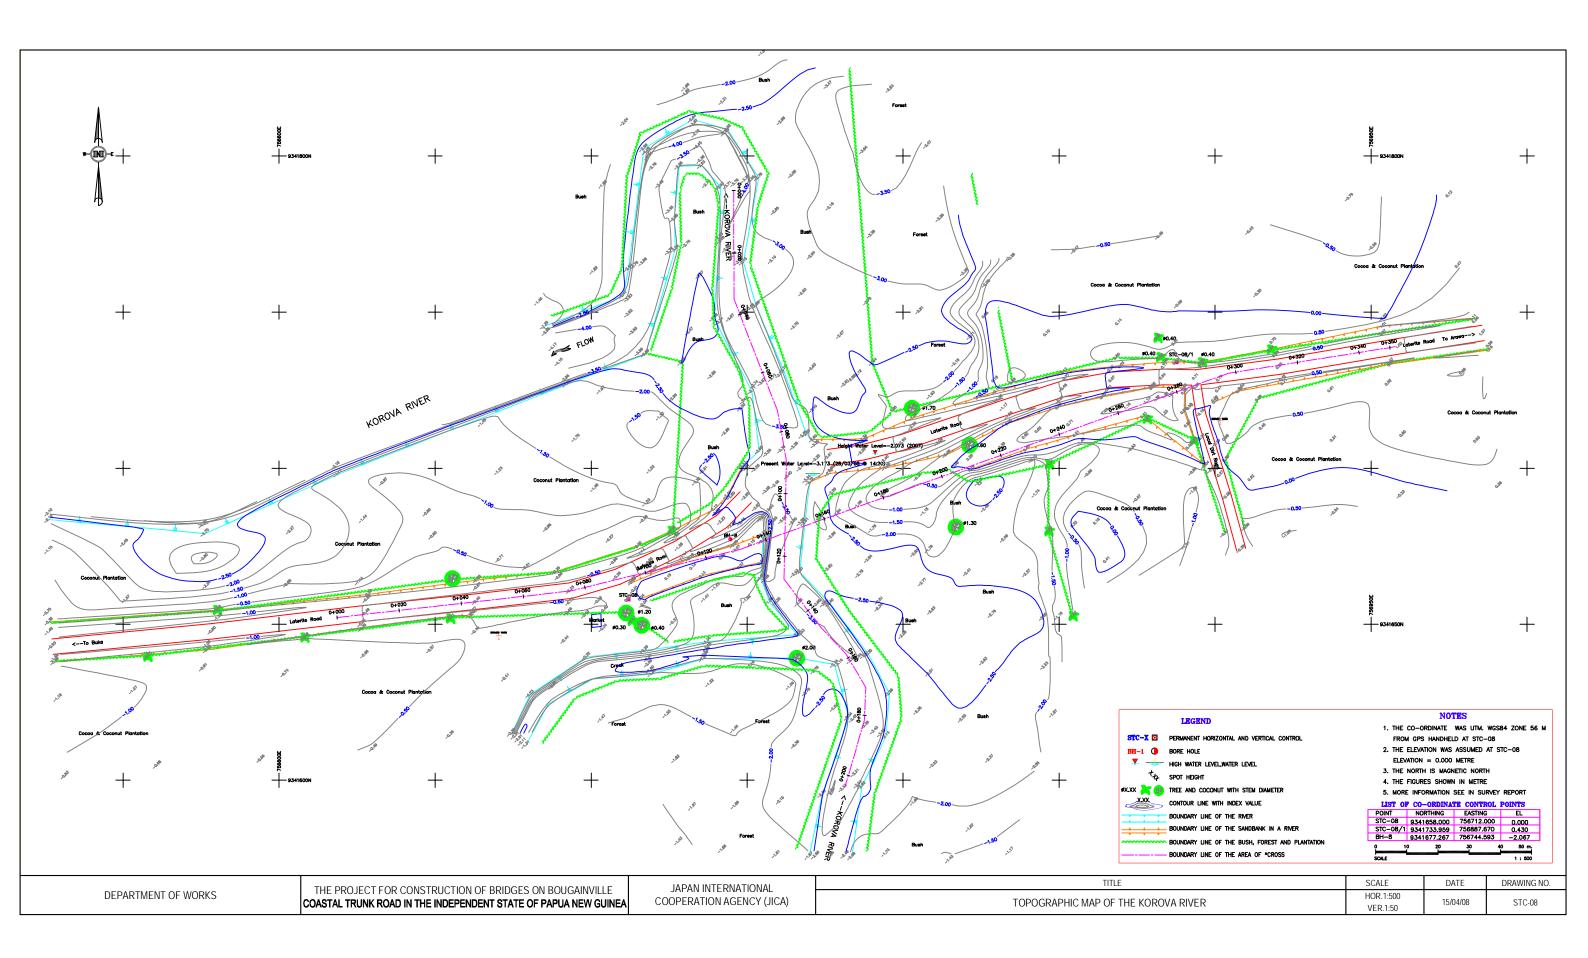
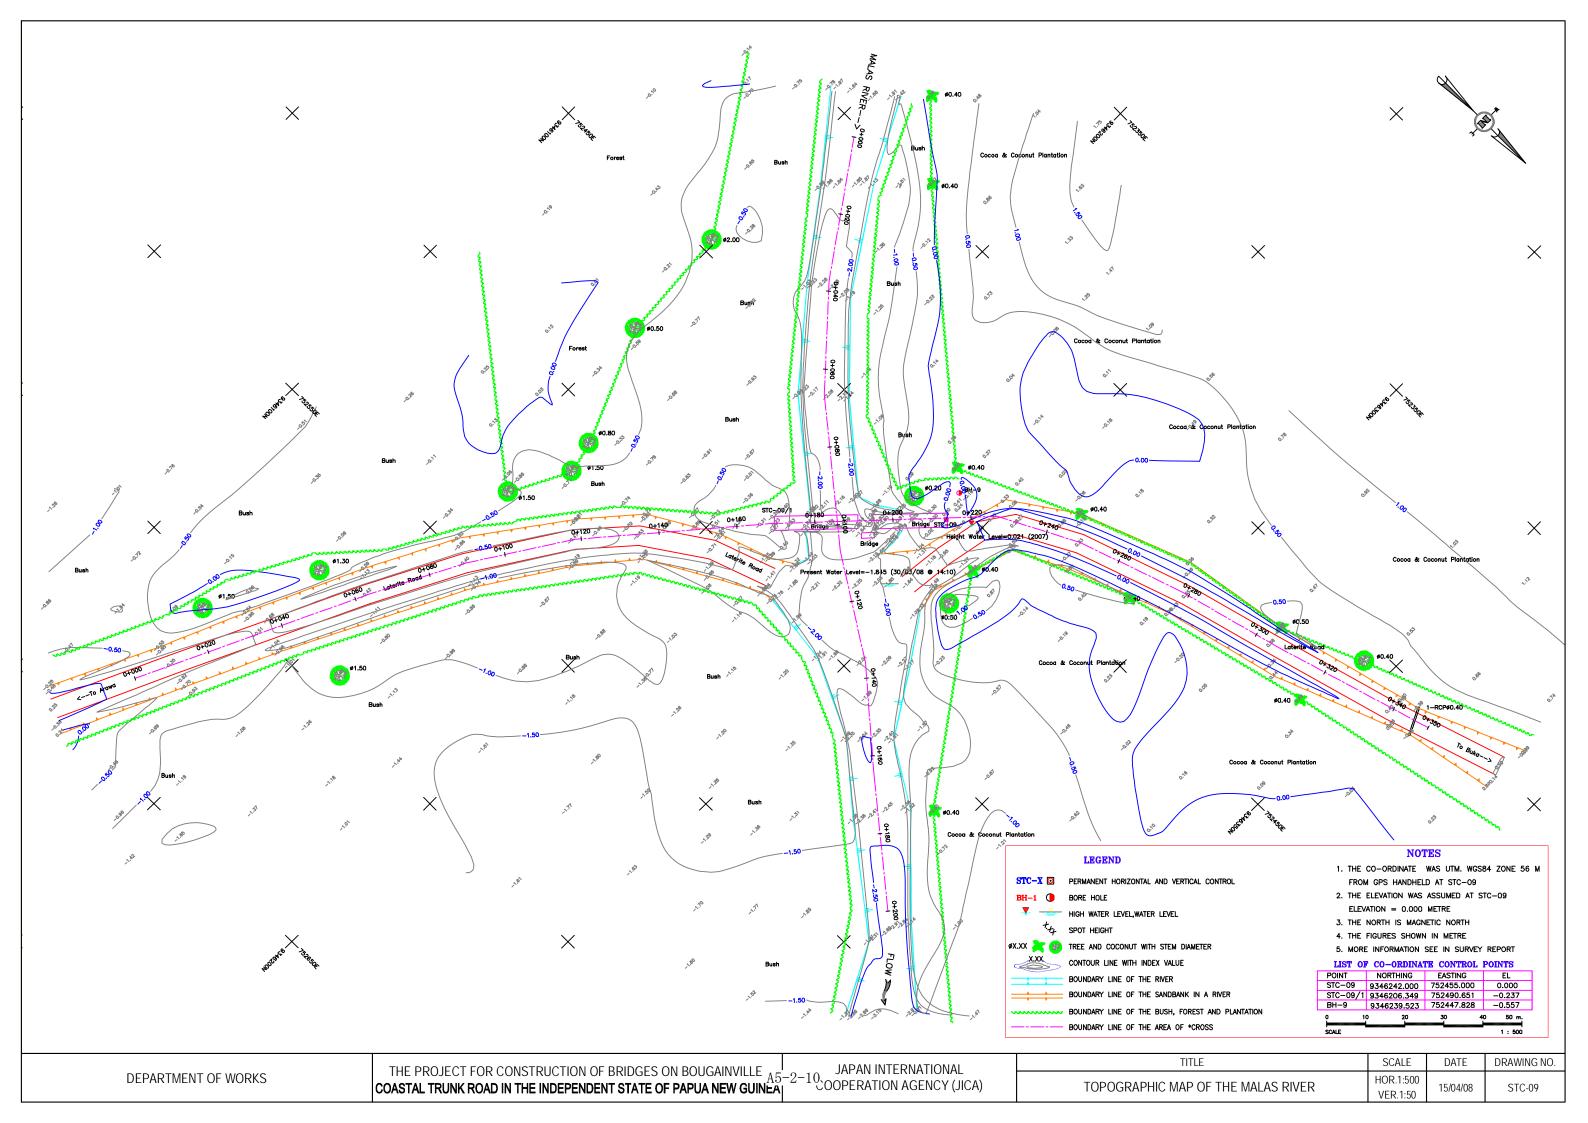
In order to gauge the current state of the target bridges and conditions on the road, topographical surveying and longitudinal and cross-sectional surveying of the road and rivers were carried out, and ground plans, longitudinal sections and cross-sectional views were prepared for each bridge. These surveying activities were carried out using total station and GPS surveying instruments. At each bridge point, temporary benchmarks acting as reference points (2 at each bridge) were set under instructions from the Study Team.

The surveying drawings, benchmarks and benchmark coordinates are indicated in the following drawings.
