Soil Investigation Survey Report

For the Basic Design Team Study on the
Project for Improvement of Water Supply
System in Honiara and Provincial Centers in
the Solomon Islands

Kenneth Bulehite
April 2008

The Project for Improvement of Water Supply System in Honiara and Provincial Centers in the Solomon Islands: Soil Investigation Survey

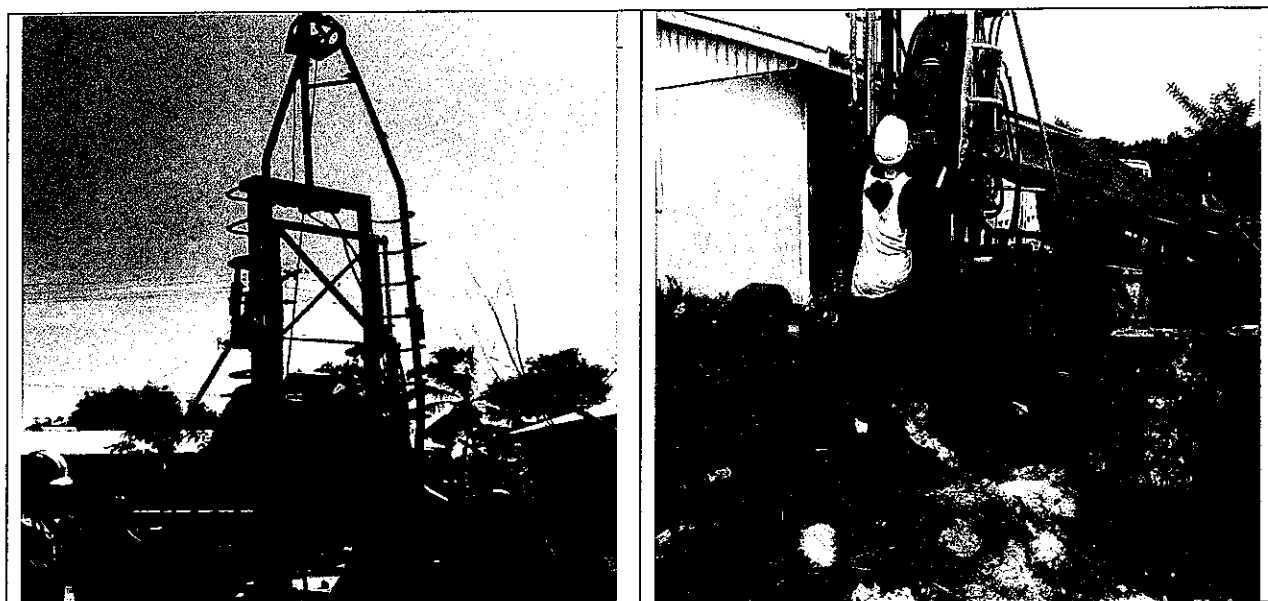
Plate 1: Drilling Rig G 210B

Data sampling for the laboratory and in situ testing especially Standard Penetration Test was done using drilling rig with rotary bit.

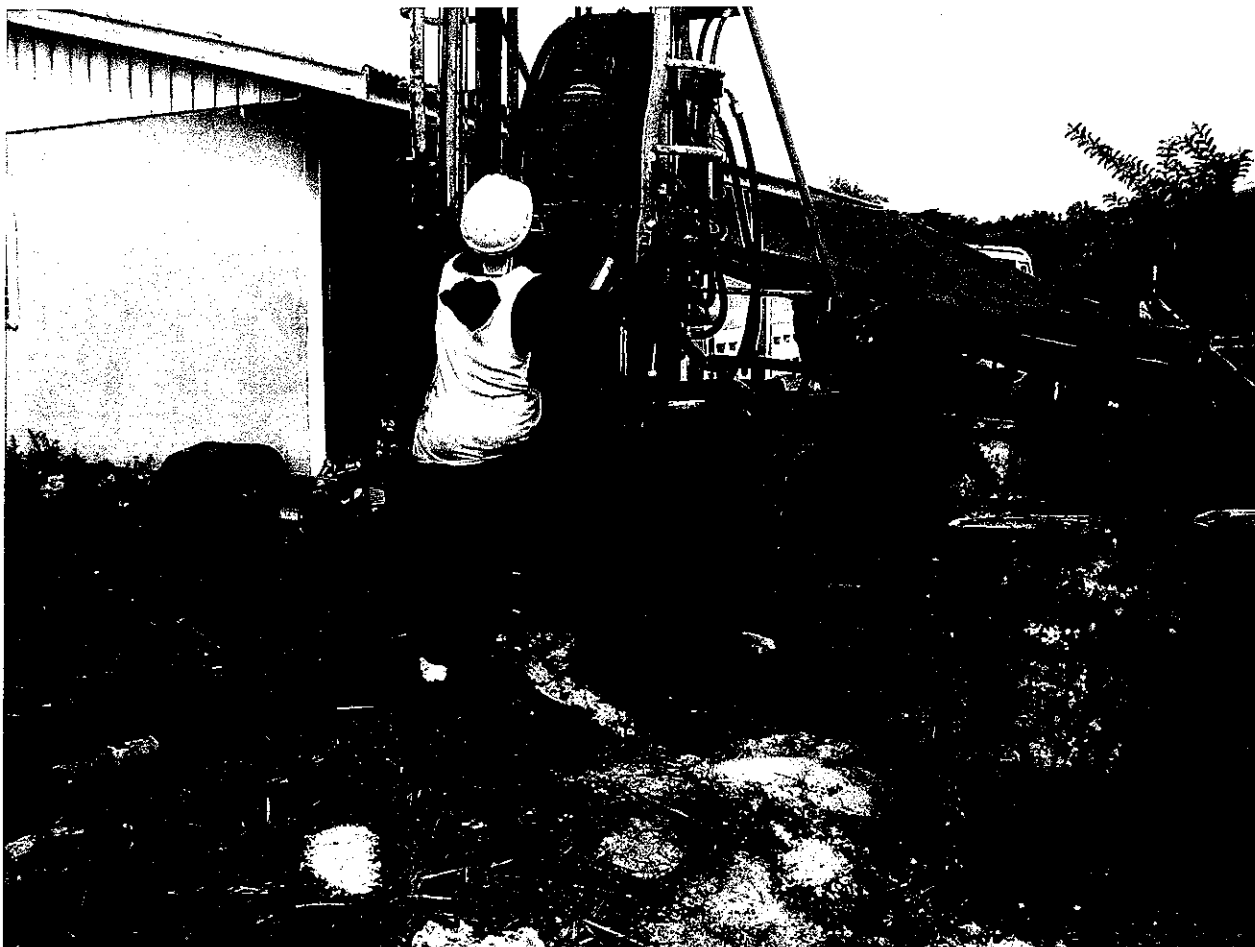
Plate 4.1: Drilling rig and Operator at Test Site

The borehole drilling was done using boring rig equipment. The borehole log for each of the borehole is a borehole journal was document in a log sheet of paper to provide the description of strata of the soil.

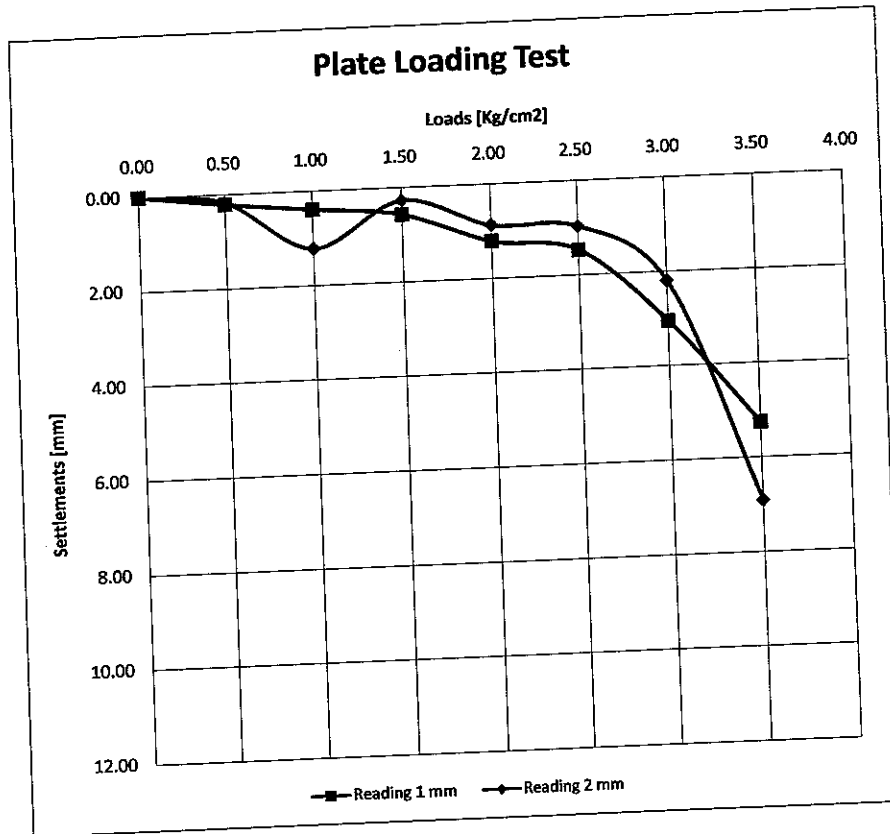
Figure 4.3: Plate loading Test for Kongulai Service Reservoir

The result of the plate loading test were tabulated in Table 4.3 and graphed in Figure 4.3. The ultimate bearing loading for the soil condition is 3.0 kg / cm^2 or 30 ton / m^2 .

Loads kg/cm ²	Reading 1 mm	Reading 2 mm
0.00	0.00	0.00
0.50	0.21	0.17
1.00	0.39	1.22
1.50	0.57	0.27
2.00	1.21	0.87
2.50	1.47	0.97
3.00	3.05	2.20
3.50	5.25	6.90

From the test the ultimate bearing capacity is 30 ton / m^2 , which the recommended maximum loads applied.

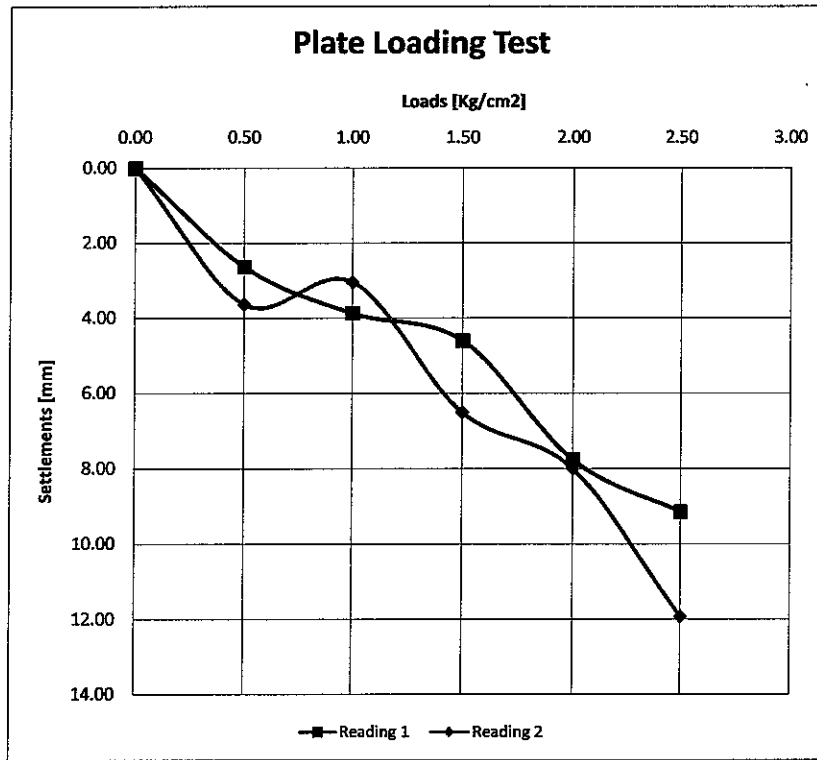
Figure 4.8: Plate loading Test for Proposed Rove Water Treatment Facility

The result of the plate loading test were tabulated in Table 4.8 and graphed in Figure 4.8. The soil shows a steady increase as the load is applied. The Soil strength at the proposed site near the stream could be higher the clay soil tested. However ultimate bearing loading for the soil condition in Rove is 1.5 kg / cm^2 or 15 ton / m^2 , the test was done upper part of the proposed site.

Loads	Reading 1	Reading 2
kg/cm2	mm	mm
0.00	0.00	0.00
0.50	2.63	3.63
1.00	3.87	3.04
1.50	4.60	6.50
2.00	7.76	8.00
2.50	9.14	11.92

The test result shows that the ultimate bearing 15 ton / m². The site needs to be prepared to compact the soil sub-base level to improve the strength of the soil. The area that was proposed as the site for the proposed rove water treatment site is situated on the lower site from the test site. However, it needs to be compacted to accomplish the required strength.

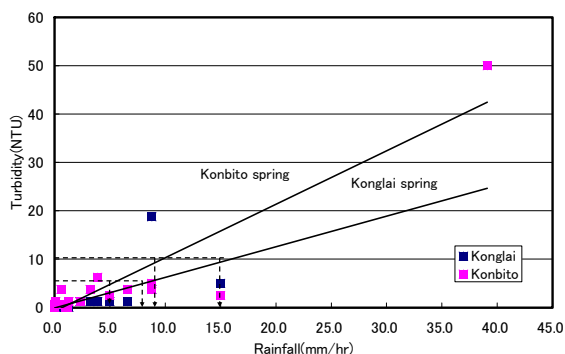
図-1 降雨強度と原水濁度の関係

高濁度対応型調整池の使用頻度を検討するために、高濁度の発生頻度の検討を行った。日水質分析データを用いコングライ湧水およびコンビト湧水における降雨強度と原水濁度の関係を検討した。結果を図-1 に示す。また 2007 年 4 月～2008 年 3 月における各降雨強度の年間発生頻度を図-2 に示す。

※1 濁度 1 度=0.8NTU として換算した。
