BASIC DESIGN STUDY REPORT
ON
THE PROJECT FOR
REHABILITATION OF NATIONAL TRUNK ROAD N8
IN
THE REPUBLIC OF GHANA

DECEMBER 2008

JAPAN INTERNATIONAL COOPERATION AGENCY

CONSTRUCTION PROJECT CONSULTANTS, INC.

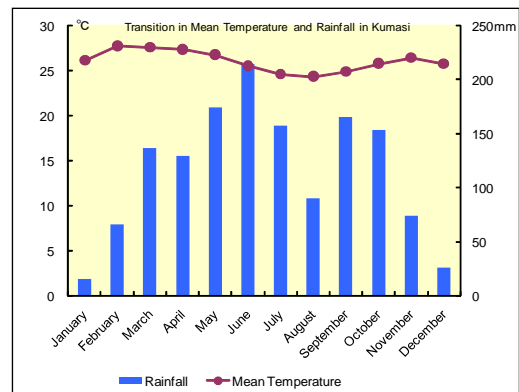
Fig. 1-2 Weather Conditions at Project Site

The annual air temperature variation in the target area is small. The rainy season lasts for six months between May and October and is subdivided into a major rainy season between May and June and a minor rainy season between September and October. The annual average precipitation is 600mm along the coastal region and 1,500mm in the central region (the target sites are inland). Except for the dry season which occurs between November and February, the number of rainy days tends to be large even though the amount of rainfall is small.

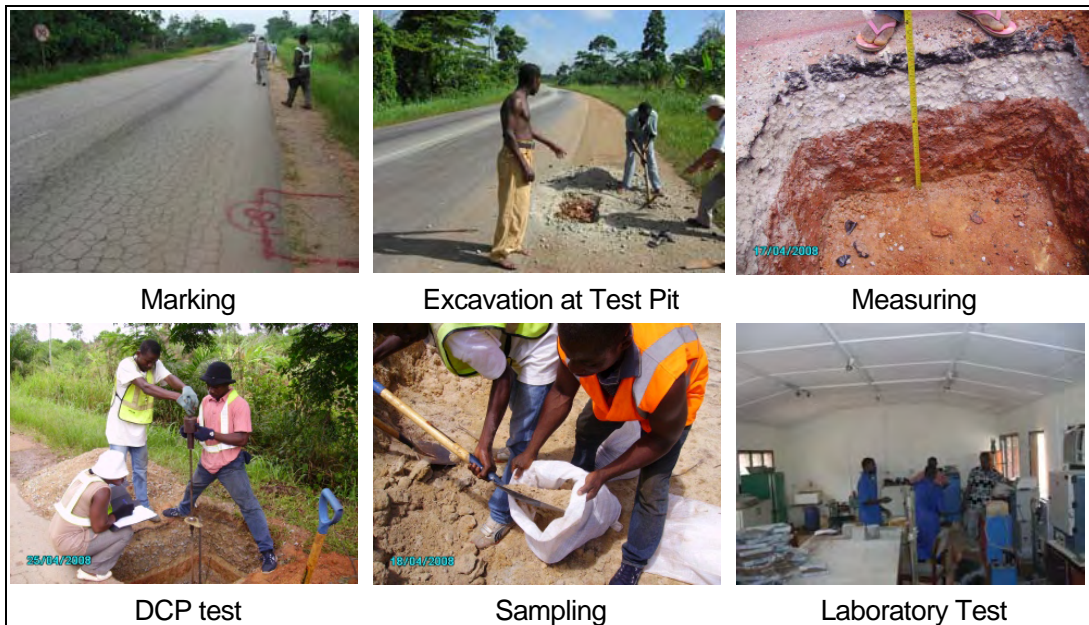
Fig. 1-4 Working Scenes at Test Pit

By excavating test pits on the target road shoulders, thickness of each layer of the existing pavement was confirmed. Also, dynamic cone penetration testing (hereinafter referred to as “DCP”) was conducted in order to grasp the bearing capacity of the road bed. In addition, laboratory tests were conducted on samples collected from the test pits.

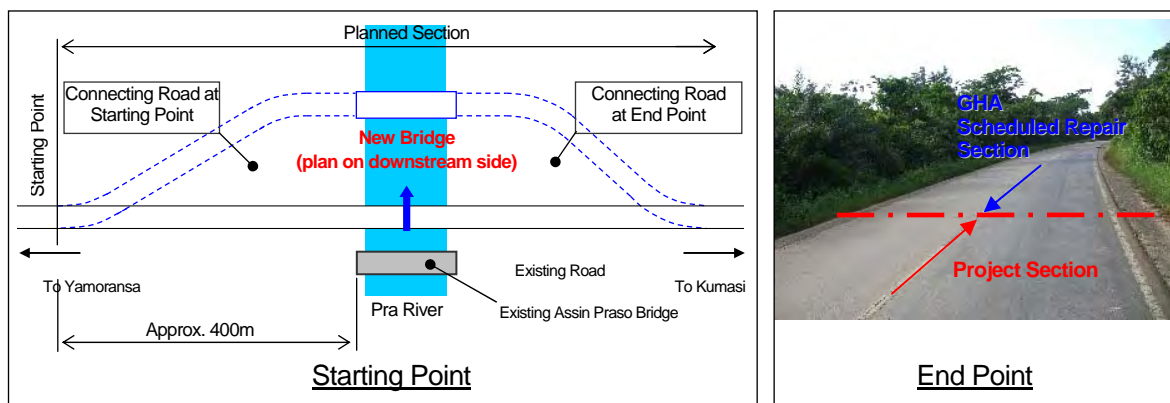
Fig. 2-3 Starting and End Points of Proposed Section

With respect to Assin Praso Bridge, a new bridge will be constructed 30m downstream and the Ghanaian side plans to retain the existing bridge exclusively for pedestrian use.

As the result of confirming and analyzing the existing culverts and concrete pipes, culverts and box culverts more than 90cm diameter will be effectively utilized; whereas, concrete pipe culverts less than 90cm in diameter that do not satisfy the GHA standards will be replaced with 90cm diameter pipes and corrugated pipes will be replaced with concrete structures.

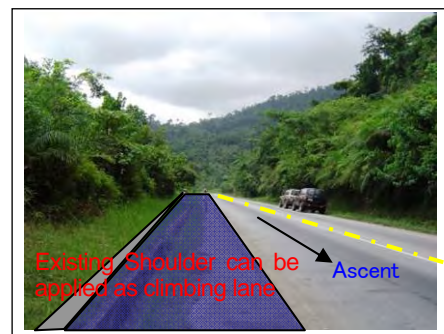
Fig. 2-4 Climbing Lane

For the establishment of climbing lanes, considering that the ratio of large vehicles passing along the target road is high at over 20% and the climbing speed is less than 20km/hr, which is less than half of 40km/hr, climbing lanes will be established in the mountainous section. In order to minimize the impact on the presently stable slope face, the existing shoulder of the uphill lane will be widened for a climbing lane. Accordingly, shoulders at the side of the new climbing lane will not be installed so that this section will have single-sided shoulder. The width of the climbing lane will be 3.5m according to the Ghanaian design standard. Climbing lanes will be installed over 1.68km from the 43.5km point on the right lane and over 1.29km from the 45.2km point on the left lane.

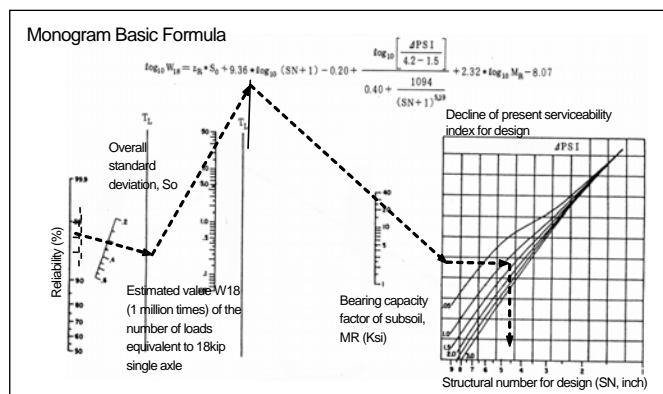
Fig. 2-6 Monogram for Flexible Pavement Design

In the pavement design under the Project, based on the basic formula (nomogram chart for flexible pavement design, see Fig. 2-6) for flexible pavement in accordance with the AASHTO Guide, SN=4.8 was obtained

as a result of calculating the pavement structural number (SN) allowable for the assumed traffic load necessary for the proposed road,.

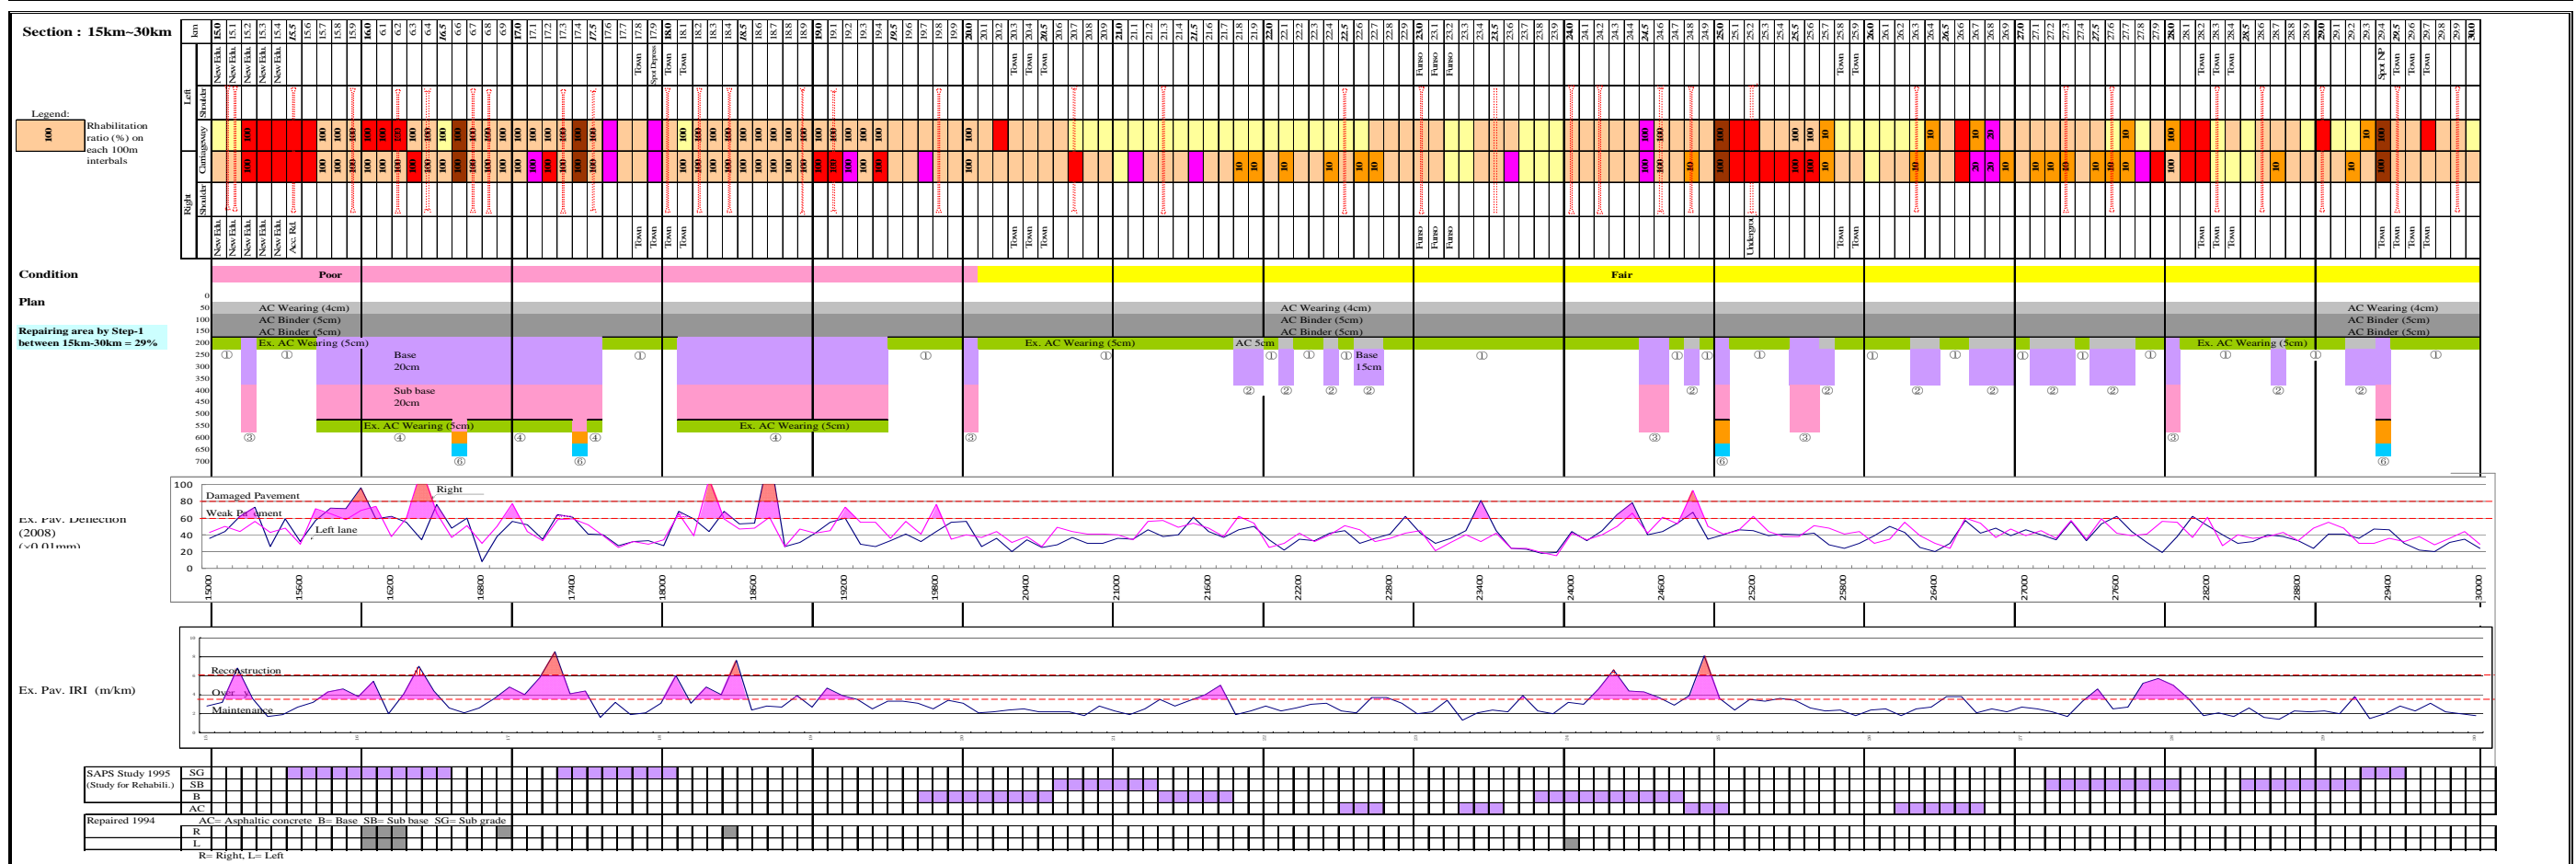
Fig. 2-7 (1) Road Damage and Rehabilitation Method (1/2)

In the next paragraph, diagrams showing the damage condition, strength, surface smoothness, past repair history and repair method in the plan are shown.

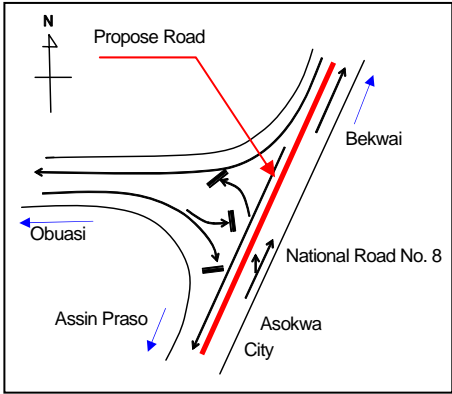
<p>The aim of the plan is to follow the existing intersection model. On the assumption that the main road will be the target road under the Project and the subordinate road will be the road between Asokwa and Obuasi, traffic flow within the intersection shall be taken into account in the plan.</p>
