7. Others

CLIENT:	JCA	SURFACE RL:	1284.28 m	DRILLER:	Soil Trade LLC
PROJECT:	Basic Design Study for Construction of Railway Fly-over	HOLE DEPTH:	13.0 m	DRILL RIG:	UGB-50 m
LOCATION:	Ulaanbaatar City	GROUND WATER LEVEL:	Detected 4.9 m Stabilized 4.2 m	HOLE DIA:	168 mm
				DATE:	04/20/2008
				LOGGED:	T.Renchindorj

(a) Gurvaljin Bridge

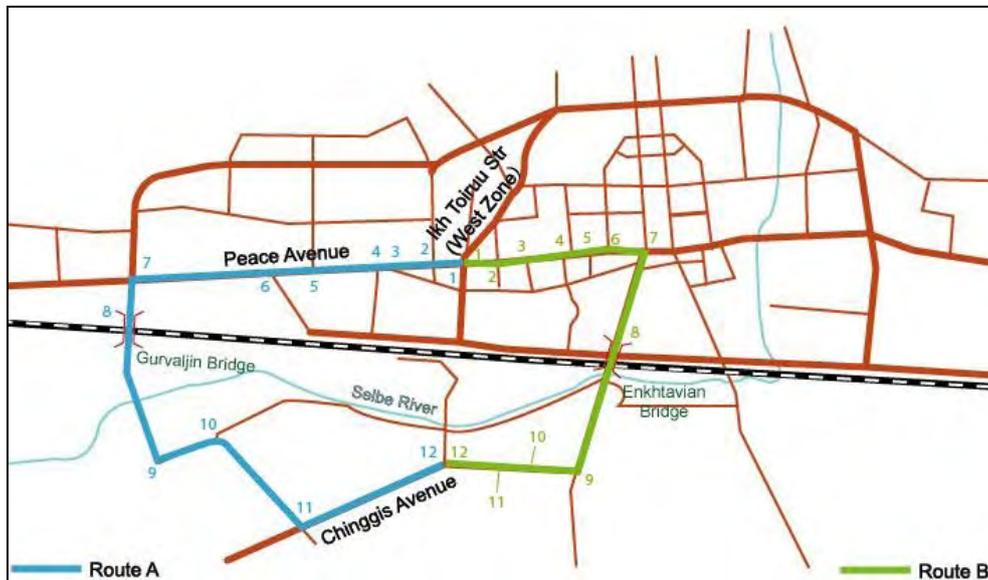
Figure 1 Survey Routes for Travel Speed Survey

For this survey, 2 routes are identified to cover the major roads in the center of Ulaanbaatar City as shown in Figure 1. Three runs were carried out morning time (0700H to 1000H), afternoon (1000H to 1700H) and evening time (1700H to 2000H) in both directions.

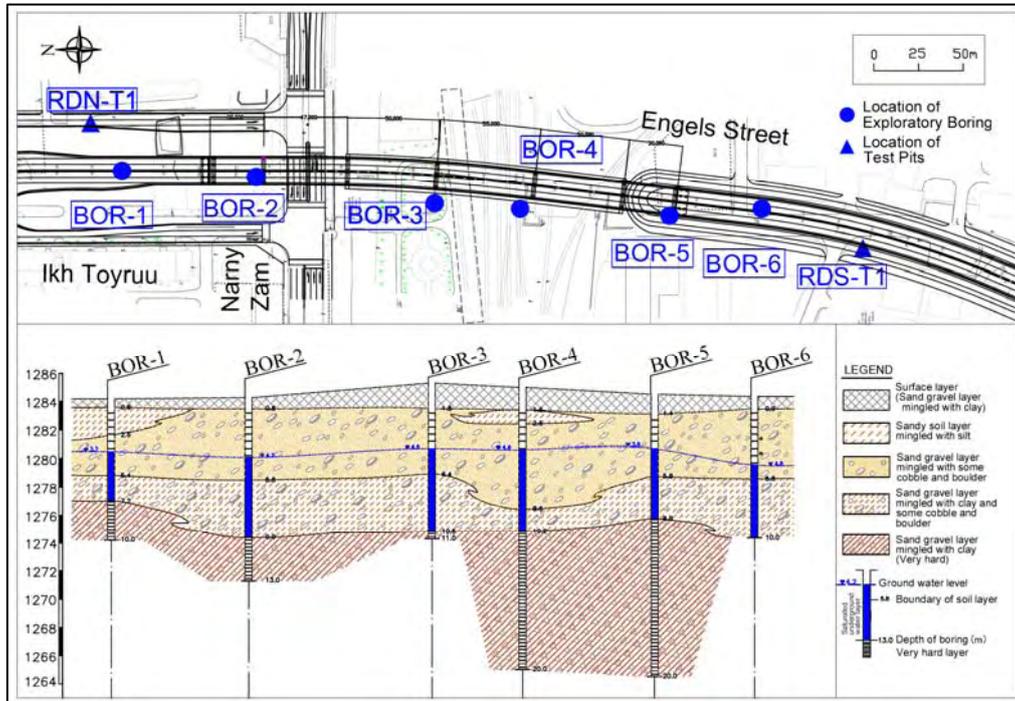
Figure 2 Geological Profile and Locations of Exploratory Boring and Test Pits

The exploratory borings with standard penetration tests were carried out at 6 locations and the Test Pit digging survey was carried out at 2 locations (refer to Figure 2).

Figure 2 illustrates the geological profile, as well as the locations of exploratory boring and test pit digging survey.

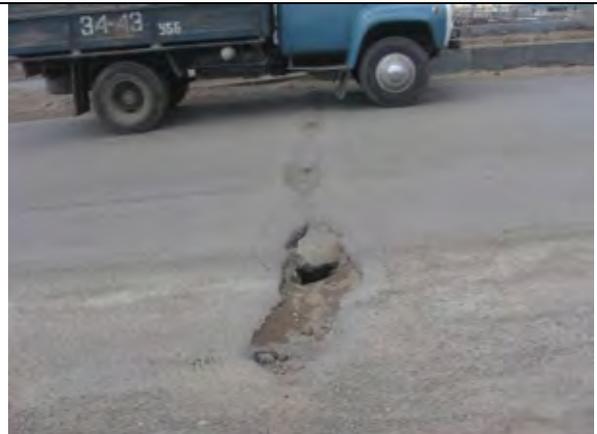
Depression at the Expansion Joint.
Steel Chanel of the Joint seems to be forfeited at construction of overlay for surface course.

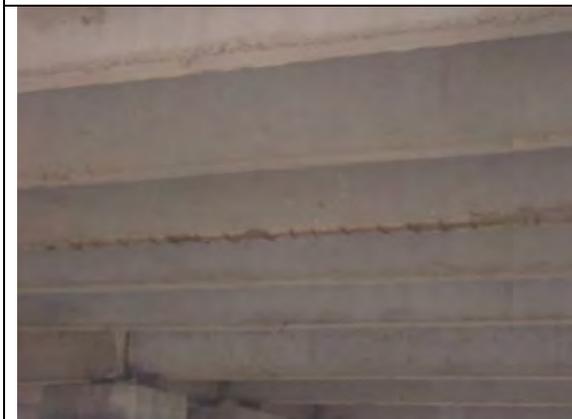
Result of Soundness Survey
<p>General Exfoliations at covered concrete and isolated lime are appeared at the Super Structure. It is highly possible that the soundness of the bridge would be severely degraded due to increasing of heavy traffic and frost damage. Piers that has been assembled with pre-cast block is at high risk of collapse by earthquake.</p> <p>Deck Slab Isolated Lime has bee appeared at deck slab spreading throughout particularly at interfiling concrete. Repeating of freeze and thawing are causing developing of cracks and isolated limes.</p> <p>Main Girders Concrete of bottom part of the main girders has been exfoliated and reinforcing bars have been exposed due to shoddy work at the construction period and/or frost damage. It is highly possible that the girder would be severely degraded due to increasing of heavy traffic and frost damage.</p> <p>Substructure Significant deformation has not been appeared at Piers and Abutments. A part of pier concrete have been damaged and reinforcing bars have been exposed. It seems to be caused by shoddy work at the construction period.</p>

Exfoliation of concrete and rusty exposed reinforcing bar at the bottom of Main Girder

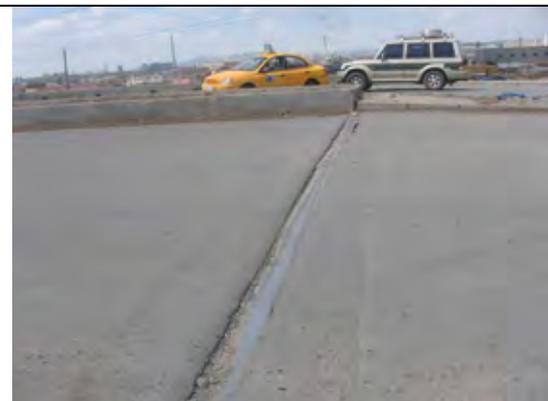
Expansion Joint at North Side
Overlay was finished.

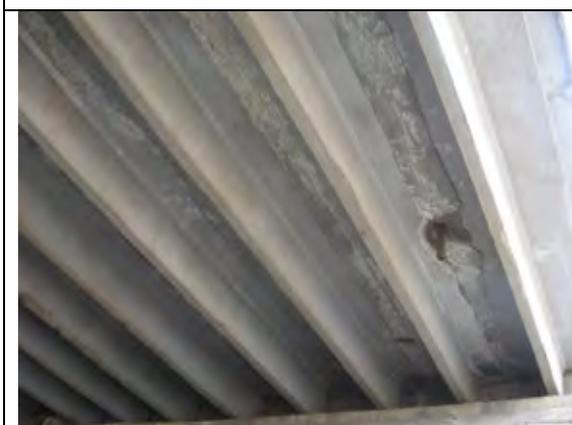
Isolated lime at Inter filling concrete (South side)

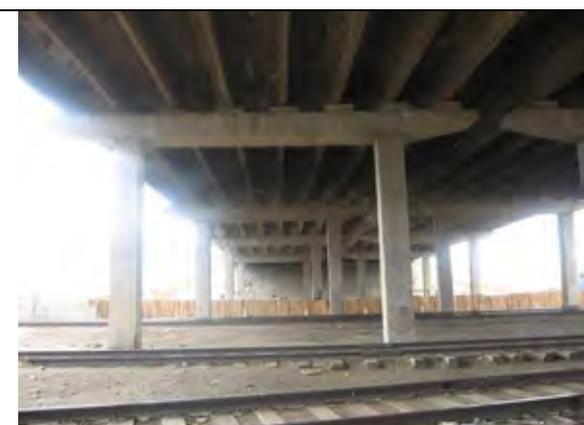
Piers have been constructed with Cumulated Pre-casting concrete block.

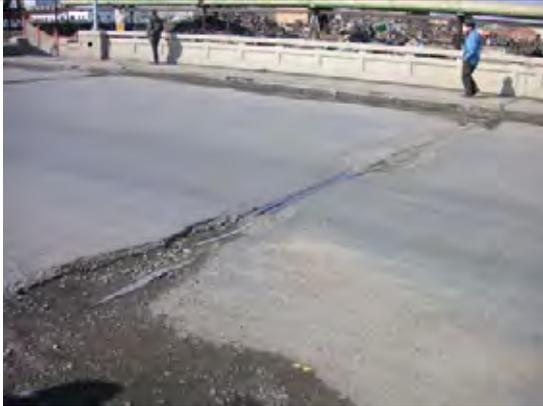
Expansion Joint (North Side) / Steel Channel has been loosed

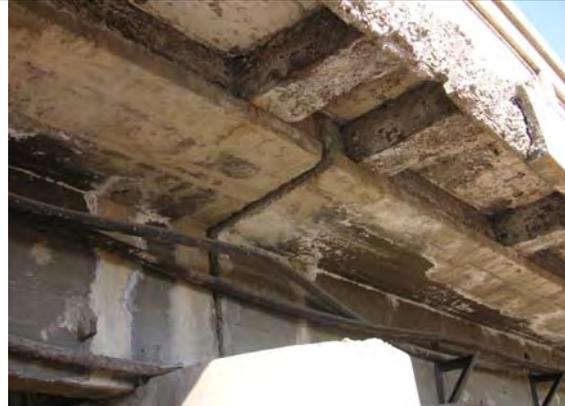
Damage on main girder (East Side) because of shoddy work and frost damage

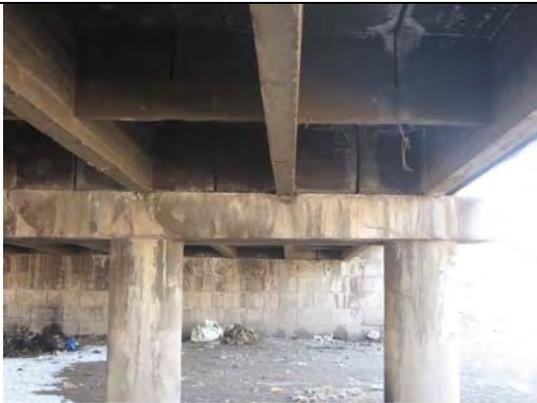
Result of Soundness Survey
<p>Deck Slab :</p> <p>Isolated lime has been appeared at joint and edge of deck slab due to small cracks arisen by repeated traffic load. There are some part exfoliated. It seems to be due to shoddy work at the construction and frees and thaws.</p> <p>Rust of reinforcing bar has not been developed at the moment, it will become the condition that reinforcing bar is easily rust after neutralization of the concrete due to effluence of lime in concrete by the isolated lime. Additionally increasing of heavy vehicle will induce development of the isolated lime.</p> <p>Main Girders :</p> <p>There are crossing beams distributing load of deck slab. Huge damage has not been appeared.</p> <p>46-year passed has been passed since it was constructed, so that deterioration can be appeared according to increasing of heavy vehicle.</p> <p>Substructure</p> <p>No damage and deformation can be seen at main column and blest wall but connecting part of main girder and crossing beam of pier has been damaged. Temperature variation is inducing the stress concentration at the beam since there are not bearings and the girders are directly set on the beam.</p>

Isolated Lime defulmented to the beam from deck slab and girders

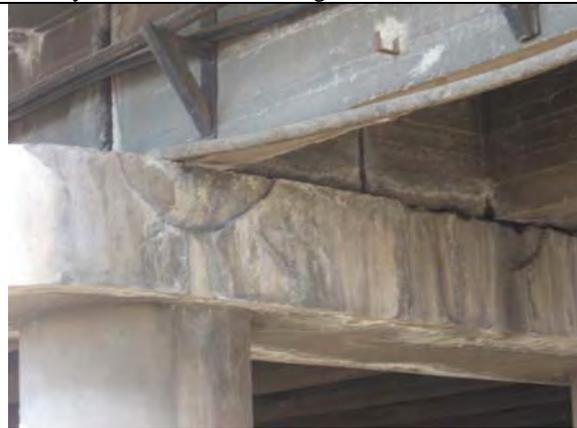
Damage at Crossing Beam /

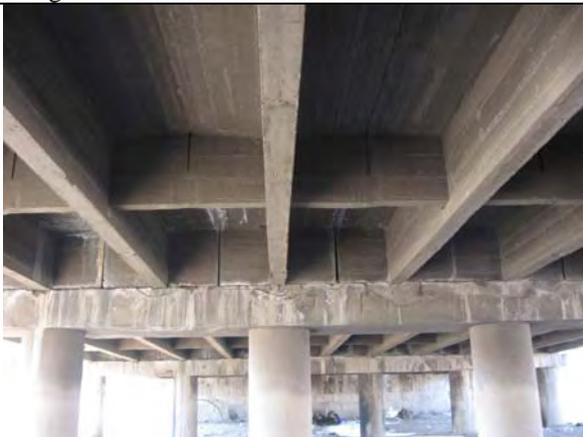
There are not bearing on the beam. The damage seems to be induced by stress concentration because of temperature variation.

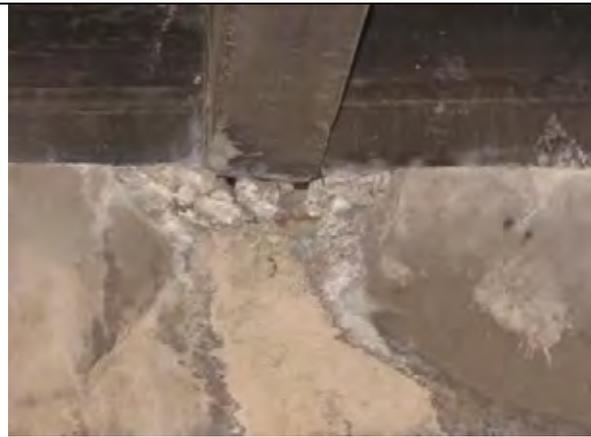
Damage at bearing sheet of girder at the Abutment

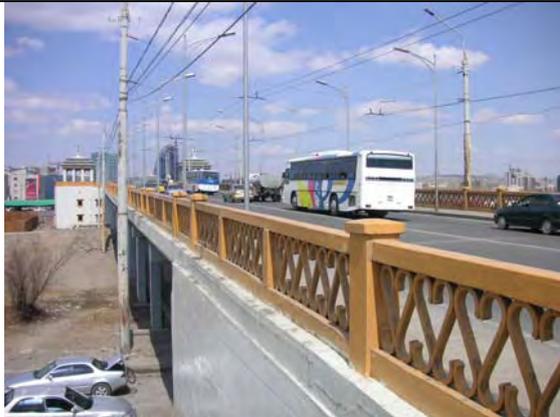
Traffic control has been implemented. Bus is able to pass.

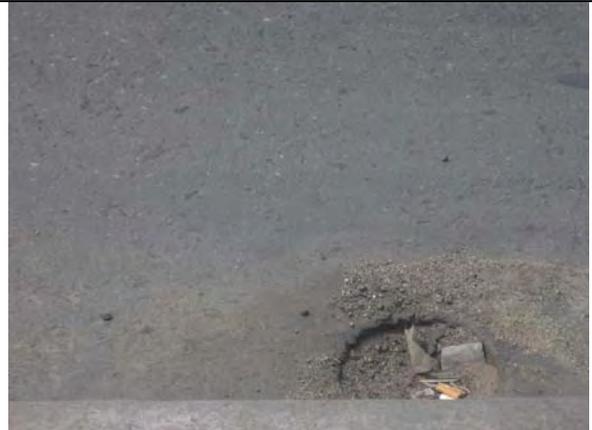
Catch basin of drainage has been clogged.

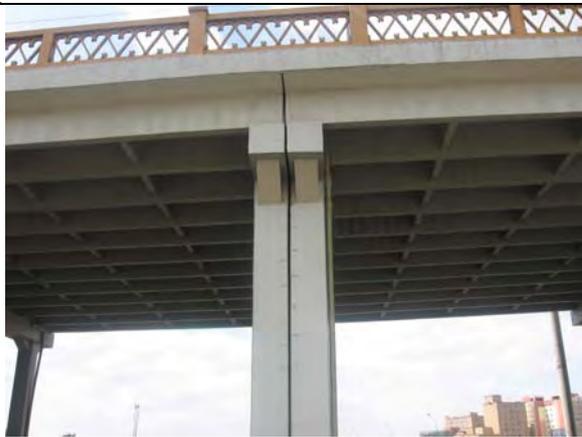
Deck slab has been coupled on the simple beam.

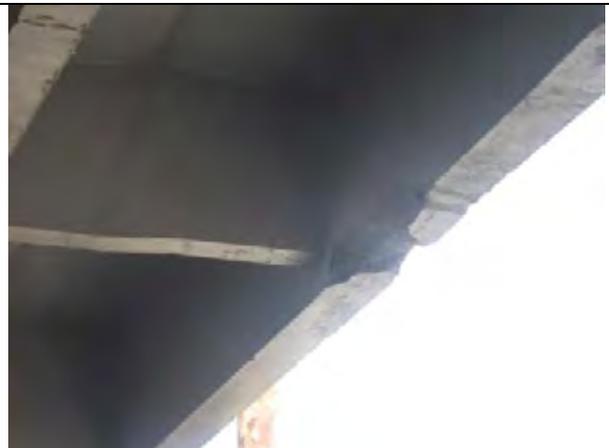
Damaged at main girder

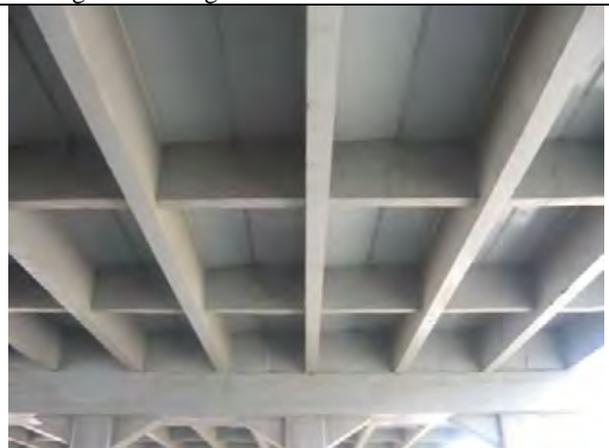
Crossing beam; there are some traces of rehabilitation. Huge deterioration has not been appeared.

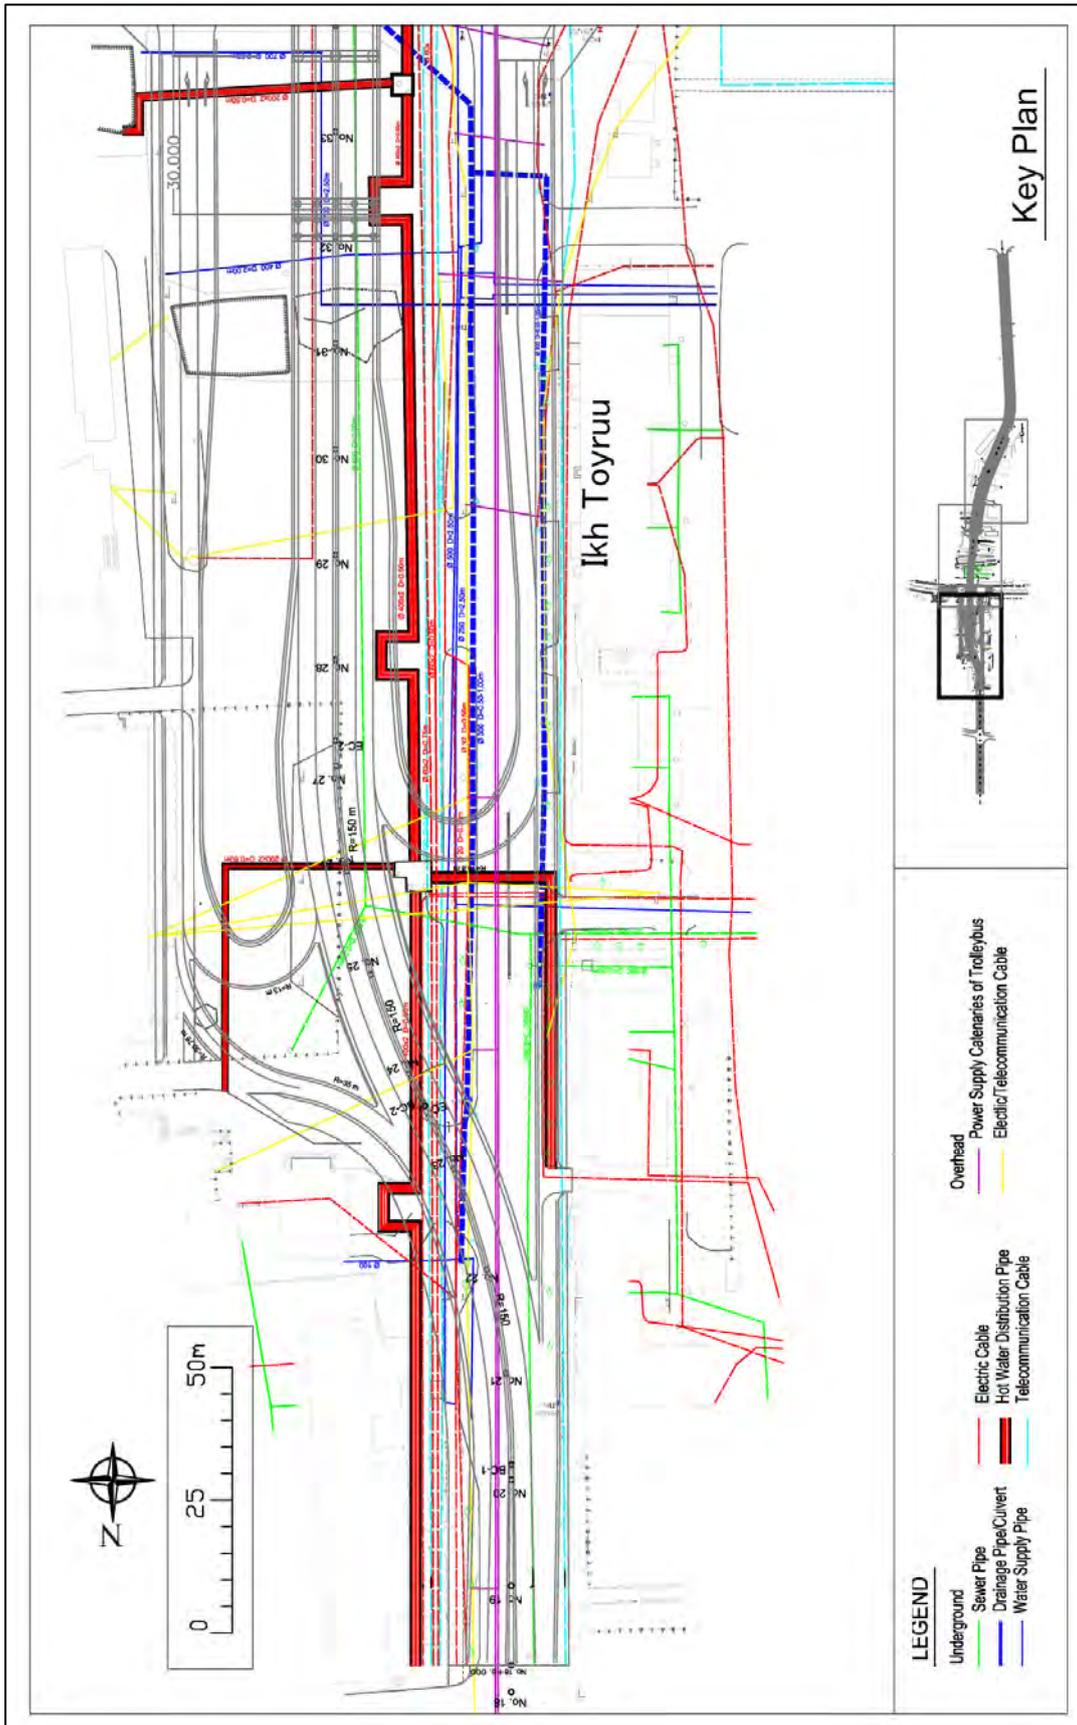
Figure 3 Location of Utilities (1/3)

Table 10 List of Utilities Affected by the Construction Works
