CHAPTER 4 EXTENT OF FLOOD DAMAGE

4.1 RIVER SYSTEM

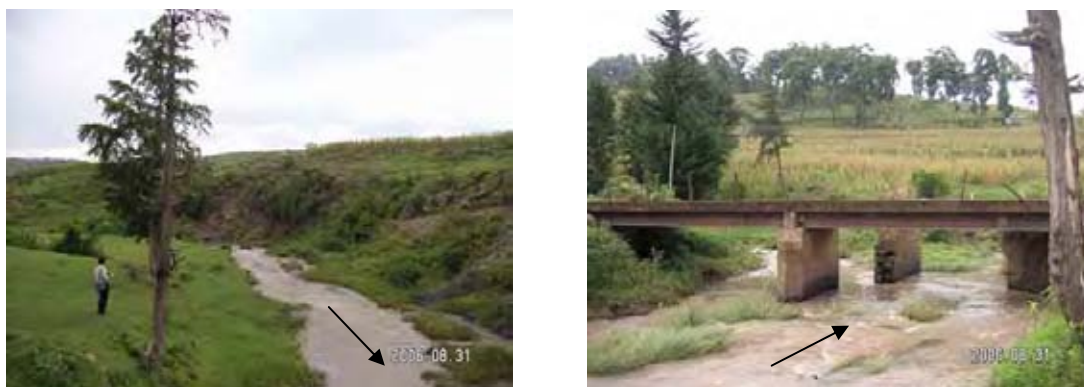
Figure 4.1.4 River Channel at Lumbwa in Upper Nyando River

The Nyando River originates in Tindaret forest in the north-eastern corner of the basin where it has a ground elevation of El.1,700 m. Passing through the forest zone toward the south, the Nyando River flows down through the mountainous area and changes its flow direction to south-westerly at Londiani. The river flows down through the V-shape valley in the upper and middle reaches of the basin for approximately 50 km collecting several small tributaries. Near Koru at the right bank, the Nyando River joins the second largest tributary, the Pararget River. The total catchment area is around 1,286 km².

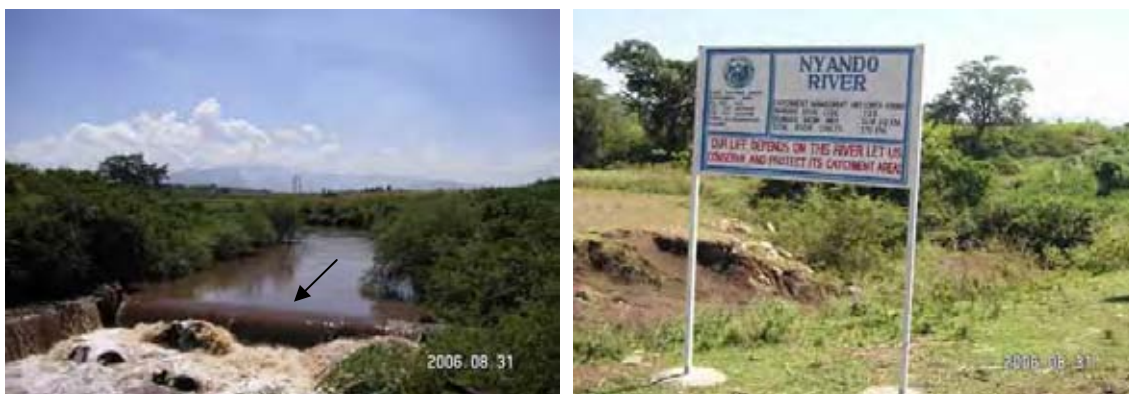
Figure 4.1.5 Intake Weir at Muhoroni (left) and Billboard at Chemeli in Middle Nyando River

The Nyando River flows down further in a westerly direction for about 30 km passing through the middle basin towards a confluence with the largest tributary, the Ainamutua River which has a catchment area of 960 km² at the right bank. The river width in this reach of the Nyando River is 20-40 m with a riverbed slope of 1/45- 1/160 on the average. (Figure 4.1.5)

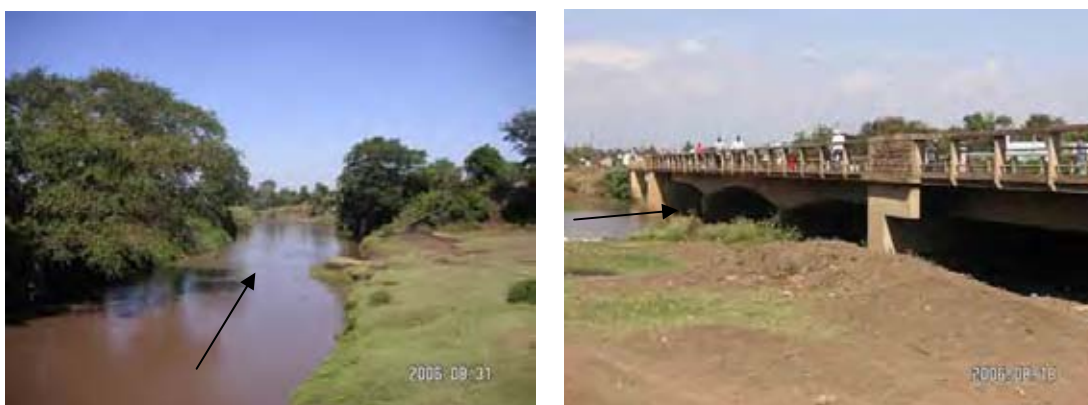
Figure 4.1.6 1GD03 Water Gauging Station (left) and Ahero Bridge in Lower Nyando River

The Nyando River has a catchment area of 2,247 km² at the confluence with the Ainamutua River where it changes its flow direction to south-westerly and reaches Ahero after flowing for about 18 km. A key water level gauging station, 1GD03, is located at the left bank at this point (Ogira) as shown in Figure 4.1.6. The catchment area at 1GD03 is 2,625 km². After passing 1GD03 station, the river flows down an extensive flood plain, and also meanders because of the gentle riverbed slope. The meandering continues to Ahero Bridge as shown in Figure 4.1.6.

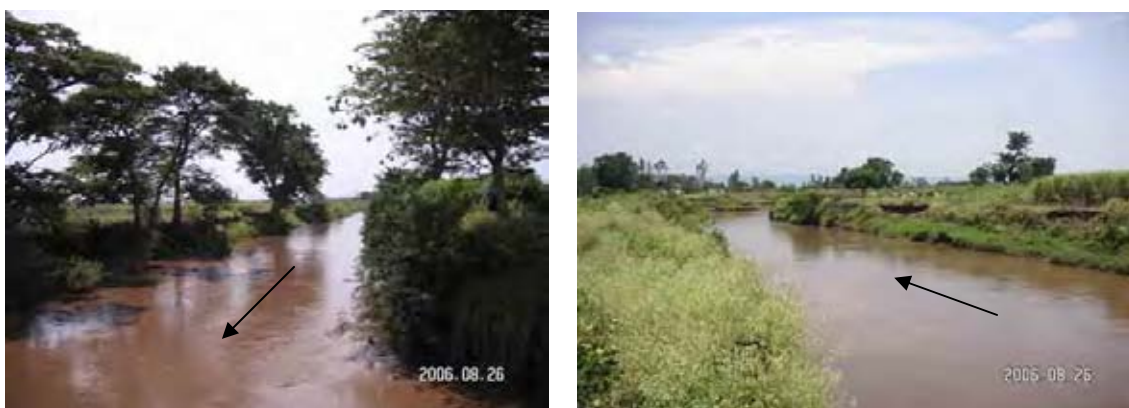
Figure 4.1.7 River Channel at Apond in Lower Nyando River

At Ahero, the river changes its flow direction to south and flows down through the low-lying area of the Kano Plain for about 10 km. In this reach, average river width and riverbed slope are around 50 m and 1/1,600, respectively. Figures 4.1.7 and 4.1.8 show the downstream stretches.

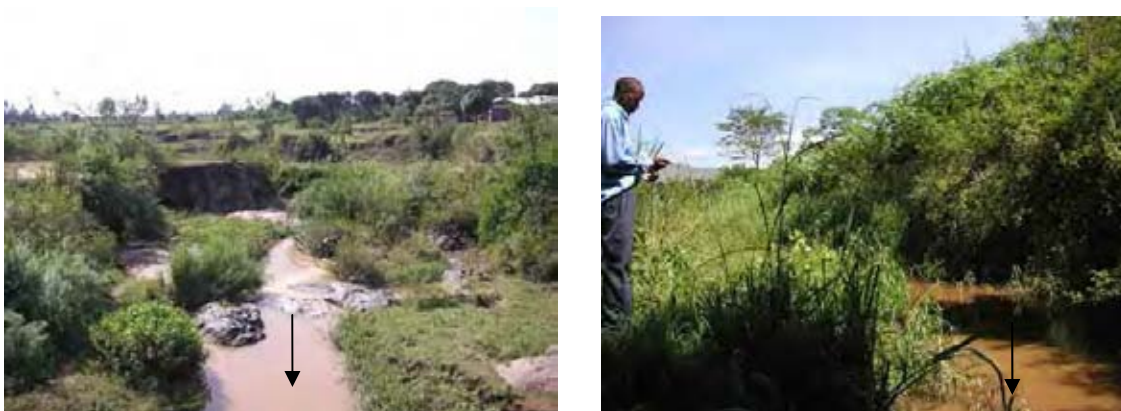
Figure 4.1.9 River Channel of Nyamasaria (left) and Oroba in Middle Reaches

The Luando, starts in the southern slopes of a hilly area of Nandi Escarpment and also reaches a swamp area. Figure 4.1.9 shows river conditions of the upper Nyamasaria and Oroba after passing through the mountains. Also Figure 4.1.10 shows the river channels in the lower reaches of Luando and Ombeyi rivers downstream of A1 trunk road.

After being temporarily retarded in the Ombeyi swamp (as illustrated in Figure 4.1.3), the flood water flows down towards Winam Gulf branching into Luando, Ombeyi and Miriu. However, during ordinary flow, it is observed that no water is flowing in the Ombeyi and Miriu due to blockage of the inlet to the swamp as shown in Figure 4.1.9.

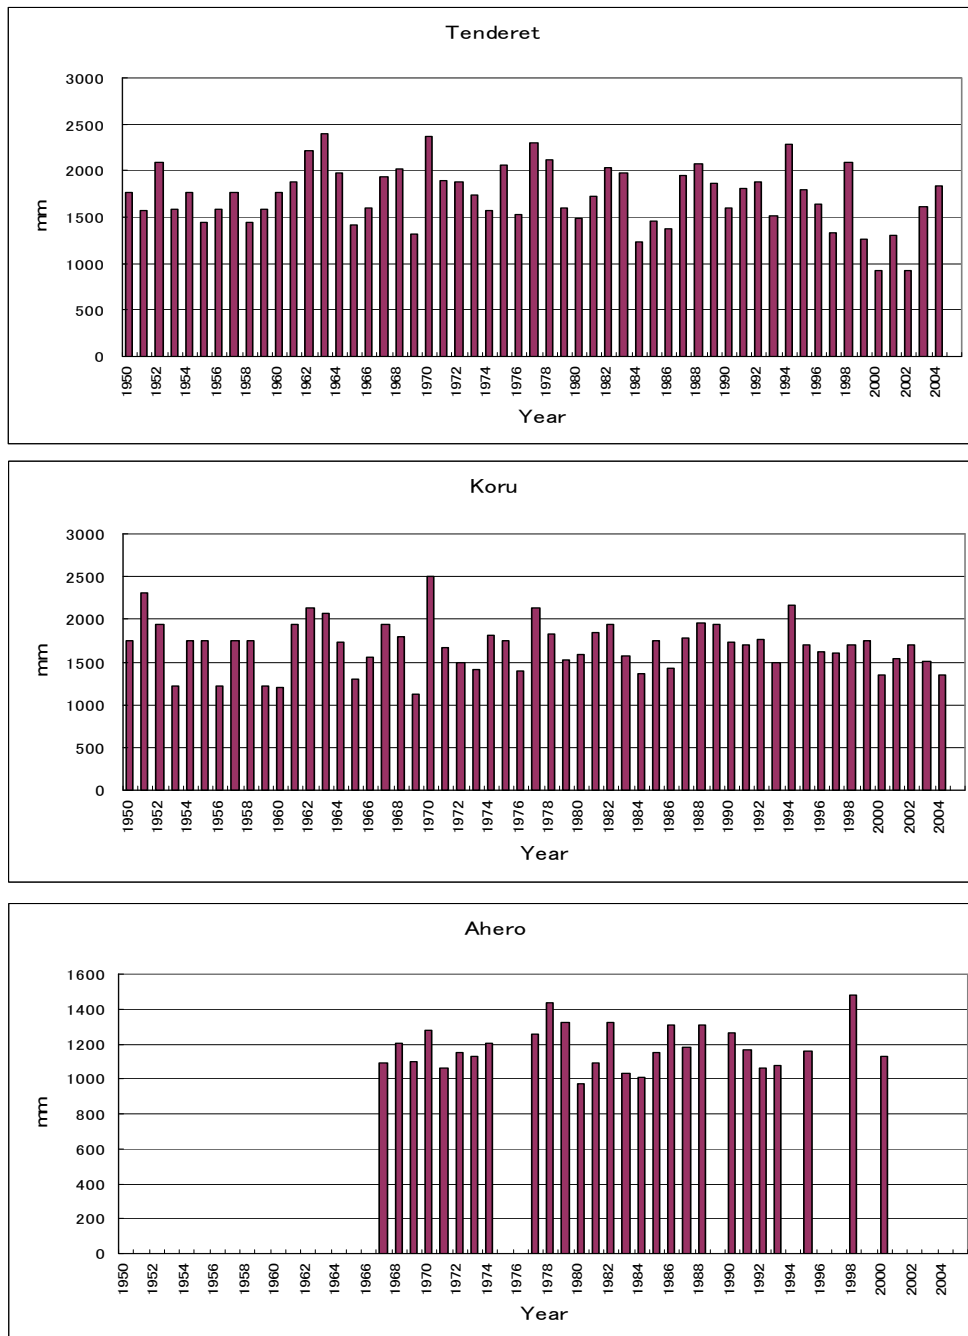
The annual rainfall varies from more than 2,500 mm in the upper basin to 1,000 mm near the lakeshore as shown in Figure 4.2.3 (showing upper to lower basin). No significant long-term trend can be recognised although large variations in annual rainfall amounts are repeatedly observed.

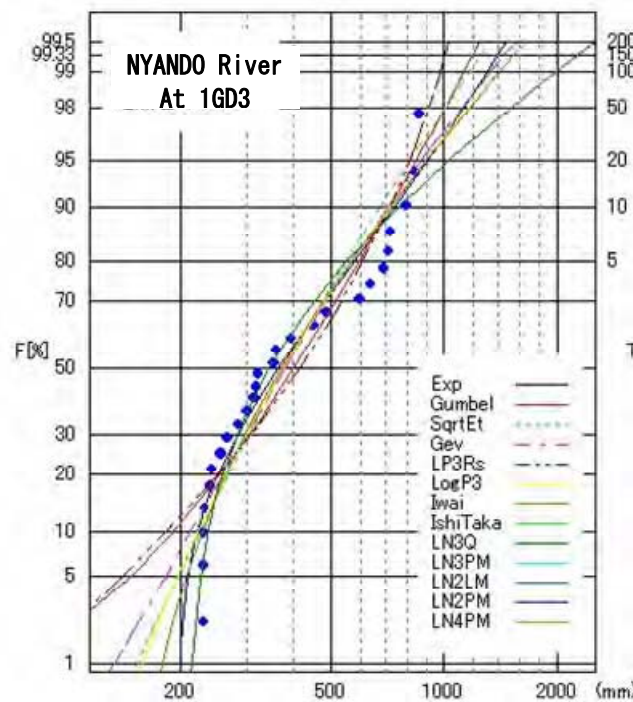
The probability analysis result for the reviewed data is illustrated in Figure 4.2.7 using several methods based on the adjusted annual maximum discharges.

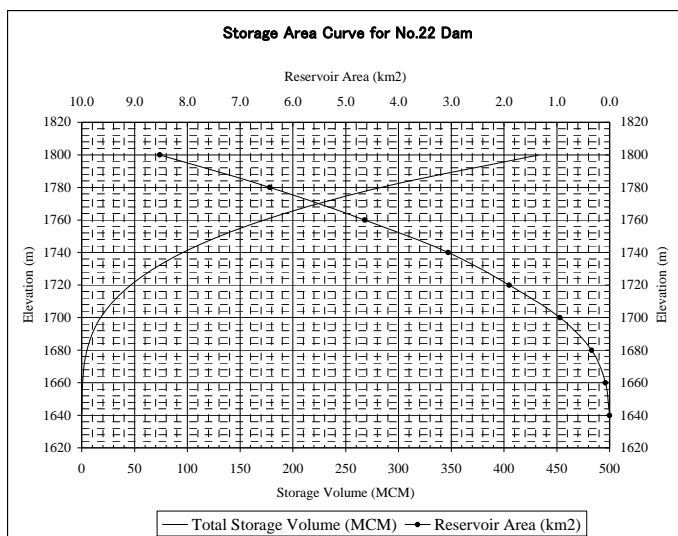
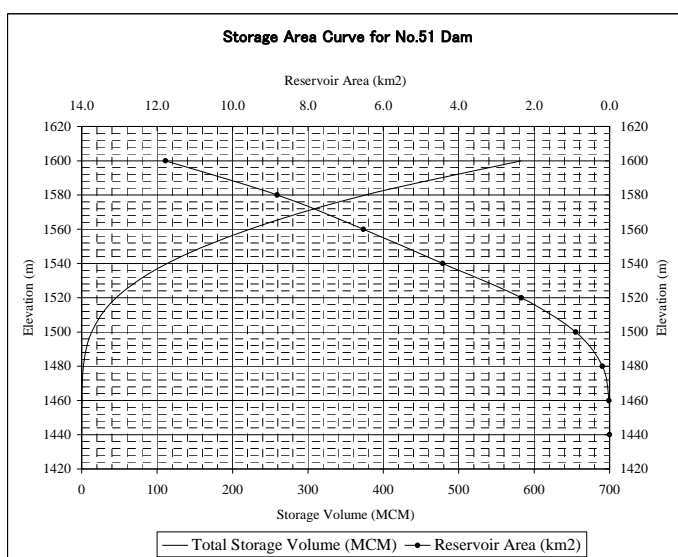
Figure 4.2.9 Storage Area Curve

In order to check peak discharge reduction by the proposed dam reservoirs, storage area curves of each proposed dam are estimated based on the 1/50,000 topographic map are presented in Figure 4.2.9.

Dam No. 11
River Name Nyando
River Bed Elevation 1400.0 El.m
Dam Height*2 100.0 m
Dam Crest Elevation 1500.0 El.m
Gross Storage Volume 0.0 MCM

Dam No. 51
River Name Kibos
River Bed Elevation 1440.0 El.m
Dam Height*1 97.0 m
Dam Crest Elevation 1537.0 El.m
Gross Storage Volume 0.0 MCM

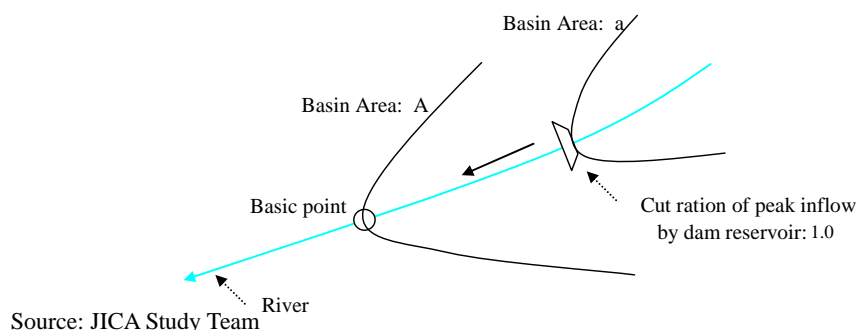
Figure 4.2.10 Explanation of Symbols in the Equation

Figure 4.2.10 illustrates the locations of the basic point, dam site and basin areas.

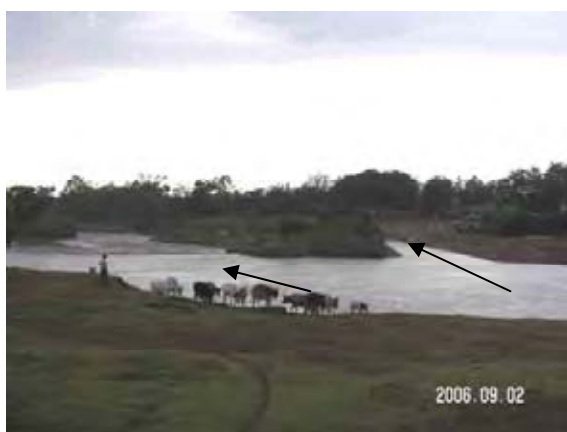
Among those, immediately downstream of Ahero bridge in the lower Nyando river basin, an intake weir which was built across the river channel exists for water intake to farmlands situated on the right bank of the Nyando River as illustrated in Figure 4.4.3.

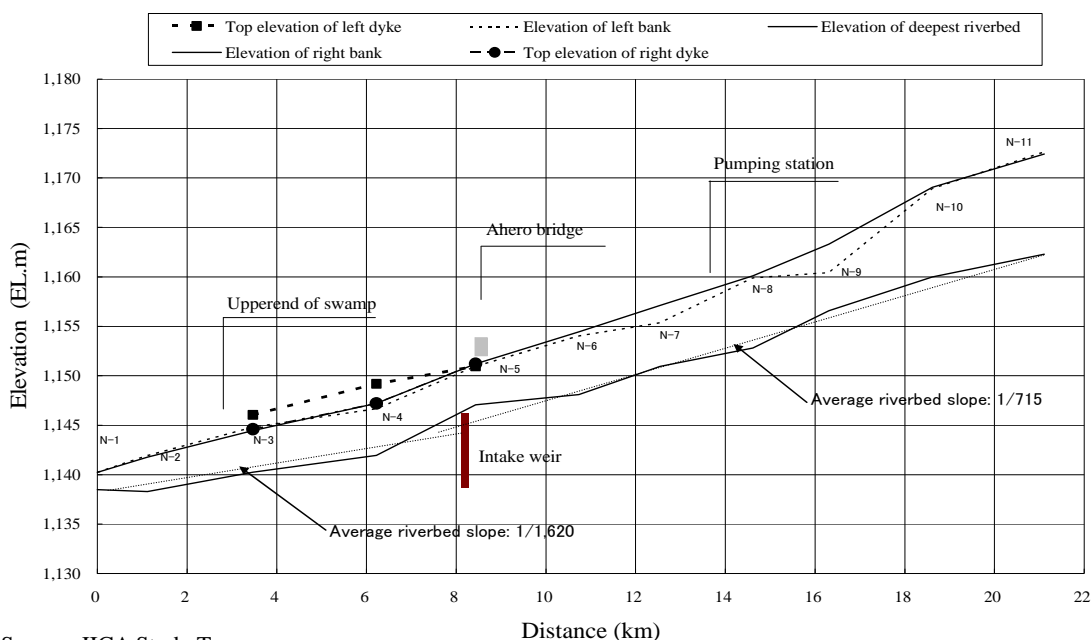
Figure 4.4.5 Longitudinal Profile of Existing Lower Nyando

Based on the cross sections surveyed, the longitudinal profile and channel cross sections were developed. The developed longitudinal profile is sketched in Figure 4.4.5 and representative cross section at N-3, in Figure 4.4.6.

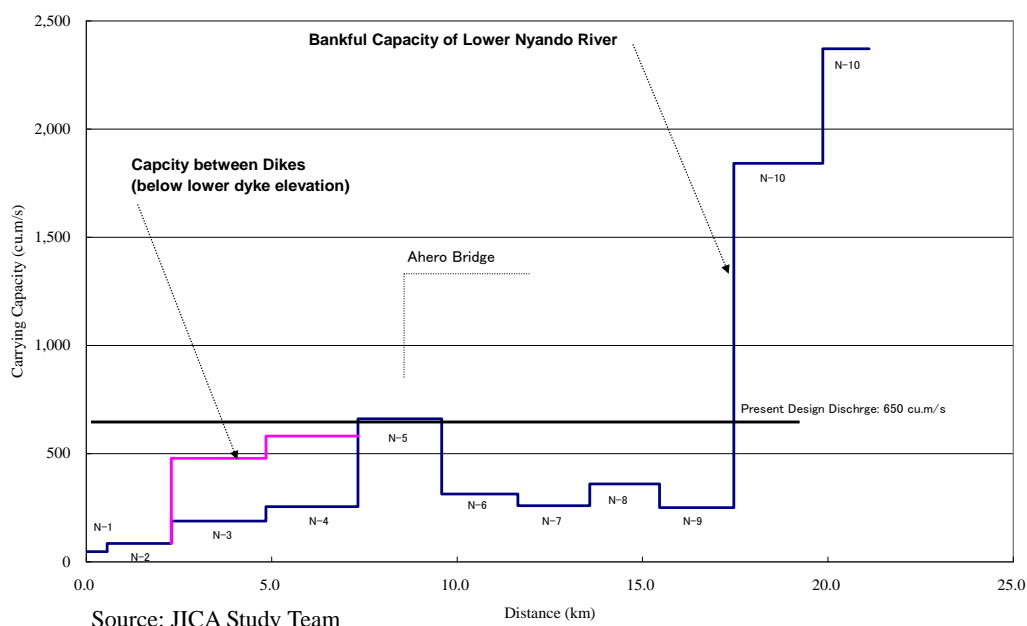
Figure 4.4.7 Channel Flow Carrying Capacity in Lower Nyando

Channel flow carrying capacities in the lower Nyando were estimated by a uniform flow method assuming a water surface gradient of 1/1,600 for the lower reaches from the intake weir downstream of Ahero Bridge and 1/700 for the upper reaches from the intake weir to the upper end and Manning’s roughness coefficient of 0.03. Figure 4.4.7 illustrates the estimated full capacity ranges from 200 to 300 m³/s. In the reaches improved by dyke construction downstream of Ahero Bridge, the capacity exceeds around 500 m³/s; however this is still less than the 650 m³/s of the current design discharge of the lower stretch of Nyando River.

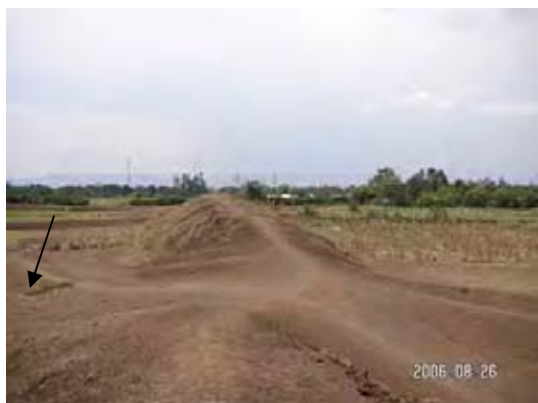
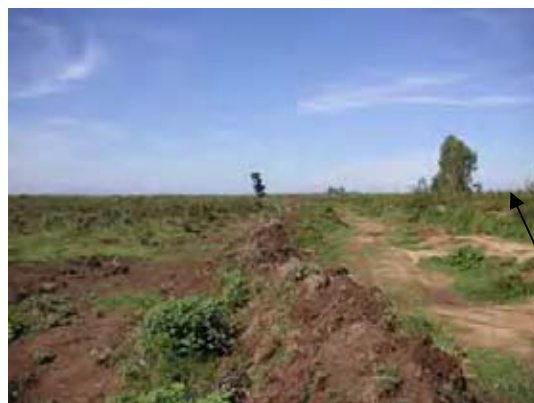
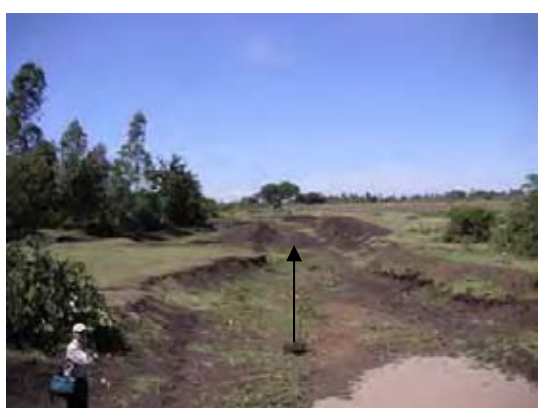
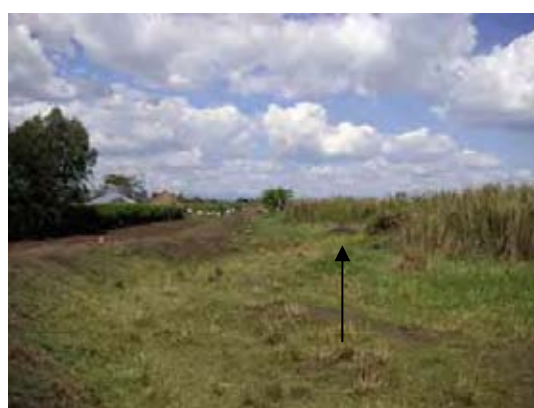
Figure 4.4.8 Present Condition of Dykes and Channels

A dyke is generally constructed using excavated earth. Therefore, earth dykes are subject to erosion and penetration by river water and can be easily damaged or destroyed. It is therefore important to consider that the earth dyke must be a tough structure with enough section or size and well compacted against flood water level and its duration. The following Figure 4.4.8 presents the existing condition of dykes and channels.

Dyke on Left Bank of Nyando

Dyke on Left Bank of Nyamasaria

River Channel of Lower Ombeyi

River Channel of Upper Miriu

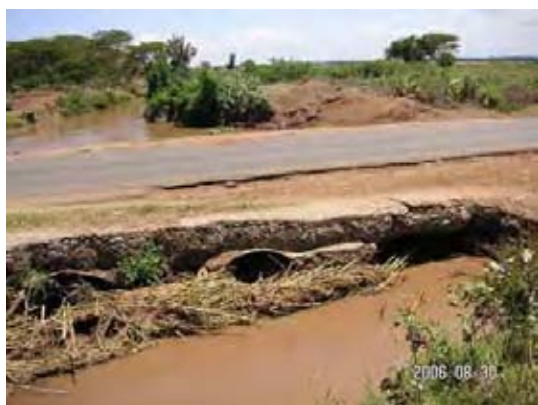
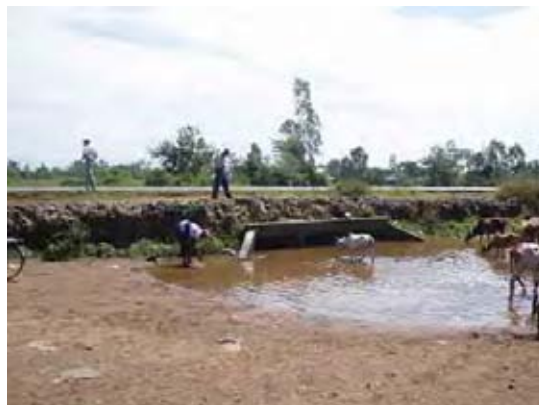
Figure 4.4.9 Present Condition of Culvert Type Bridges

Figure 4.4.9 shows present conditions of culvert type bridges on the A1 trunk road in the Awach Kano and Miriu rivers. The flow area of bridge culverts is quite small even for the normal flow rates outside the rainy season from April to May.

Culvert under A1 Trunk Road (Awach Kano R.)

Culvert under A1 Trunk Road (Miriu R.)

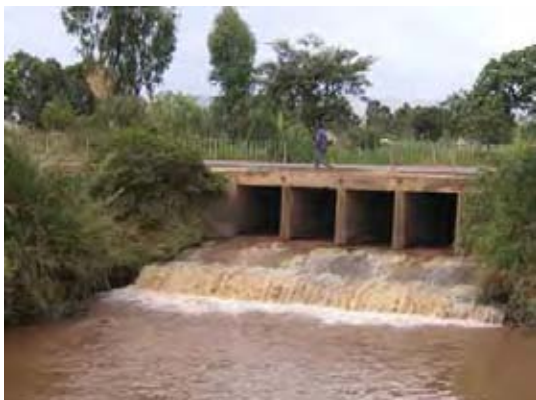
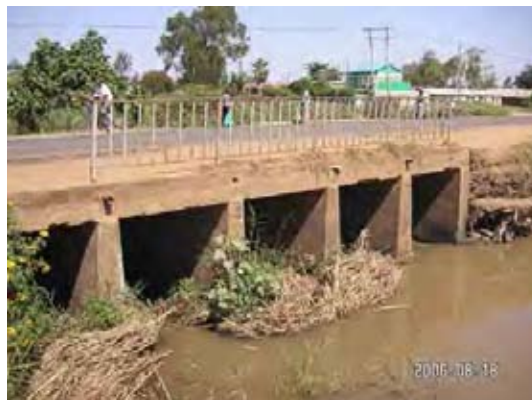
Figure 4.4.10 Present Condition of Nyamasaria Bridge

seems to be too short to work as protection of the river bank and riverbed.

Downstream view

Upstream view

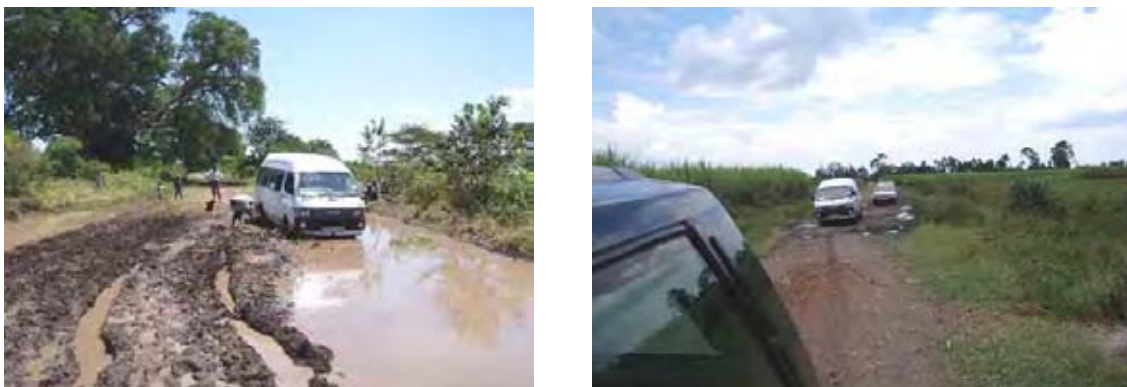
Figure 4.4.12 Condition of Local Road connecting Ombeyi and Chiga

According to the interview survey on flood damage and structures major local roads submerge frequently due to flood water in the rainy season. The main road in the inundation area is considerably important to maintain a safe evacuation route. From such viewpoint, it can be said that a fail safe concept is necessary in the severe inundation areas. The following Figure 4.4.12 shows one of the local roads that submerge in the rainy season.
