JUBA URBAN WATER SUPPLY AND CAPACITY DEVELOPMENT STUDY IN THE SOUTHERN SUDAN

FINAL REPORT (MAIN)

SEPTEMBER 2009

**TOKYO ENGINEERING CONSULTANTS CO., LTD. (TEC)
EIGHT-JAPAN ENGINEERING CONSULTANTS INC. (EJEC)**

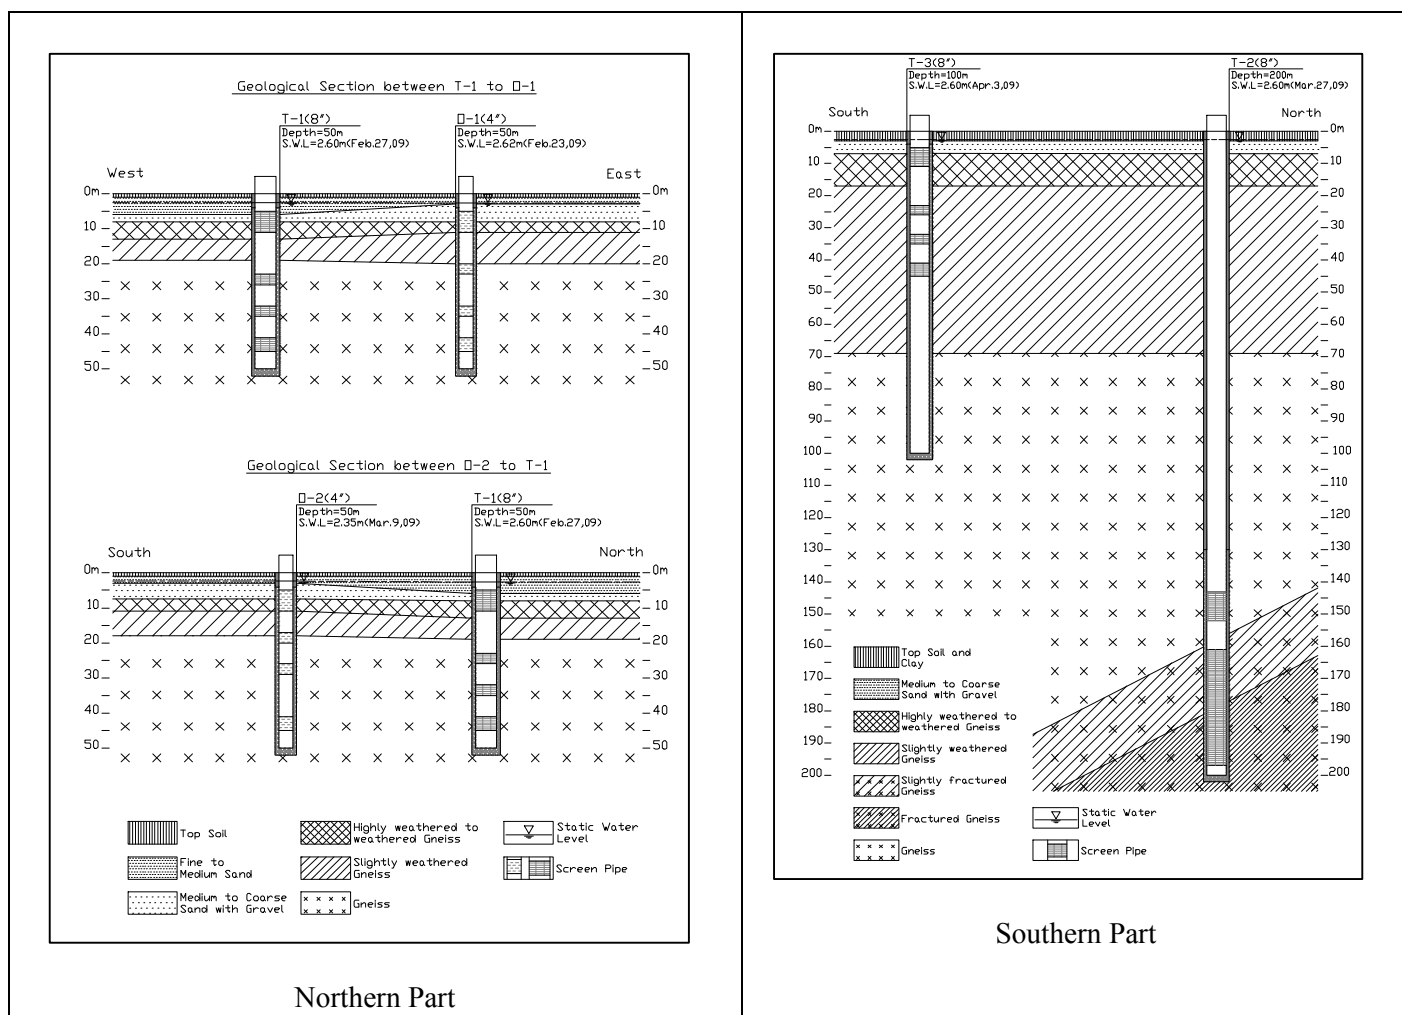
Figure 4.6 Geological Section of of Tokiman Paleochannel

The characteristic of aquifers of the site was estimated from the borehole logs of T-1, O-1 and O-2 presented in Annex A-3. Two major aquifers are identified and named as Aquifer 1 and Aquifer 2. Aquifer 1 is unconfined type and whereas Aquifer 2 is distributed in weathered zone and fracture zone of granitic gneiss.

Geological class	Geological formation	Aquifer	Groundwater
Alluvial deposit	<ul style="list-style-type: none"> • Top Soil • Fine to medium Sand • Medium to coarse Sand 	Aquifer 1	Static water level: 2.4 m-2.6 m.
Undifferentiated Gneiss Group	<ul style="list-style-type: none"> • Weathered Gneiss • Slightly weathered Gneiss 	Aquifer 2	Distributed along the boundary of Aquifer 1.
	<ul style="list-style-type: none"> • Granitic fine Gneiss • Schist (T-1 only) 		Distributed in a fracture zone

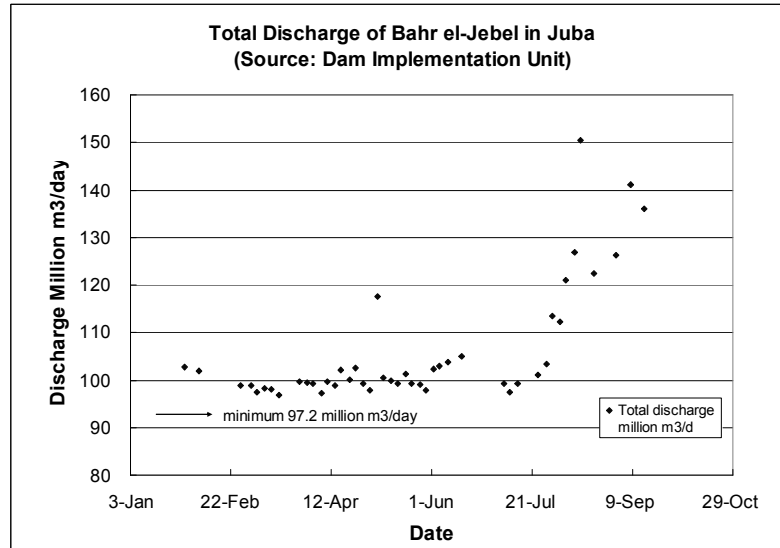
Figure 4.8 Total Discharge Rate of Bahr el-Jebel in 2008

The ADCP data collected is tabulated in Appendix-B and is shown in Figure 4.8. Table 4.13 summarizes the data of the minimum and maximum flow. The minimum and maximum flow rates during this period are 1,125 m³/s or 97.2 million m³/d and 1,742 m³/s or 150.5 million m³/d, respectively. The depth of the river ranges between 4.0 m to 6.5 m from the bed.

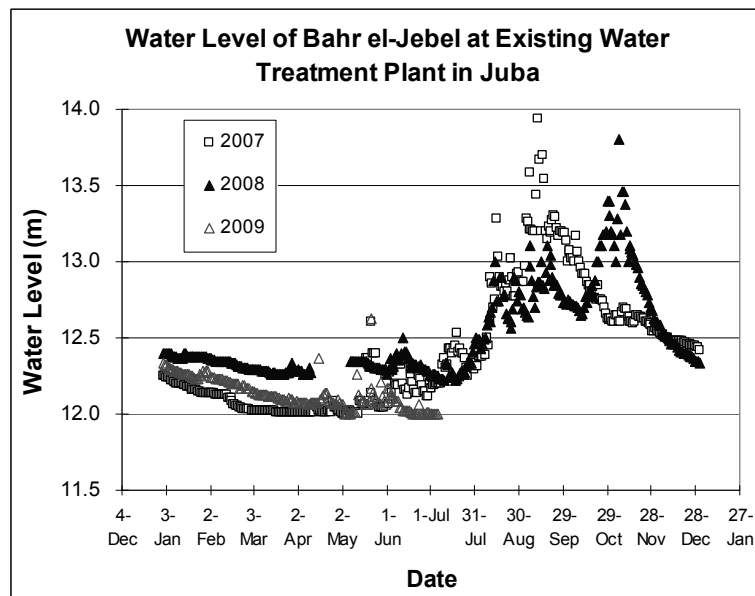
Figure 4.10 Water Level of the Bahr el-Jebel at Location near Existing Water Treatment Plant

Figure 4.10 shows the daily fluctuation of water level in 2007 to 2009. The lowest and highest water levels are approximately 12 m and 14 m, respectively. Comparing the historical water levels, the recent water levels have been declining.

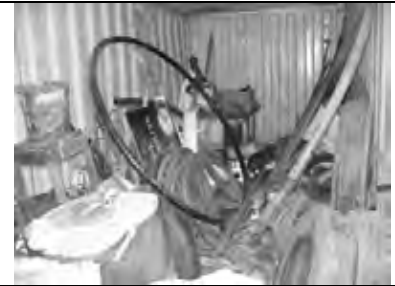
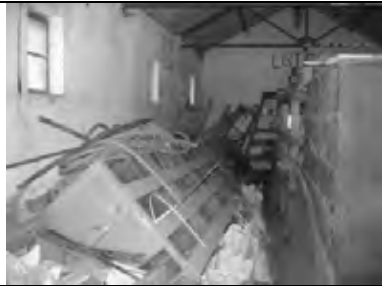
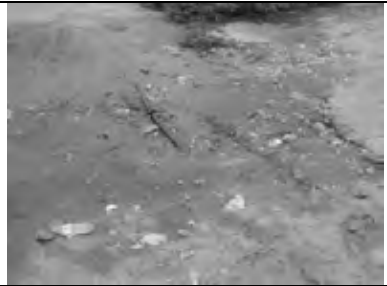
View of storage room for spare parts at WTP	Another storage for spare parts	Water supply pipelines visible on ground

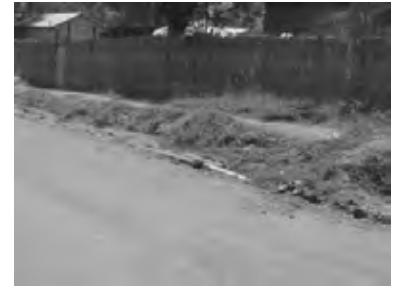
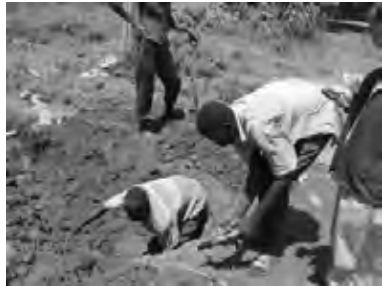
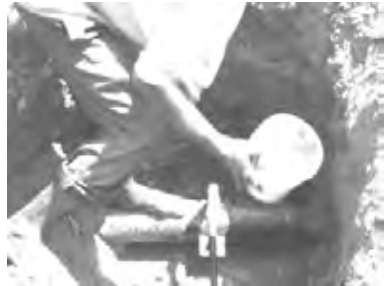
Water supply pipelines visible on ground	Leakage repair works in progress	Leakage repair works take major part of time

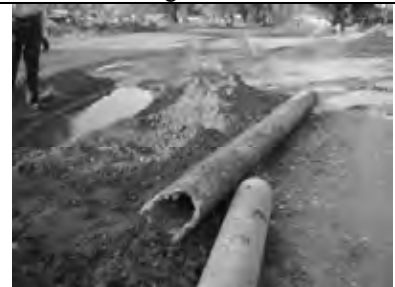
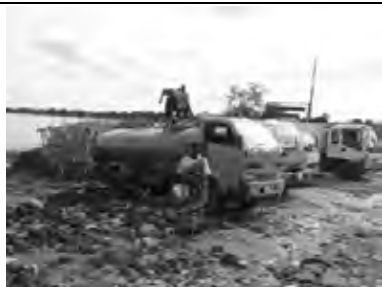
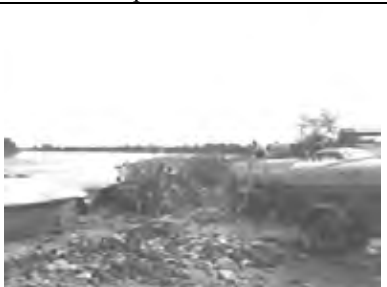
Leakage and broken pipes	Private water tanks drawing water from river	Another view of water tank filling
