## 2.4 Result of Each Pilot Project Site (Action U6 - U14)

### 1. Results of Pilot Project in Pilot Project Site-1 (Zagazig East)

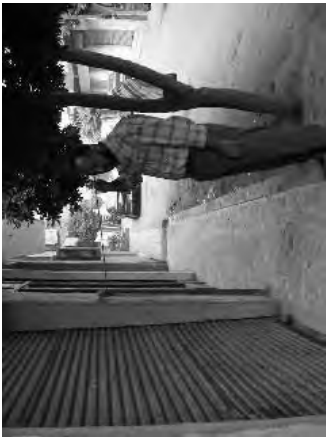
**Figure 1-1 Detecting Leakage on House Connection by Acoustic Rod**

When leakage occurs, leaking sound spreads through the pipe. At the point where valves are available, acoustic rod or digital sound detector was useful for detecting the sound. The method of leaking sound detection is shown on Figure 1-1.

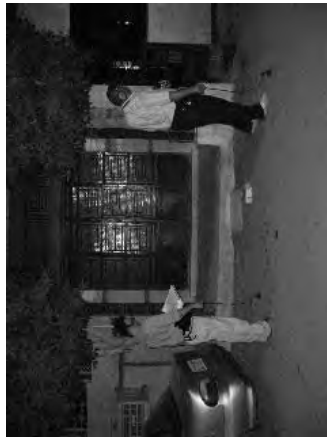
**Figure 1-2 Detection Work by Leak Detector**

To detect the leakage on the distribution pipeline, the leak detector was used. The leak detection activity using the leak detector is shown in Figure 1-2. It was helpful to confirm the location of the leakage by night survey to isolate the background noise caused by traffic during daytime.

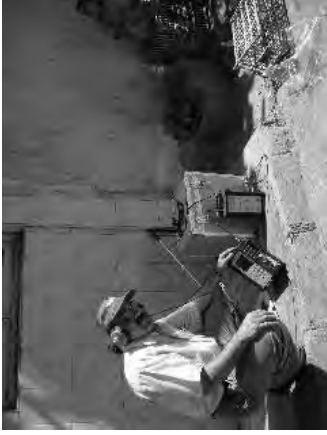
**Figure 1-3 Leak Sound Correlator**

Leak Sound Correlator was applied to confirm the leaking point when leak sound is detected in two points. This equipment identifies the location of leaks by intercepting leak noise that is caught by a sensor at two valves or hydrants. It measures the difference in transmission time between two points, and processes the data by computer. Thus, it exactly shows the leaking point. The following figure shows the use of leak sound correlator in the activity area.

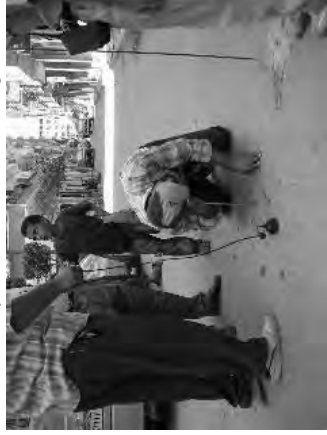
**Figure 1-4 Method of Confirming Exact Location of Leak Point**

After detecting leak point, some holes were drilled at the detected leak points and acoustic rod was inserted in the hole to confirm the exact location of the leak point. This method is very useful especially in paved roads to make the decision of excavation in paved road worth. Figure 1-4 shows the confirmation of leaks when found by acoustic rod drilled in the ground.

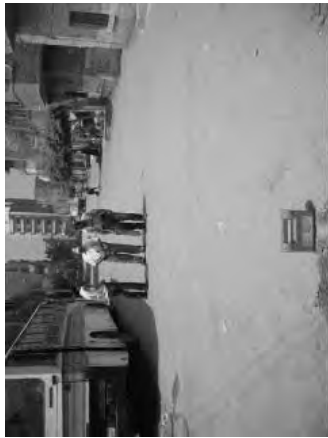
**Figure 1-5 Pipe & Cable Locator**

This device was used for locating pipes and cables under the ground.

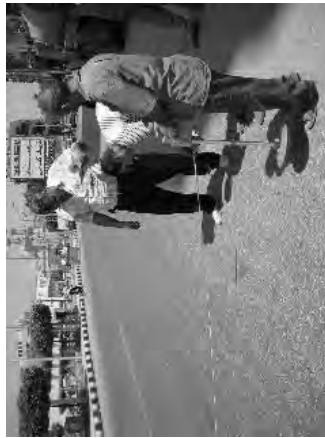
**Figure 1-6 Metal Locator**

A sensor of this device detects the location of hidden iron-made structures such as valve boxes and stop valves. In some locations, the asphalt paving covered the surface box of the valves and the cover of the valve chambers. The use of metal locator has led to the detection and relocation of these iron-made structures.

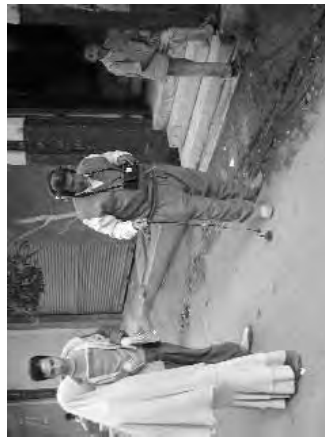
**Figure 2-2 Detection Work by Leak Detector in Hihya A-2**

To detect the leakage on the distribution pipeline, the leak detector was used. The leak detection activity using the leak detector is shown in Figure 2-2. It was helpful to confirm the location of the leakage by night survey to isolate the background noise caused by traffic during daylight.

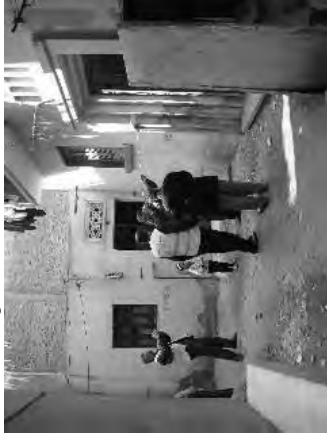
**Figure 3-1 Detecting Leakage on House Connection by Acoustic Rod in Zagazig west A-3**

When leakage occurs, leaking sound spreads through the pipe. At the point where valves are available, acoustic rod or digital sound detector was useful for detecting the sound. The method of leaking sound detection is shown on Figure 3-1.

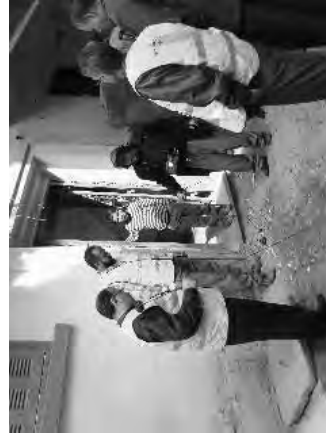
**Figure 3-2 Detection Work by Leak Detector in Zagazig west A-3**

To detect the leakage on the distribution pipeline, the leak detector was used. The leak detection activity using the leak detector is shown in Figure 3-2. It was helpful to confirm the location of the leakage by night survey to isolate the background noise caused by traffic during daylight.

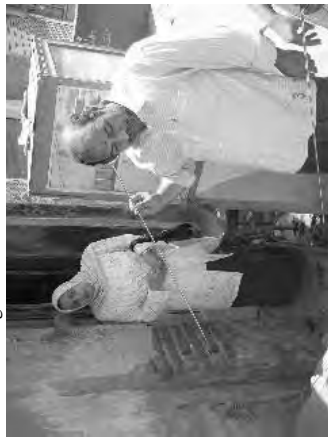
**Figure 4-1 Detecting Leakage on House Connection by Acoustic Rod**

When leakage occurs, leaking sound spreads through the pipe. At the point where valves are available, acoustic rod or digital sound detector was useful for detecting the sound. The method of leaking sound detection is shown on Figure 4-1.

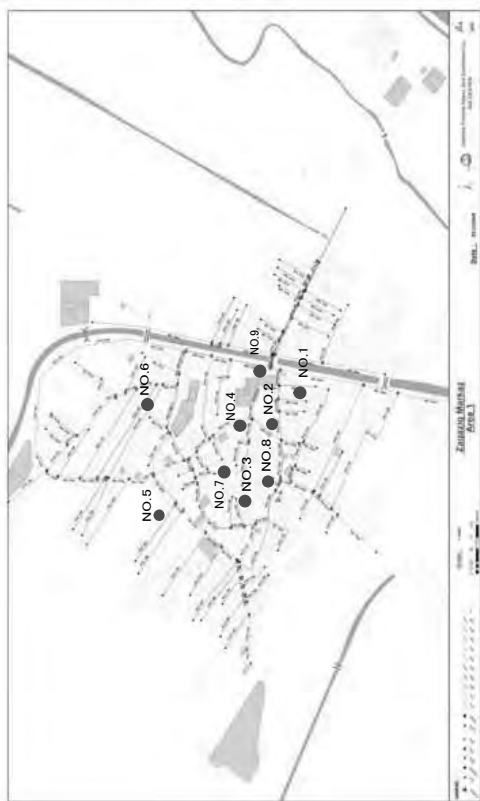
**Figure 4-2 Location of detected leaks in Zagazig Markaz Area-1**

The location of detected leaks is shown as following figure.

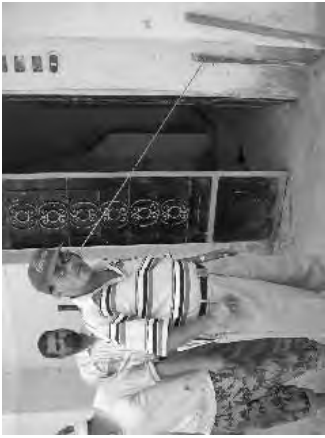
**Figure 5-1 Detecting Leakage on House Connection by Acoustic Rod**

When leakage occurs, leaking sound spreads through the pipe. At the point where valves are available, acoustic rod or digital sound detector was useful for detecting the sound. The method of leaking sound detection is shown on Figure 5-1.

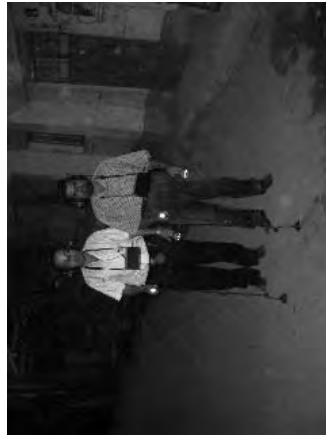
**Figure 5-2 Detection Work by Leak Detector**

To detect the leakage on the distribution pipeline, the leak detector was used. The leak detection activity using the leak detector is shown in Figure 5-2. It was helpful to confirm the location of the leakage by night survey to isolate the background noise caused by traffic during daytime.

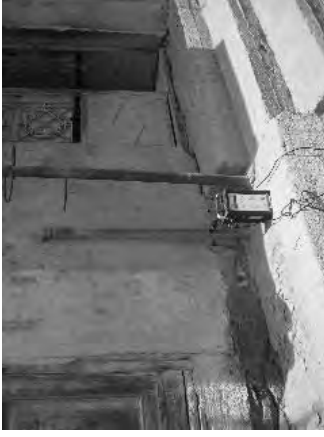
**Figure 5-3 Leak Sound Correlator**

Leak Sound Correlator was applied to confirm the leaking point when leak sound is detected in two points. This equipment identifies the location of leaks by intercepting leak noise that is caught by a sensor at two valves or hydrants. It measures the difference in transmission time between two points, and processes the data by computer. Thus, it exactly shows the leaking point. The following figure shows the use of leak sound correlator in the activity area.

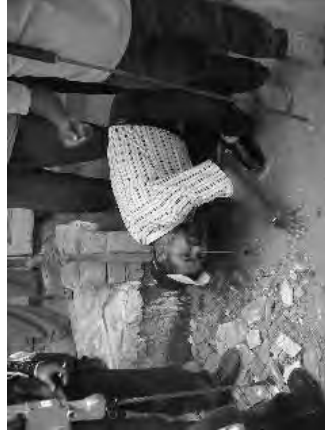
**Figure 5-4 Method of Confirming Exact Location of Leak Point**

After detecting leak point, some holes were drilled at the detected leak points and acoustic rod was inserted in the hole to confirm the exact location of the leak point. This method is very useful especially in paved roads to make the decision of excavation in paved road worth. Figure 5-4 shows the confirmation of leaks when found by acoustic rod drilled in the ground.

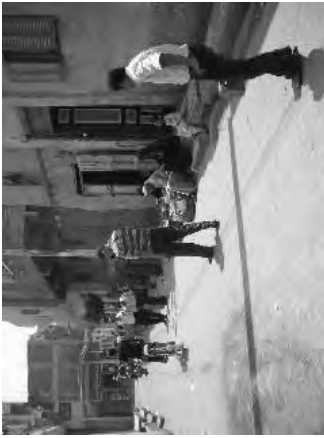
**Figure 5-5 Pipe & Cable Locator**

This device was used for locating pipes and cables under the ground.

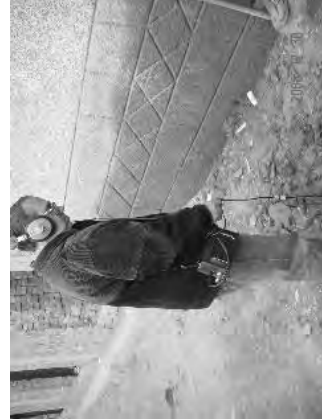
Figure 6-2 Detection Work by Leak Detector

To detect the leakage on the distribution pipeline, the leak detector was used. The leak detection activity using the leak detector is shown in Figure 6-2. It was helpful to confirm the location of the leakage by night survey to isolate the background noise caused by traffic during daytime.

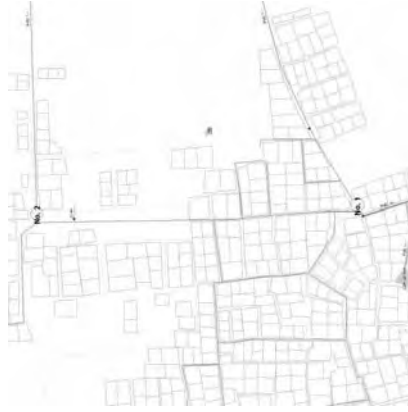
**Figure 6-3 Location of detected leaks in Diarb Nigm Markz Area-2**

The location of detected leaks is shown as following figure.

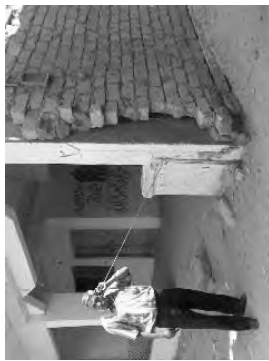
**Figure 7-1 Detecting Leakage on House Connection by Acoustic Rod**

When leakage occurs, leaking sound spreads through the pipe. At the point where valves are available, acoustic rod or digital sound detector was useful for detecting the sound. The method of leaking sound detection is shown on Figure 7-1.

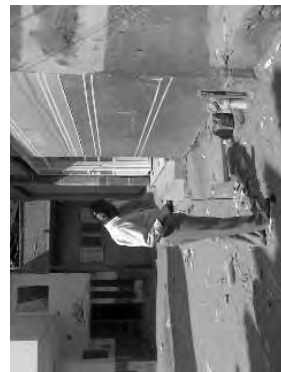
**Figure 7-2 Detection Work by Leak Detector**

To detect the leakage on the distribution pipeline, the leak detector was used. The leak detection activity using the leak detector is shown in Figure 7-2. It was helpful to confirm the location of the leakage by night survey to isolate the background noise caused by traffic during daytime.

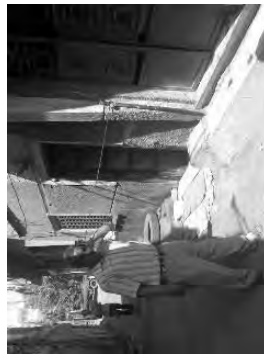
Figure 8-1 Detecting Leakage on House Connection by Acoustic Rod

When leakage occurs, leaking sound spreads through the pipe. At the point where valves are available, acoustic rod or digital sound detector was useful for detecting the sound. The method of leaking sound detection is shown on Figure 8-1.

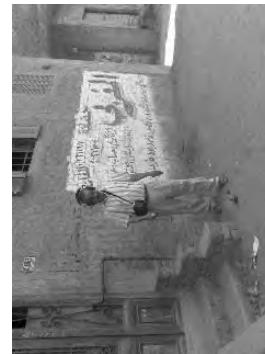
Figure 8-2 Detection Work by Leak Detector

To detect the leakage on the distribution pipeline, the leak detector was used. The leak detection activity using the leak detector is shown in Figure 8-2. It was helpful to confirm the location of the leakage by night survey to isolate the background noise caused by traffic during daytime.

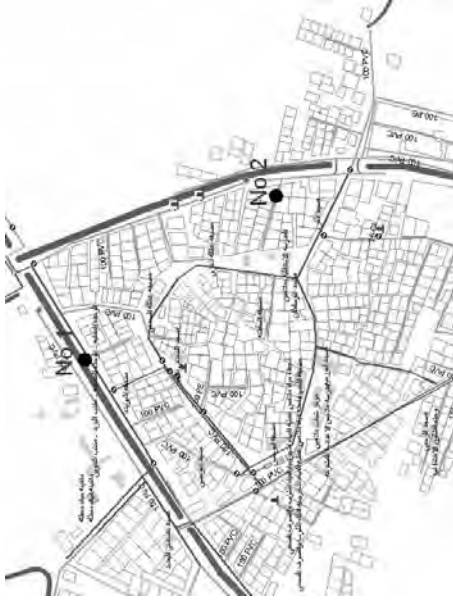
**Figure 8-3 Location of detected leaks in Minia Alqamah Markz Area-3**

The location of detected leaks is shown as following figure.

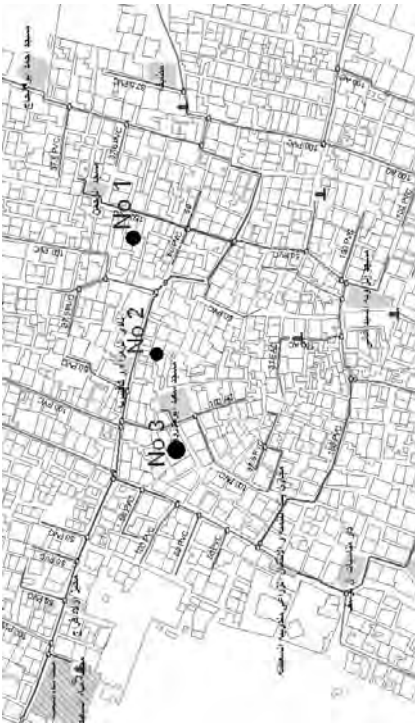
**Figure 9-3 Location of detected leaks in Bilbais Markz Area-4**

The location of detected leaks is shown as following figure.

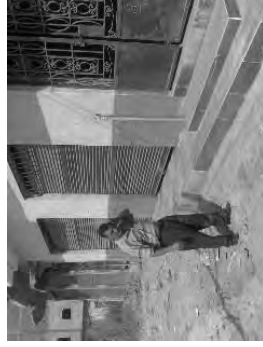
**Figure 10-1 Detecting Leakage on House Connection by Acoustic Rod**

When leakage occurs, leaking sound spreads through the pipe. At the point where valves are available, acoustic rod or digital sound detector was useful for detecting the sound. The method of leaking sound detection is shown on Figure 10-1.

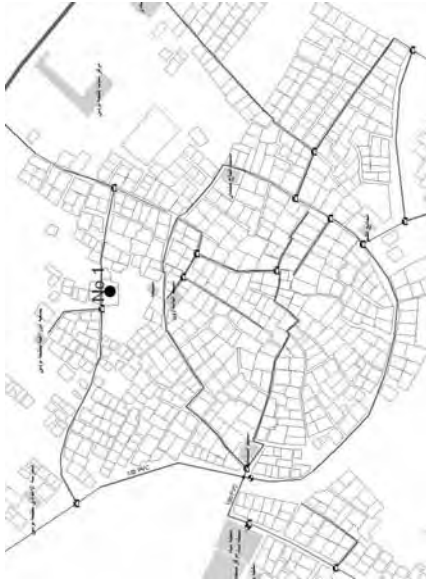
**Figure 10-3 Location of detected leaks in Zagazig Markz Area-5**

The location of detected leaks is shown as following figure.

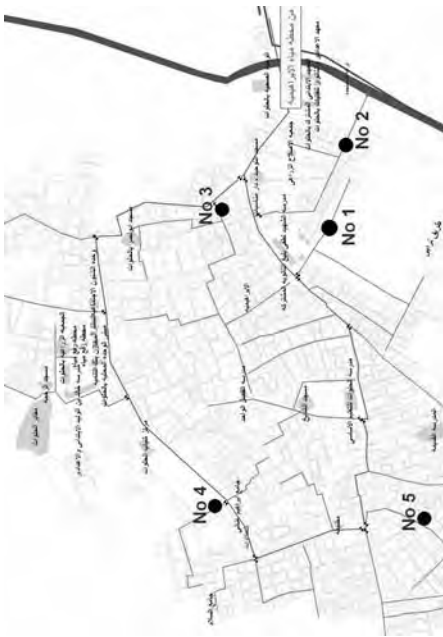
Figure 11-3 Location of detected leaks in Ibrahimia Markaz Area-2

The location of detected leaks is shown as following figure.
