5.4.3 Local Geology

5.4.4 Results of Geo Investigation

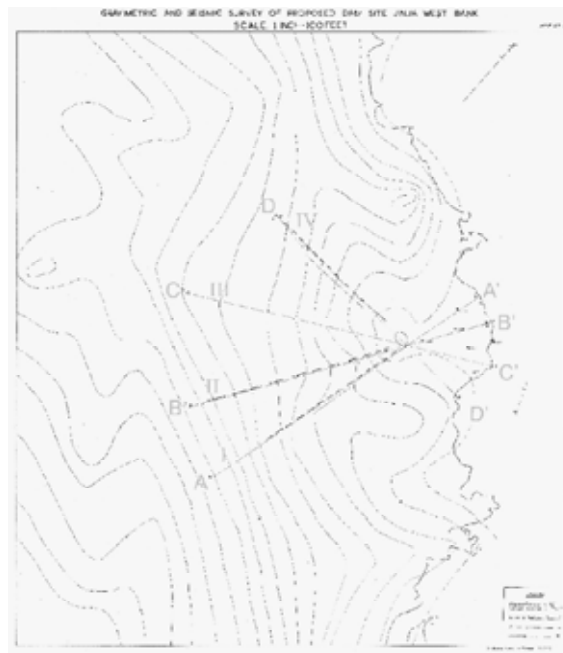
Gravimetric and seismic surveys had been performed on the west bank of the River Nile as a part of the geological surveys for the dam site. Figure 5.4.5 shows the locations of survey lines. The results of the surveys were compiled into geological cross sections along with results of drillings on the west bank. Figure 5.4.6 collects the speculated geological sections. The notable point understood from these sections is the uniformity in thickness of soil and decomposed layers overlying fresh Amphibolite. Except around the river bank, soil and decomposed layers were speculated to be distributed with nearly-constant thickness, in other words, the top surface of fresh Amphibolite was expected to emerge at roughly the same elevation everywhere in the surveyed area, although it is assumed to have certain ranges of unforeseeable undulation.

Figure 5.4.5 Survey Lines of Gravimetric and Seismic Surveys

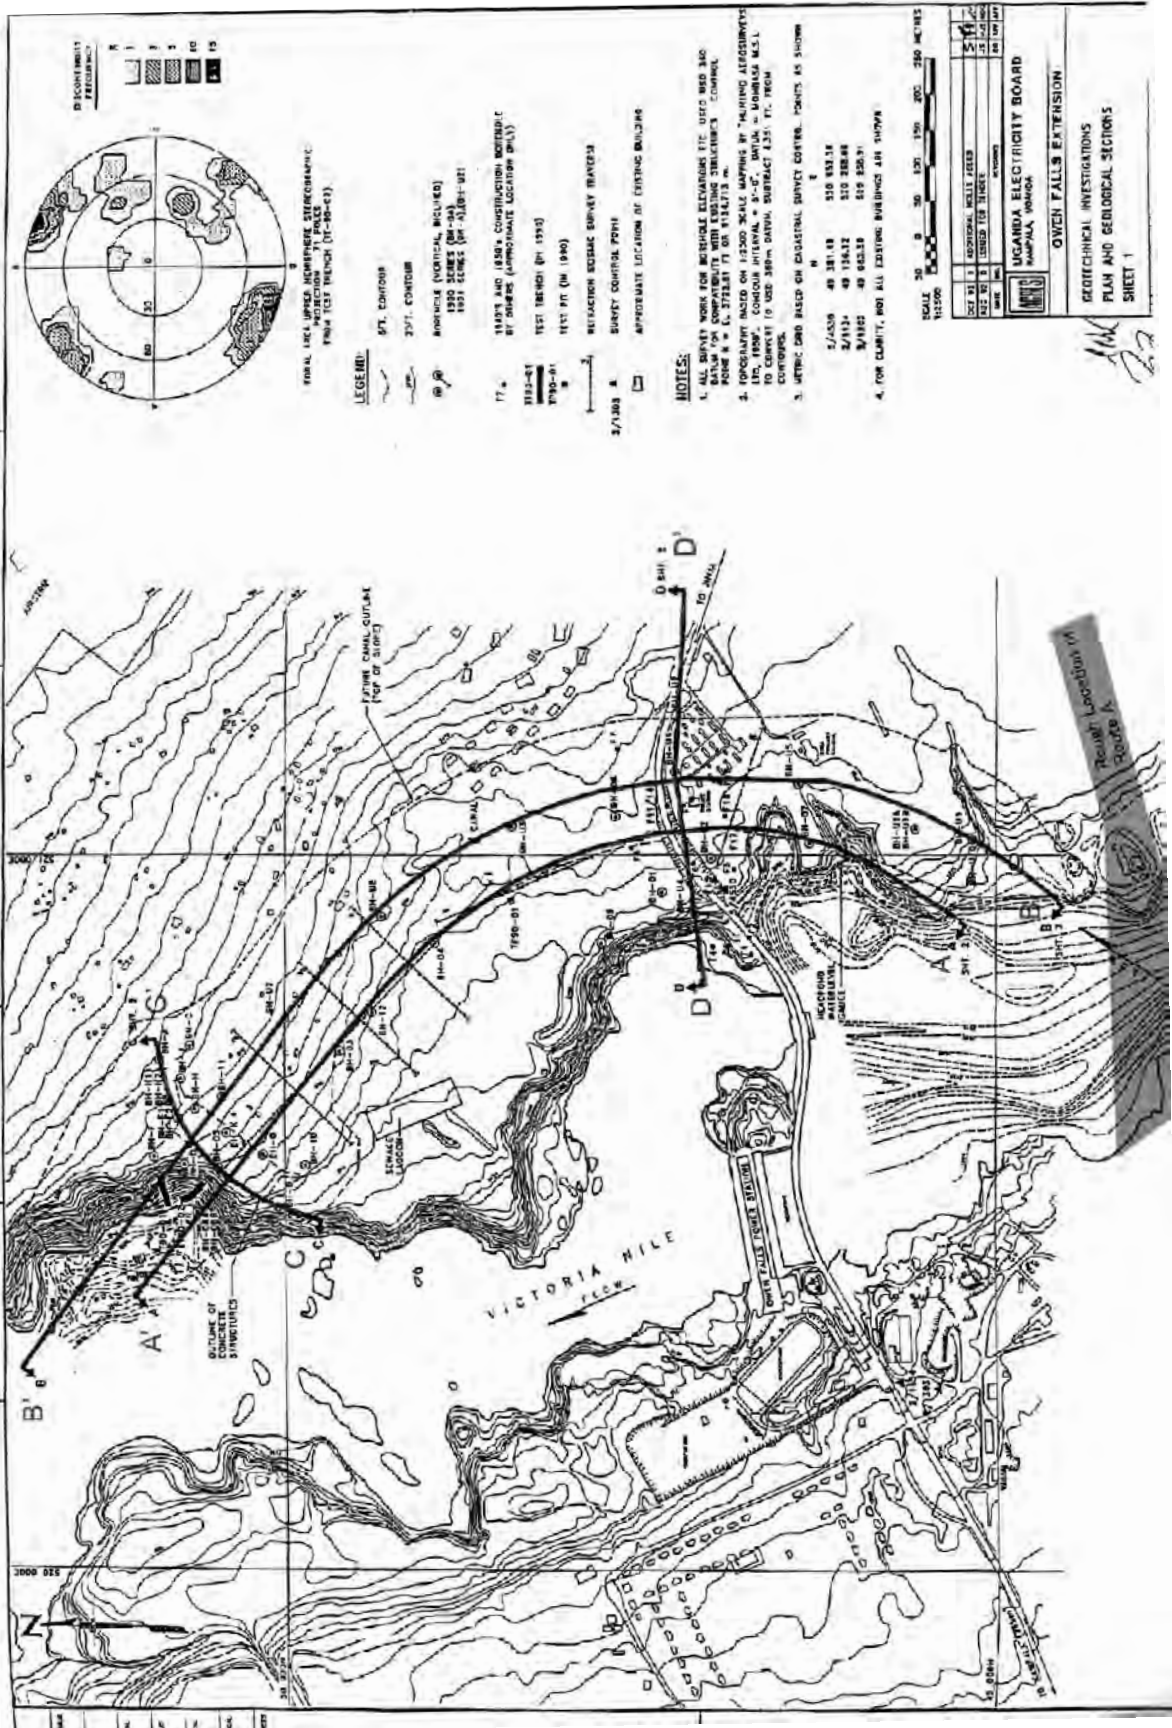
The Ugandan Electricity Generation Company Ltd (UEGCL) provided 4 geological sections which run along and cross the planned (and possibly realized) course of the Kiira Canal. Figure 5.4.7 shows the locations of geological sections which are summarised in Figure 5.4.8. Additional interpretations were added on Figure 5.4.8.

Figure 5.4.7 Survey Lines of Geological Sections for the Construction of the Kiira Canal

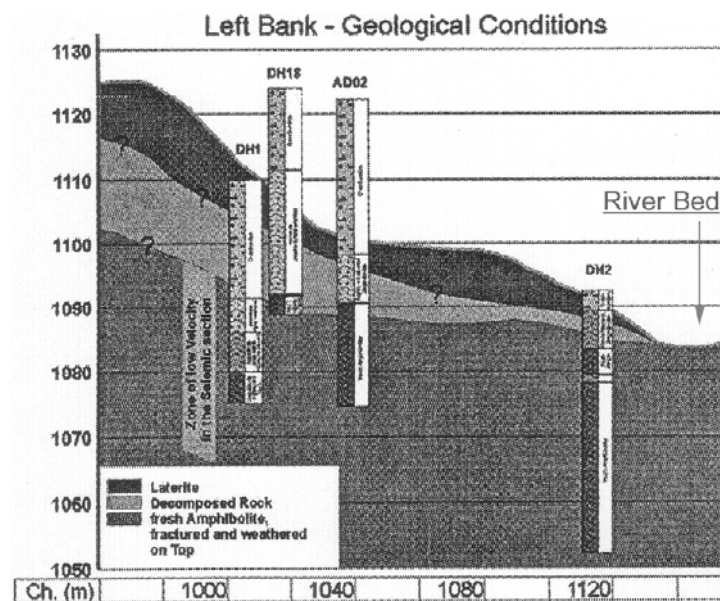
Figure 5.4.9 speculates the geological condition at the left bank of Bujagali Dam.

Figure 5.4.9 Geological Conditions at the Left Bank of Bujagali Dam (currently under construction)

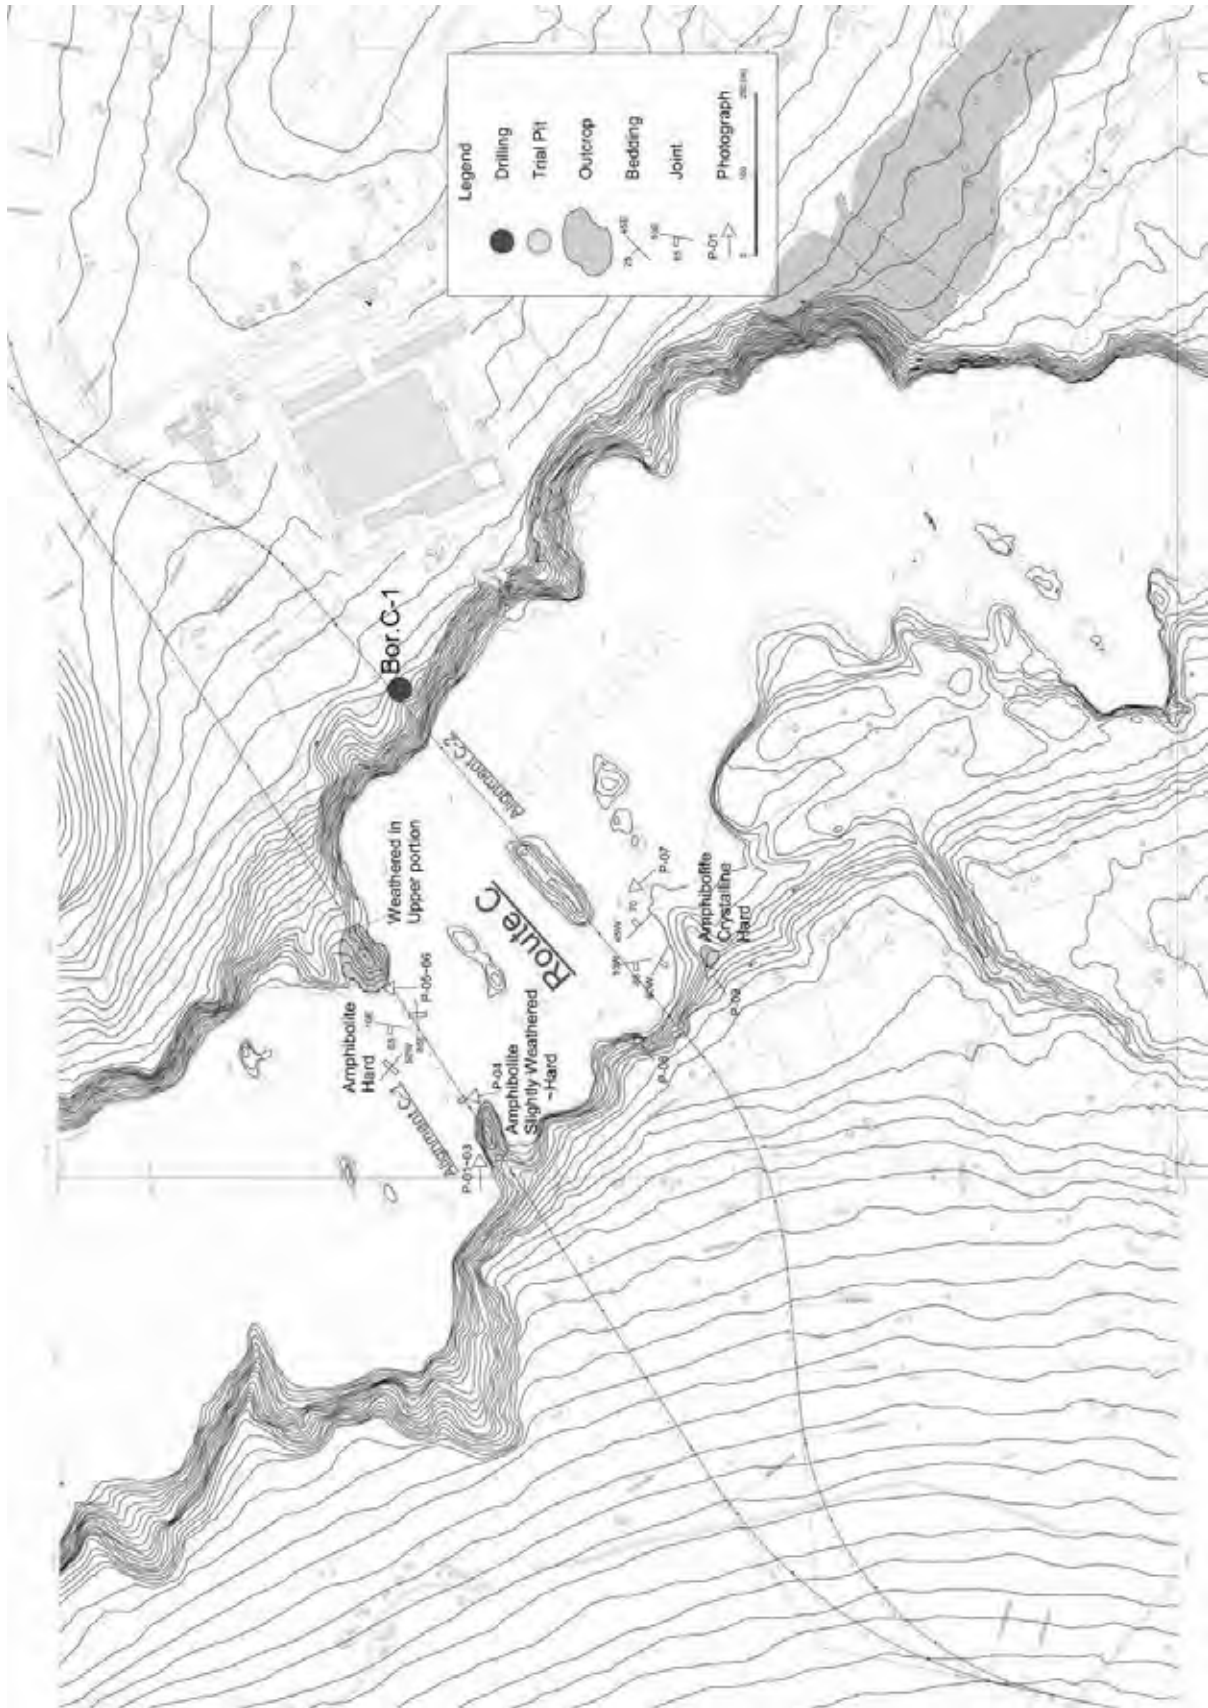
Prior to the drilling investigation, a geological reconnaissance of the site was performed. The results of the reconnaissance are shown in Figures 5.4.10 and 5.4.11.

Figure 5.4.11 Route Map and the Locations of Investigation

The locations of drilling investigations are shown in Figures 5.4.10 and 5.4.11. Drilling investigation was executed by 2 different types of drill rig, due to the limited capabilities of drill rigs available in Uganda at the time of the study. A wire-line type drill rig which was incapable of performing a Standard Penetration Test (SPT) was mobilised to obtain core sample, whereas a drill rig which is specialized in performing SPT was mobilised to carry out the investigation. Thus 2 drilling logs for each investigated site were prepared. Drilling logs and photos of core boxes are organized in Appendix 4.

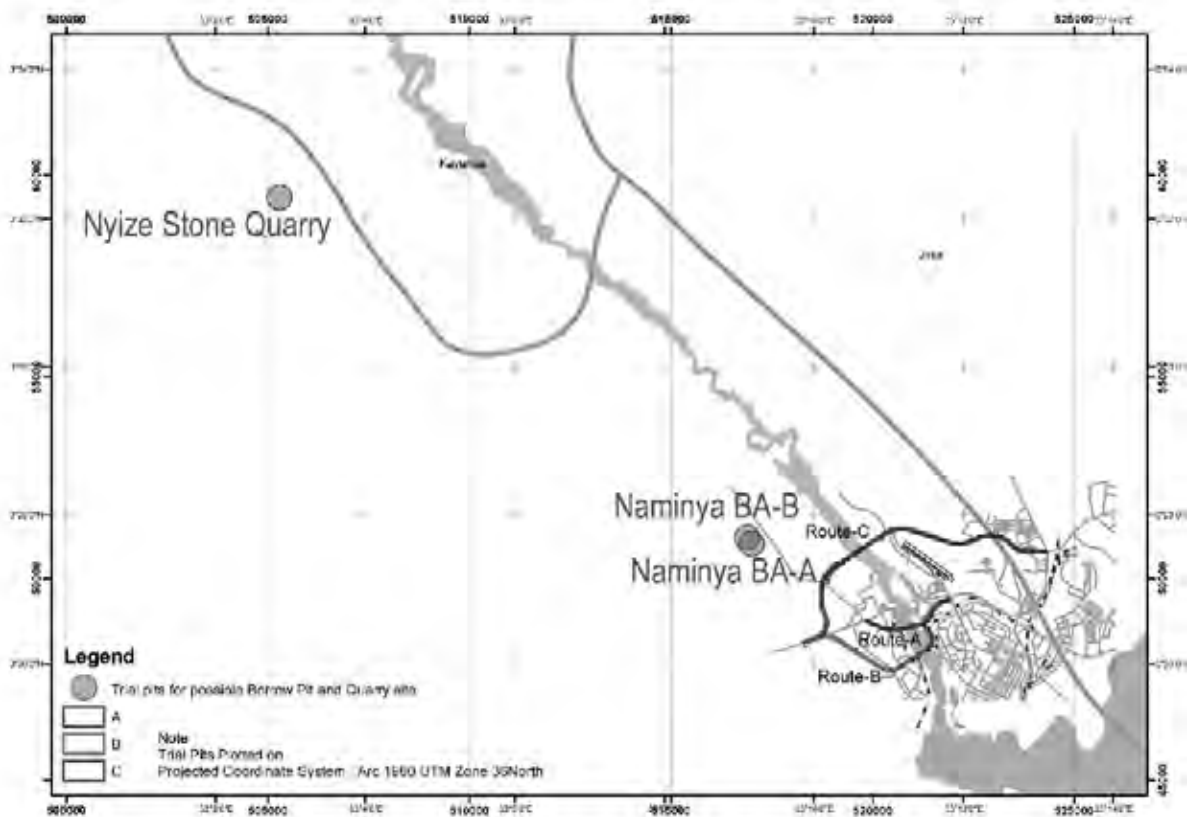
Possible sources of construction materials were explored, and as a result, 1 possible quarry site and 2 possible borrow pits were investigated. Figure 5.4.19 shows the approximate locations of the quarry and borrow pits investigated.

Figure 5.4.19 Locations of Possible Quarry and Borrow Pits

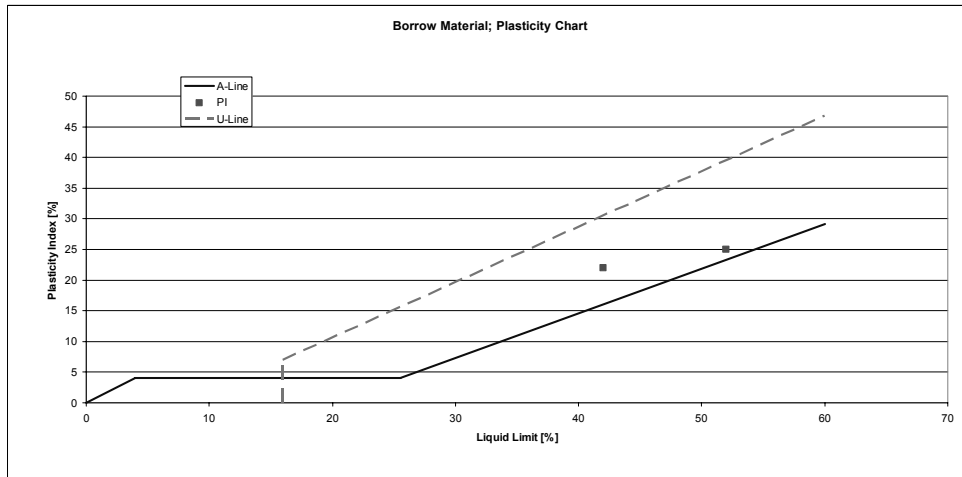
Overview of the plasticity results and need for stabilising the borrow area samples when used for earthworks and pavement layers are shown graphically in Figure 5.4.20.

Figure 5.4.20 Plasticity Chart and Stabilisation Need for Borrow Area Materials

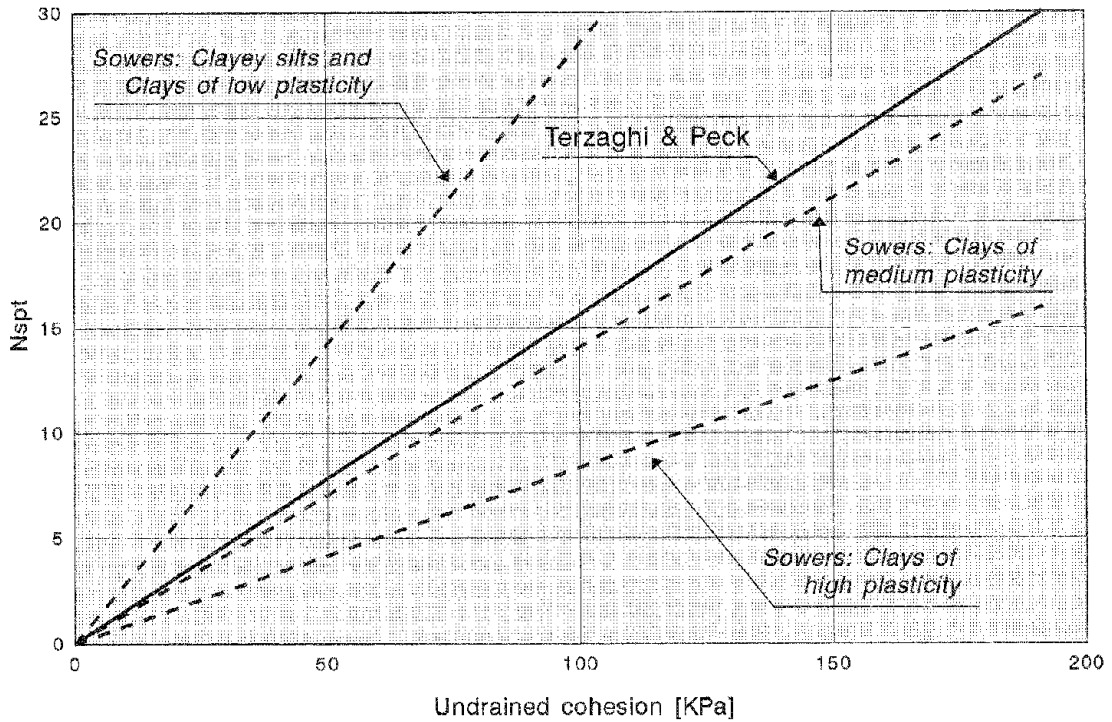
For cohesive soils, undrained cohesion for each stratum was estimated from the average values of N_{SPT} measured at the stratum. Figure 5.4.21 shows the commonly accepted correlation between undrained cohesion and N_{SPT} .

Figure 5.4.21 Determination of Cohesion with Nspt

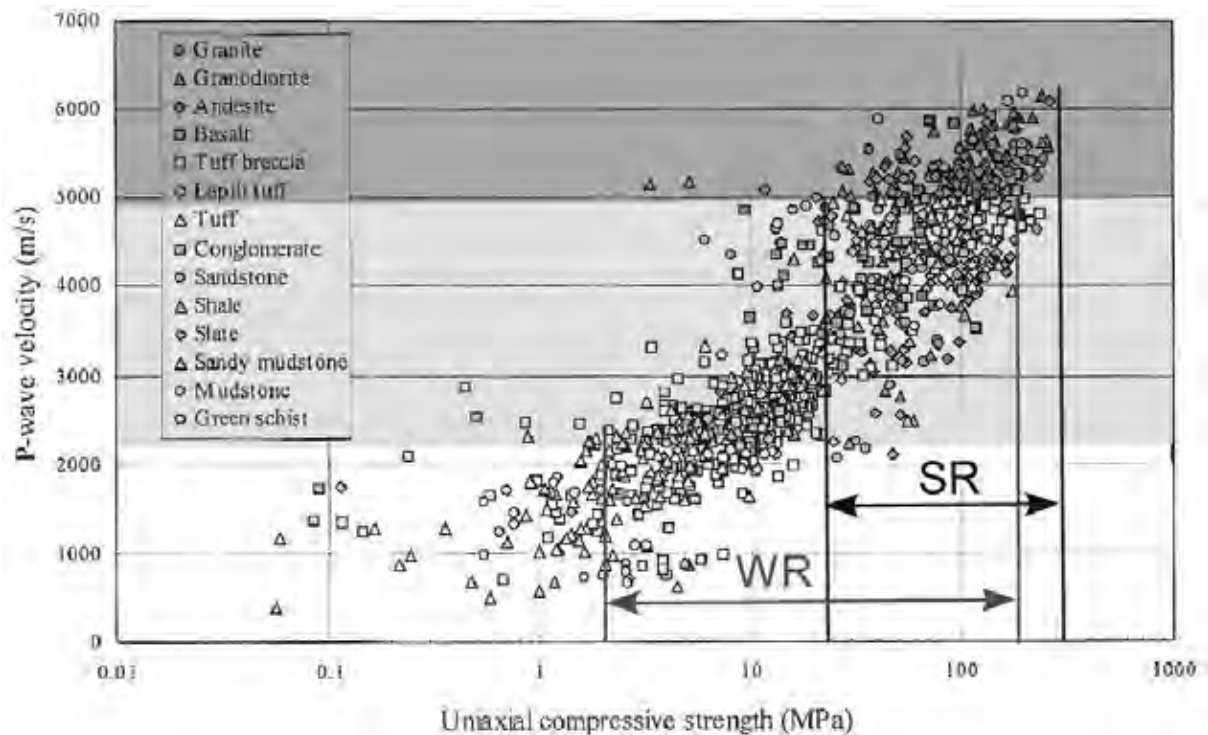
Figure 5.4.22 shows the commonly accepted correlation between uniaxial compressive strength and P-wave velocity. According to Figure 5.4.8, P-wave velocity assumed for WR/Amp is more than 2.2 km/sec, whereas the SR/Amp is more than 4.9 km/sec. The assumed ranges for uniaxial compressive strength (q_u) are also shown in Figure 5.4.22. The lab test results for WR/Amp ($q_u=24$ MPa) falls in the middle of the assumed range as shown in Figure 5.4.22. Moreover, the average lab test result for SR/Amp ($q_u=50$ Mpa) fall slightly lower than the middle of the range. Amphiboite is a sort of hard rock in general, thus in relation with P-wave velocity, a somewhat higher uniaxial compressive strength than tested in the lab might well be expected.

Figure 5.4.22 Correlation between Uniaxial Compressive Strength and P-wave Velocity
