5.4.3 Local Geology

5.4.4 Results of Geo Investigation

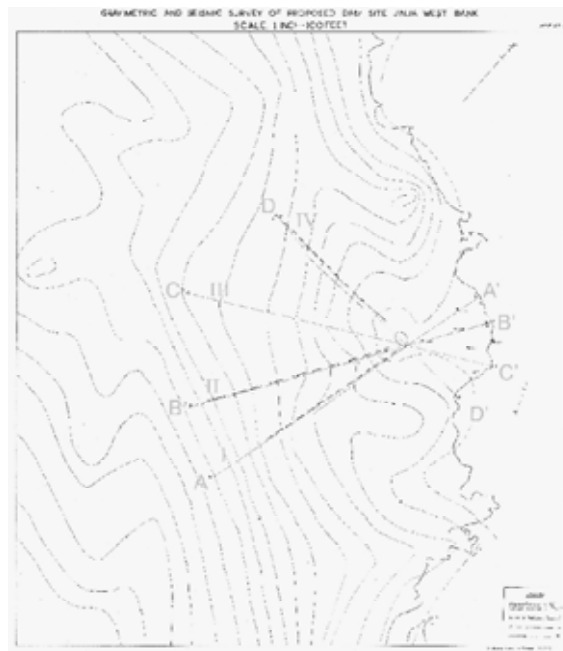
Figure 5.4.5 Survey Lines of Gravimetric and Seismic Surveys

Gravimetric and seismic surveys had been performed on the west bank of the River Nile as a part of the geological surveys for the dam site. Figure 5.4.5 shows the locations of survey lines. The results of the surveys were compiled into geological cross sections along with results of drillings on the west bank. Figure 5.4.6 collects the speculated geological sections. The notable point understood from these sections is the uniformity in thickness of soil and decomposed layers overlying fresh Amphibolite. Except around the river bank, soil and decomposed layers were speculated to be distributed with nearly-constant thickness, in other words, the top surface of fresh Amphibolite was expected to emerge at roughly the same elevation everywhere in the surveyed area, although it is assumed to have certain ranges of unforeseeable undulation.

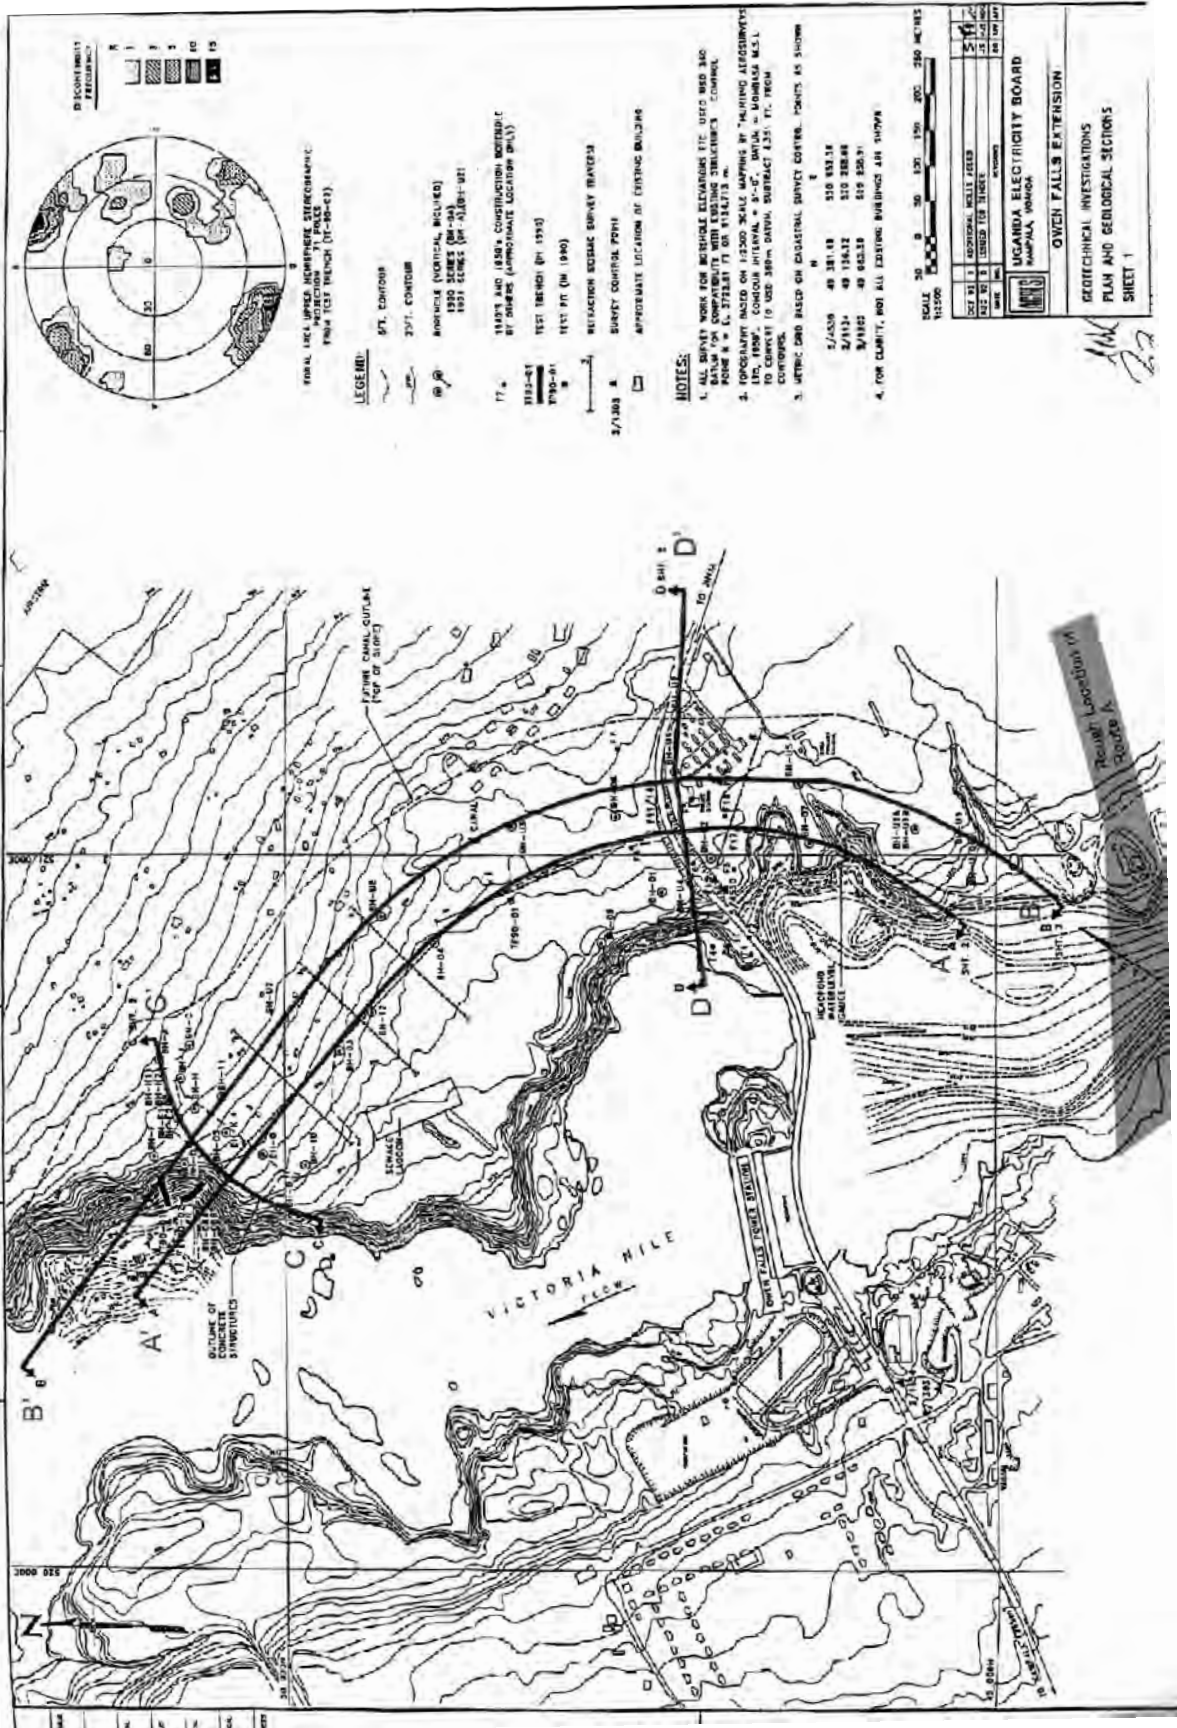
Figure 5.4.7 Survey Lines of Geological Sections for the Construction of the Kiira Canal

The Ugandan Electricity Generation Company Ltd (UEGCL) provided 4 geological sections which run along and cross the planned (and possibly realized) course of the Kiira Canal. Figure 5.4.7 shows the locations of geological sections which are summarised in Figure 5.4.8. Additional interpretations were added on Figure 5.4.8.

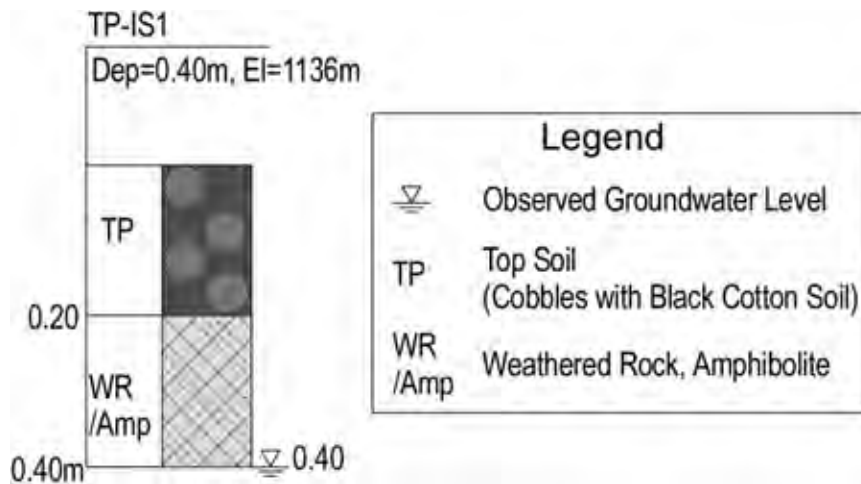
Figure 5.4.16 Columnar Section of TP-IS1

Figure 5.4.16 shows the columnar section observed at TP-IS1.

Top soil covered the island surface with thickness of 20cm. The Top soil was composed of semi-round cobble of Amphibolite and Black Cotton soil. Under the top soil, weathered Amphibolite underlay the island. Even though weathered Amphibolite was partially argillised and cracks were filled with fine materials, rock pieces obtained from the excavation site retained their shapes firmly and apparently remained rock structures. In some cases, a single hammer hit could break rock pieces easily, but others resisted firmly.

Groundwater table was confirmed at depth of 40 cm and excavation was terminated due to the absence of a drainage system. The level of the ground water table was apparently the same as that of the River Nile. Around the ground water table, argillation of weathered Amphibolite was notable in some limited places, at the same time the rest of rock pieces maintain their hardness supposedly with medium strength. The cracks between rock pieces were open and had some space to allow water to intrude into the ground of the island. As described above, the weathering condition was varied by location, so the intervals of discontinuities also extended up to 20 cm.
