**THE FEASIBILITY STUDY
ON
THE CONSTRUCTION
OF
A NEW BRIDGE ACROSS RIVER NILE AT JINJA
IN
THE REPUBLIC OF UGANDA**

FINAL REPORT

VOLUME 3: APPENDICES

OCTOBER 2009

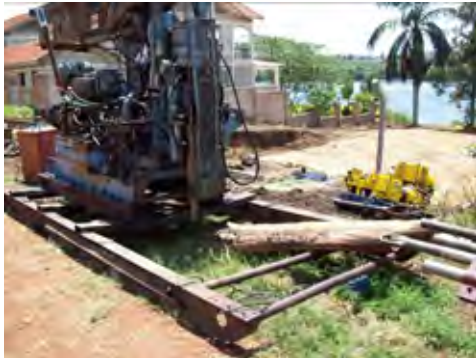
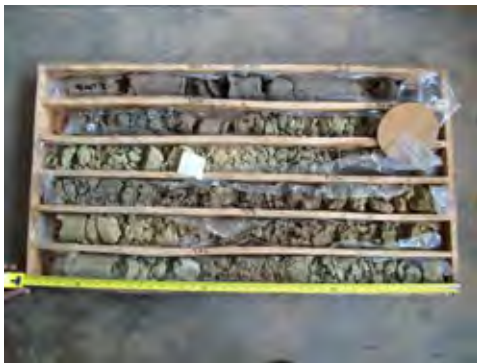
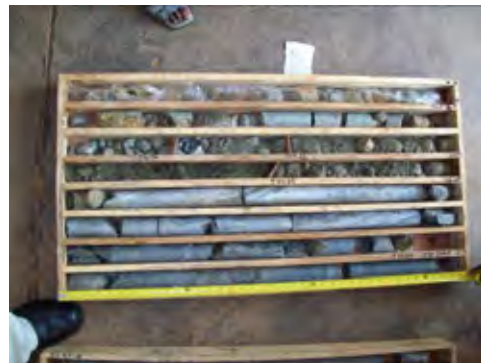
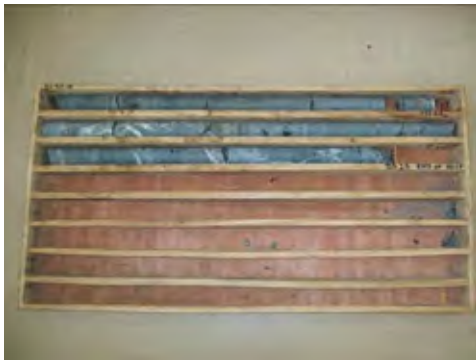
Bor.A-2-2

BH No.: BH A-2-2 (521239 N, 48549 E)
RL: 1143

DEPTH (m)	FIELD SPT VALUE	N- VALUE	Water Table Depth(m):	Not encountered
			SOIL DESCRIPTION (By visual inspection)	REMARKS
0.00				
1.50	2, 4, 5	9	Brown - grey- yellow silty sand	Loose
1.95				
3.00	7, 9, 20	29	Brown - grey- yellow silty sand	Medium dense
3.45				
4.50	15, 23, 27	50	Brown - grey- yellow silty sandy clay	Hard
4.95				
6.00	22, 37, 43	80	Brown - grey silty sandy clay	Hard
6.45				
7.50	19, 53, 100	153	Brown - grey silty sandy clay	Hard
7.95				
9.00	24, 35, 56	91	Brown - grey silty sand	Very dense
9.45				
10.50	13, 18, 64	82	Brown - grey silty sandy clay	Hard
10.95

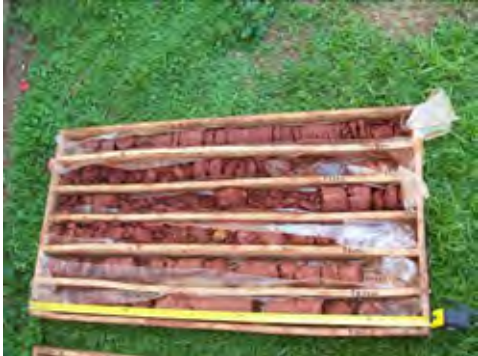
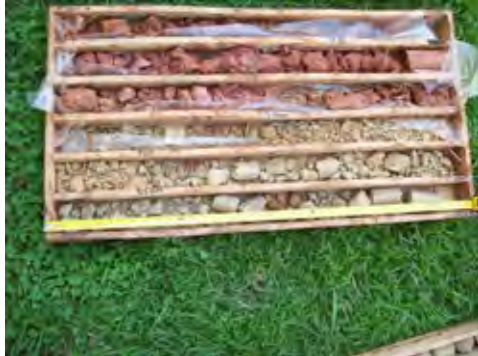
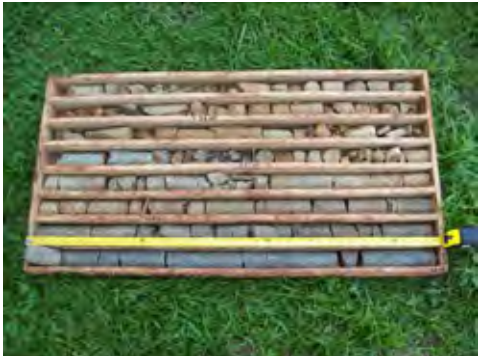
Bor.C-1

BH No.: **BH C-1** **(520161 N, 50420 E)**

DEPTH (m) 0.00	FIELD SPT VALUE	N- VALUE	SOIL DESCRIPTION (By visual inspection)	REMARKS
1.50 1.95	3, 4, 6	10	Brown silty clay	Stiff
3.00 3.45	2, 4, 6	10	Brown silty clay	Stiff
4.50 4.95	3, 3, 5	8	Brown-red-yellow schist silt	Loose
6.00 6.45	4, 4, 7	11	Brown - black schist silt	Medium dense
7.50 7.95	8, 9, 14	23	Brown - yellow schist silty clay	Very stiff
9.00 9.45	8, 10, 13	23	Brown - yellow - black schist silty clay	Very stiff
10.50 10.95	9, 10, 14	24	Brown - yellow schist silty clay	Very stiff
12.00 12.45	11, 19, 32	51	Brown - yellow schist silty clay	Hard
13.50 13.95	28, 48, 130	178	Brown - red- yellow sandy silty clay	Hard
15.00 15.45	24, 54, 142	196	Brown - grey- yellow silty clay	Hard

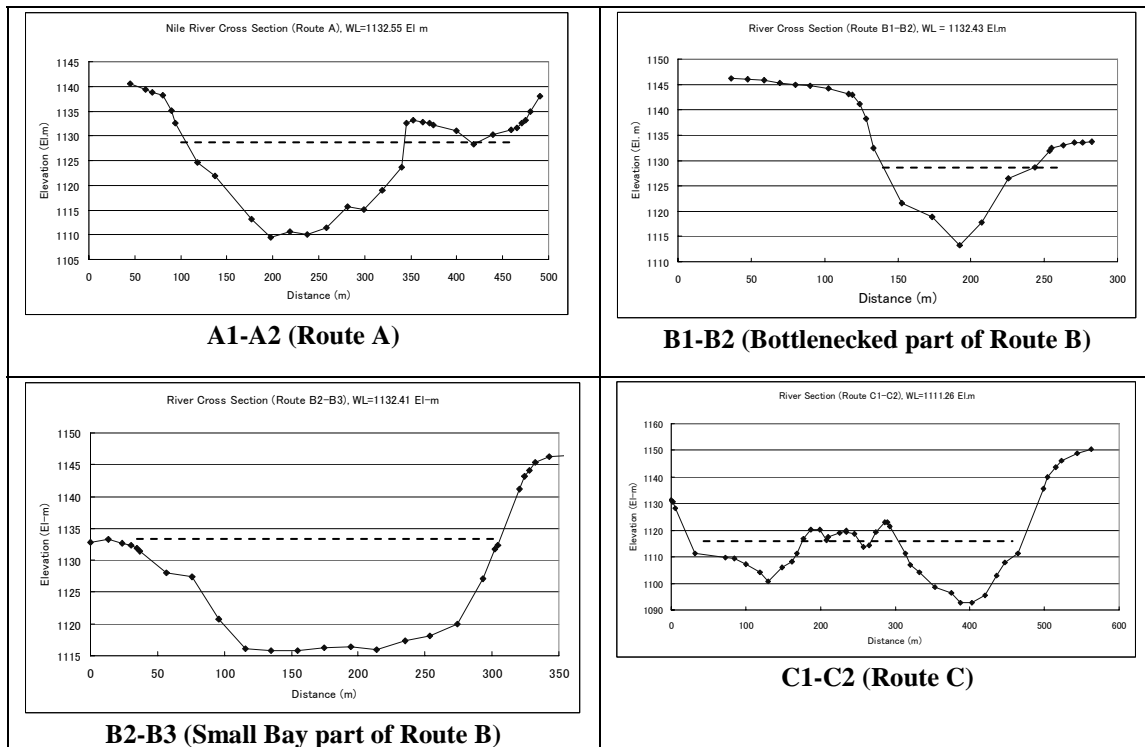
Figure 3 Cross Section of the River Nile

Note: Exact location of Point A1, A2, B1, B2, B3, C1 and C2 are described in the survey section of the Progress Report of this study. Dotted lines drawn in these figures indicate the water levels measured during the field survey period of this study. (Source: This Study, 2009)

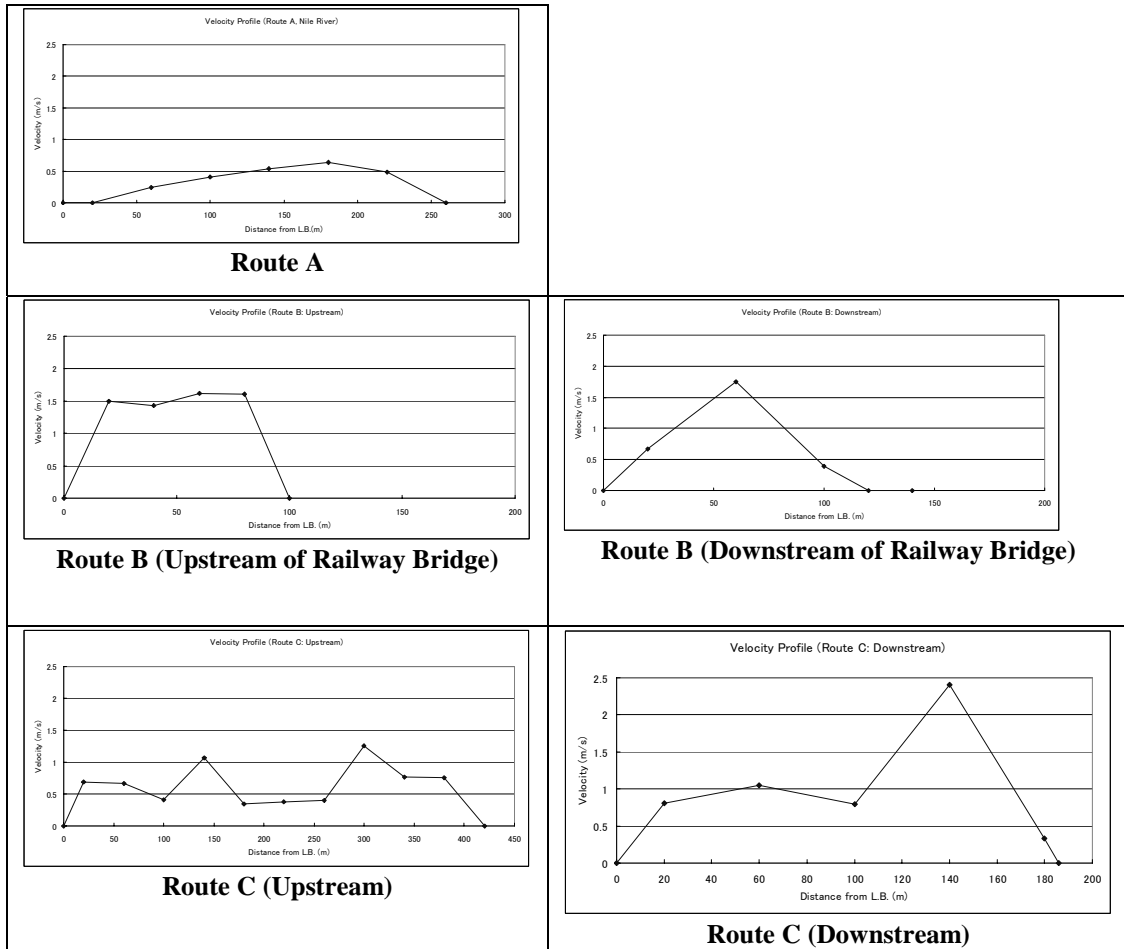
Figure 4 Cross-Sectional Velocity Profile of River Nile

Note: Velocity survey was conducted in December 2008. (Source: JICA Study Team, 2009)

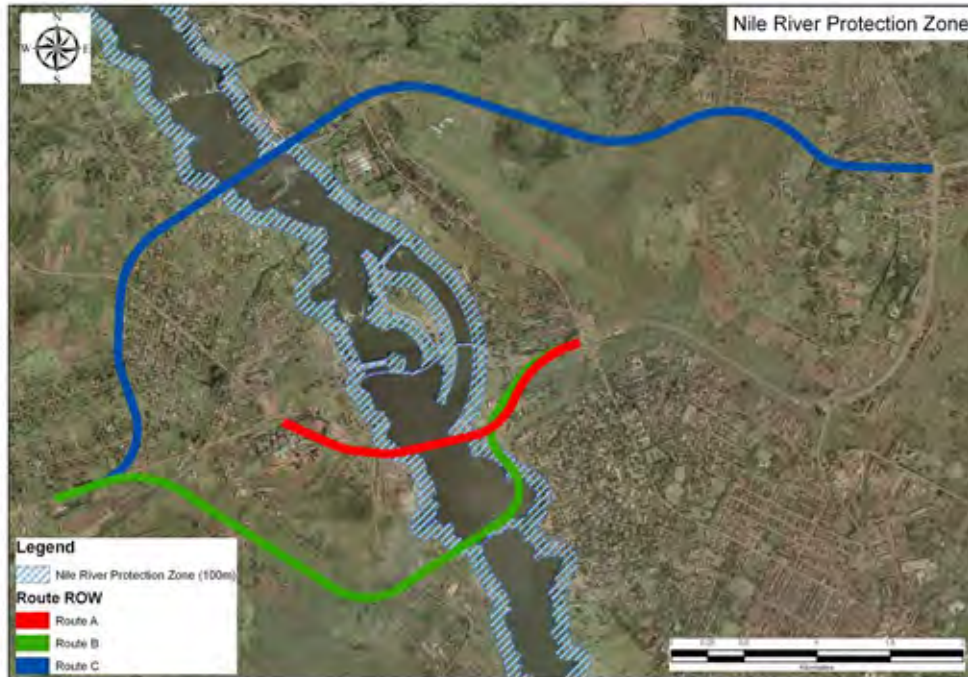
Figure 9 Victoria Nile Conservation Area

Note that shaded strips along both riverbanks are declared as “conservation area” by law.

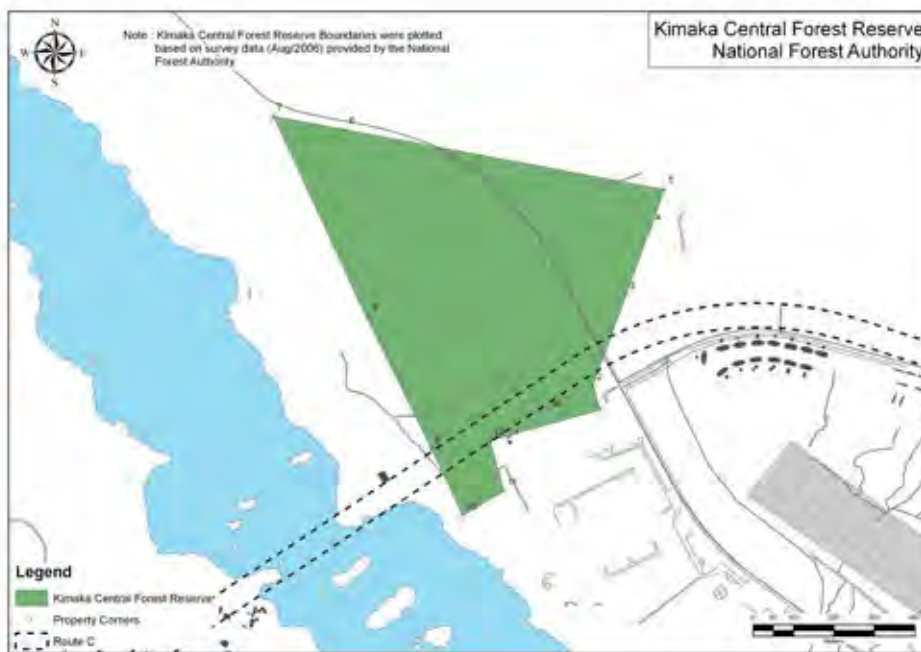
Figure 10 Kimaka Forest Reserve

Note that dotted lines indicate RoW of Alignment C
