## Report on Field Survey of PV-Diesel Hybrid System in Mandhoo Island

添付資料 10 地方環礁島 (Fanadhoo and Gan Islands) での  
太陽光発電システム運用状況調査結果

Report on Field Survey of PV Systems in Gan and Fonadhoo Islands in Laamu Atoll

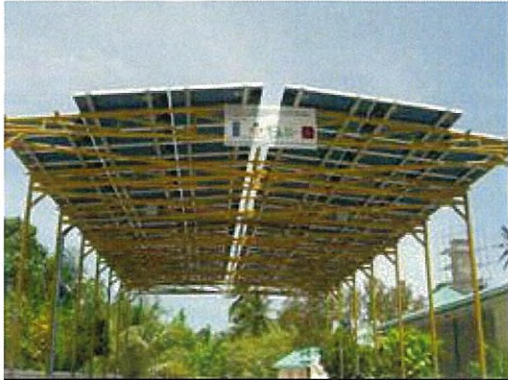
- ✓ The appearance of PV modules (160 pieces, 80 Wp, BP Solar) is good condition.
- ✓ All diesel generators are maintained well. (ex. cleaning, changing filters, oil and lubricant, etc.)
- ✓ Connection cables for the new inverter are extended or jumped from existing cables. Several parts are thinner than the existing cables. It might cause the over current and/or voltage drop.
- ✓ Battery bank is left without charging. Although the condition seems to be good from the appearance, it causes the sulfation and stratification of the batteries. It results in shorten of the battery life.
- ✓ According to the operator, the peak load is approx. 25 kW in daytime and approx. 35 kW in nighttime. On the condition that PV generates well but demand is low, the diesel load factor will be low. It might affect the efficiency and engine life.

PV Array

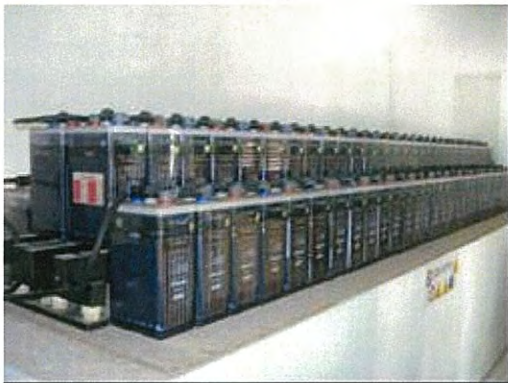
Battery Bank

- ✓ As for battery bank, the floating charging is required to prolong its life. It is better to utilize them for the emergency purpose or to transfer them to another island.

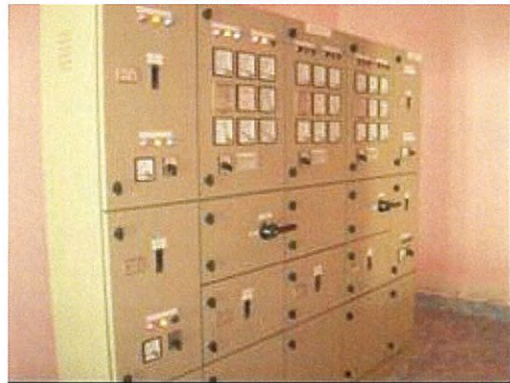
Generator Control and Distribution Panels

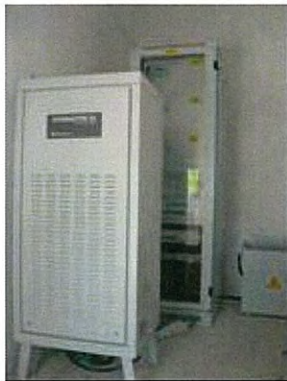
Ex and present inverter

- ✓ As for cable size, it is better to check the capacity and to change into proper size depending on the necessity.
- ✓ By appearance, inverters showing the operation status of PV will be preferred. Now the operator is not aware how to open the inverter panel.

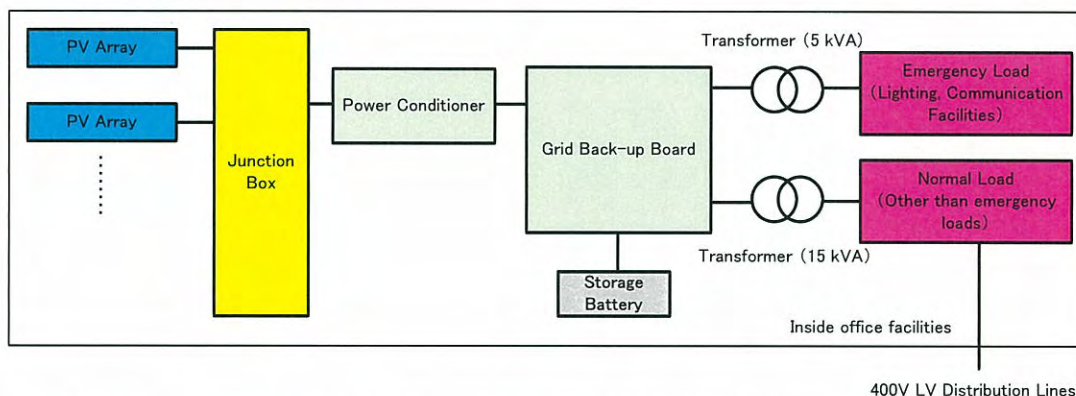
No.	Name of Equipment	Multi-Purpose Building	Island Office
1	Solar array (175 W)	11.2 kW	5.6 kW
2	Power conditioner	10 kW	10 kW
3	Grid backup board	1 set	1 set
4	Storage battery	288V 220Ah	288V 100Ah
5	Transformer	15kVA and 5kVA	15kVA and 5kVA

Figure 1: The Block Diagram and the Specifications of the PV Systems Installed into Gan and Fonadhoo Islands

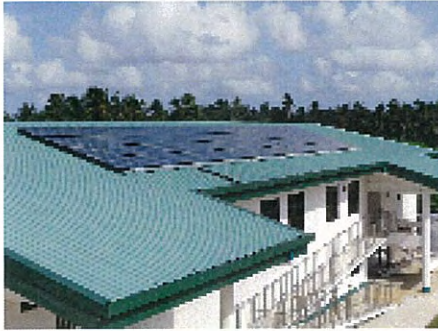
- ✓ The appearance of PV modules is good condition.
- ✓ The Battery condition seems to be good from the appearance,
- ✓ According to the administrative staff, these facilities have worked well since they were installed in 2006.
- ✓ Output of PV seemed to be consumed by indoor consumption mainly and the remaining seemed to be charged into Battery or sent to the existing grid.

PV Array

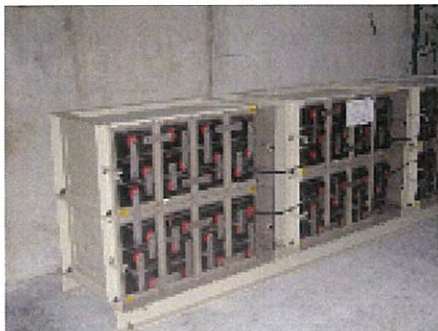
Battery Bank

- ✓ The replacement cost of battery system was not collected yet. The cost of replacement of battery is most expensive, therefore, to save money for replacement of Battery was recommended by JICA Study Team.

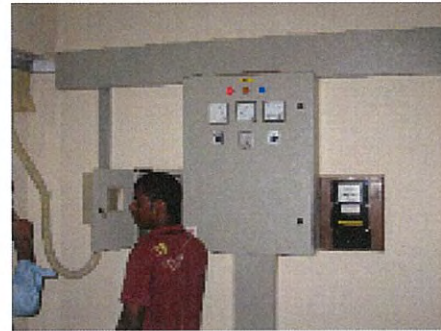
- ✓ The Excess output from PV system is sent to the existing grid, however, it was not controlled and the excess was sent free.
- ✓ The workers in charge of O&M don't know how to measure the amount of excess power from PV system to the existing grid, therefore, JICA Study Team provided necessary instruction for them.

Meters

- ✓ To make the workers in charge of O&M maintain periodically and measure the meters periodically.
- ✓ To save money for the Replacement of Battery should be recommended by the Central Government.
- ✓ Either MHTE or STELCO will have to monitor the system and assist the Multi-Purpose Building and the Island Office. Periodical reporting and monitoring system may have to be considered.
- ✓ In order to analyze and evaluate the economy and efficiency of the system, it is recommendable to record the operation data such as load curve, fuel consumption and maintenance record.

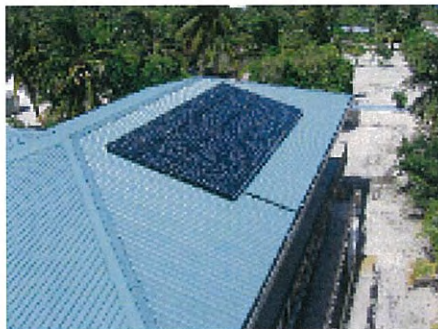
- ✓ The appearance of PV modules is good condition.
- ✓ The Battery condition seems to be good from the appearance,
- ✓ According to the administrative staff, these facilities have worked well since they were installed in 2006.
- ✓ Output of PV seemed to be consumed by indoor consumption mainly and the remaining seemed to be charged into Battery or sent to the existing grid.

PV Array

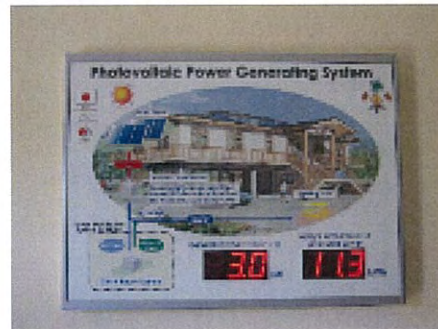
Board

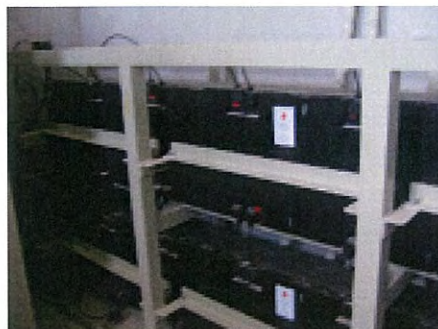
Battery Bank

- ✓ The replacement cost of battery was not collected yet. The cost of replacement of battery is most expensive, therefore, to save money for replacement of Battery was recommended by JICA Study Team.
