Appendix 5: Calculation of Design Water Supply

Appendix 7: Water Hammer Analysis

Water Hammer Analysis on New Water Transmission Pipeline (800mm ϕ) from Mareza 2 Pump Station to Ljubovic Reservoir (20,000 m³)

THE PREPARATORY SURVEY II ON THE PROJECT FOR URGENT REHABILITATION OF WATER SUPPLY SYSTEM IN THE CAPITAL CITY OF PODGORICA IN MONTENEGRO

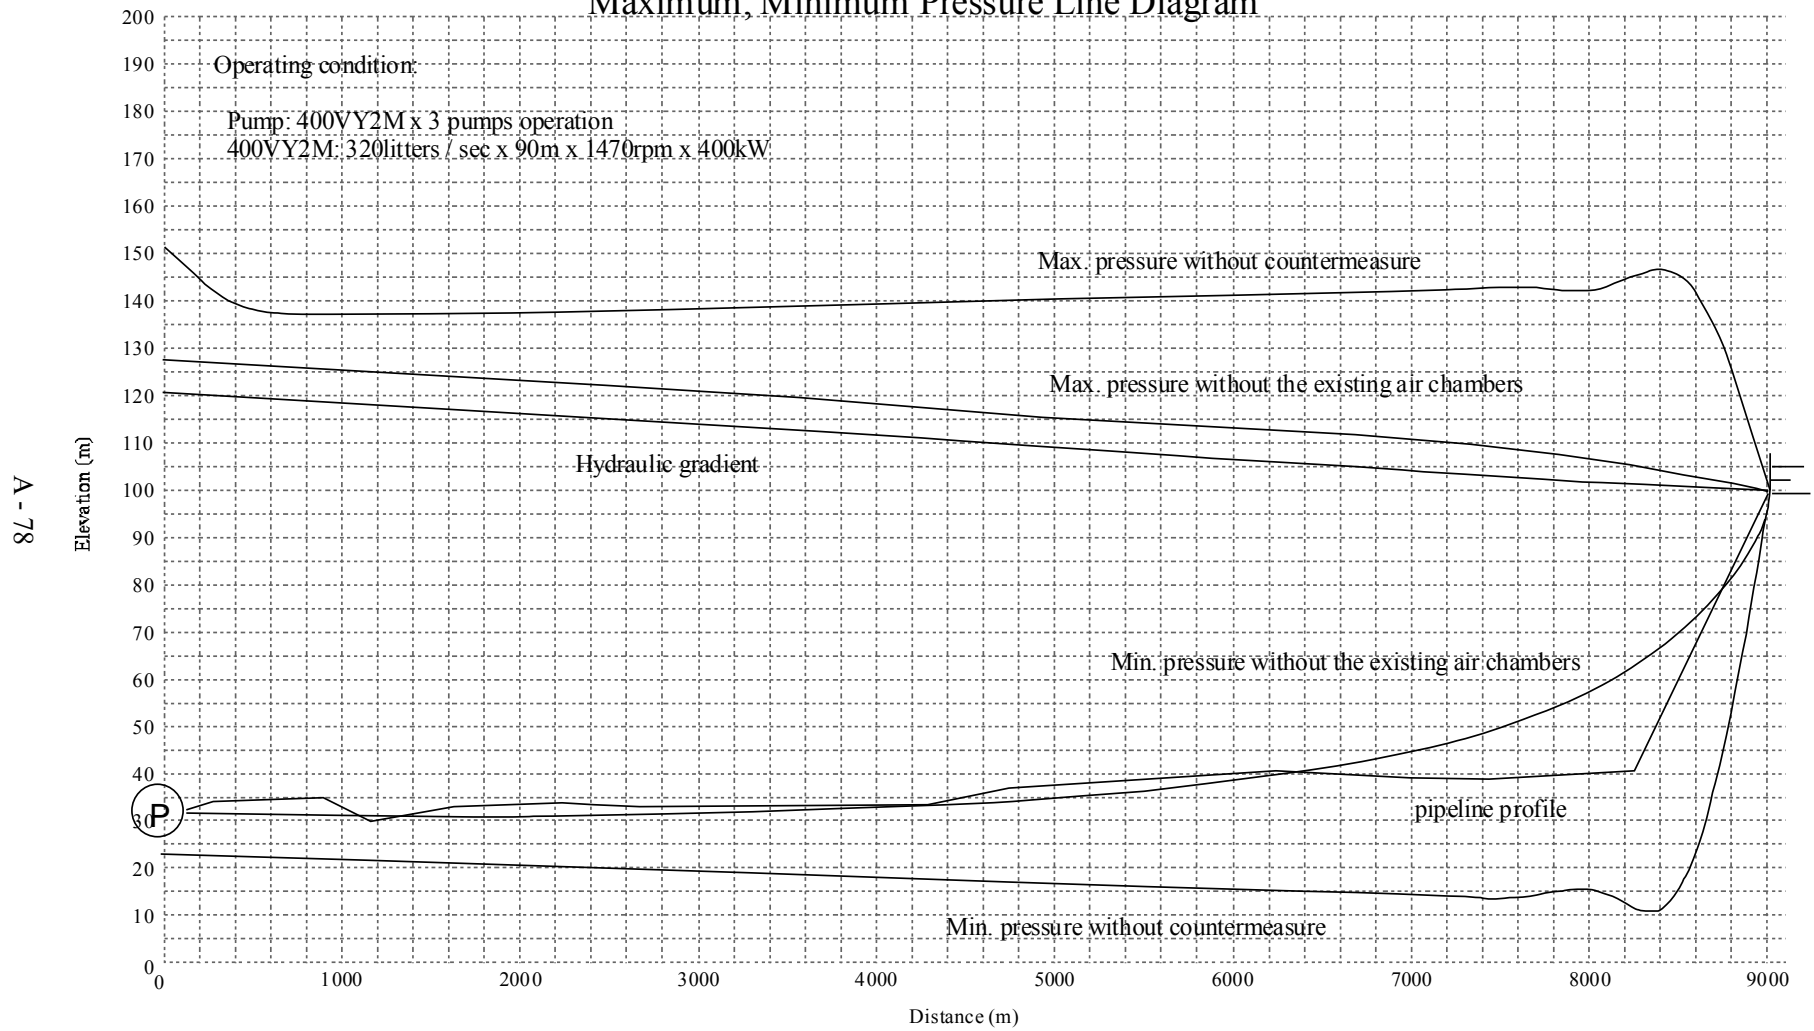
Maximum, Minimum Pressure Line Diagram

Distance from PS (m)	Elevation (EL m)
Minimum Pressure -0.0419 MPa	8869.6 m	95.8 EL m
Maximum Pressure : 0.9379 MPa	0.0 m	32.0 EL m

Pressure in the pipeline will become negative.

However, water column separation will not occur.

Maximum pressure in the pipeline is within allowable range.

Maximum and Minimum Pressure Lines are shown as attached herewith.

5. CALCULATION RESULTS WITHOUT COUNTERMEASURE (CASE 1)

Distance from PS (m)	Elevation (EL m)
Minimum Pressure -0.4436 MPa	8464.5 m	64.0 EL m
Maximum Pressure : 1.1739 MPa	0.0 m	32.0 EL m

Water Column separation will occur. Countermeasures are necessary.

Maximum and Minimum Pressure Line are shown as attached herewith.

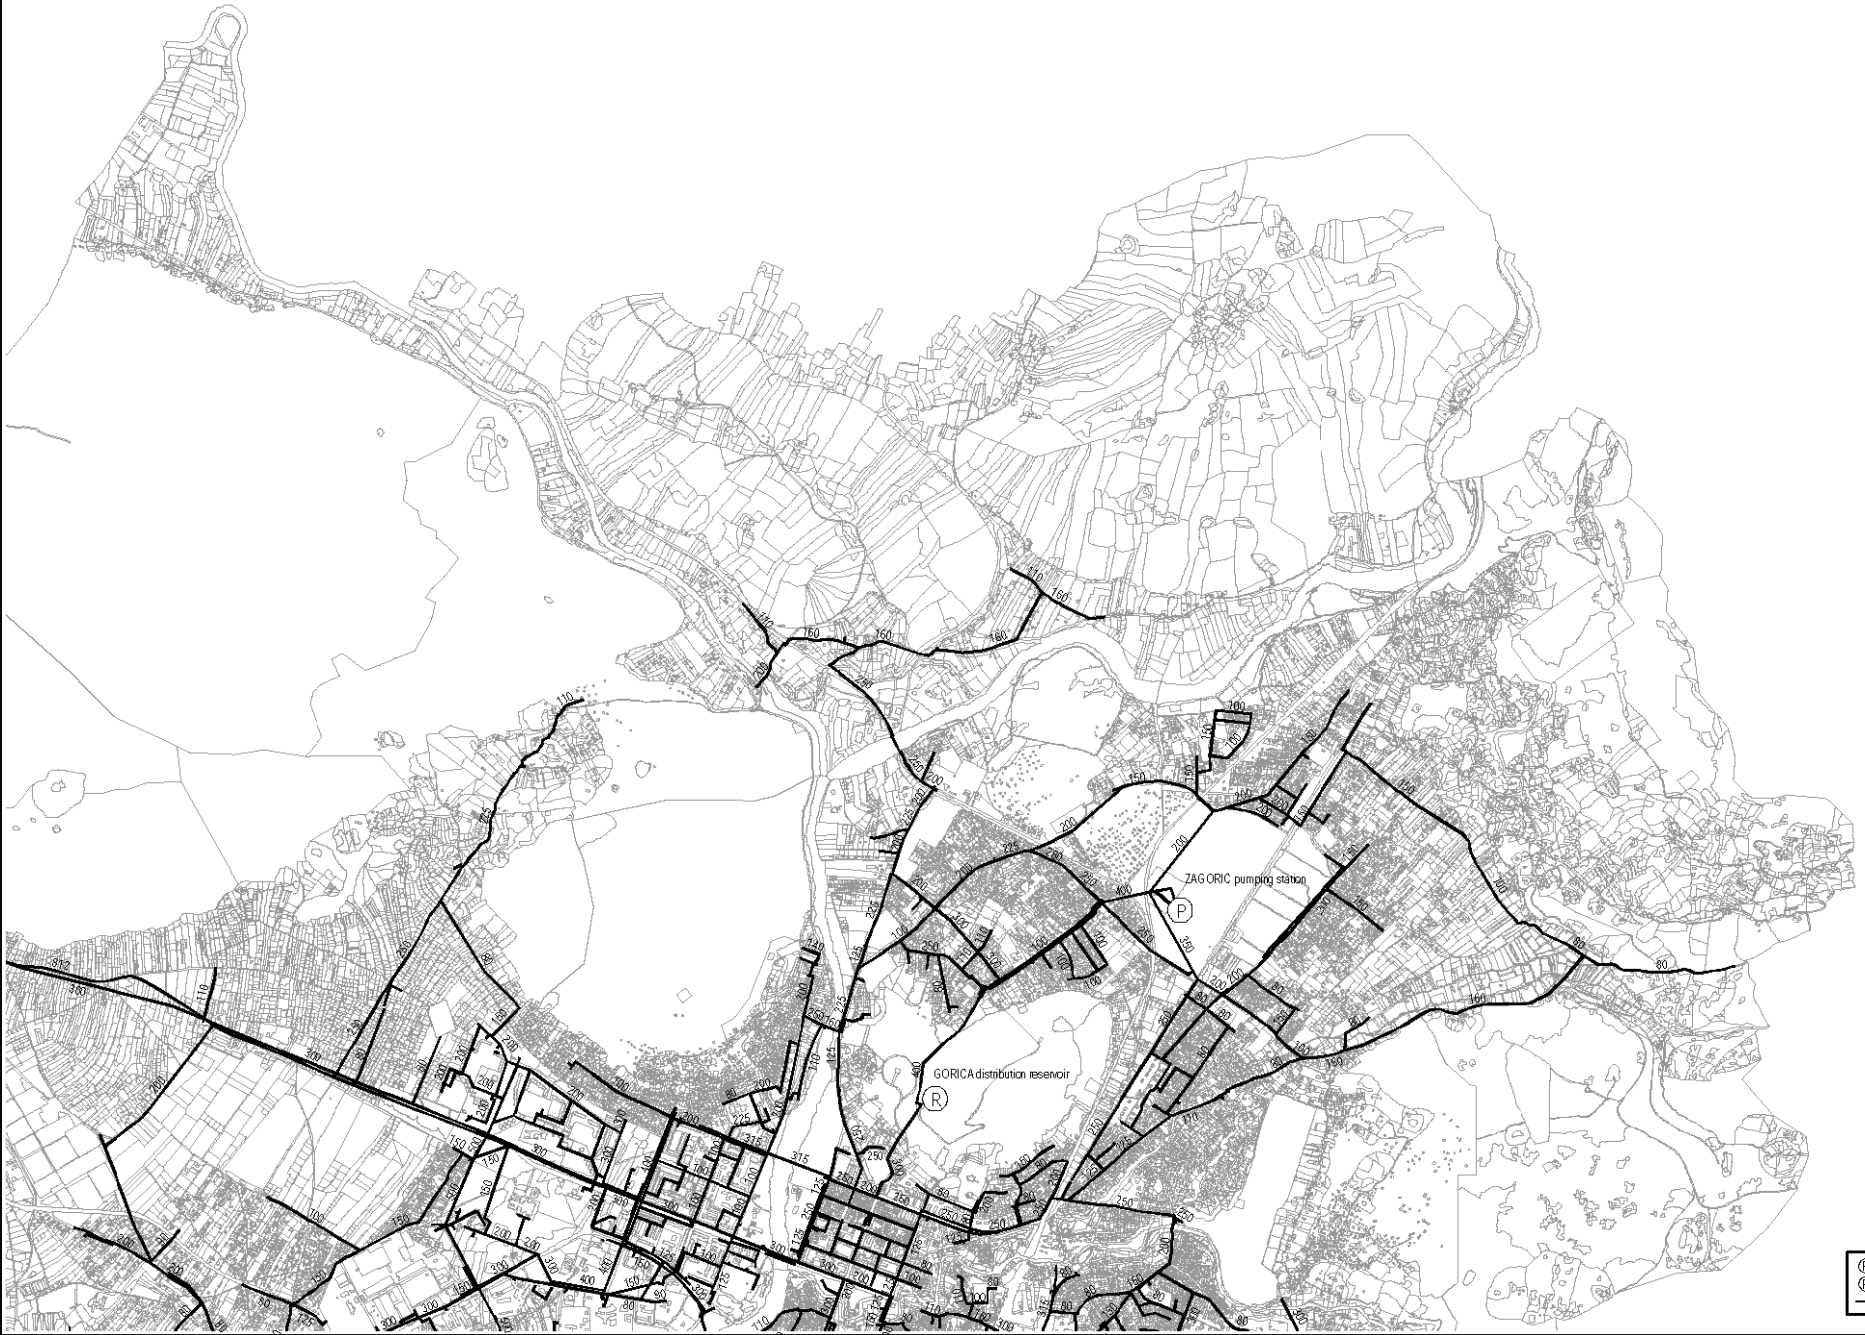
Distribution network (Map-1)

Pumping station
-

Distribution reservoir
-

Distribution pipeline

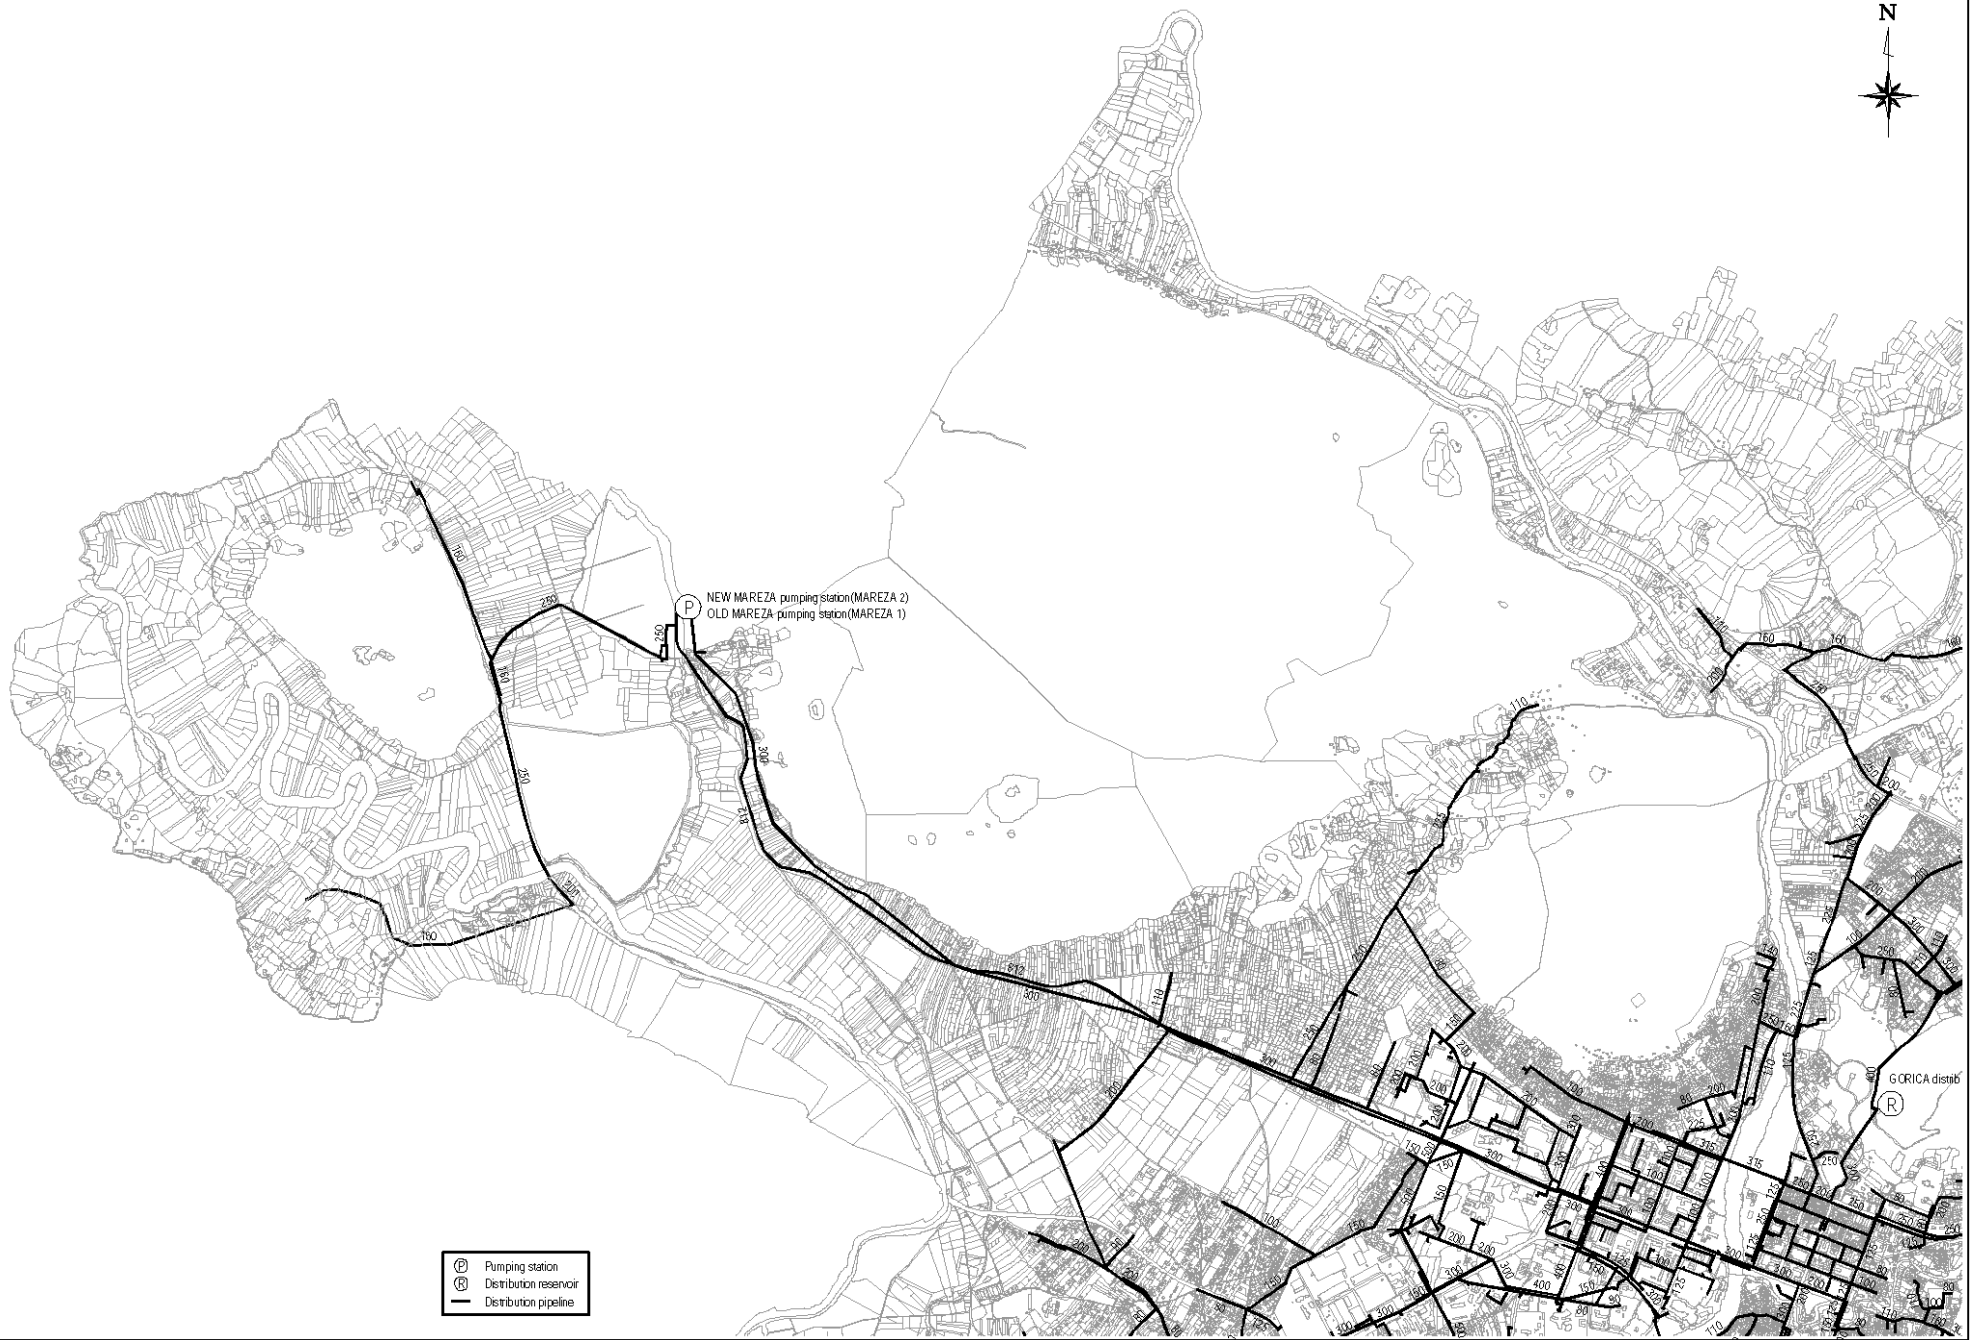
Distribution network (Map-2)

- Pumping station
- Distribution reservoir
- Distribution pipeline
