付属資料 8 ギラン州現地踏査報告書

Field Reconnaissance Report For The Study on Integrated Water Resources Management For Sefidrud River Basin

Reconnaissance Report

Date: Feb 07~08, 2007

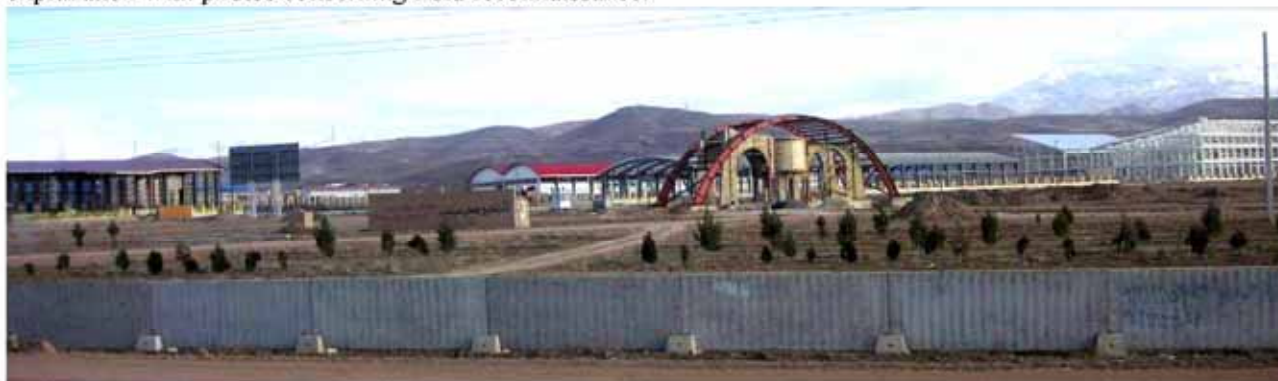
Photo-1: Industrial Development in and around Qazvin Area

Industrial zones are developed quickly in and around Qazvin area and water demand for industry will be increased shortly. Therefore, industrial water demand & supply, and water sources must be carefully examined. In addition, effluent from factories must be treated properly, and the treated water may be preferable used for watering the plants surrounding such factories. Thus, the environmental regulation is necessary on effluent from factories.

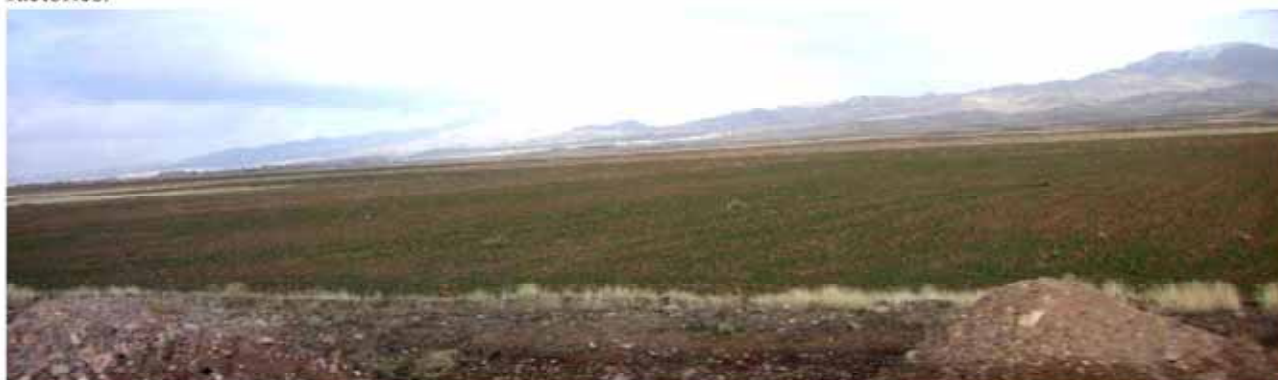
Photo-2: Large-scale Farmland in Mahmud abad

Large-scale farming is on going in and around Mahmud abad and wheat is growing. It is common practice that the farm should be divided into appropriate sizes, and wind break forests to prevent wind erosion and drainage to prevent surface erosion by the storm water should be provided from the viewpoint of soil conservation.

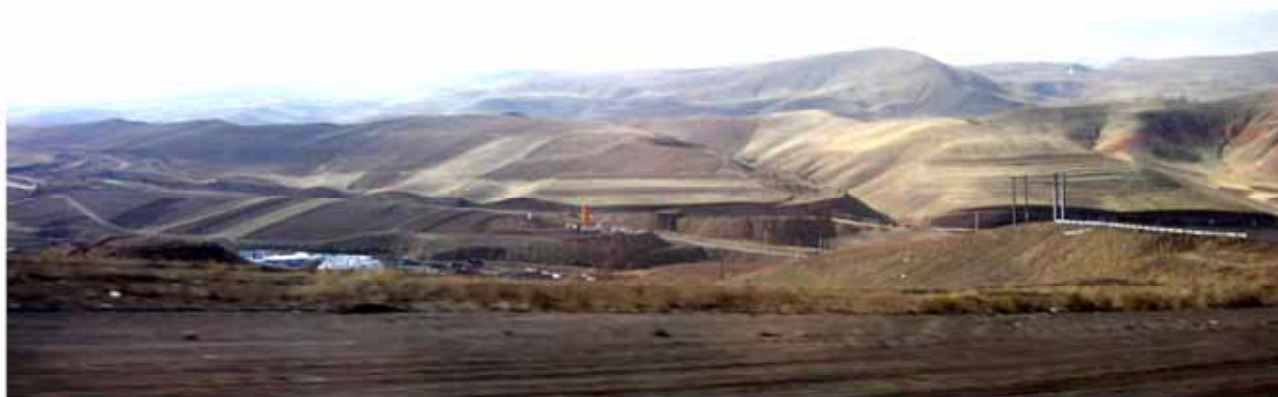
Photo-3: Highland Area around Kuhin

Cultivation has been carried out even to the top of hills in Kuhin area. The Shahrud River basin, right tributary of the Sefidrud River, starts around here.

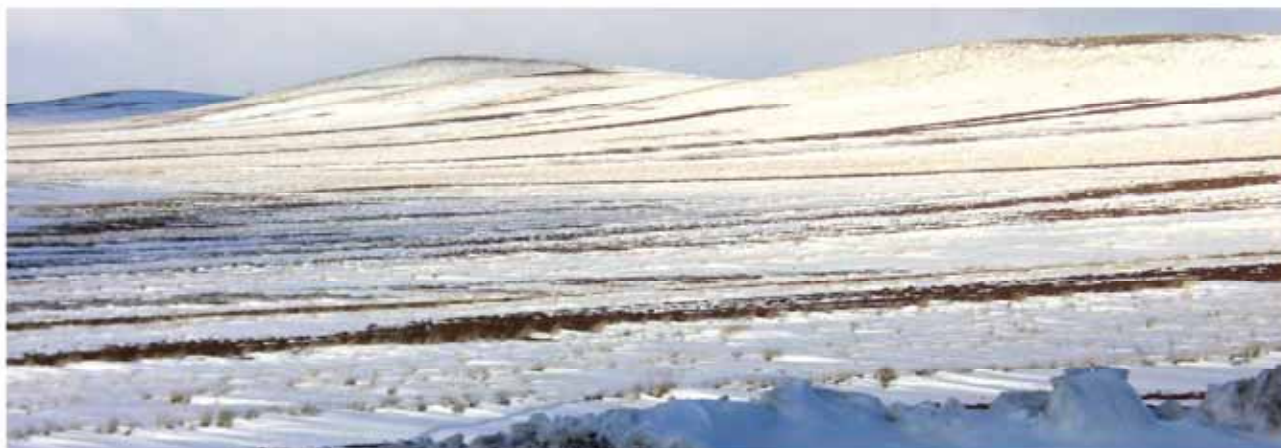
Photo-4: Highland Area around Kuhin (after snowfall)

The top of hills in Kuhin area is covered with snow of 20~30cm in depth on the 8 Feb. 2007. When fine weather comes back, snow will be melted and soils will be washed down together with snow-melt water, and contour farming and wind protection forests should be provided from the view point of soil conservation and appropriate farming.

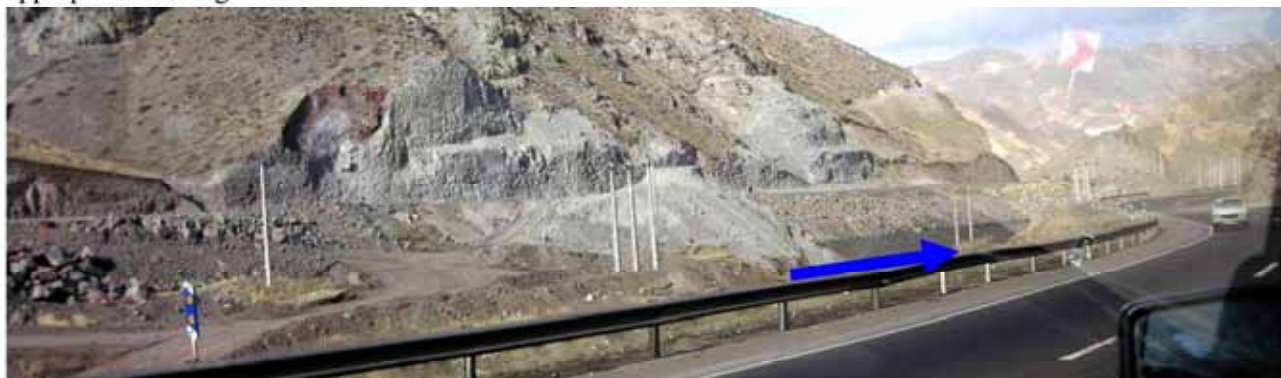
Photo-5: Creation of New Sediment Deposit by Road Construction

The road section between Kuhin to Lowshan is aligned along the Molla Ali River, the tributary of the Shahrud River, and the expansion work of the road is currently under going by cutting the hillside of the opposite side of the valley. The cut material is disposed and fills the bottom of the valley without any care of the flush-down of the material downstream. The Molla Ali River joins the Shahrud River and flows down into Manjil reservoir. The material created by the road construction is one of the major causes of sedimentation and water pollution of the reservoir. From the river environmental point of view, countermeasures for such construction activity should be taken in order to avoid construction disposals dumping in rivers. Also regulation on environmental consideration and the EIA in connection with such road construction work should be formulated and strictly implemented.

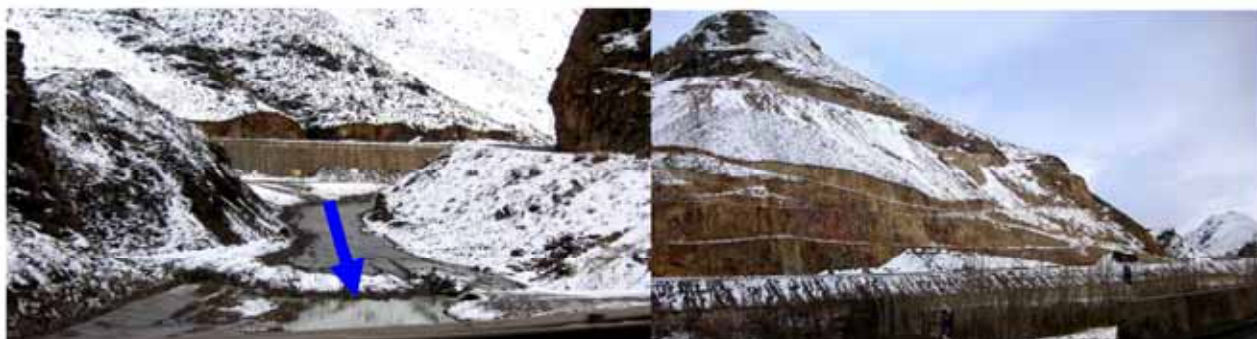
Photo-6: Creation of Sediment Deposit by Road Construction - 2

On the left: Disposal of debris dumped in the river bed. On the right: Bench cut method on the hillside slope of the valley.

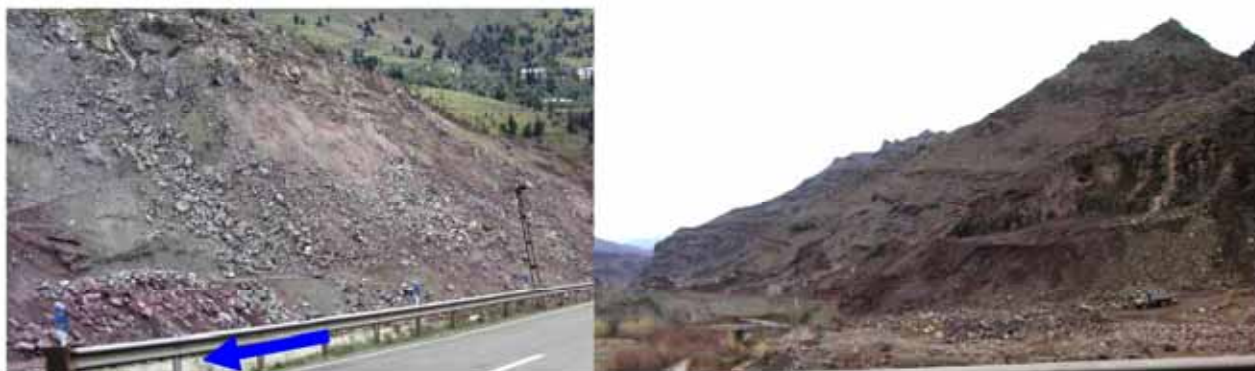
Photo-7: Creation of Sediment Deposit by Road Construction - 3

There are no countermeasures for slope protection. Road construction works create new sources of debris.

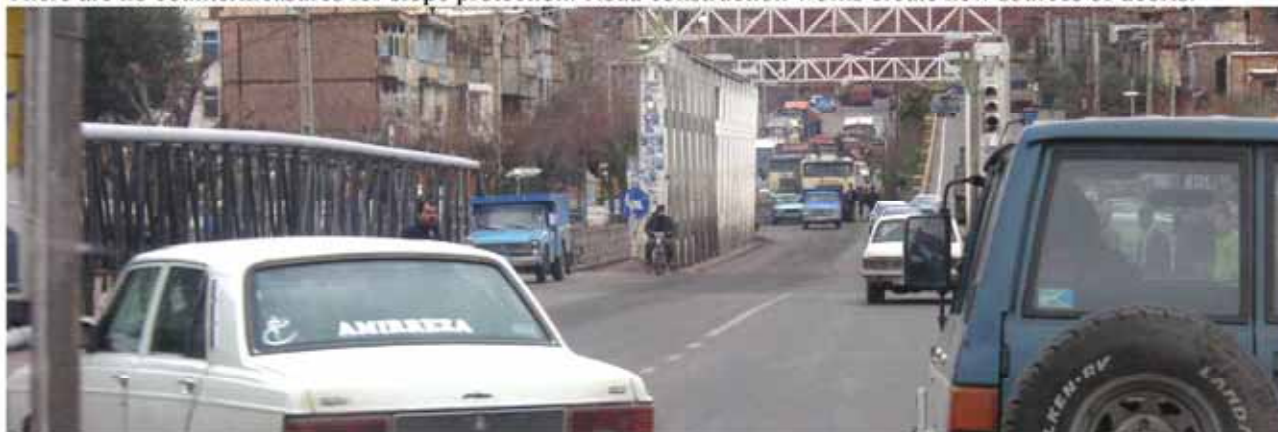
Photo-8: Bridge crossing Shahrud River at Lowshan

Bridges are usually served as bottleneck for the traffic and the flood flows. The bridge here is the one on the Shahrud River at Lowshan.

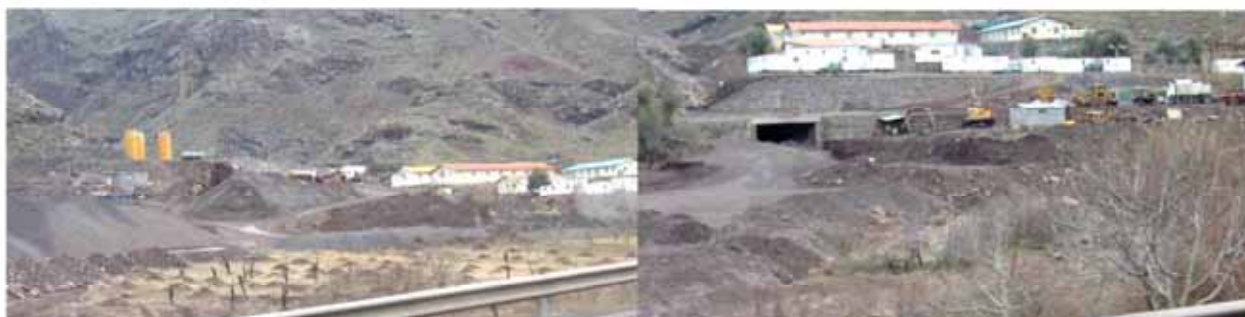
Photo-9: Hillside Quarry on Lower Shahrud River

People are careless about creating new sources of debris along the river.

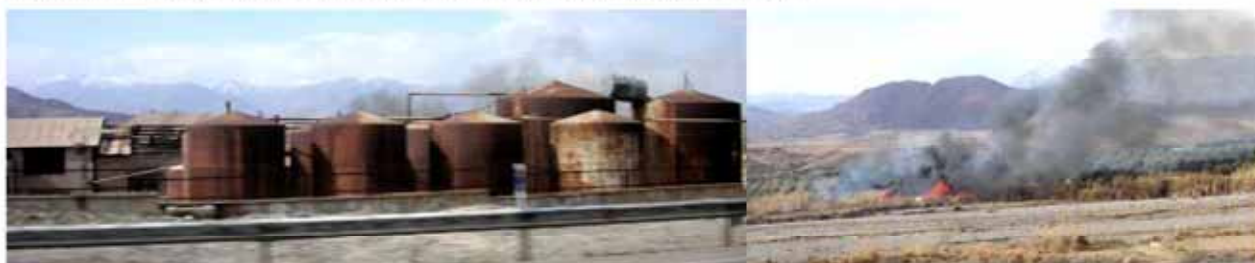
Photo-10: Cause of Water Quality Deterioration

On the river bed of the downstream of the Sefidrud River, there are some old factories and disposal areas. The untreated effluent from these places flows into the river and deteriorate the water quality.

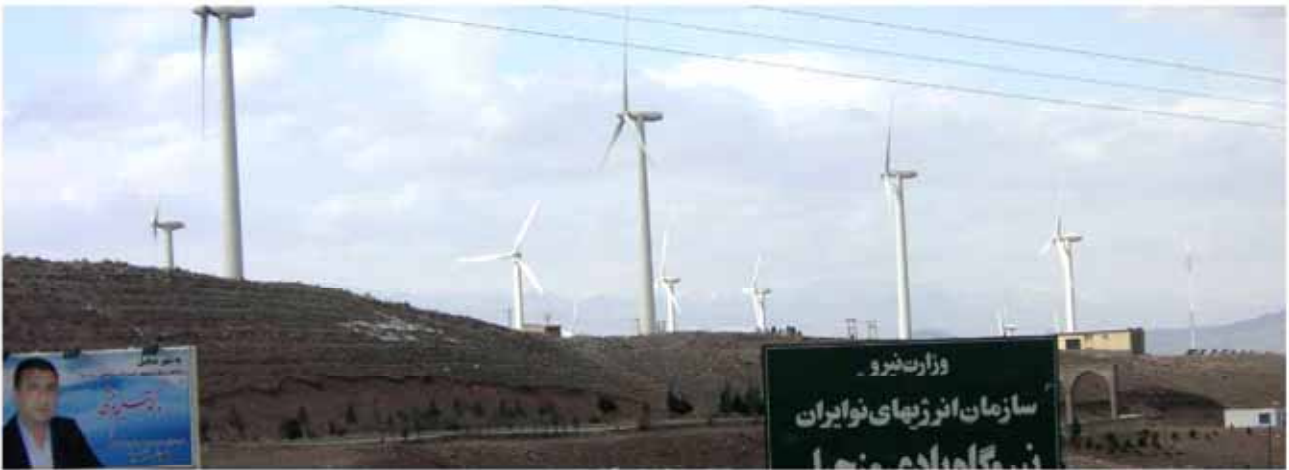
Photo-11: Wind Power on the Left Bank of the Damsite

At present, 60 units are installed and 300 units are planned altogether.

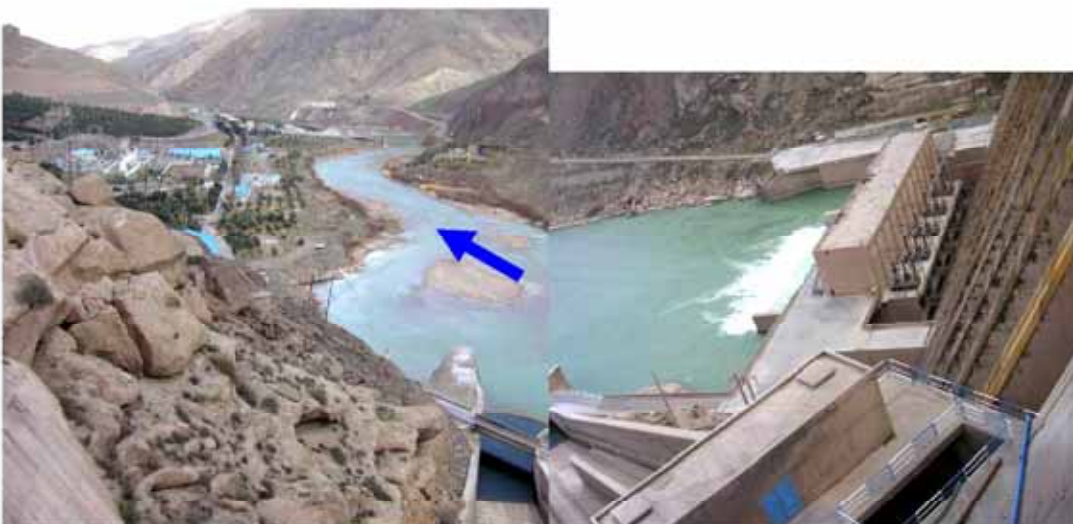
Photo-13: Downstream view of Manjil Dam-2

Spillway and power station are located on the downstream face of the Dam. Sediment deposition can be seen on the downstream of the power station.

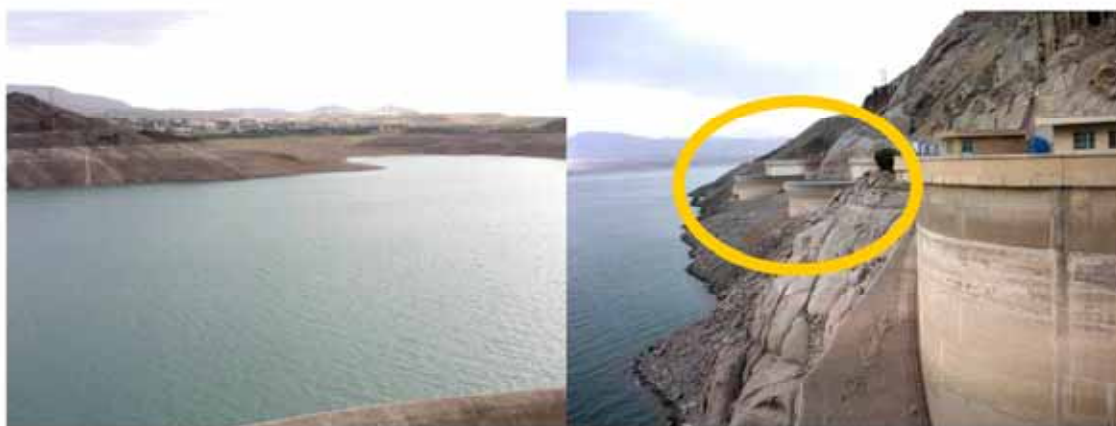
Photo-14: Manjil Reservoir

On the left: Town adjacent to the reservoir. On the right: Emergency spillway-2 units.

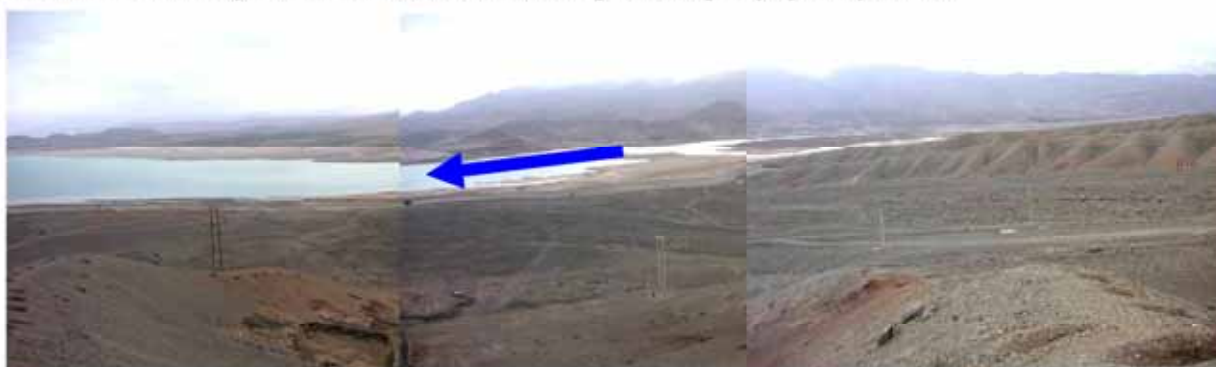
Photo-15: Sedimentation of the Reservoir on the Left Tributary, the Qezl Owzan River

The center of the photo is the most accumulated area of sediment from the Qezl Owzan River.

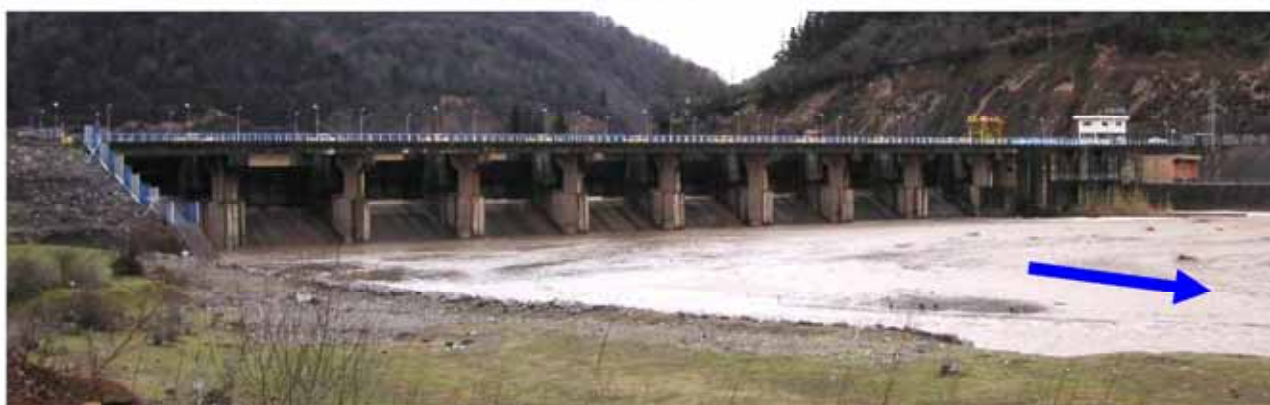
Photo-17: Tarik Diversion Dam on the Sefidrud River

Water for Gilan irrigation area is diverted from this weir.

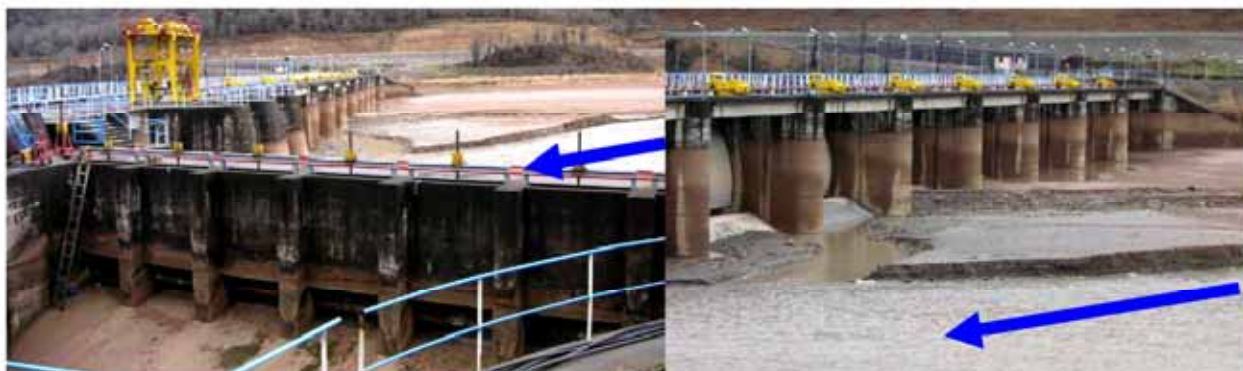
Photo-17: Upstream Condition of Tarik Diversion Dam

Although the sediment is accumulated in front of the dam, the intake-function is maintained by the sand removal gates. On the left: Intake is closed because of non-irrigation season at present. On the right: Sediment condition in front of the gates.

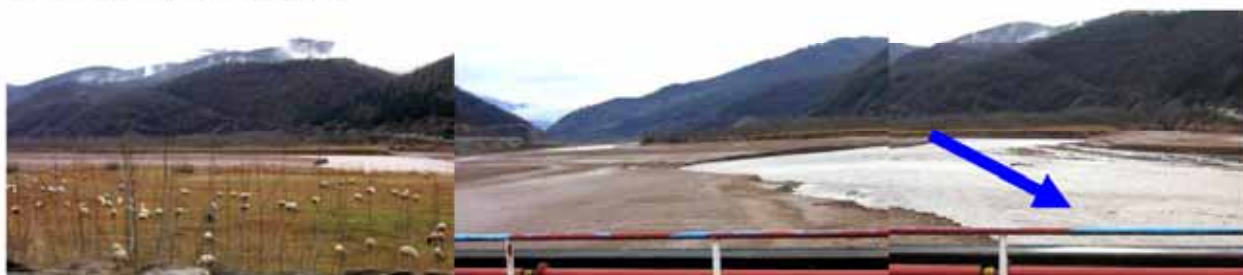
Photo-18: Sediment Condition on Upstream of the Dam

On the left: Sediment deposition can be seen mainly on the right bank of the immediate upstream of the Tarik diversion dam. On the right: River course of the Sefidrud is aligned on the left through the sediment deposition.

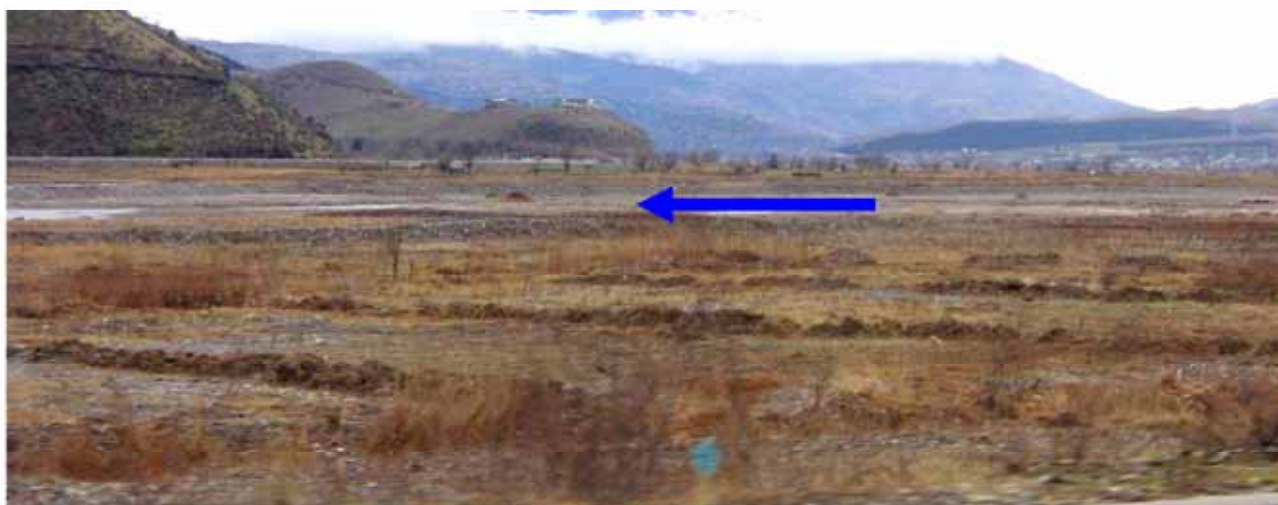
Photo-19: Lower reaches of the Sefidrud River

The lower reaches of the Sefidrud River forms wide river beds where paddy fields and sediment deposit can be seen. The sediment deposit on the paddy field may be flushed down with flood.

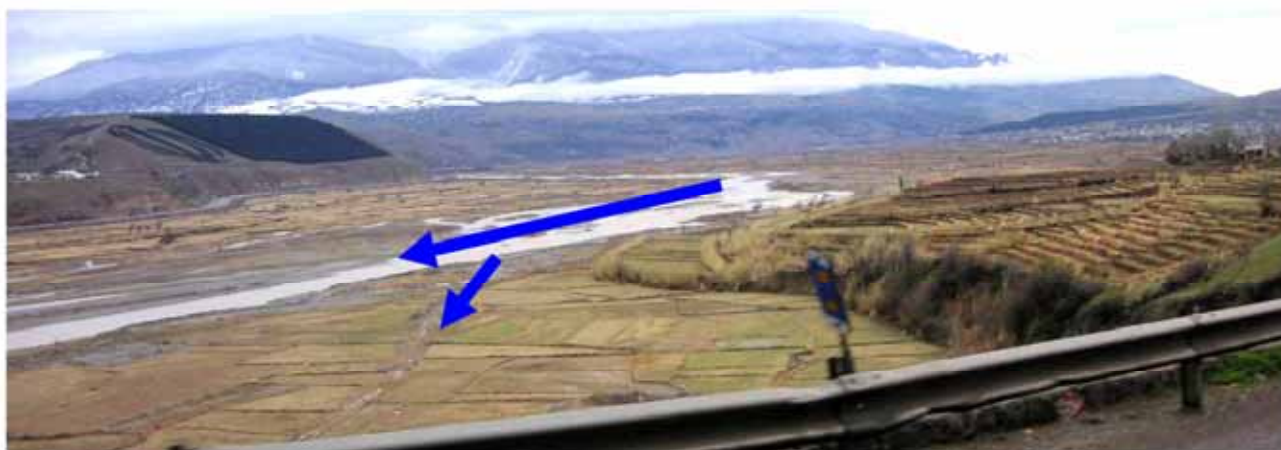
Photo-19: Cultivation along the River Bed of the Lower Reaches of the Sefidrud

On the Lower Reaches of the Sefidrud, where the river comes out to flat plain, river terraces are formed and utilized for paddy cultivation as is shown in the photo on the right. Even the river bank along the river course, paddy fields are developed taking the water from the Sefidrud River through the canal.

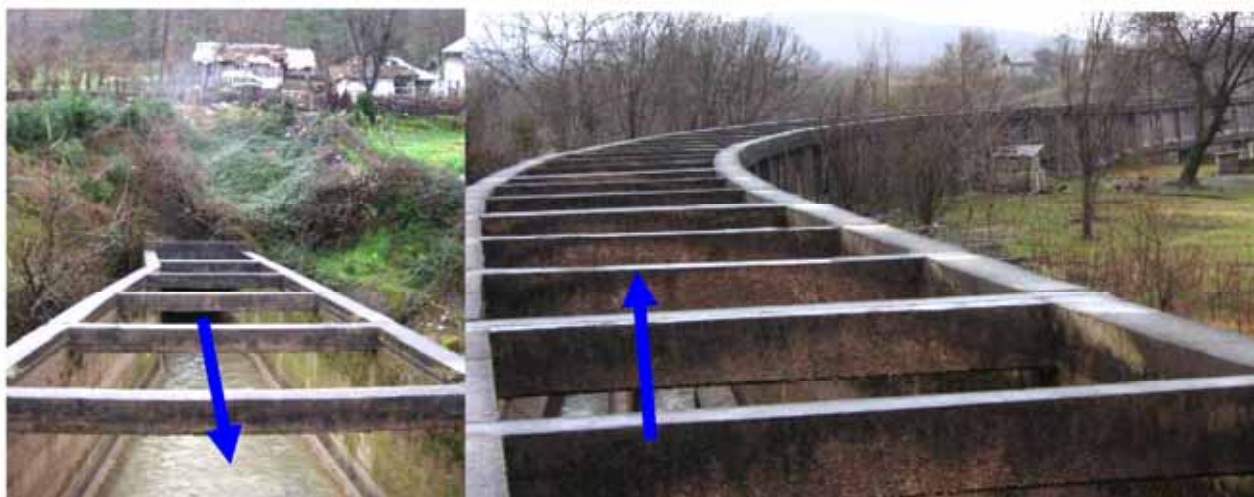
Photo-20: Outlet of Intake Tunnel and Adjacent Main Canal

Irrigation facilities have not been repaired for the last 38 years. Canal dredging is carried out once in every 4 to 5 years because of shortage of funds. On the left: Outlet of intake tunnel with the length of around 17 km constructed 38 years ago. On the right: Adjacent main canal.

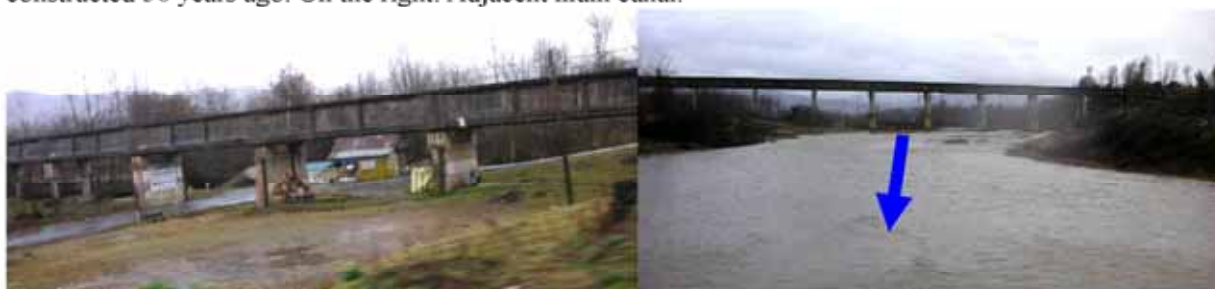
Photo-21: Aqueduct Bridges of the Main Canal

Main canal is passing through aqueduct bridges on rivers and plains in order to keep its gradient. On the left: Aqueduct bridge on the plain. On the right: Aqueduct bridge on one of the rivers.

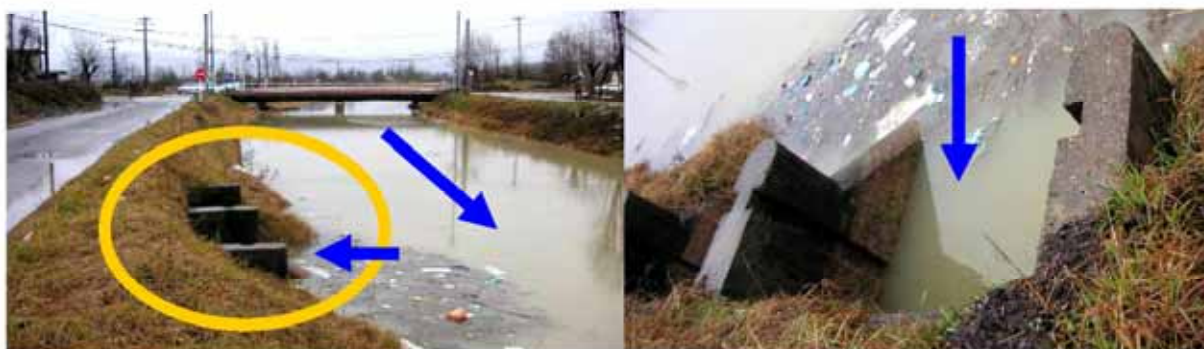
Photo-22: Main and Intake of Secondary Canal

On the left: Main canal and intake of secondary canal. On the right: Intake of secondary canal.

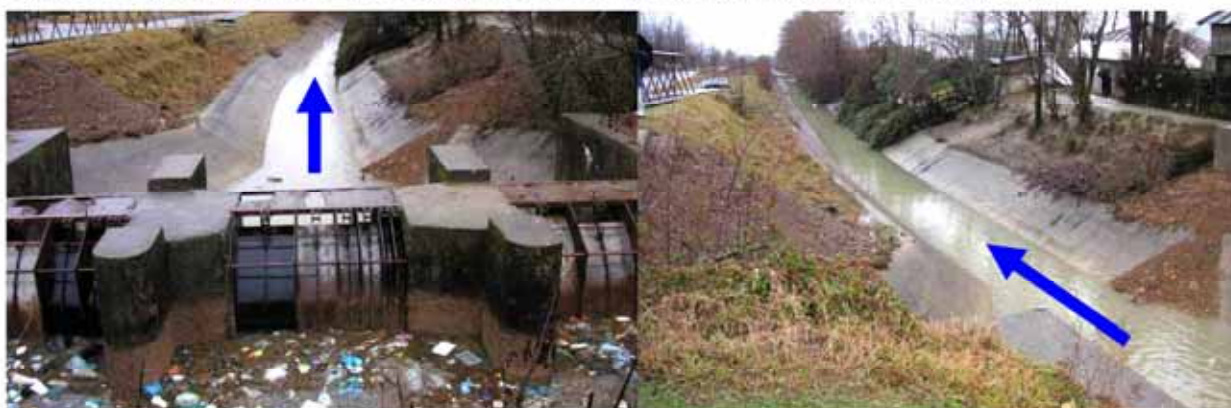
Photo-23: Intake Gate of Secondary Canal and Secondary Canal

On the left: Intake gate of secondary canal, which has been deteriorated. Replacement is required for the gates.
On the right: Secondary canal condition.

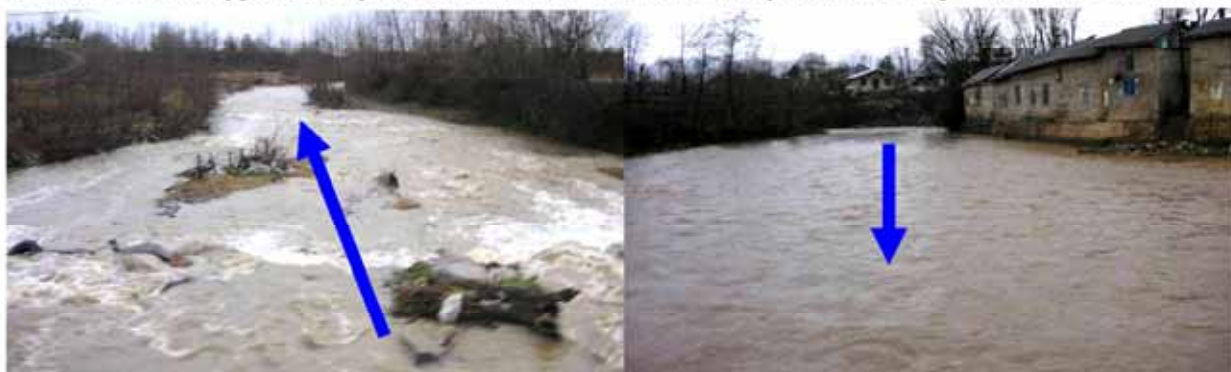
Photo-25: Rivers flowing down Galan Irrigation Area

There are 15 small rivers flowing down Gilan irrigation area and in winter season these rivers are sometimes flooded as shown in the photos. Irrigation water is taken from these rivers in the beginning of irrigation season until June, however the rivers are dried out and the water from the Sefidrud River is required. The water resources of these small rivers must be utilized.

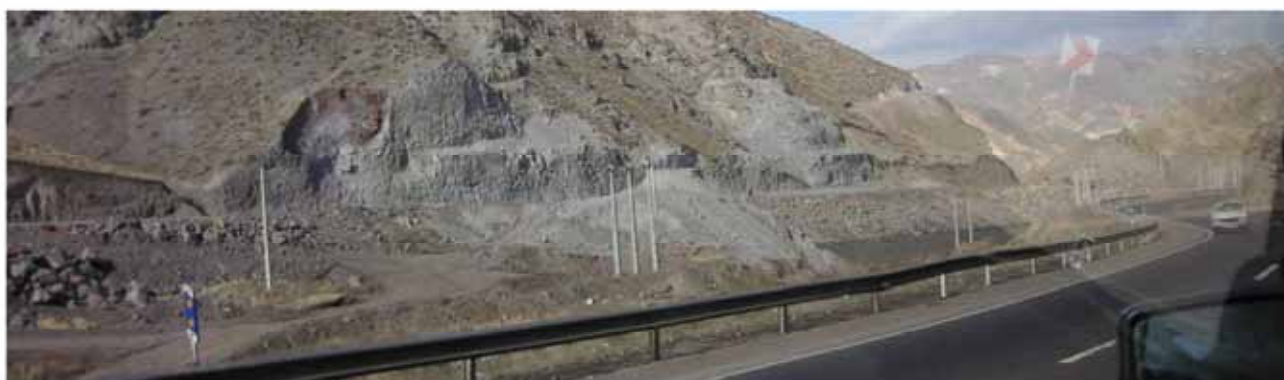
Kuhin より Lowshan に至る道路は、Molla Ali 川に隣接しており、さらに新たな道路が急傾斜の崖を切り崩して Mokka Ali 川の河川敷の埋め立て工事が実施されている。同河川は Lowshan で Shahrud 川に合流し Manjil ダムに流入し、ダムの堆砂および水質汚濁の主要な原因となっている。これらの道路工事や各種の建設工事における土砂流出対策、砂防対策の検討が求められる。河川に土砂を放置しないこと、河川に土砂を流さないなどの河川環境保全対策の徹底が重要と考えられる。道路工事における EIA や環境社会配慮検討の徹底が求められる。

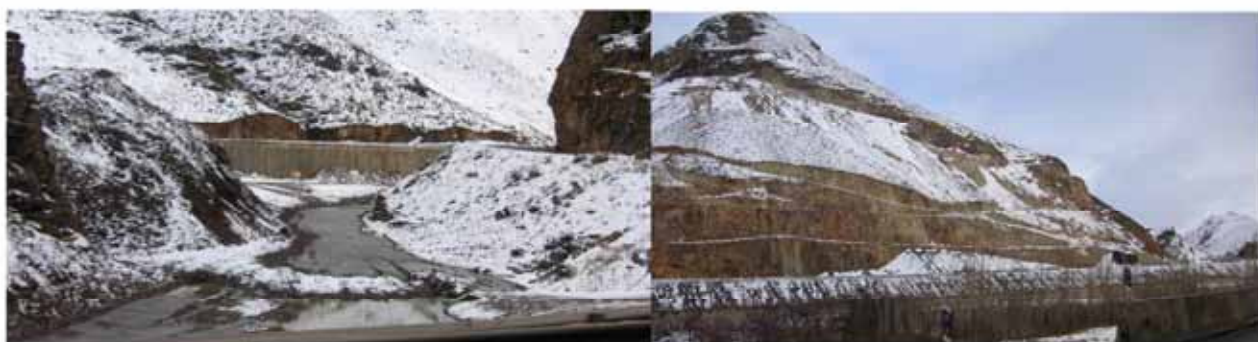
Molla Ali 川上流域における道路工事における山腹斜面掘削および土砂による河川敷の埋設の状況。この工法によって排出された土砂が洪水時に下流へ運搬されダムに堆積する。

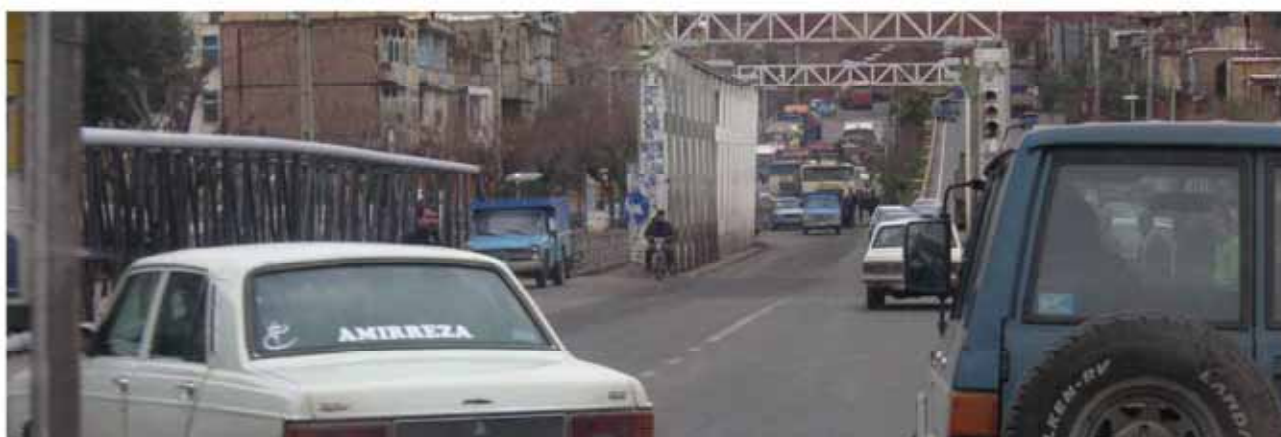
Lowshan 市内で Shahrud 川にかかる道路の橋梁が交通のボトルネックとなり、地域交通渋滞の原因となっている。また、同じ場所で川幅が最も狭くなっており、橋脚などの構造物が流下能力の制限要因となっている。

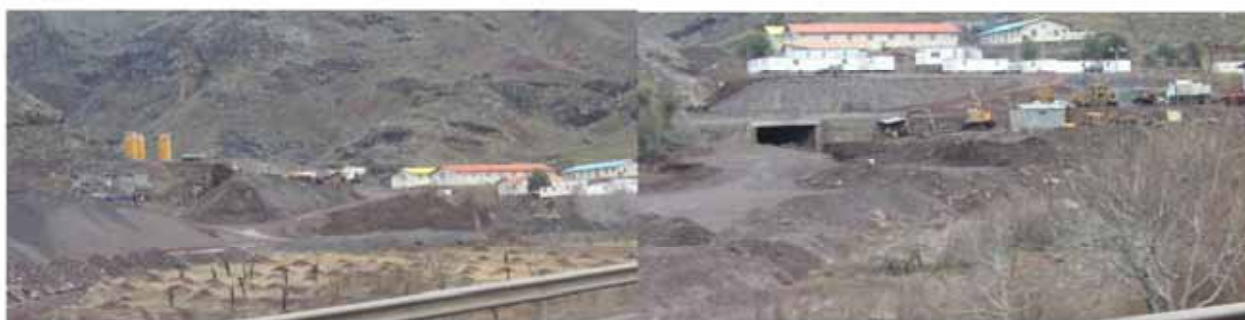
Shahrud 川下流域で河川敷に隣接する山腹で山砂の採石が行われており、これらの土砂が河川敷で貯留堆積されており、洪水とともに流下する可能性がある。

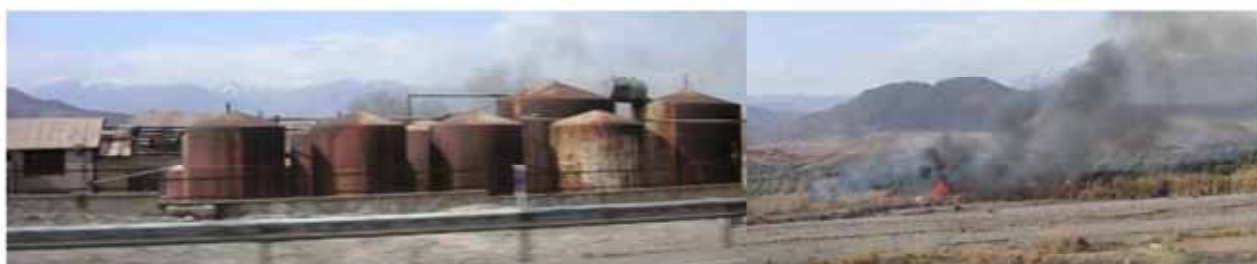
Sefid rud 川下流域では河川敷に隣接してかなり古い設備の工場群が立地しており、これらの工場からの未処理水の排水がダムの水質悪化の原因となっている。ダム上流域の工場等における排水管理や排

水浄化対策が求められる。また、河川敷で廃棄物の焼却が行われており、このような行為が水質悪化の原因となるため、河川敷における廃棄物の投棄や処理を中止させる対策が求められる。

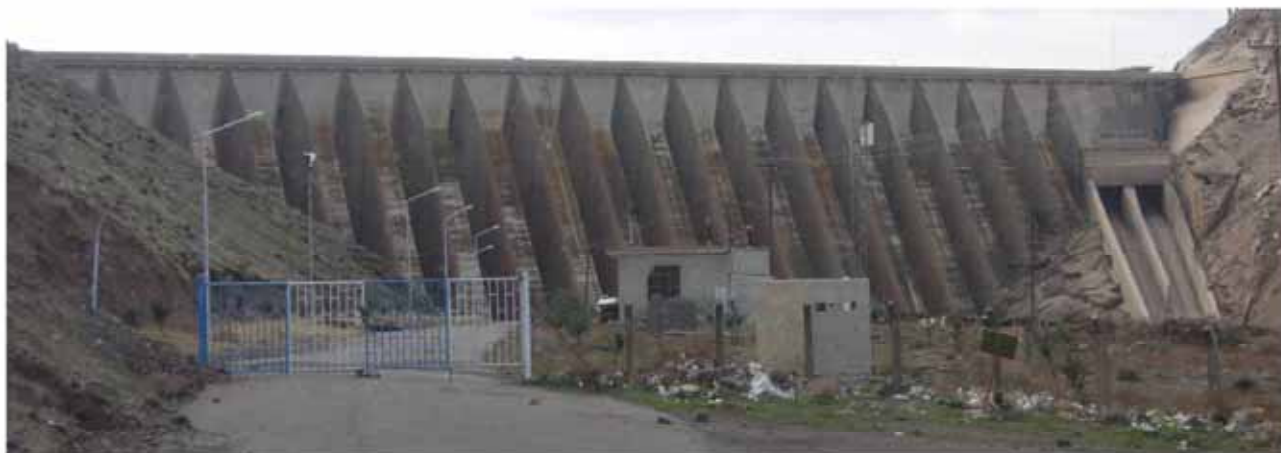
Manjil Dam 堤体下流側、地形的には好条件を備えた位置にダムが立地しており、規模も理想的である。発電所の設置位置は経済的・効率的に設計されている。下流側に発電所を設置して落差を大きくとれば設備費は大きくなるが、同じ水量で発電量を大きくすることは可能であったと考えられる。

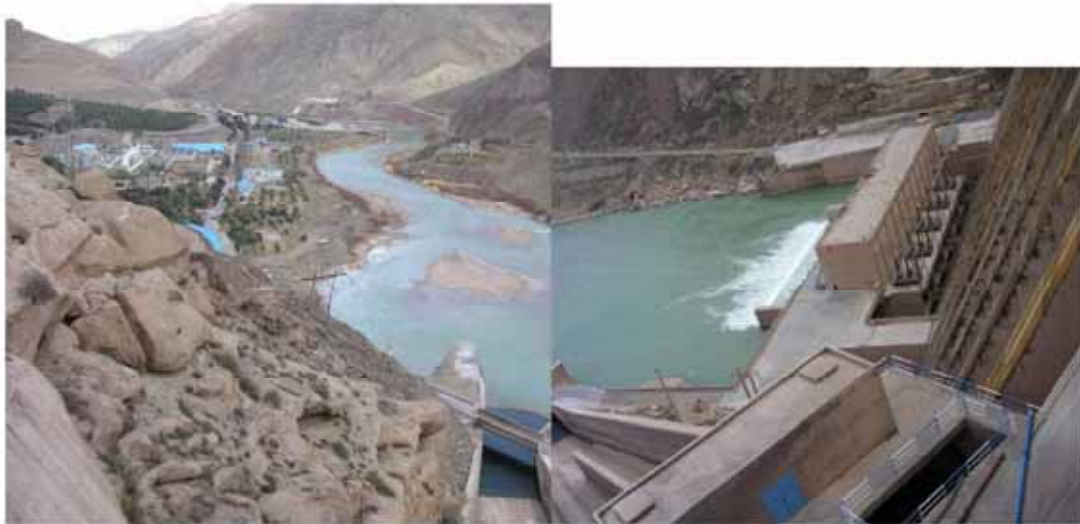
ダムの下流側河川および発電所の位置、余水吐の先に堆砂が見られる。

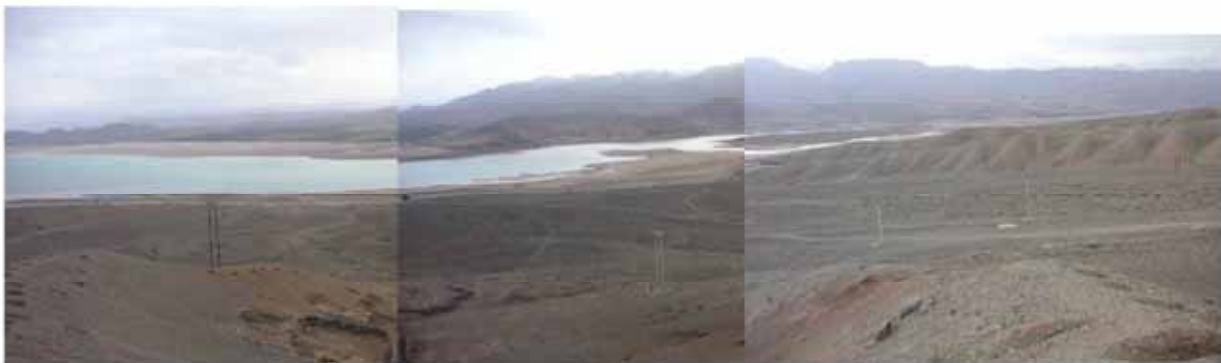
ダム湖左岸西側の Qezel Ozan 川の堆砂状況（写真中央部の砂州が堆砂の最も多い箇所）

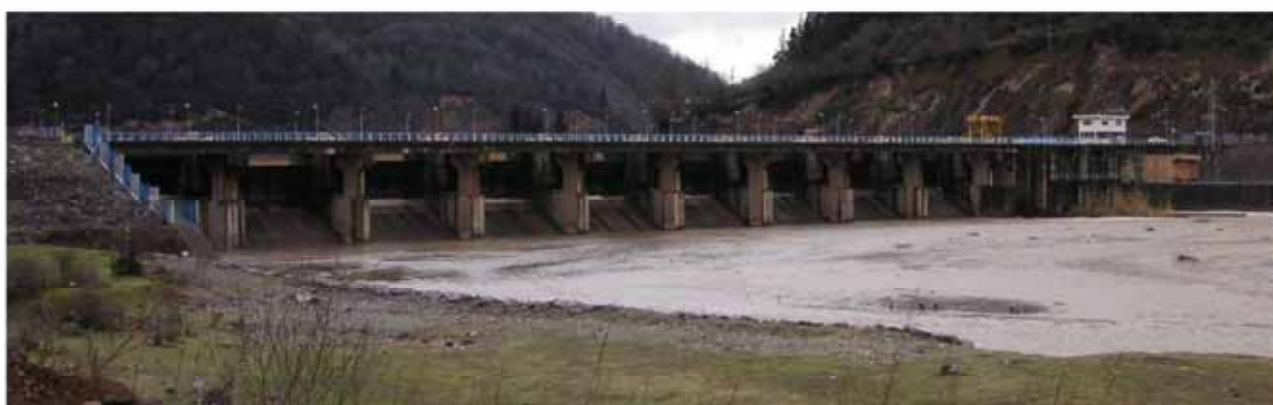
Gilan 灌漑用水の頭首工、Tarik Dam の下流側、排砂ゲートによる排水が行われており用水路への取水は行われていない。この頭首工からトンネルによる導水が行われ、ギラン地区左岸側の灌漑用水水源となっている。

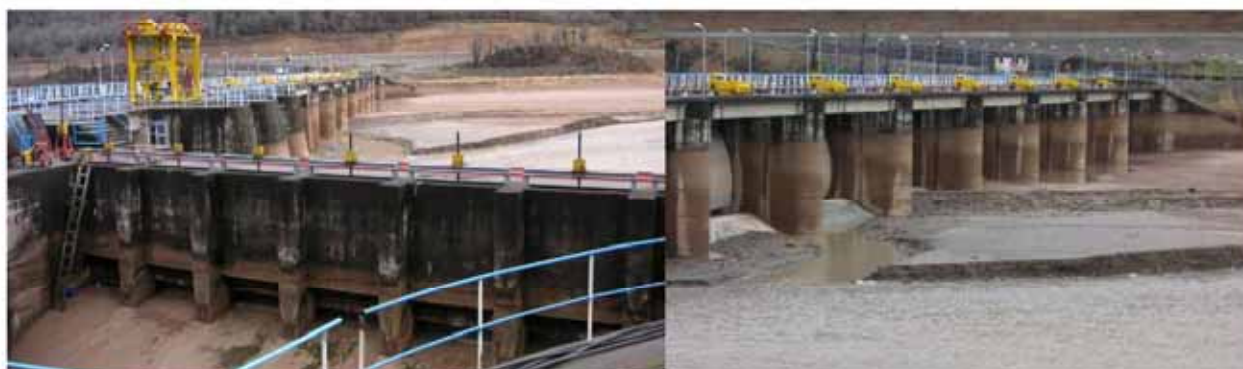
水路への取水口と水門前の堆砂状況、取水機能は維持されているが、貯水能力は極めて小さい。

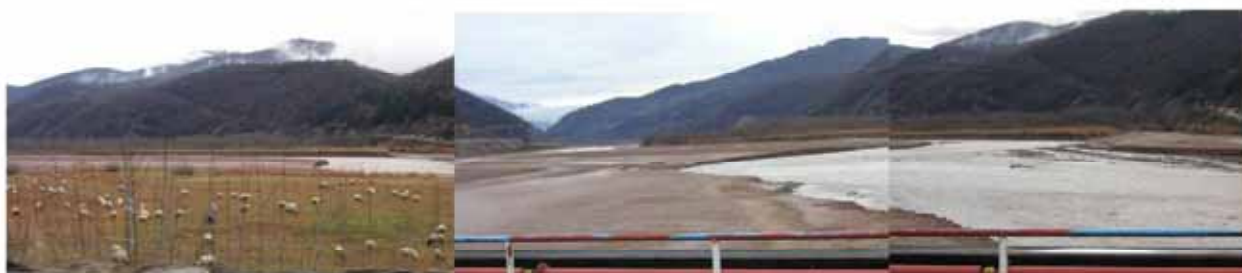
ダム湖の堆砂状況、ほとんど全面に堆砂があり、右岸側は草地となっており羊が放牧されている。

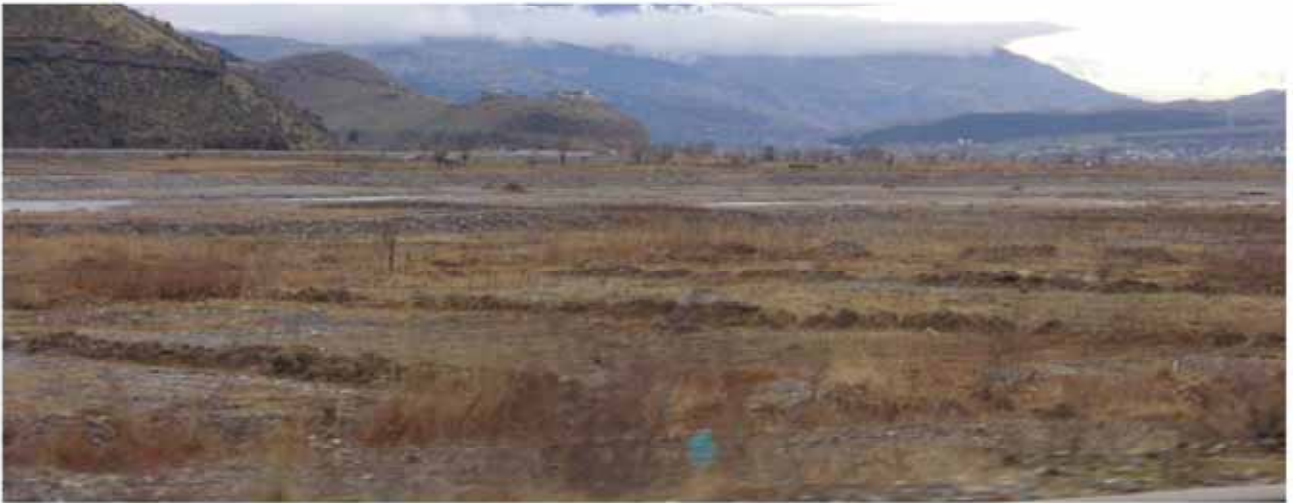
平野部に入って川幅の広いところは流れが緩やかとなり土砂の堆砂が多く見られる。また、水田に土砂が堆積した状況が見られる。

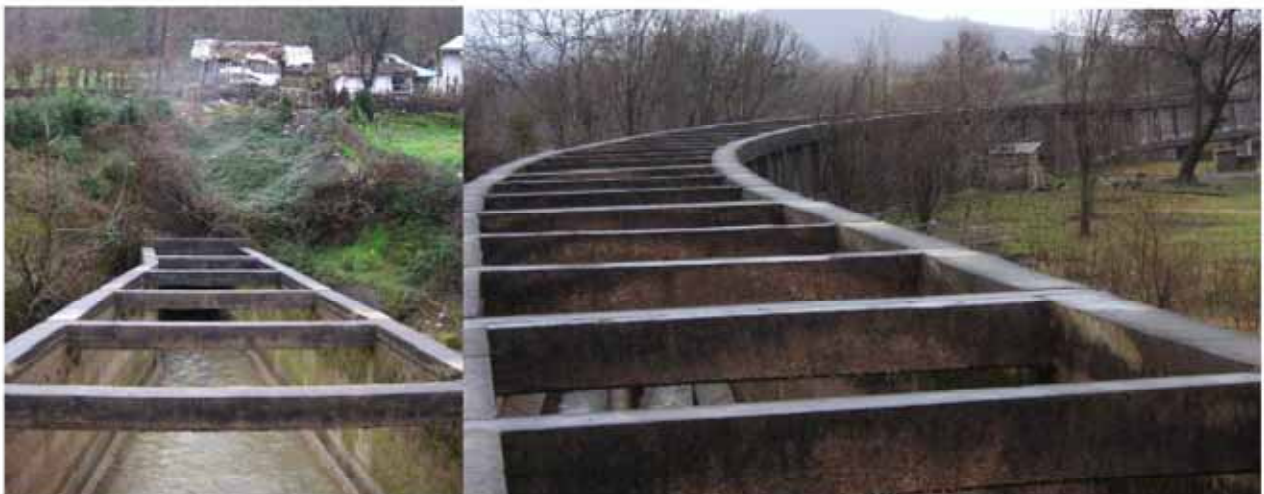
一次水路トンネル出口とそこから続く水道橋の状況、水門などの劣化が目立ち、水路自体管理がなされているが、ゲートなどの改修が望まれる。

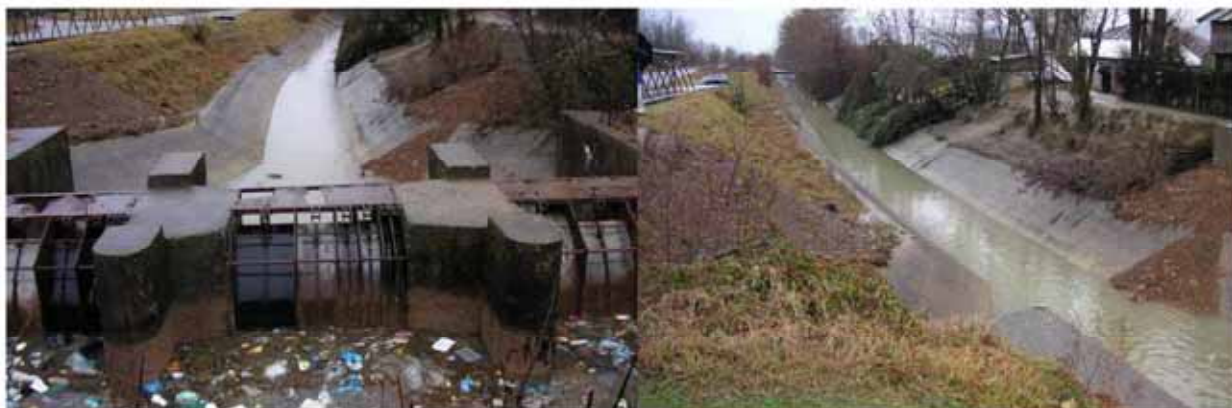
道路を挟んで第二次支線水路のゲートが設置されている。ゲートから第二次支線水路が続く。ゲートの劣化が進んでおり、早急な改修が望まれる。

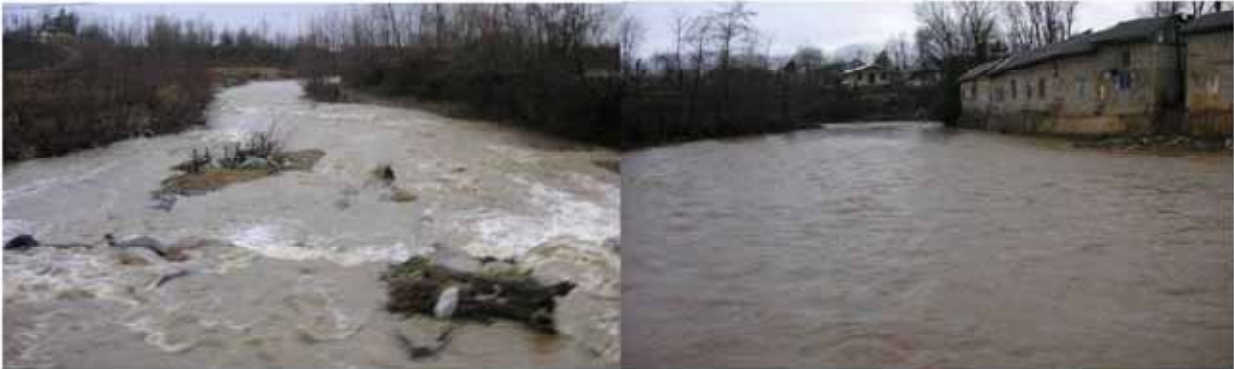
Gilan 州灌漑地域内の河川の状況、冬期は雨量が多く小河川が氾濫することもある。この河川からも取水がおこなわれているが、水の需要期には枯れる。有効な水資源の利用方法検討が望まれる。
