## 第3章 事業概要

### 3.1 事業の目的

#### 3.2.1 事業の概要

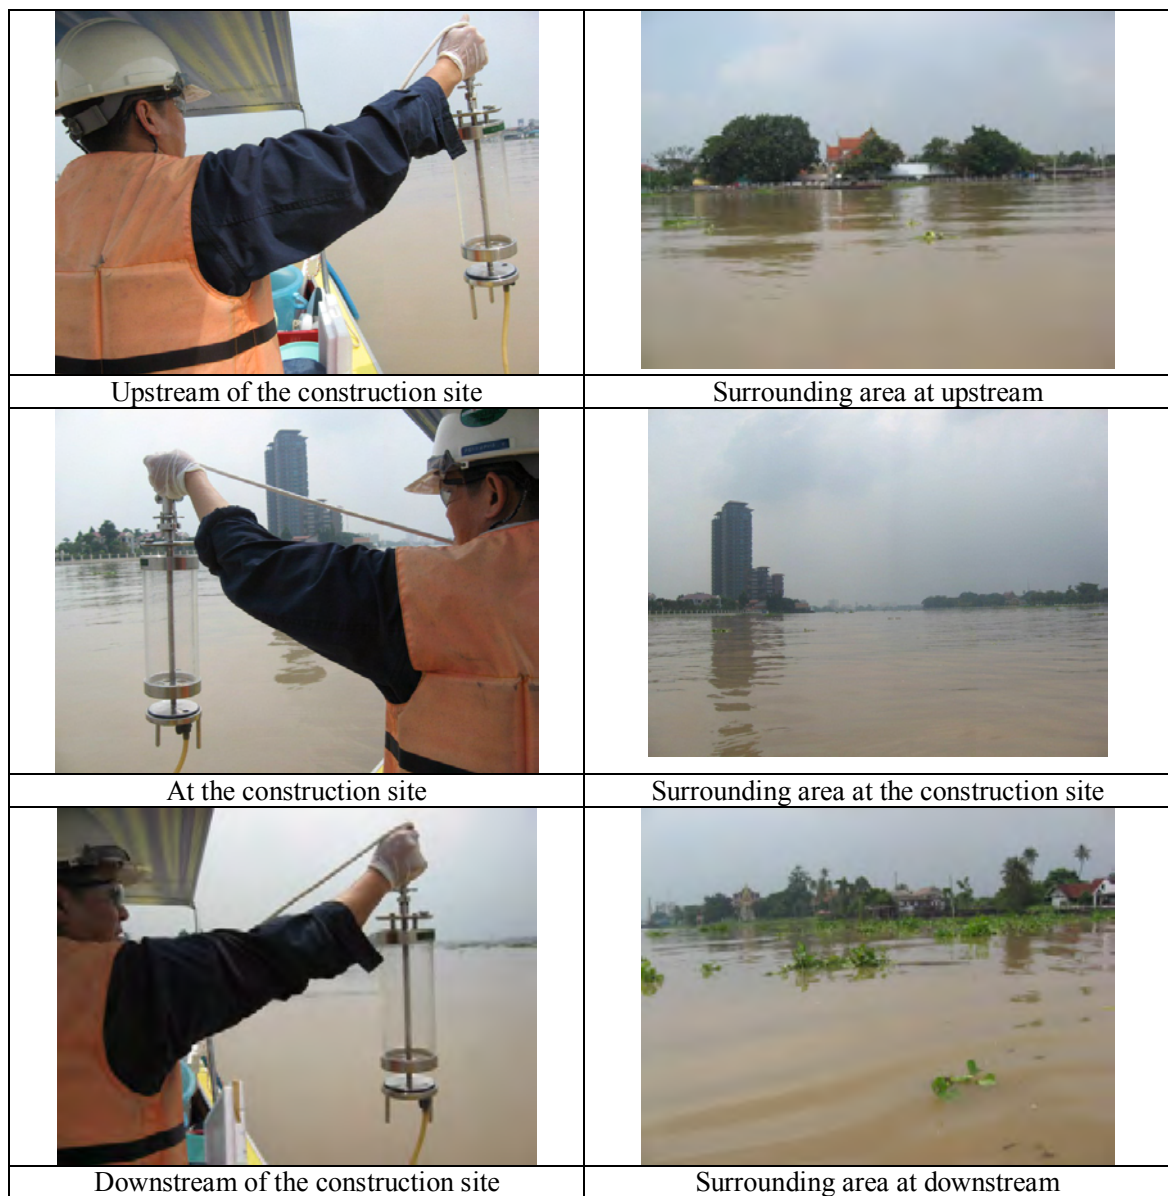
図 6.1.1 水質調査サンプリング状況

水質調査のサンプリング状況を図 6.1.1 に、調査結果を表 6.1.4 に示した。水質の調査地点は、チャオプラヤ川の架橋地点、並びに架橋地点の上流 1km、下流 1km 地点である。

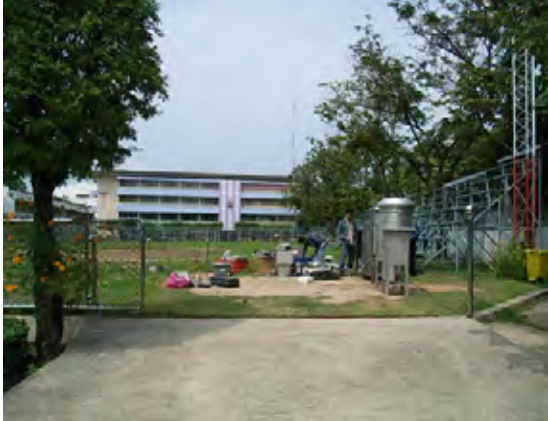
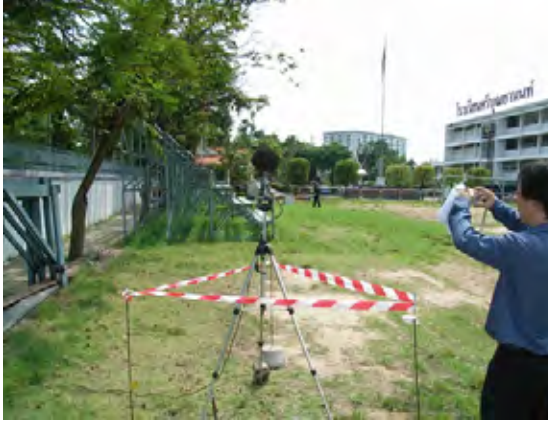
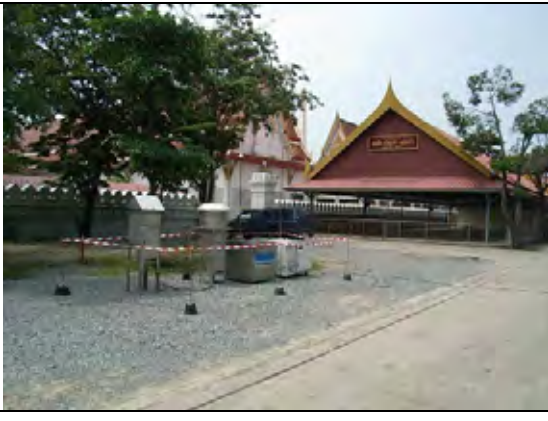
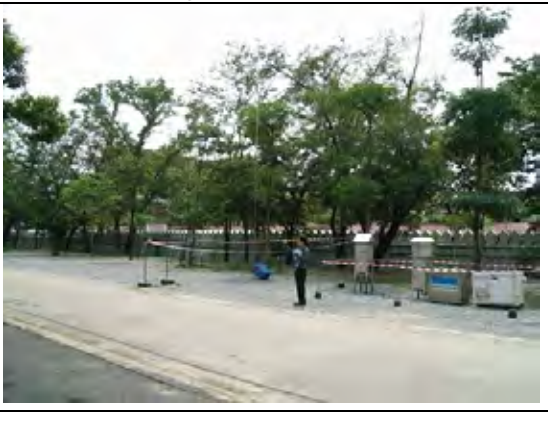
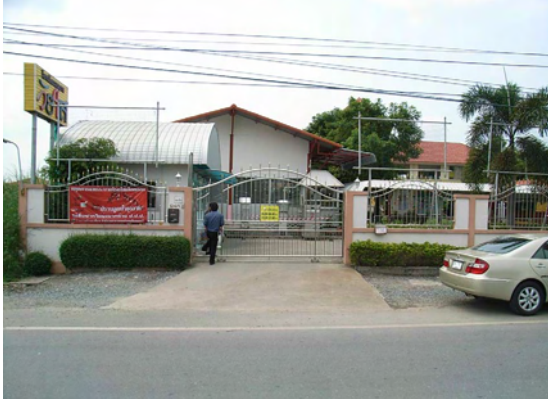
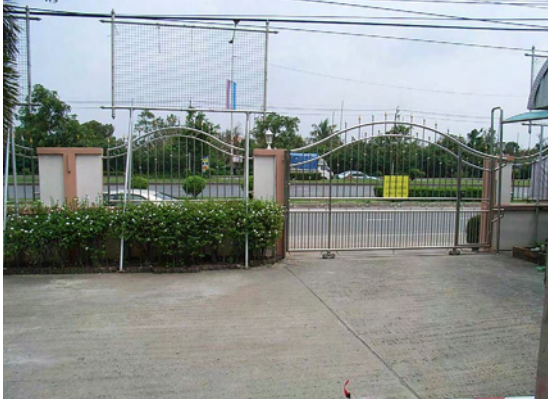
図 6.1.2 大気質、騒音、振動の調査地点状況

大気質調査の比較結果を表 6.1.5 に示した。大気質及び騒音・振動の調査地点状況写真を図 6.1.2 に示した。

| Sri boonyanon school | View to Planning Road direction |
| Wat chalerm pra klat | Pole for weather monitoring |
| Wai sai kindergarten | From sampling point to Road |

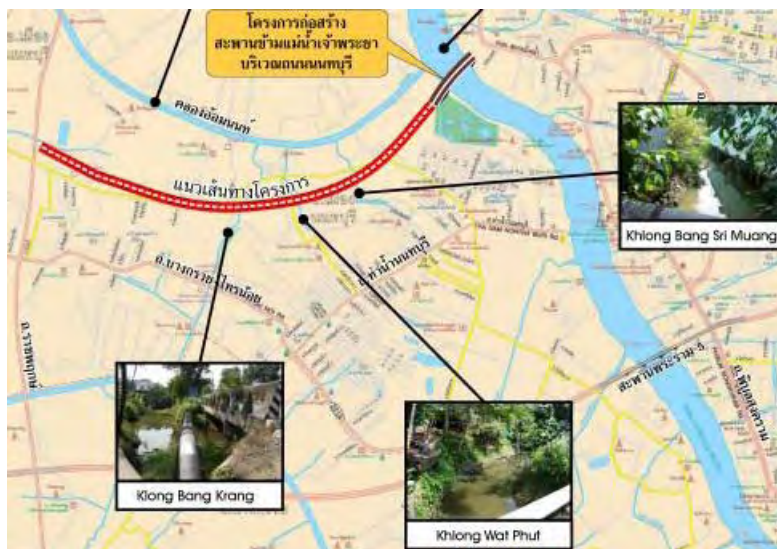
図 6.1.5 計画道路が中小河川と交差する地点

また、計画道路は図 6.1.5 に示すとおり 3 箇所小さな運河と交差する。

3 箇所の交差部のうち、東側のクローン・バンスリムアンは高架構造で計画されている。クローン・ワットプートとクローン・バン克蘭は、計画道路が盛土構造であるが、河川との交差部では橋梁で跨ぐ計画となっている。工事は乾期を中心に実施され、河川の仮締切りや切り回し工法を採用することにより、現在の河川機能を保持することから工事中・供用後とも洪水や土砂流失による水質汚濁への影響は殆ど無いと推定される。
