CHAPTER 3 PROJECT OUTLINES

3.2.1 PROJECT OUTLINE

The Project starts from Nonthaburi 1 Road on the east side of the Chao Phraya River, pass over the river by an extradosed bridge and ends at Ratcha Phruk Road on the west side of the river.

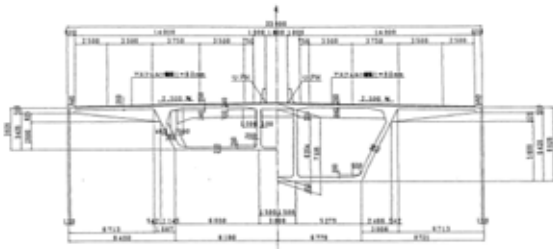
Deck Slab	Span	6.780m	
		Thickness	0.260m	
	Deck Slab Reinforced Rib	Spacing	2.500m	
		Height	1.200m	
		Thickness	0.250m	
	Web Minimum Thickness	Outside Web	0.350m	
		Inside Web	0.300m

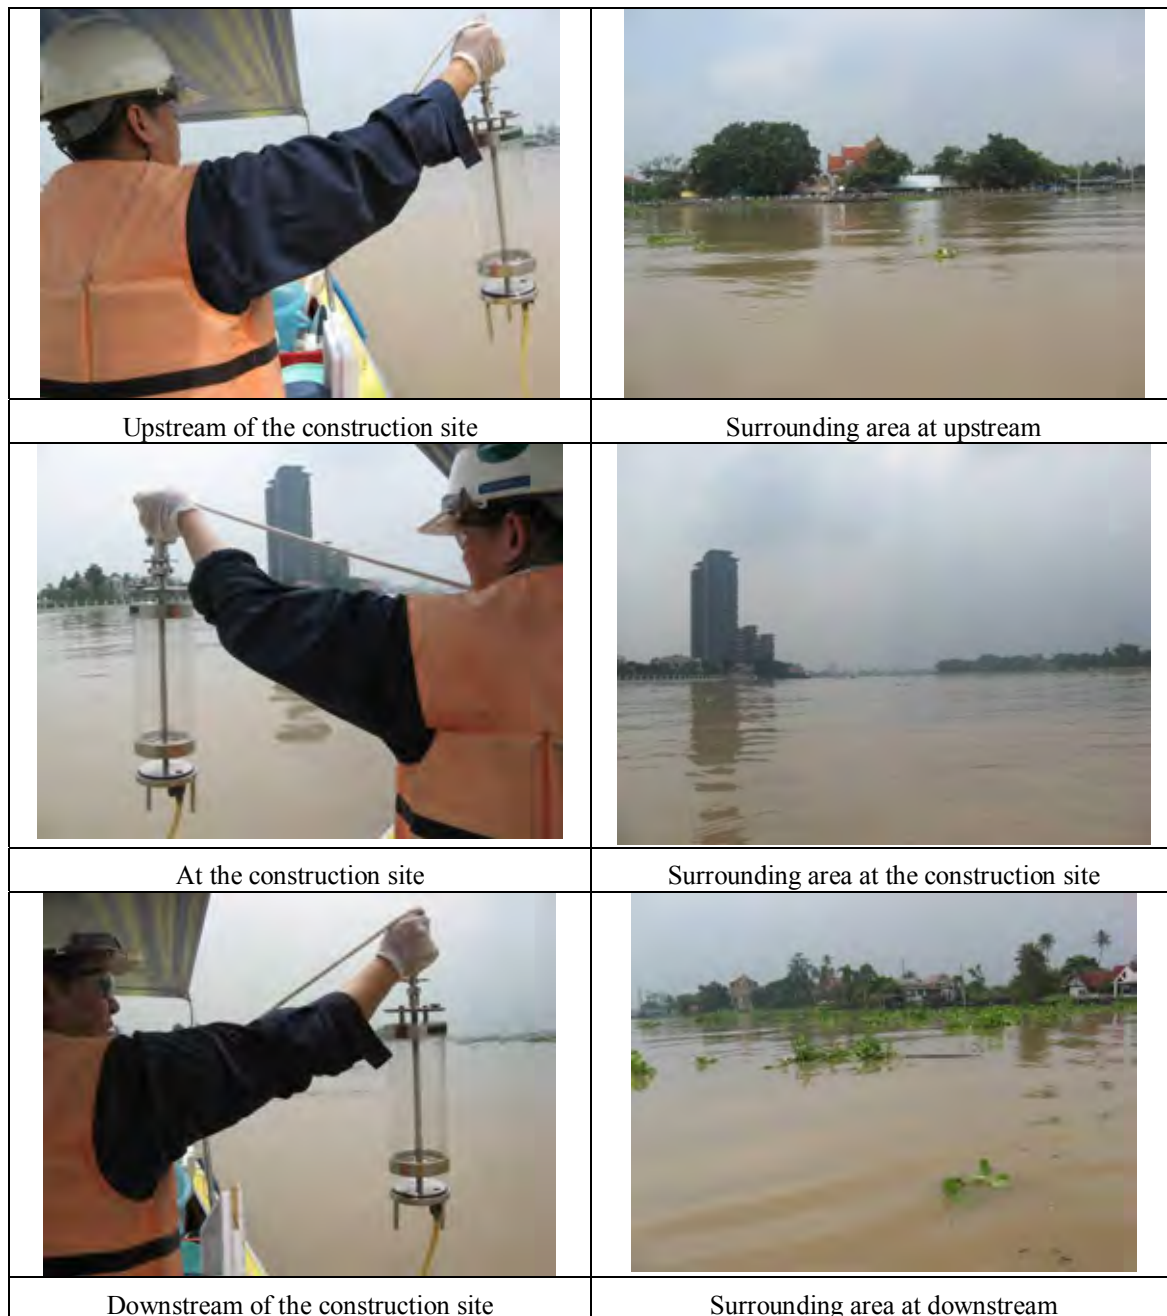
Figure 6.1.1 Status of Water Sampling

The present status and conditions of the locations of sampling points can be seen in the selected photographs shown in Figure 6.1.1 and the laboratory water quality result was shown in Table 6.1.4. It has to be noted that the water sampling locations are within one kilometer upstream of the construction site, and limited to one kilometer downstream of the construction site.

Station 3: Chao Phraya River (Downstream of the construction site)

*Sampling date: supplement survey October 7, 2009 and EIA report August 20-21, 2005

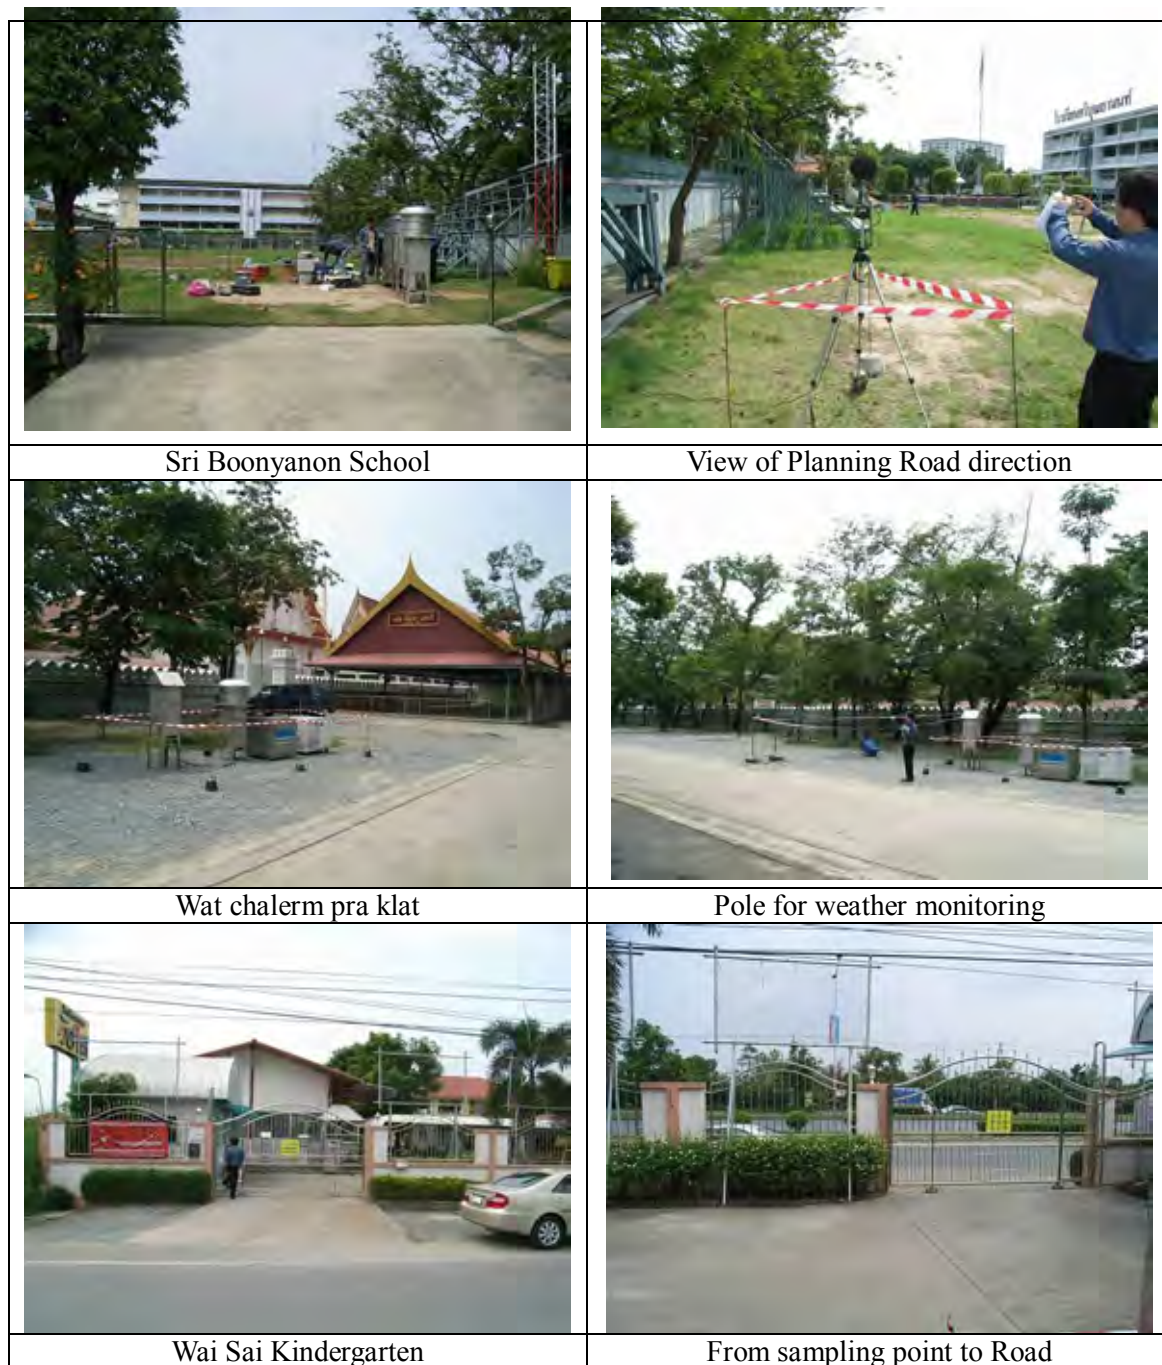
Figure 6.1.2 Status of Sampling Locations for Air and Noise/Vibration

Air quality survey result was shown in Table 6.1.5. Status of air quality and noise/vibration sampling locations were shown in Figure 6.1.2.

Air quality samplings as reported in the EIA report were conducted during Saturday and Tuesday dated 20-25 August 2005, and the supplemental surveys were also conducted during Saturday and Thursday dated 10-15 October 2009 for almost five consecutive days. CO, and NO₂ level tended to be higher than the levels of pollution mentioned in the EIA. But all in all, the air pollution concentration, including the ozone level, were still below the maximum limit stated in the standard.

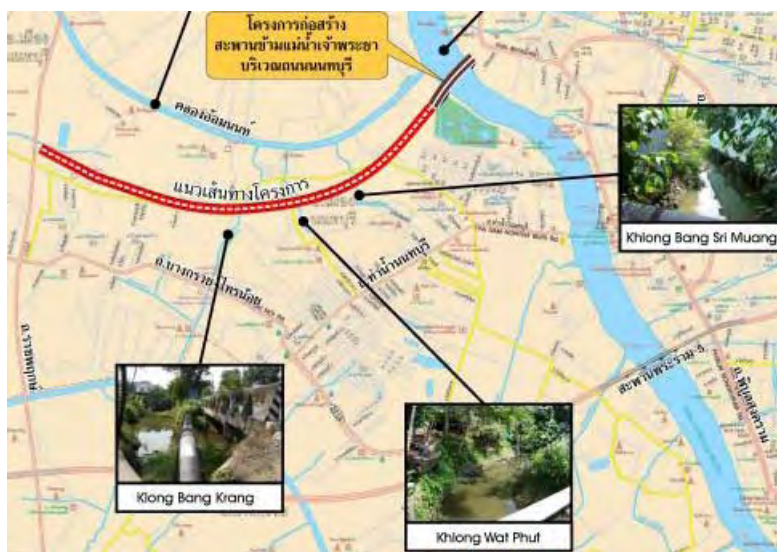
Figure 6.1.5 Location of Small Canal Crossing

On the east side of Project Area, the planned road section has a road crossing with three small canals as shown in Figure 6.1.5.
