**PREPARATORY SURVEY  
FOR  
THE CHAO PHRAYA RIVER  
CROSSING BRIDGE AT  
NONTHABURI 1 ROAD  
CONSTRUCTION PROJECT**

**FINAL REPORT**

**JANUARY 2010**

**NIPPON KOEI CO., LTD.  
CHODAI CO., LTD.**

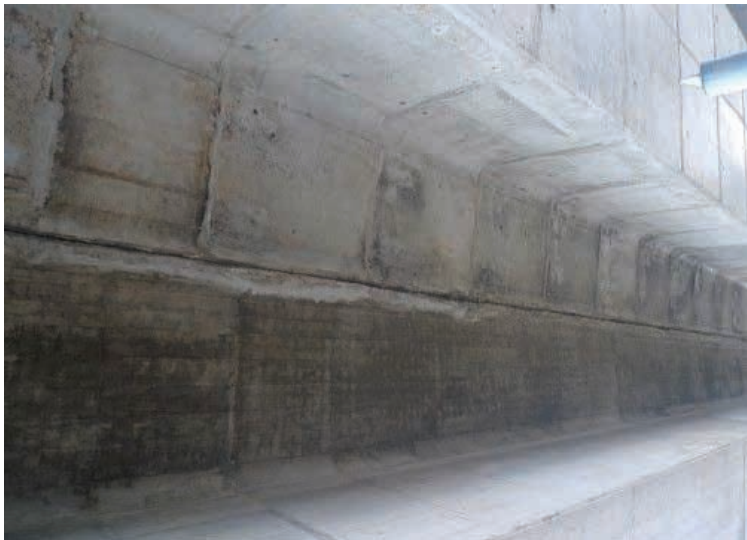
Picture No.	4
	Span	1
	Member	Longitudinal joint
	Longitudinal joint between girder	
	Leakage from joint

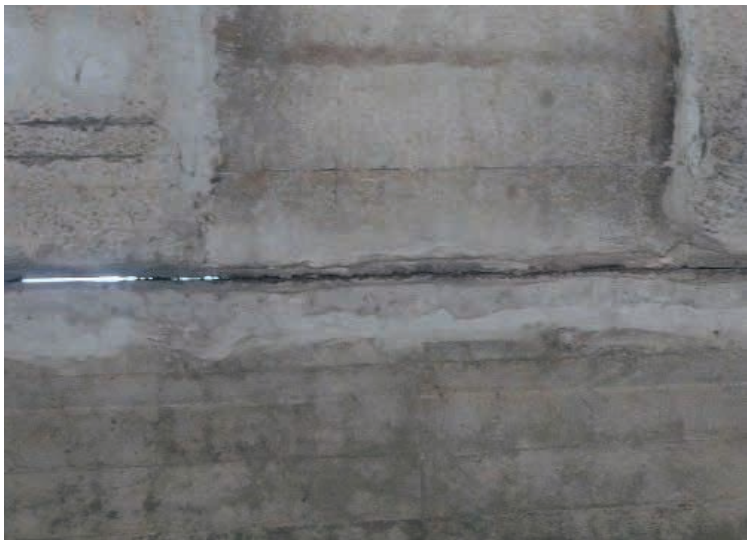
Picture No.	5
	Span	1
	Member	Longitudinal joint
	Longitudinal joint between girder	
	Exfoliation of concrete

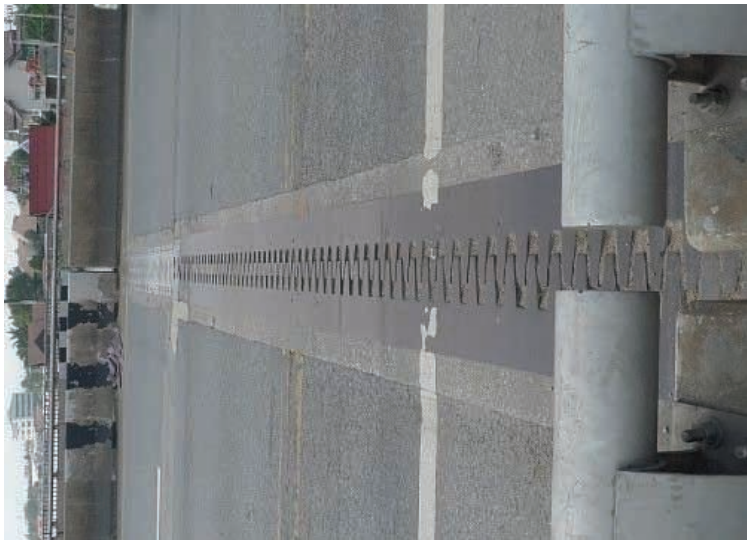
Picture No.	7
	Span	1
	Member	Side barror
	コンクリートの剥離

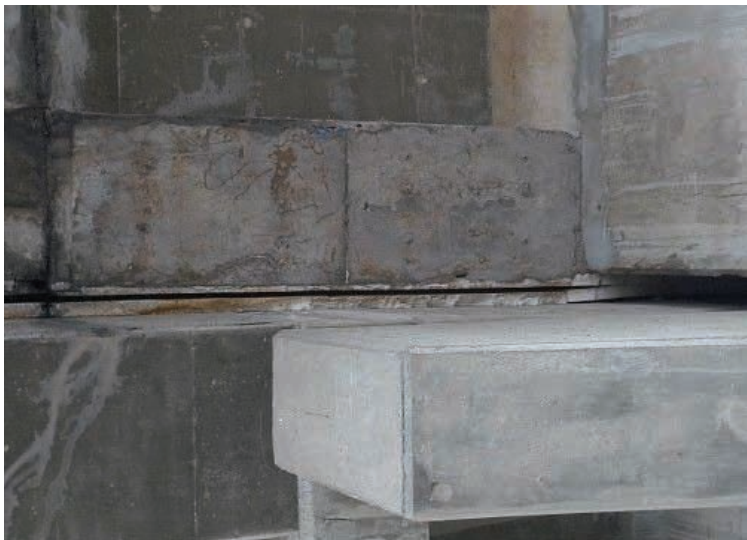
Picture No.	8
	Span	1
	Member	Expansion joint
	Leakage

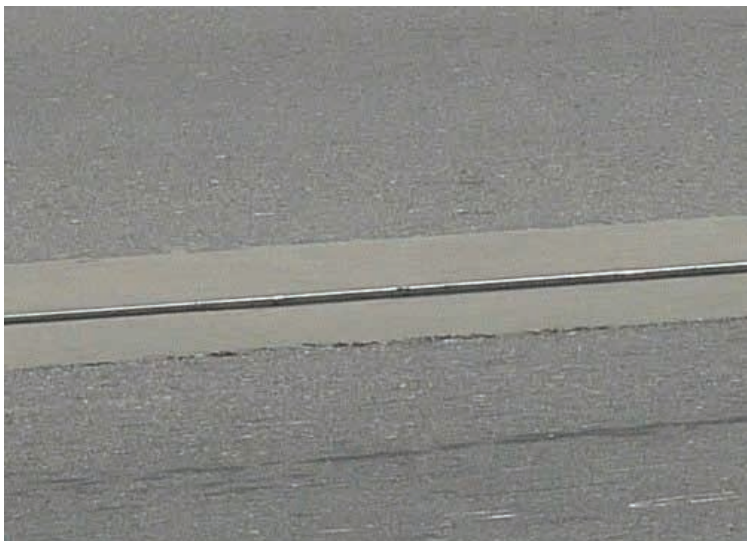
Picture No.	9
	Span	1
	Member	Longitudinal joint
	Difference of grade

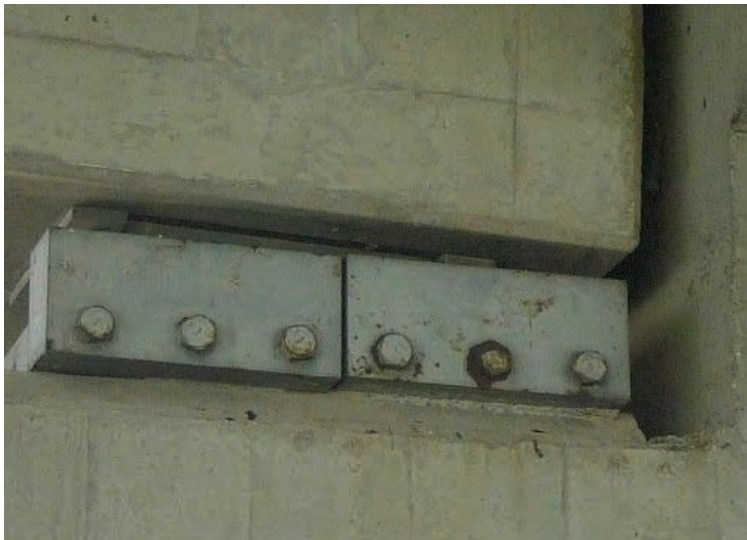
Picture No.	10
	Span	1
	Member	Bearing
	Deterioration of corrosion proofing

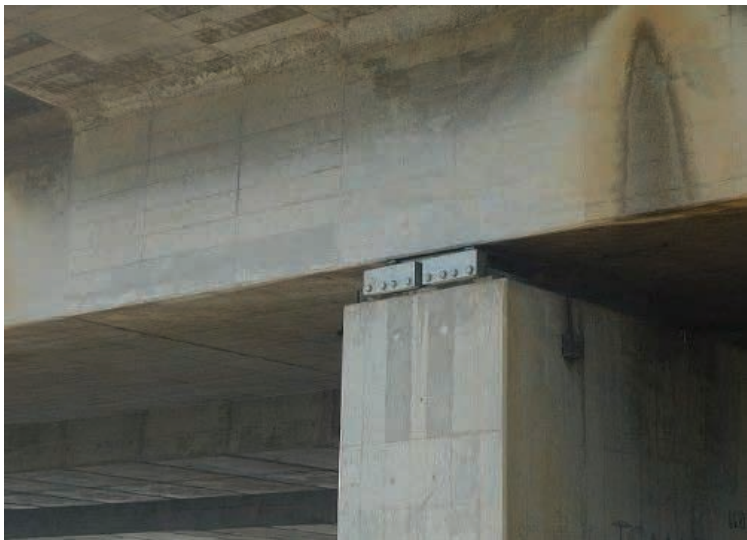
Picture No.	11
	Span	1
	Member	bearing
	Spacing of side block	
<i>*Survey on board, 31-oct</i>

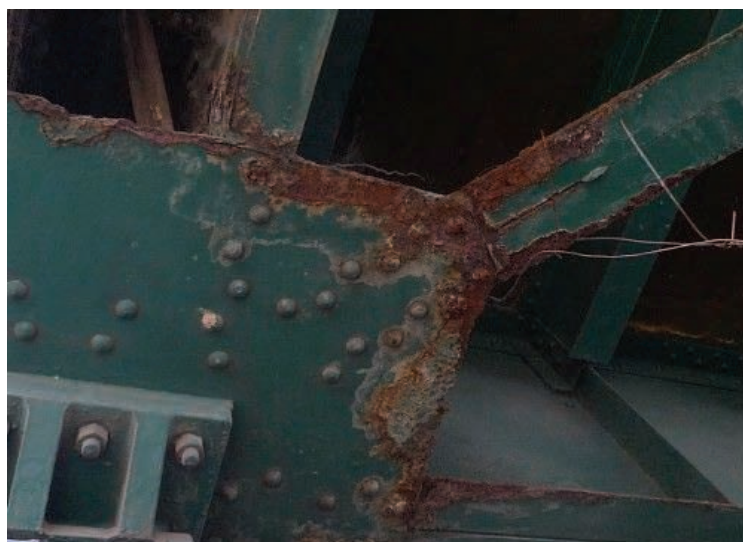
Picture No.	9
Span	1
Member	Approach bridge
Corrosion on bearing	
Deterioration of corrosion proofing

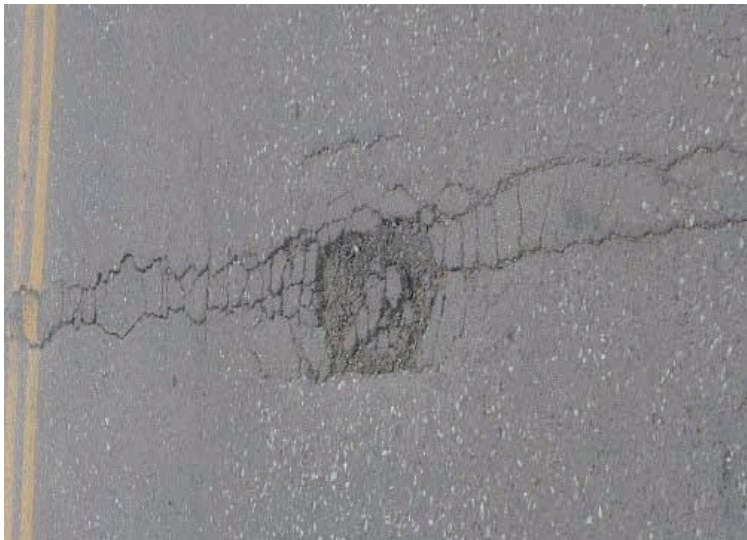
Picture No.	22
	Span	1
	Member	Pavement
	Breaking of pavement on cross beam	
	Severe leakage is found on bottom slab.	
	It is estimated that this breaking go through slab.

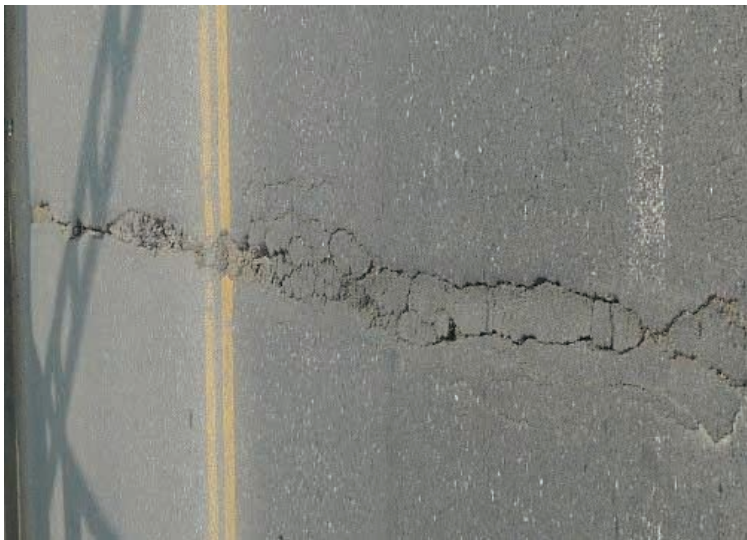
Picture No.	23
	Span	1
	Member	Pavement
	Breaking of pavement on cross beam

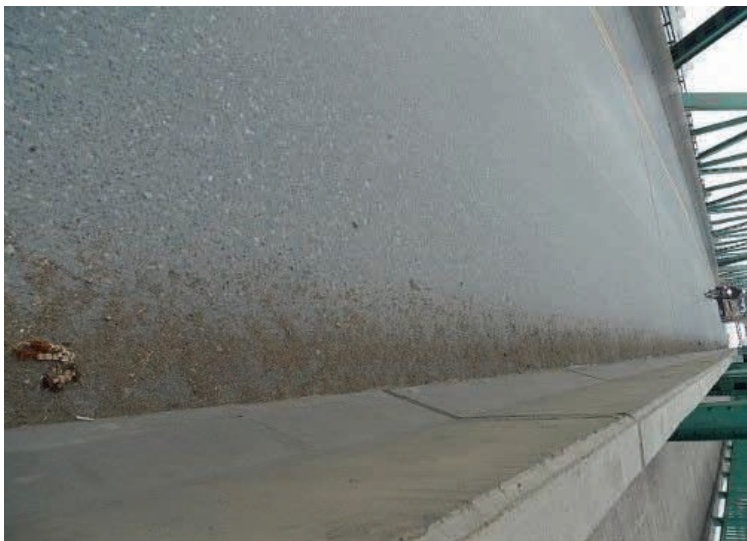
Picture No.	24
	Span	1
	Member	Drainage
	Catch basin may exist under barrier	
	Deterioration of drain function

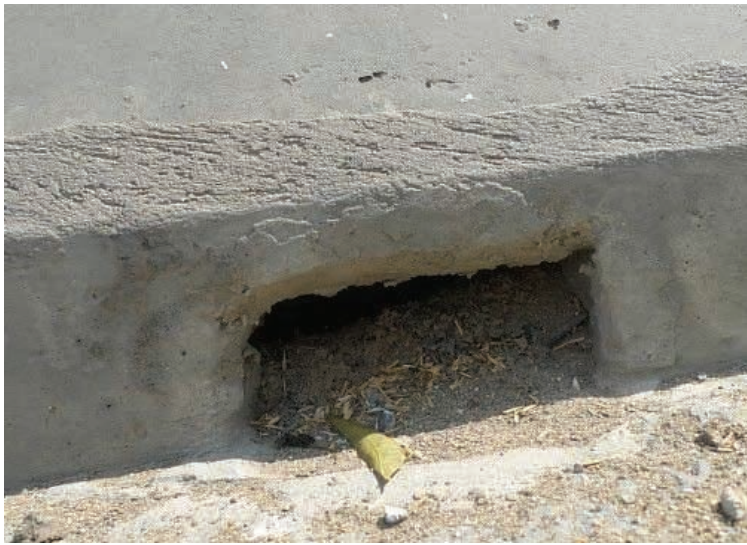
Picture No.	25
	Span	1
	Member	Drainage
	Drainage under barrier

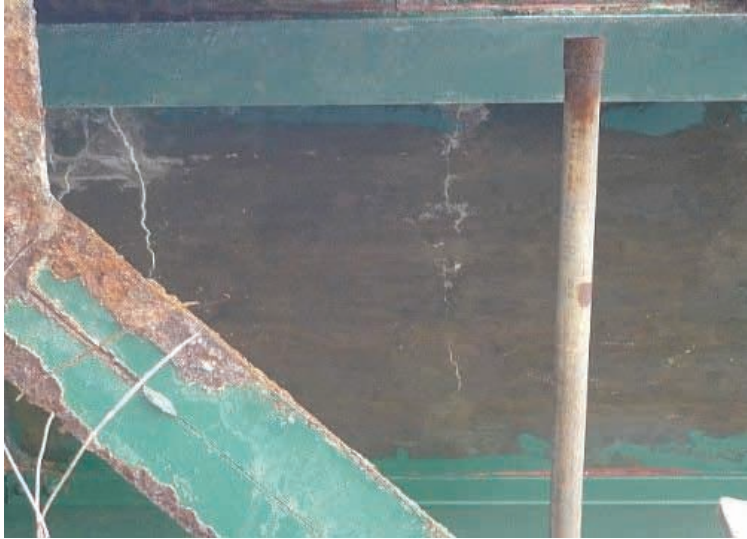
Picture No.	26
	Span	1
	Member	slab
	Crack	
	Free lime

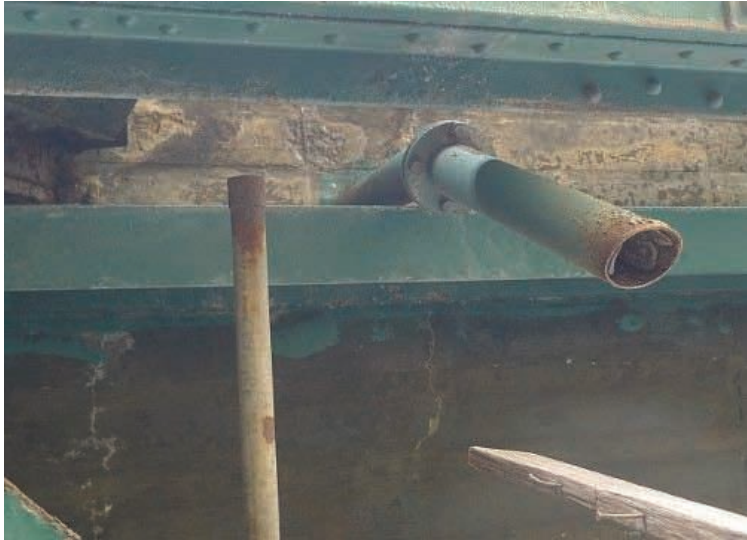
Picture No.	27
	Span	1
	Member	Slab
	Deterioration of corrosion proofing	
	Fracture of concrete surface	
	Free lime

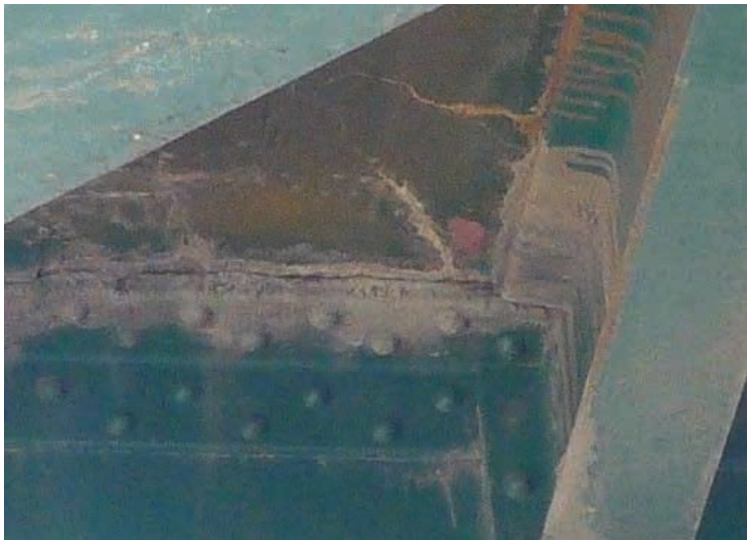
<table border="1" style="width: 100%; border-collapse: collapse;"> <tr> <td style="width: 15%;">Picture No.</td> <td style="width: 85%;">31</td> </tr> <tr> <td>Span</td> <td>1</td> </tr> <tr> <td>Member</td> <td>Slab</td> </tr> <tr> <td colspan="2">Leakage from slab on cross beam</td> </tr> <tr> <td colspan="2">Crack, free lime</td> </tr> <tr> <td colspan="2">Concrete slab was changed to dirt</td> </tr> <tr> <td colspan="2"> </td> </tr> <tr> <td colspan="2"> </td> </tr> <tr> <td colspan="2">*Survey on board, 31-oct</td> </tr> <tr> <td colspan="2"> </td> </tr> <tr> <td colspan="2"> </td> </tr> </table>	Picture No.	31	Span	1	Member	Slab	Leakage from slab on cross beam		Crack, free lime		Concrete slab was changed to dirt						*Survey on board, 31-oct							
Picture No.	31																								
Span	1																								
Member	Slab																								
Leakage from slab on cross beam

Crack, free lime																									
Concrete slab was changed to dirt																									
*Survey on board, 31-oct

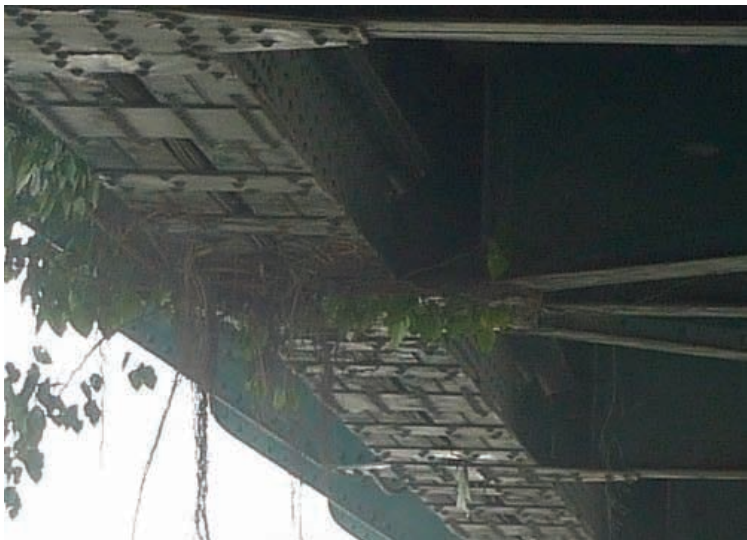
<table border="1" style="width: 100%; border-collapse: collapse;"> <tr> <td style="width: 15%;">Picture No.</td> <td style="width: 85%;">32</td> </tr> <tr> <td>Span</td> <td>1</td> </tr> <tr> <td>Member</td> <td>slab</td> </tr> <tr> <td colspan="2">Plant</td> </tr> <tr> <td colspan="2">Possibility of soil dump</td> </tr> <tr> <td colspan="2"> </td> </tr> <tr> <td colspan="2"> </td> </tr> <tr> <td colspan="2"> </td> </tr> <tr> <td colspan="2"> </td> </tr> <tr> <td colspan="2"> </td> </tr> <tr> <td colspan="2"> </td> </tr> </table>	Picture No.	32	Span	1	Member	slab	Plant		Possibility of soil dump															
Picture No.	32																								
Span	1																								
Member	slab																								
Plant

Possibility of soil dump

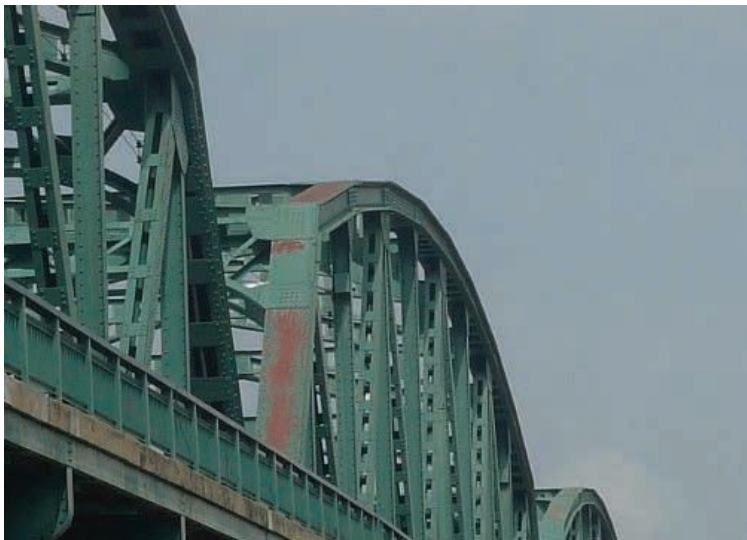
Picture No.	35
	Span	1
	Member	Chord member
	防蝕性能の劣化

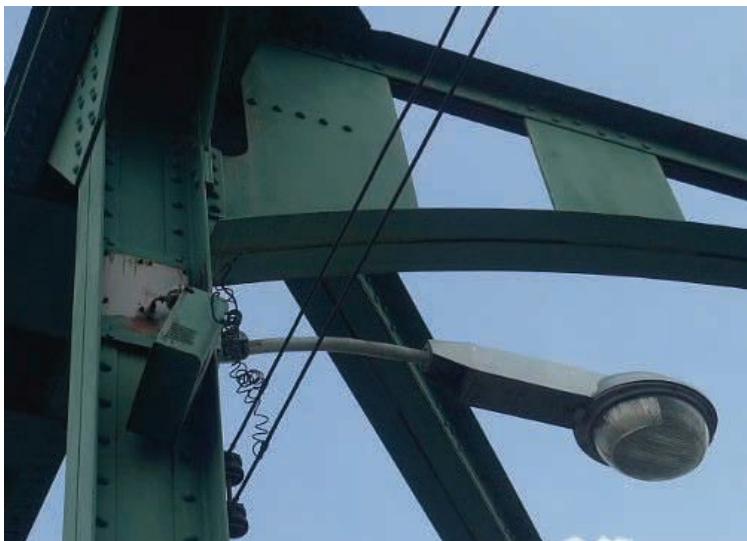
Picture No.	36
	Span	1
	Member	Lighting pole
	破損

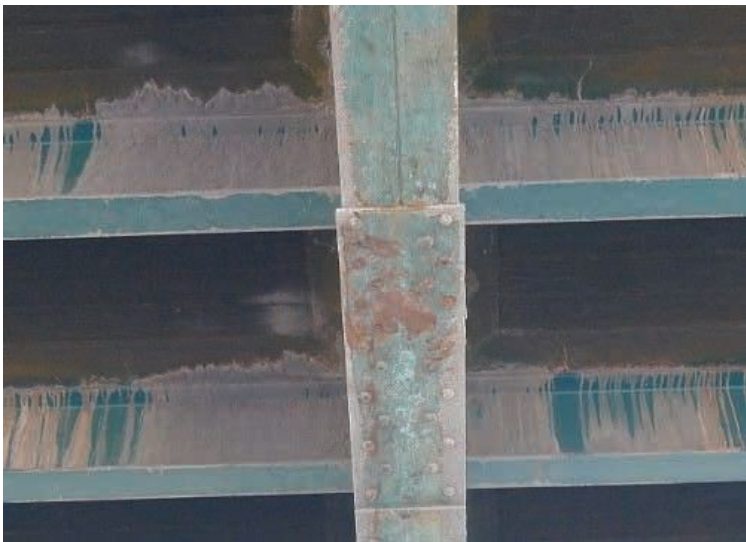
Picture No.	38
	Span	1
	Member	Transverse beam
	Corrosion and fall of rivet	
	<i>*Survey on board, 31-oct</i>

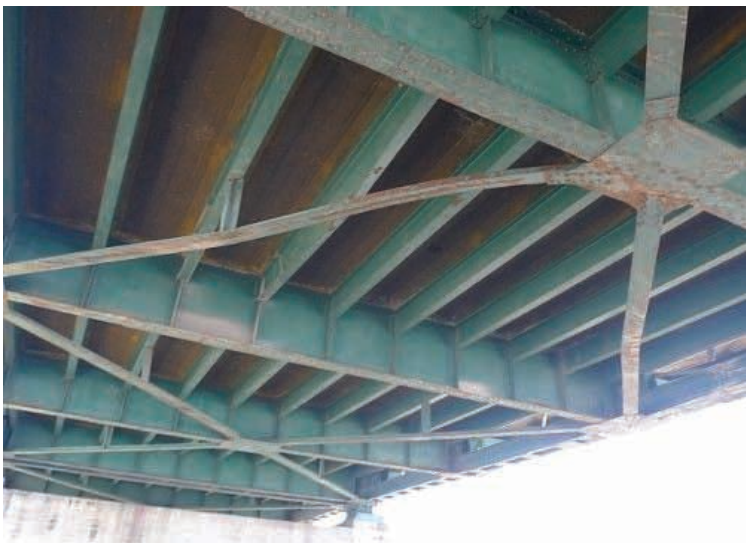
Picture No.	39
	Span	1
	Member	Cross frame
	Deformation by ship collision	
	2nd span from Bangkok side	
	<i>*Survey on board, 31-oct</i>

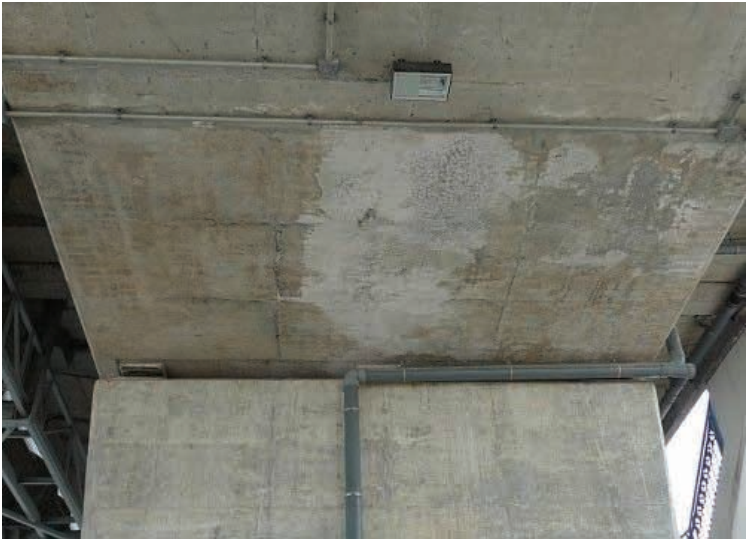
Picture No.	5
	Span	1
	Member	Box-girder
	Insufficiency of cover concrete	
	Repairing work was finished

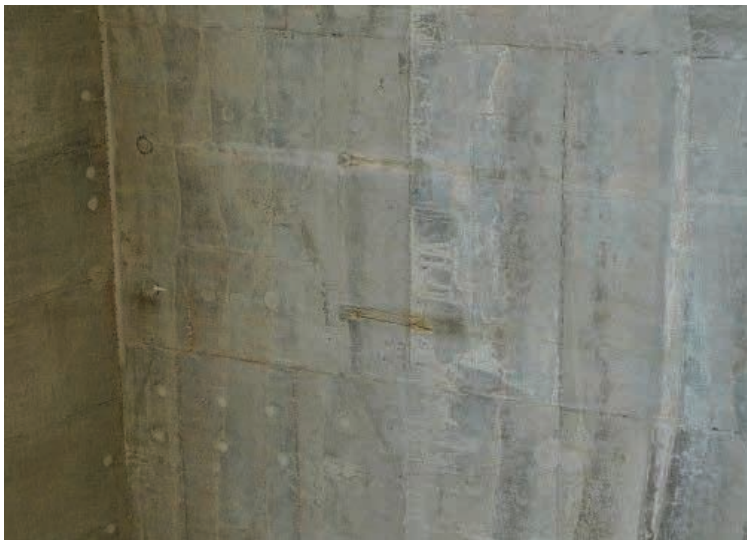
Picture No.	8	
	Span	1	
	Member	slab (walkway, roadway)	
	Ooze out of rust

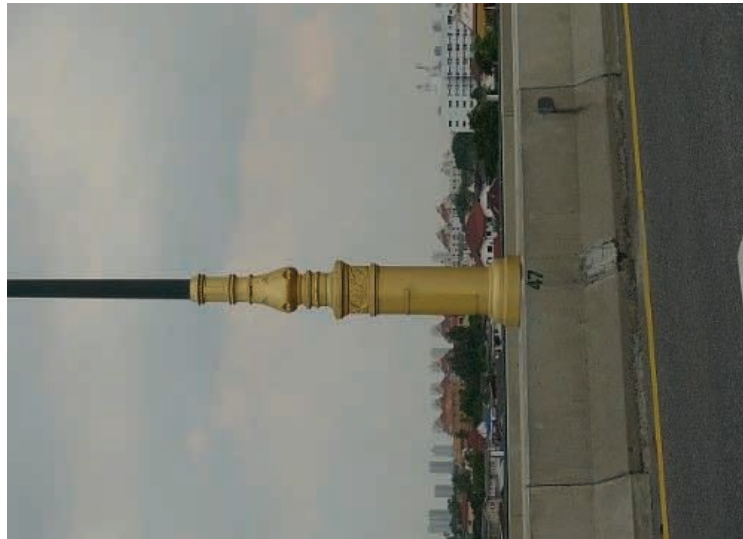
Picture No.	10
Span	1
Member	Lighting pole
Mark of filling concrete at bottom of lighting pole	
Possibility of fracturing in future

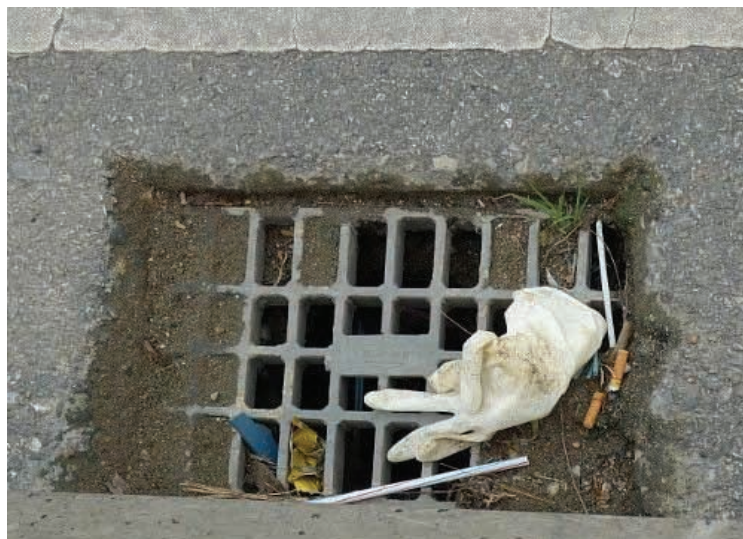
Picture No.	11
Span	1
Member	Catch basin
Partly blocked

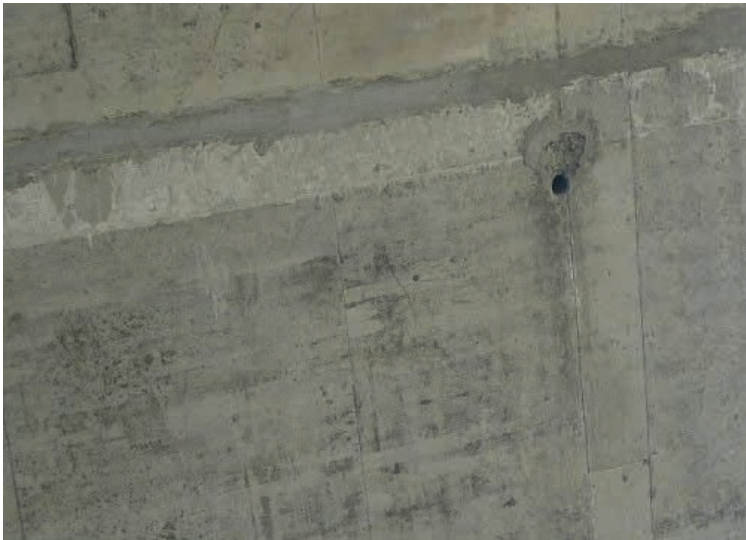
Picture No.	14
	Span	1
	Member	
	Chipped concrete around drainage

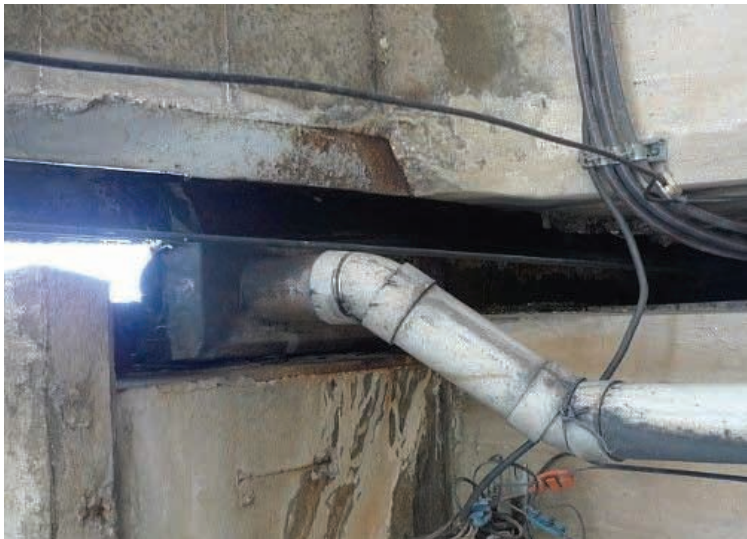
Picture No.	7
	Span	1
	Member	Expansion joint
	Deterioration of drain function

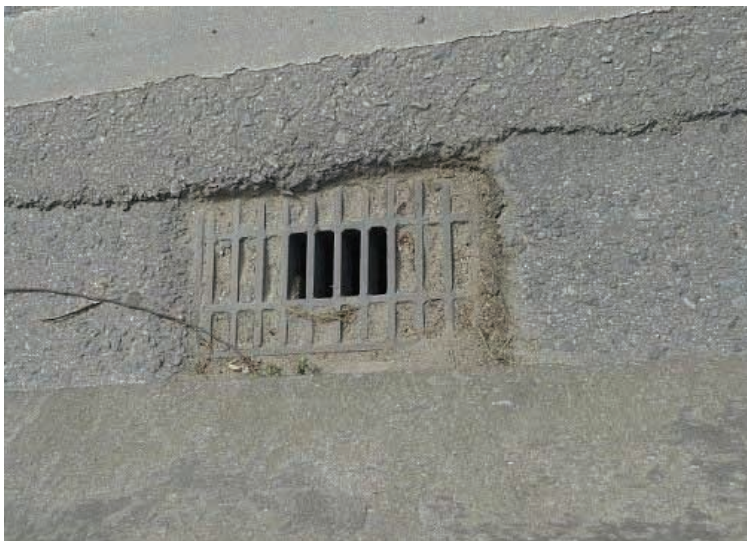
Picture No.	8
	Span	1
	Member	Drainage
	Blocking of catch basin

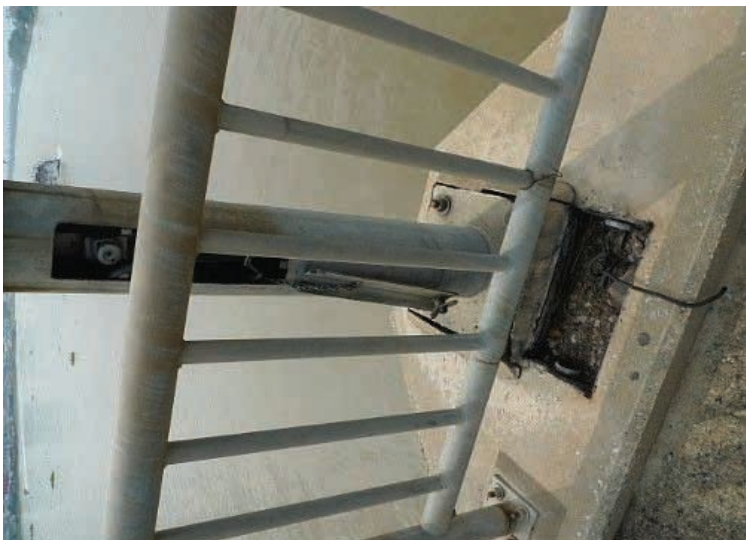
Picture No.	12
	Span	1
	Member	Lighting pole
	Damaged

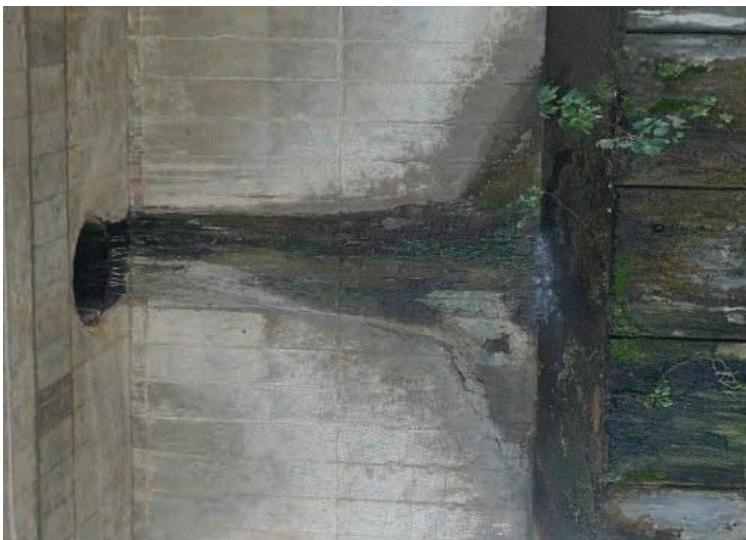
Picture No.	18
	Span	1
	Member	Water supply
	Much water from manhole due to leakage of water supply

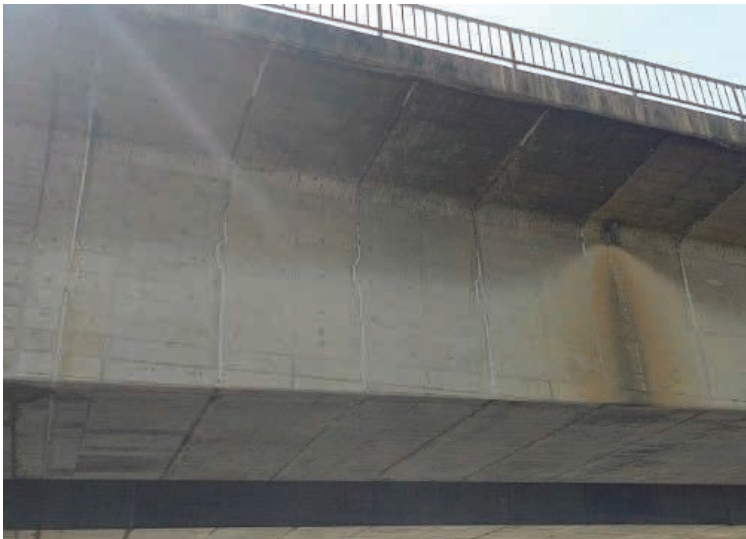
Picture No.	7
	Span	1
	Member	PC-box
	Free lime from construction joint	
	<i>*Survey on board, 31-oct</i>

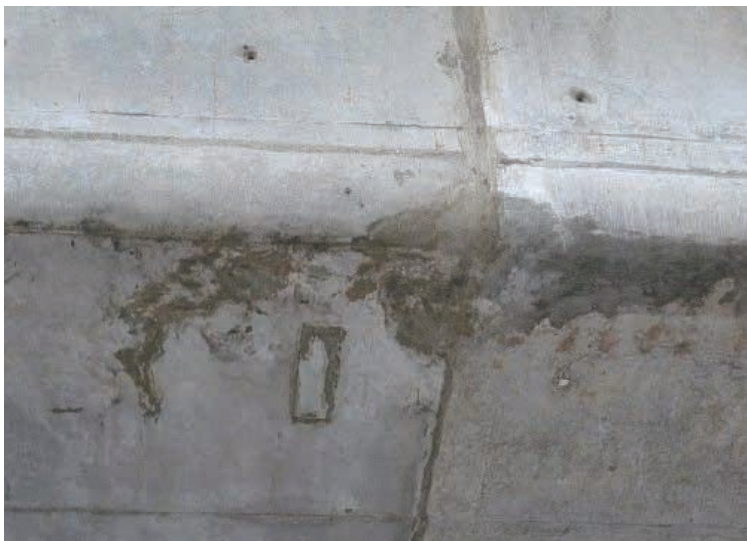
Picture No.	9
	Span	1
	Member	Girder
	Defect of construction?

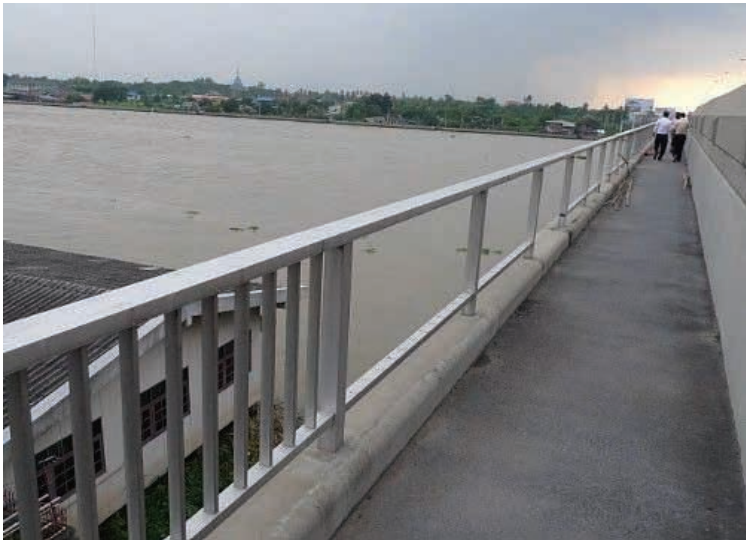
Picture No.	8
	Span	1
	Member	Handrail
	Stolen of stainless handrail

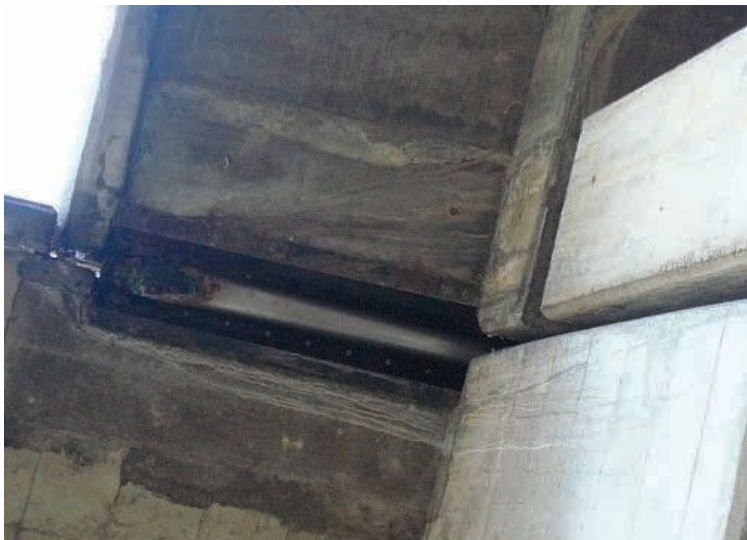
<table border="1" style="width: 100%; border-collapse: collapse;"> <tr> <td style="width: 15%;">Picture No.</td> <td style="width: 85%;">8</td> </tr> <tr> <td>Span</td> <td>1</td> </tr> <tr> <td>Member</td> <td>Expansion joint</td> </tr> <tr> <td colspan="2" style="padding: 5px;">Deterioration of drain function</td> </tr> <tr><td colspan="2" style="height: 15px;"></td></tr> <tr><td colspan="2" style="height: 15px;"></td></tr> <tr><td colspan="2" style="height: 15px;"></td></tr> <tr><td colspan="2" style="height: 15px;"></td></tr> <tr><td colspan="2" style="height: 15px;"></td></tr> <tr><td colspan="2" style="height: 15px;"></td></tr> <tr><td colspan="2" style="height: 15px;"></td></tr> <tr><td colspan="2" style="height: 15px;"></td></tr> <tr><td colspan="2" style="height: 15px;"></td></tr> </table>	Picture No.	8	Span	1	Member	Expansion joint	Deterioration of drain function

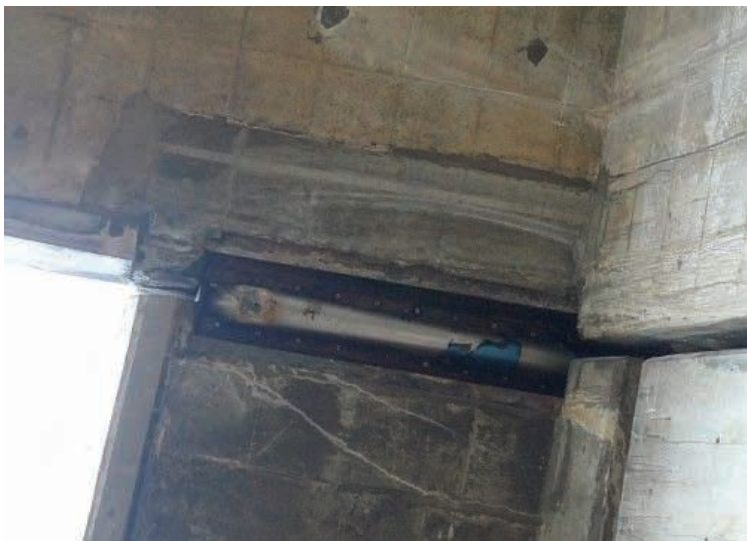
<table border="1" style="width: 100%; border-collapse: collapse;"> <tr> <td style="width: 15%;">Picture No.</td> <td style="width: 85%;">9</td> </tr> <tr> <td>Span</td> <td>1</td> </tr> <tr> <td>Member</td> <td>Expansion joint</td> </tr> <tr> <td colspan="2" style="padding: 5px;">Deterioration of drain function</td> </tr> <tr><td colspan="2" style="height: 15px;"></td></tr> <tr><td colspan="2" style="height: 15px;"></td></tr> <tr><td colspan="2" style="height: 15px;"></td></tr> <tr><td colspan="2" style="height: 15px;"></td></tr> <tr><td colspan="2" style="height: 15px;"></td></tr> <tr><td colspan="2" style="height: 15px;"></td></tr> <tr><td colspan="2" style="height: 15px;"></td></tr> <tr><td colspan="2" style="height: 15px;"></td></tr> <tr><td colspan="2" style="height: 15px;"></td></tr> </table>	Picture No.	9	Span	1	Member	Expansion joint	Deterioration of drain function

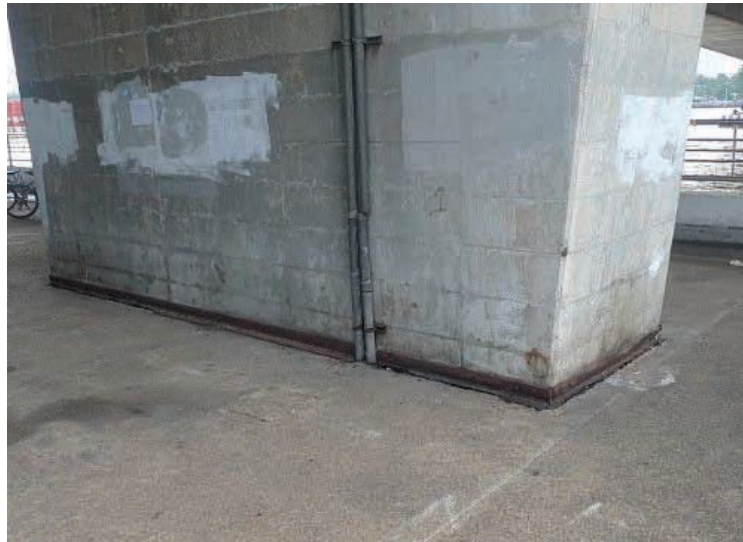
Picture No.	10
Span	1
Member	End pier
Corrosion of steel plate at base
