**Ex-Post Monitoring Report of  
Japanese ODA Loan Projects 2008  
(Botswana, Kenya, Tunisia, Guatemala)**

**January 2010**

**JAPAN INTERNATIONAL COOPERATION AGENCY**

| <b>North-South Carrier Water Project</b> | |

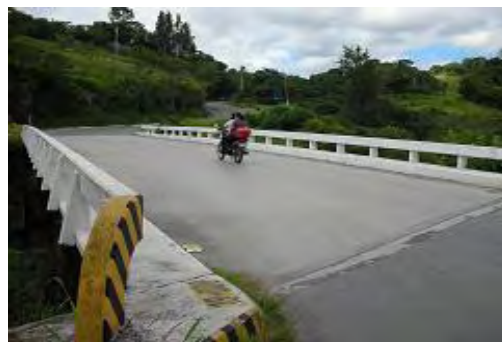
“El Chato” Bridge

In the case of roads and bridges, as shown in Table 7, the Unidad Ejecutora de Conservación Vial (COVIAL) of the Ministry of Communications, Infrastructure and Housing is the O&M organization. The Dirección General de Caminos and COVIAL, together account approximately for 70% of the Ministry’s budget<sup>10</sup>. However, since high priority is given to O&M of national highways and large-scale bridges, it cannot be said that the required O&M costs necessarily are allocated to small-scale infrastructure projects such as the FIS sub projects. For example, the priority given to O&M of the El Chato Bridge, which is covered by a case study, is in a decreasing trend, and the frequency of O&M, which had been conducted once monthly previously, had decreased to once every three months at the time of ex-post monitoring. The

content of such O&M also is limited primarily to the degree of cleaning and painting.

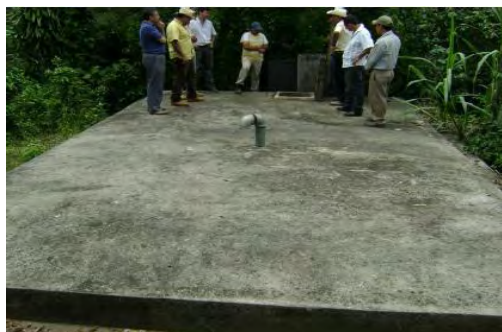
Water supply project in Bethel village

At the same time, examples observed in this monitoring also included cases in which the community had established O&M committees, collecting fees and handling O&M for small-scale irrigation works and water supply systems. In the water supply sub projects in the villages of Gualan and Bethel in Zacapa Dept., each of a total of 150 households pays 30 quetzals (approximately 380 yen) four times a
