ウズベキスタン国地すべりモニタリング  
技術向上支援プロジェクト

プロジェクト事業完了報告書  
巻末資料

## 1. C/Pによる地すべり解析レポート

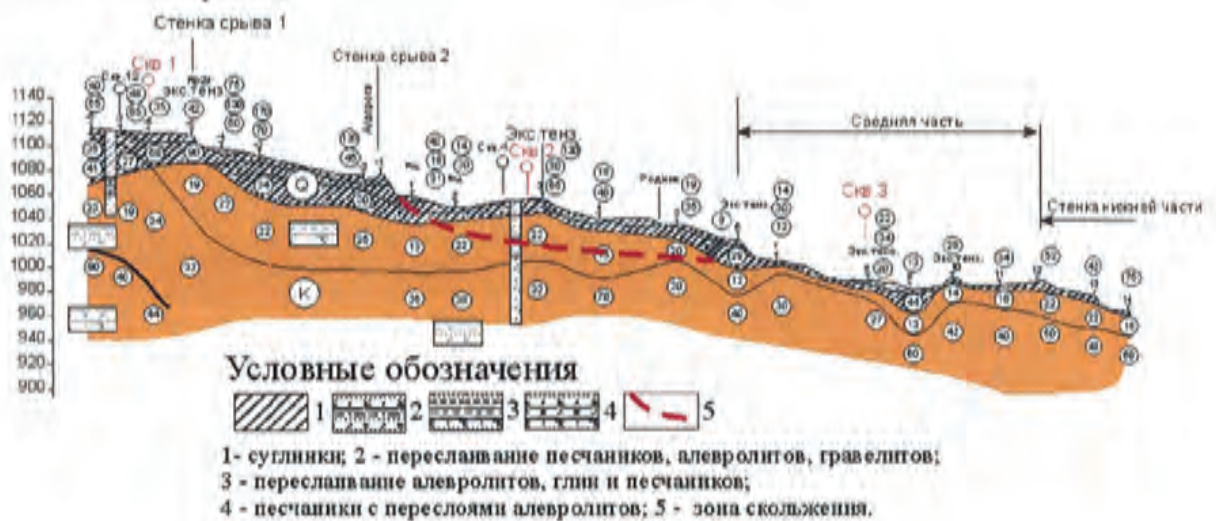
Field investigations were implemented by using electric sounding machine McOHM-EL. Based on geo resistance the geological-geophysical cross section was prepared. In the lower part extent chalk formations, sandstones with aleurolites interlayer, and in the upper part the mild clay formations bedded. On the central part of the landslide, where second borehole is located, assumed sliding plane is observed, that due to water saturation of soil typical for low geoelectric resistance. It's confirmed by inclinometer results.

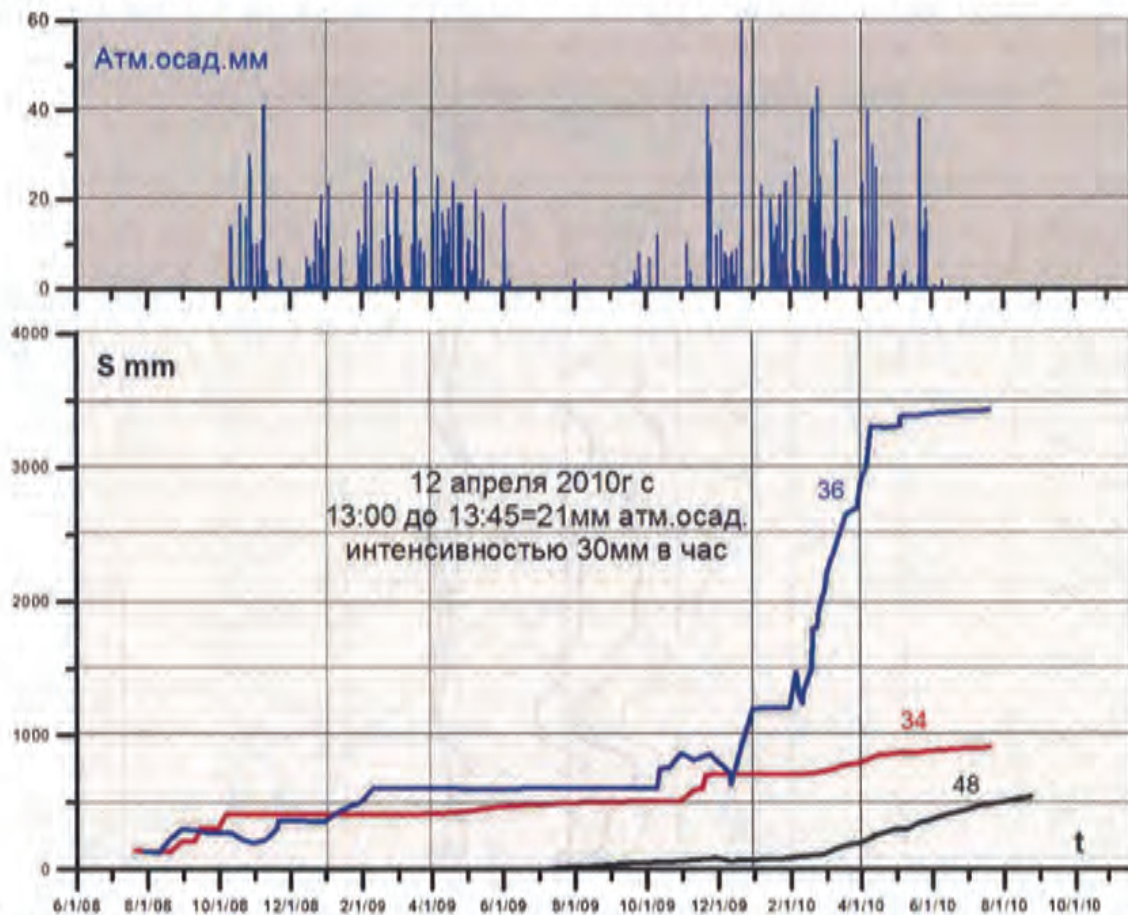
The observations using Extensometer were started from 7<sup>th</sup> July, 2008 and continued until today for Ext. 48, 34 , 36, within 24 month. Two Extensometers, where one long span and one ground type were destroyed in spring 2009 due to soil moisture and liquefaction in graben like deep cracks zones. Remaining third

Extensometer installed in the upper part shows that in the landslide scarp area (Ext. 48) the smallest displacement is up to 50 sm., that appeared in Spring 2002, in different years 2008 – 2009, the landslide movement was not observed. The landslide step lower than highway more active, where boreholes and Extensometer 34 installed. There were landslide displacements up to 50 cm. in 2008 – 2009 and speed acceleration occurred in spring 2010. Total displacement value reached 1,0 m.

However, the biggest landslide displacement occurred under the graben depression up to 3,3 m. Meanwhile, the biggest soil movement occurred on 2 – 3 of March 2010 up to 20 cm, 18 – 19 of March 2010 – 12 cm, 12 of April – 26 cm. It's correlated with amount of precipitation in February 2010 – 280 mm, and on 12 of April was rainfall with intensity of 30 mm/h. When within 40 min (rainfall data) amount of precipitation reached 21 mm, the ground water level changed dramatically.

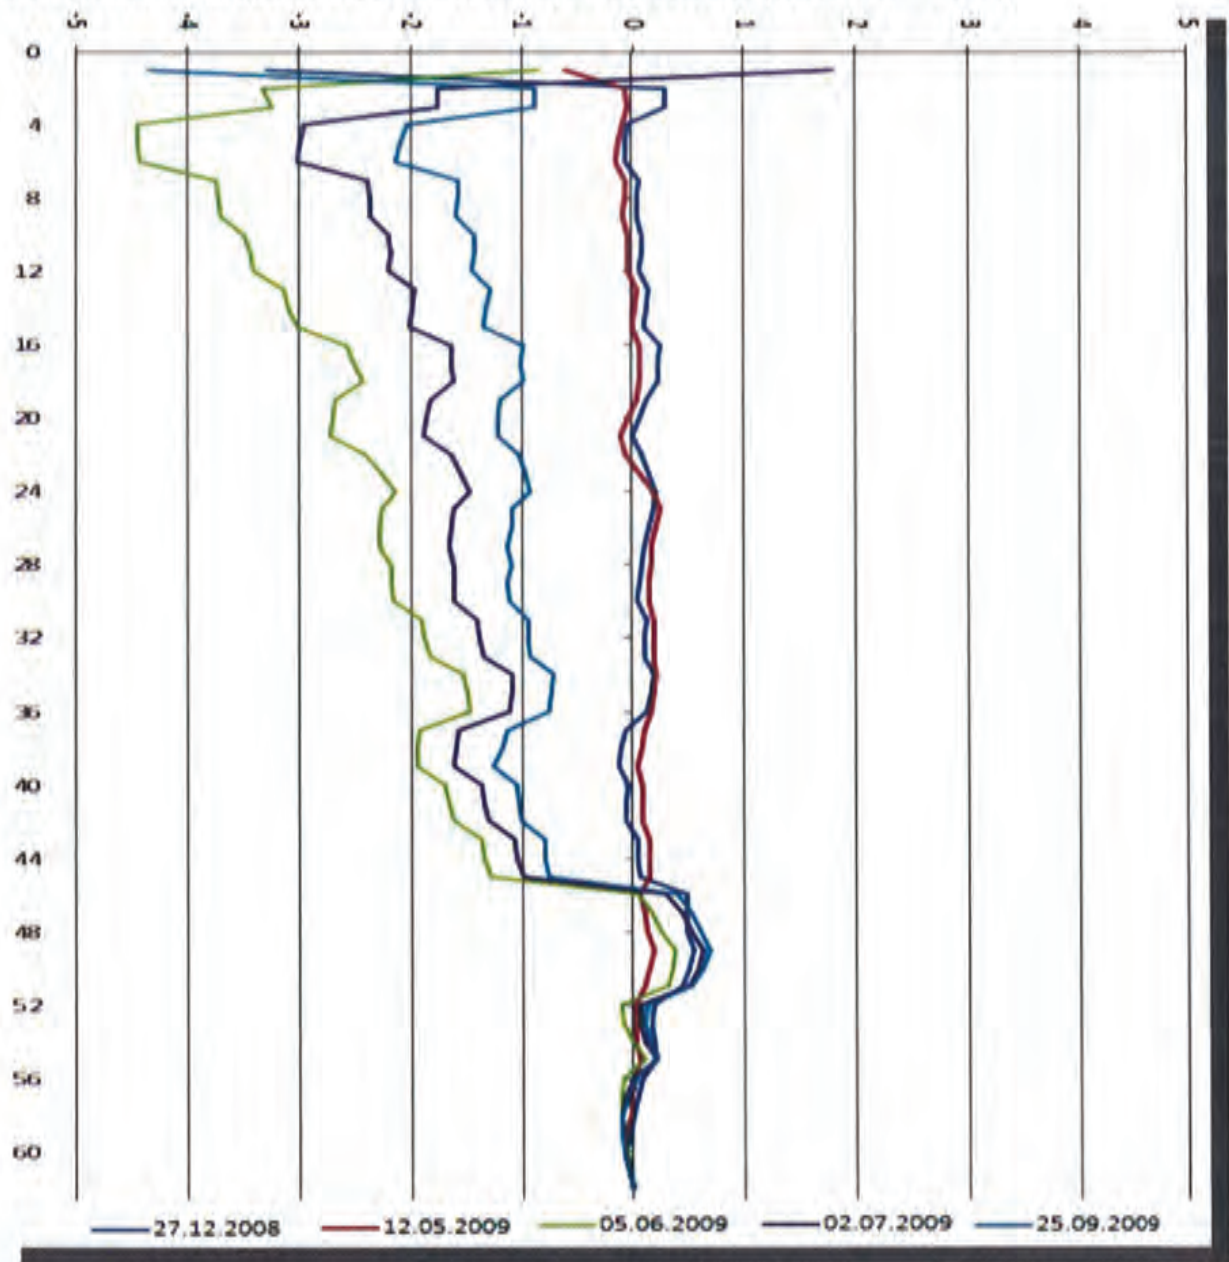
Inclinometer graph for borehole № 1, A directions (azimuth – 300°)

Borehole №1. Locates in the upper part of the site (upper than landslide scarp). The borehole was drilled on 09 of October 2008. The borehole depth is 60 m, 10 cycle measurements were implemented. Annual cycle measurement shows that measurement values closer to the surface differ on 4 mm from initial. On the depth of 45 m, clearly defined the graph cut and it's considered as border of assumed sliding plane.

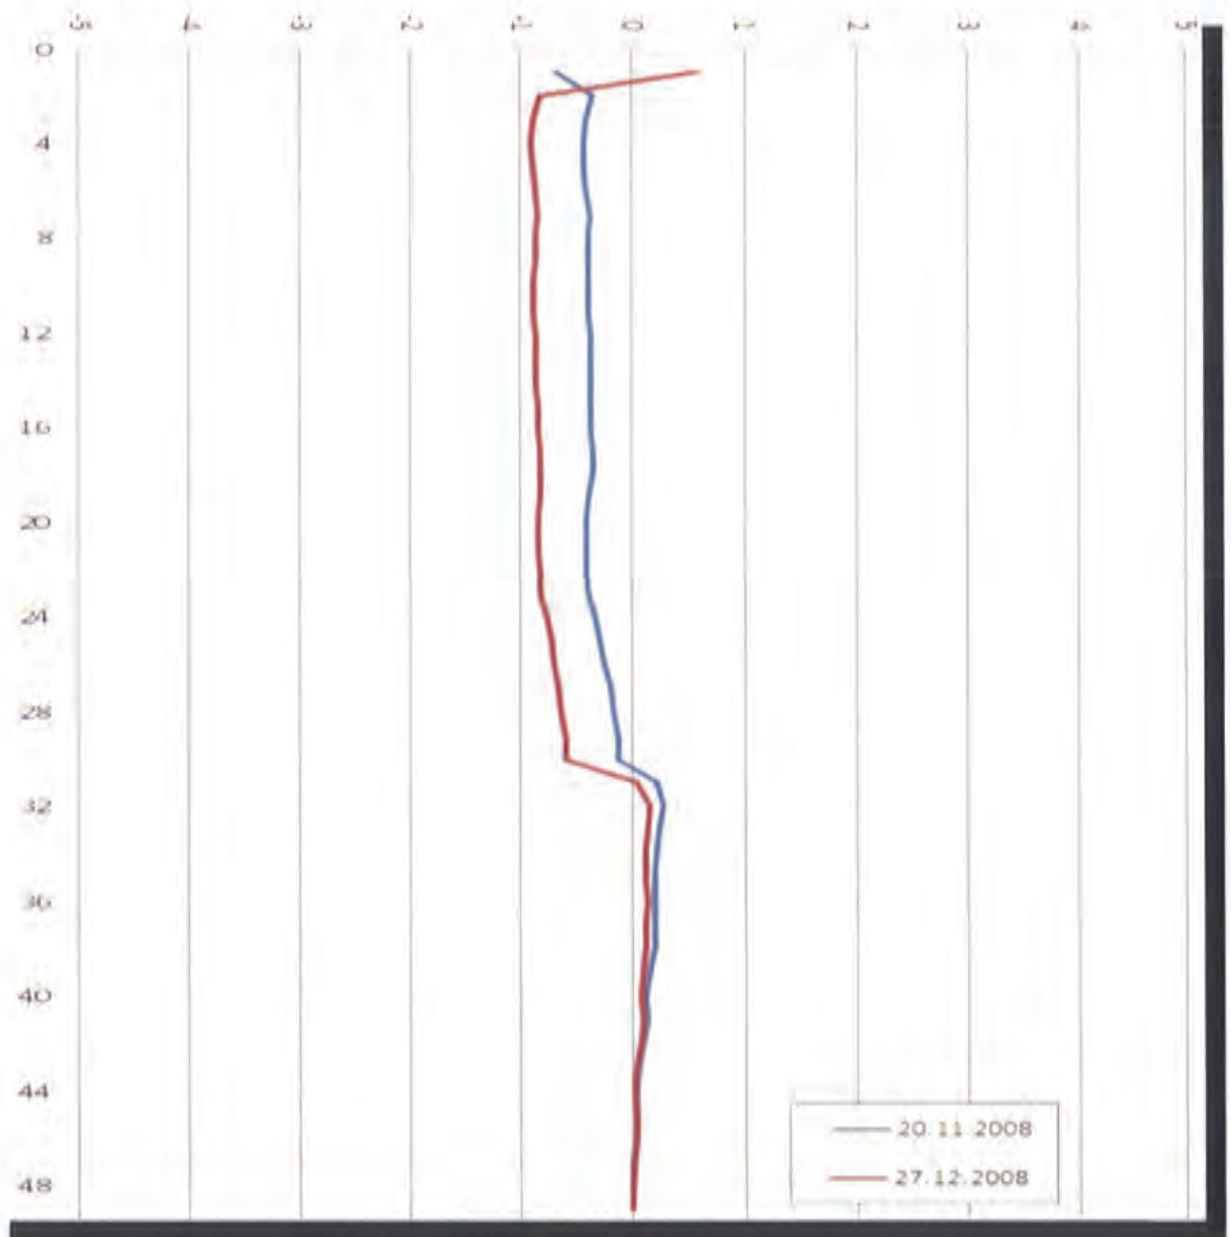
Inclinometer graph for borehole № 2, A directions (azimuth - 270°)

Borehole №2. Locates in the central part of the landslide. Drilled on 09 of October 2008. The borehole depth is 47 m, 7 cycle measurements were implemented. On the graph from the surface to 30 m depth big change is observed (aprox. 0,5 mm per month), unfortunately this year was impossible to implement measurements in winter time (because of sever cold and snowfall).

In spring time when measurement, the Inclinometer electrode putted down on 29 m depth, that give evidence of soil displacement. Received but not processed data shows that sliding plane is on 27 to 31 m depth.

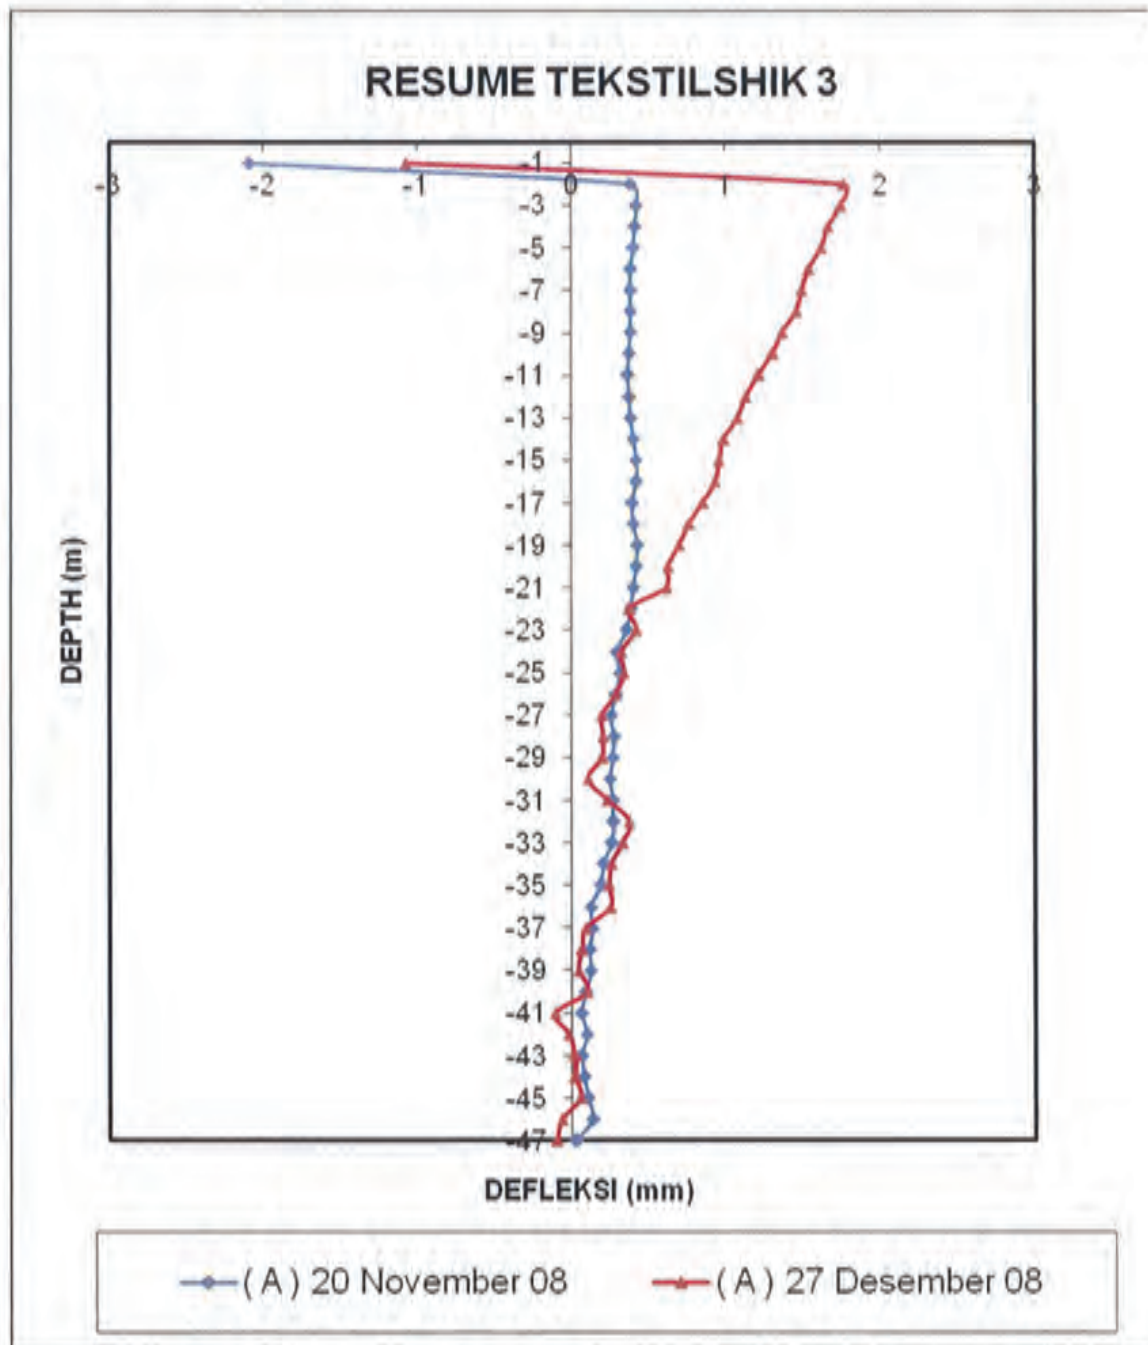
Inclinometer graph for borehole № 3, A directions (azimuth – 360°)

Borehole №3. Locates in the lower part of the landslide. Drilled on 09 of October 2008. The borehole depth is 47 m, 2 cycle measurements were implemented. In the borehole on 2 m in depth, the changes of 1 mm per month occurred, in spring time the borehole was stuck by clay on the depth.

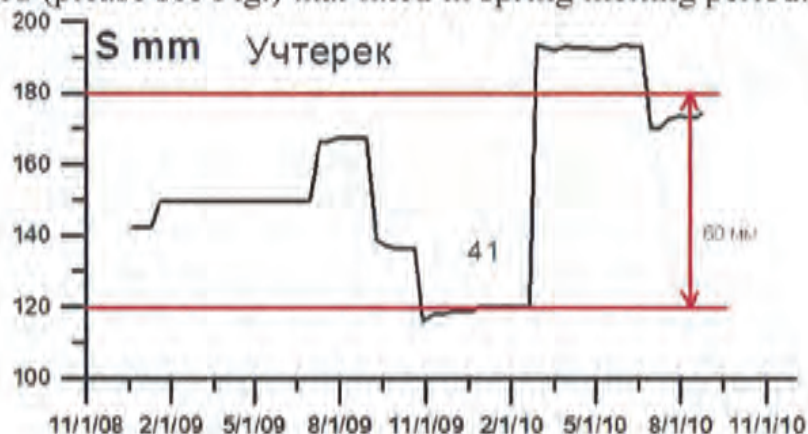
Observation results for 2008-2009 showed, that in upper part and in the central part of the village the landslide movements were not observed, that's why the Extensometer-41 remains on the crack above the village and other Extensometers were removed to the other landslide sites. For the period from 2008 to 2010 for 21 month the Extensometer 41- insignificant displacements on 32 mm distance were observed (please see Fig.) that fixed in spring melting period.

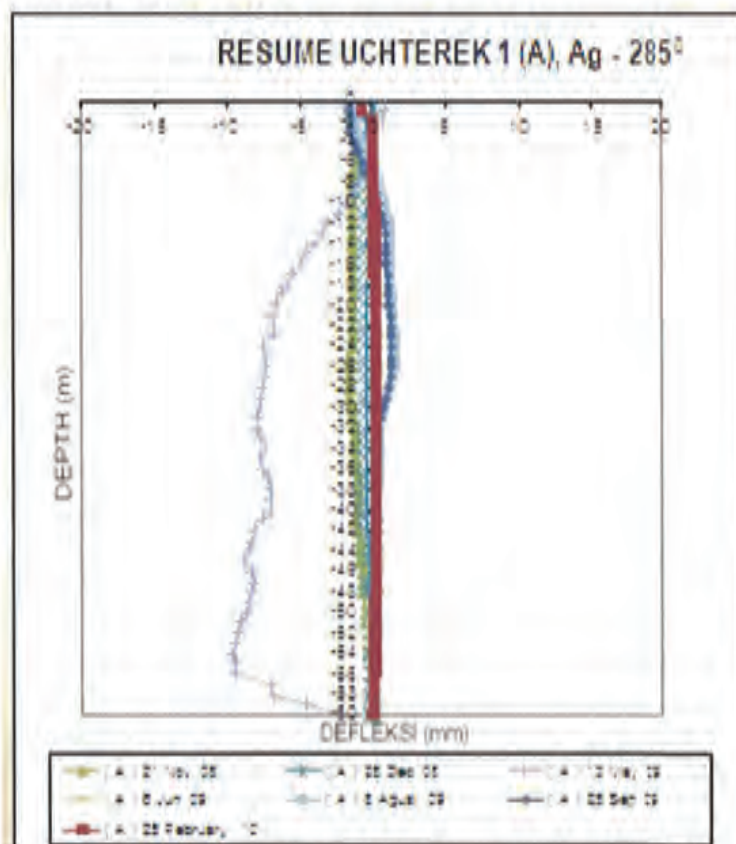
Borehole №1. Locates in the upper part of the site (150-200 m upper than Tashkent – Chingam highway). The borehole was drilled on 11 October 2008, 7 cycle measurements were implemented. On 13 of May 2009 movement within whole borehole depth were observed, during other cycles movements were not fixed.

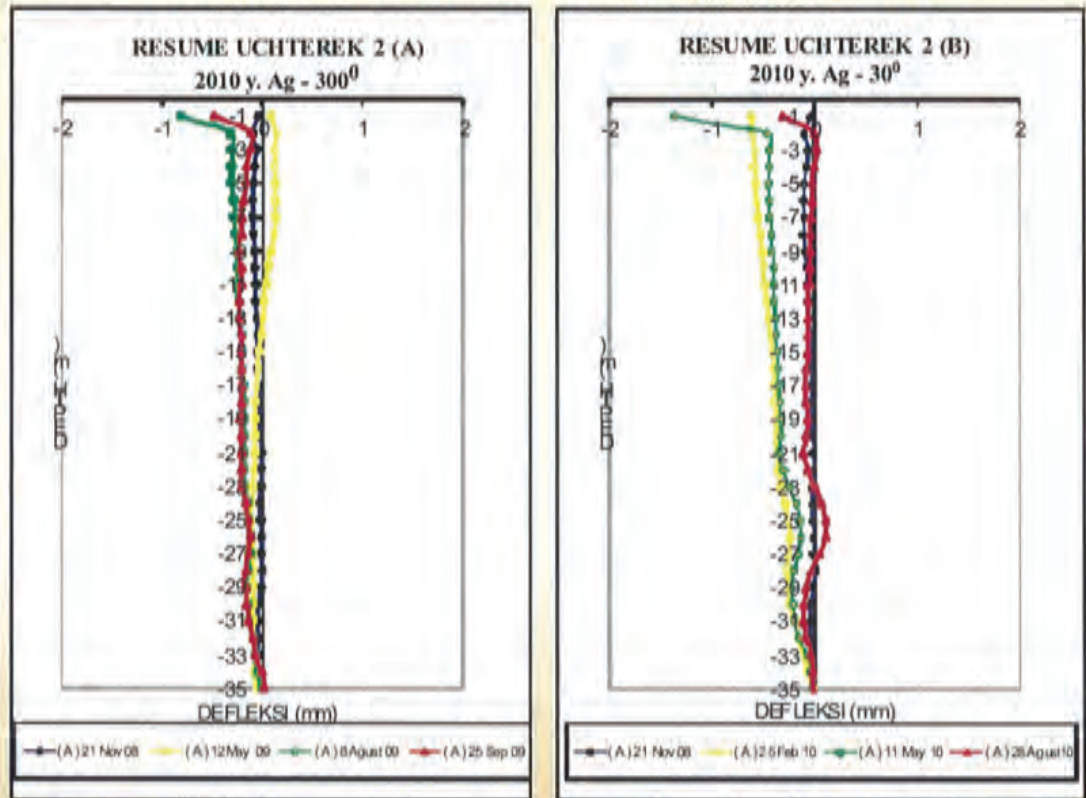
## График Инклинометрии Уч. Учтерек, скв.№2

Borehole №2. Locates along Tashkent – Chimgan highway. The borehole was drilled on 12 of October 2008. The borehole depth is 35 m, 10 cycle measurements were implemented. For the data received, seasonal changes value reaches up to 0,5 mm. Significant changes on depth are not observed.

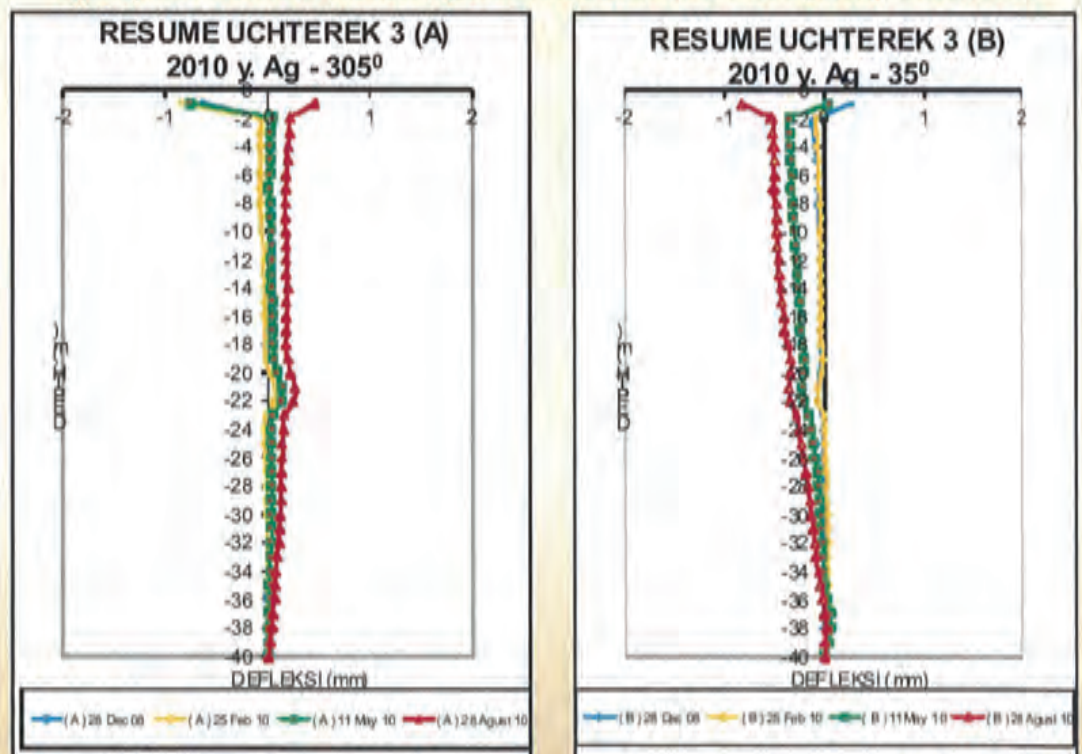
## График Инклинометрии Оползень Учтерек, скв.№3

Borehole №3. locates in the lower part of the landslide (near the living houses). Drilled on 15 November 2008. The borehole depth is 40 m, 9 cycle measurements were implemented. Based on the data received small change on depth of 20 to 22 m is observed, most probably its related to pipe expansion in depth.

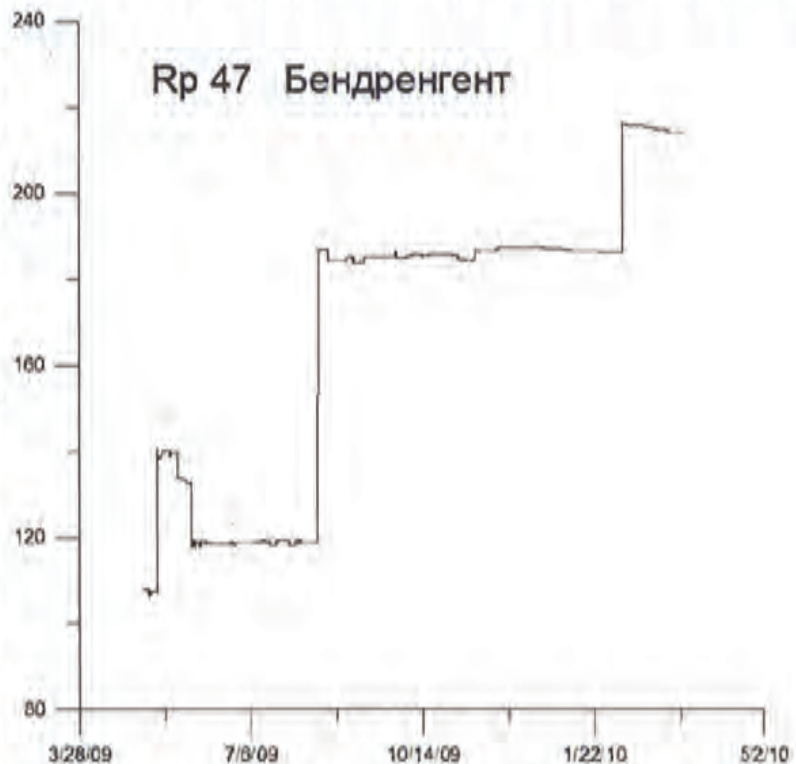
For Extensometer 47 installed in the central part of the crack for the period from 3 of May 2009 to 14 of March 2010 the displacement reached 107 mm for 16 month, confirms that crack is in active stage. Second Extensometer as far as it's located at a short distance was disassembled and removed to the other site. Observations for Extensometer 47 are planned to continue in the future.

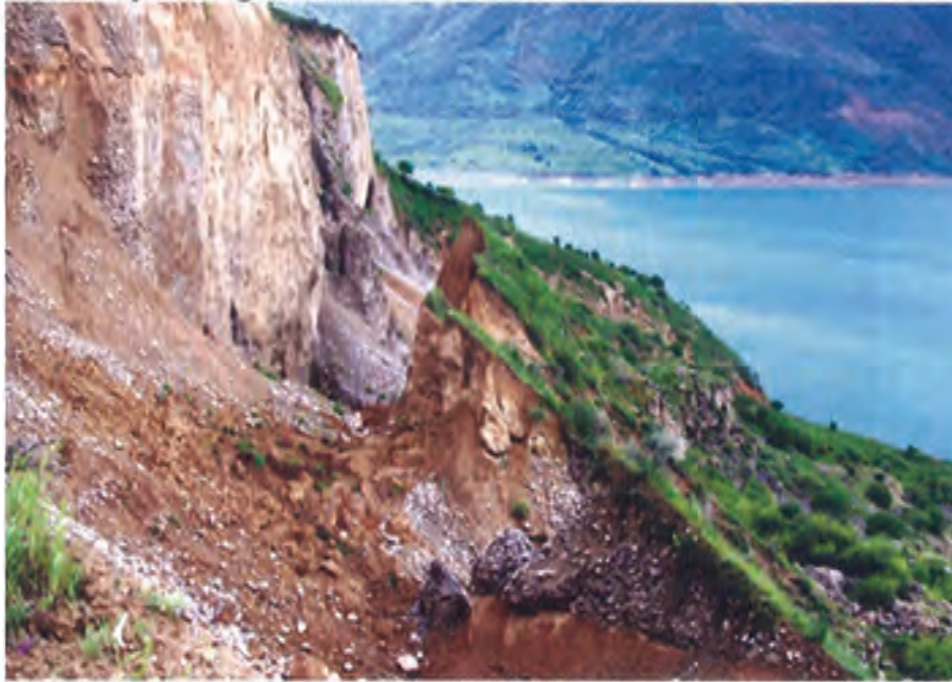
Geologic-tectonic structure of the landslide caused by flexural-tensile zone of Pskem failure. Main fault passes in the basement of landslide scarp it has 10 – 12 m width. Assumed depth and shape of landslide sliding surface has been done by the results of drilling in 80-ies and inclination angles of surface reference points. At present time the steepness of sliding surface is 26-30° in upper part, 17° in the middle part and 4-6° in lower part.

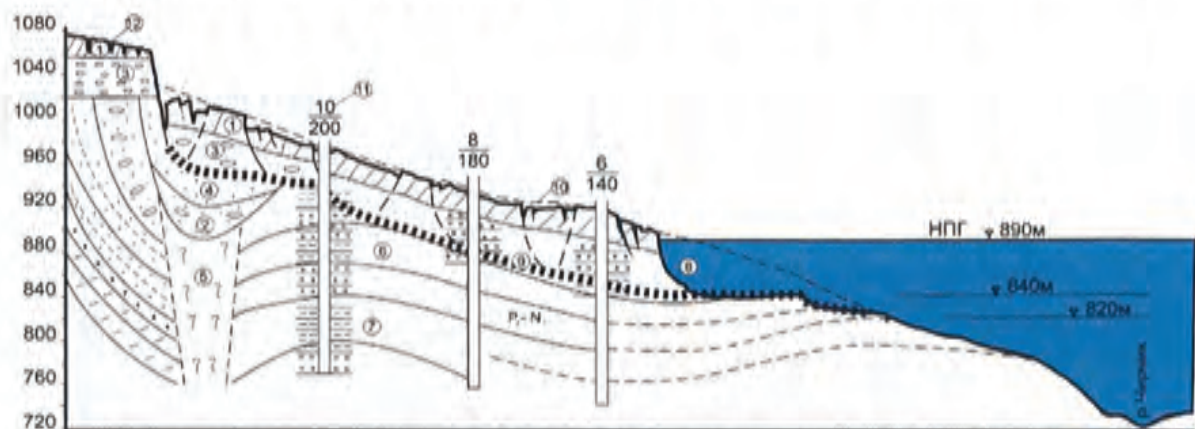
1. Лесовые породы с включением галечника; 2-гравий и галечник; 3-конгломераты; 4-переслаивание алевролита и песчаника; 5-зона тектонических нарушений; 6- переслаивание красноцветных глин, алевролита, песчаника и конгломерата; 7- переслаивание глин и песчаника; 8- зона оползня 6 августа 1082г.; 9- зона скольжения оползня; 10-поверхность склона до оползня ; 11-номер скважины и глубина ; 12-трещины 2004 -2009 г.г.

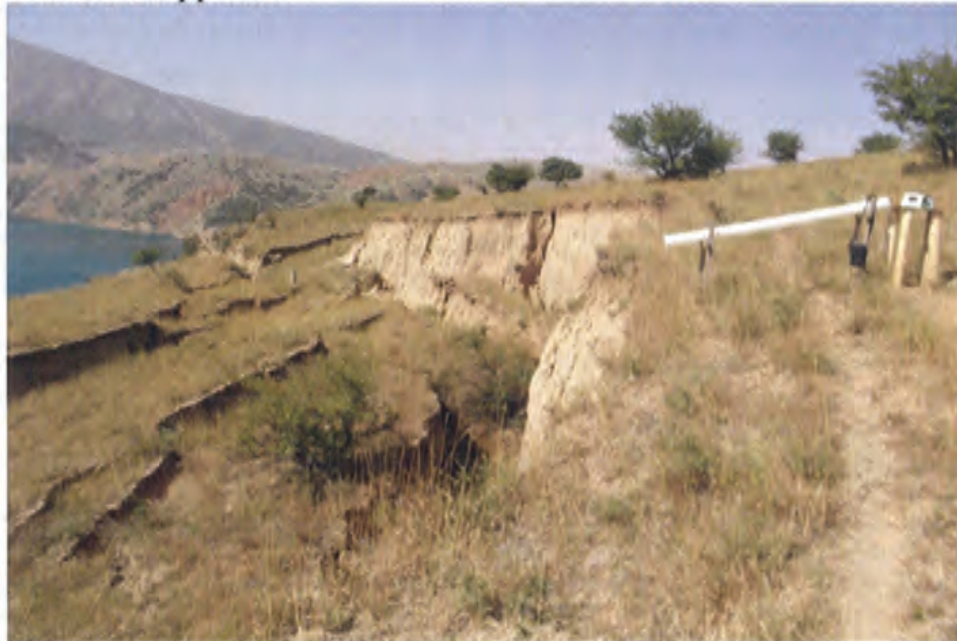
Mingchukur Landslide Rp 37 (November 2009),Rp 51 (June 2010).

Its last activity observed from 21 of March to 12 of April 2004, value of horizontal movement reached 1,6 – 1,9 m, soils movement speed exceeded last cycle in 12 – 15 times. As a result upper than landslide scarp in 35 – 40 m from the edge the new crack (please see photo) more than 300 m extension and with altitude up to 1,0 m was formed. A feature of the active displacement was simultaneous movement of whole landslide massive, a division of the landslide into different generations has not happened.

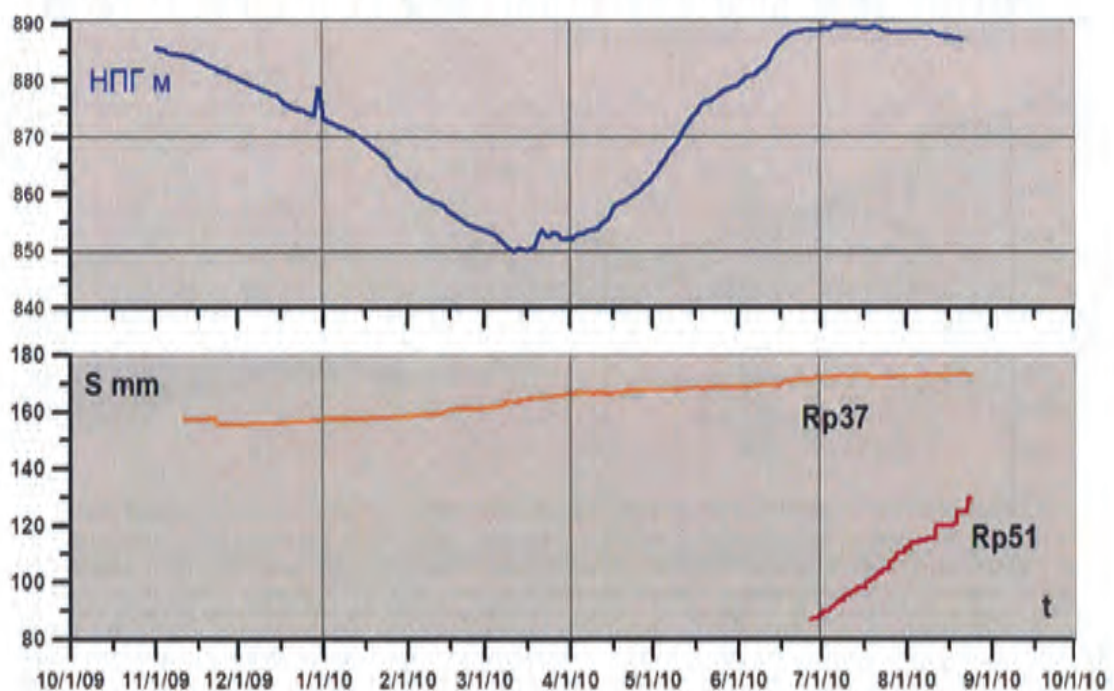
On upper zone of Mingchukur landslide at the place of new crack formation two Extensometers were installed. Ground type Extensometer 37 was installed on 11 of November 2009 in the head part of the landslide. During ten month soil displacement was 16 mm only, very low movement value. After that the long span Extensometer 51 was installed on 21 – 22 m distance above graben depression. The Extensometer was installed on 26 of June 2010, for two month or 60 days (24 of August) movement in the area reached 43 mm  $V=0,7$  mm/day. Such installation of long span Extensometers above the graben cracks considered as more correct. Correlation of Extensometer data and level of discharged water in Charvak water reservoir showed no acceleration of landslide movement when elevation of water in water reservoir is low - 850 m.

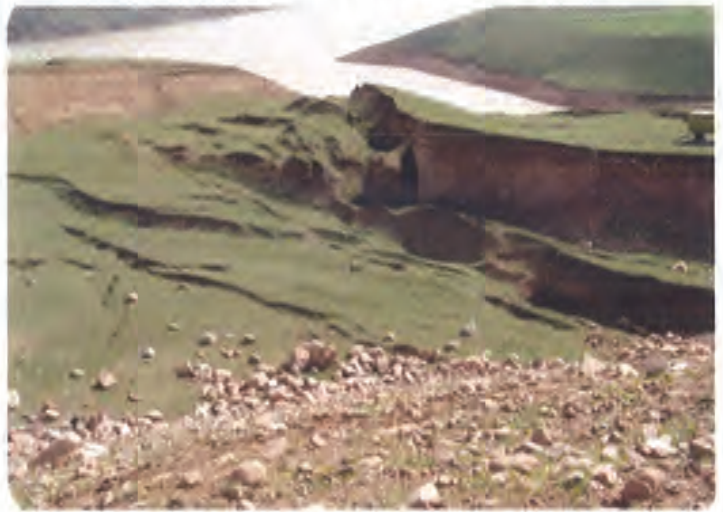
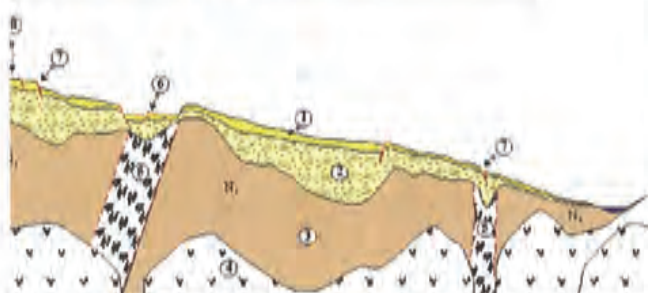
**Tanga-Topdi Landslide** (120 km of Tashkent – Osh highway) locates on the right side of Ahangaran water reservoir, on the left side of Tangatopdi gully. First cracks of 40 m length formed in March 1987 on the slope lower than highway. These cracks started to form graben dip. At the same time on the highway roadbed formed curve crack delineated head part of the landslide. From 1987 to 1990 there formed impression type landslide with extension of 290 m and of 300 m in width. The landslide's movement covered highway roadbed on 160 m distance. In its upper part the graben of 50 – 80 m in width and 2 – 3 m altitude was formed. In the center of the low zone and on the right and left sides of the Tangatopdi gully the protrusion wall has been formed on 130 – 140 extension, of 1 – 1,5 m in height. The landslide sliding plane expected on Suzak clays and sands at a depth of 25 m or 40 – 45 m, the volume of the landslide is 2,5 mln. m<sup>3</sup>.

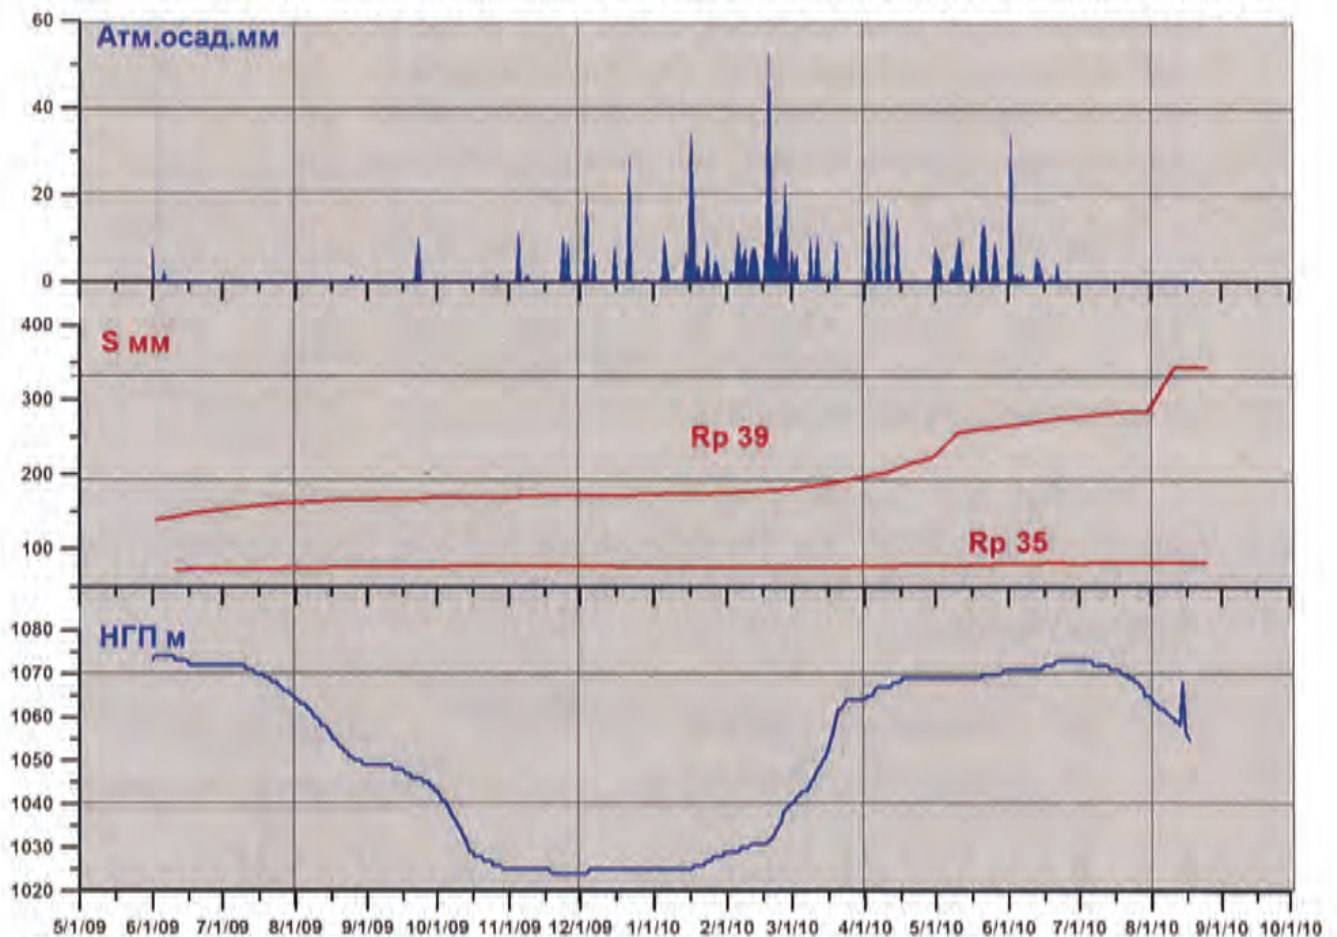
The measurements for 15 month (from 3 of June 2009 to 25 of August 2010) showed that Extensometer 39 installed in the upper zone, on the upper crack fixed 204 mm of soil movement. On correlation of data received with amount of

Graph of precipitation changes, soil movement value and water level fluctuation in water reservoir

precipitation and water level fluctuation in the water reservoir, clearly shows that landslide movement speed increasing when level of water in water reservoir reached 1070 elevation and it's in above the flood-plain condition. Landslide movement speed was not increased in spring 2010 when water level in water reservoir was in low elevations. It is a very important indicator.

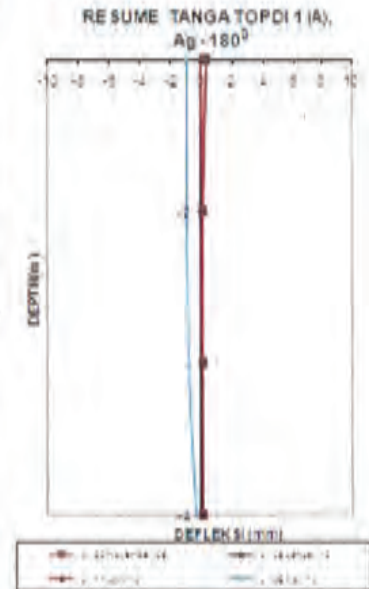
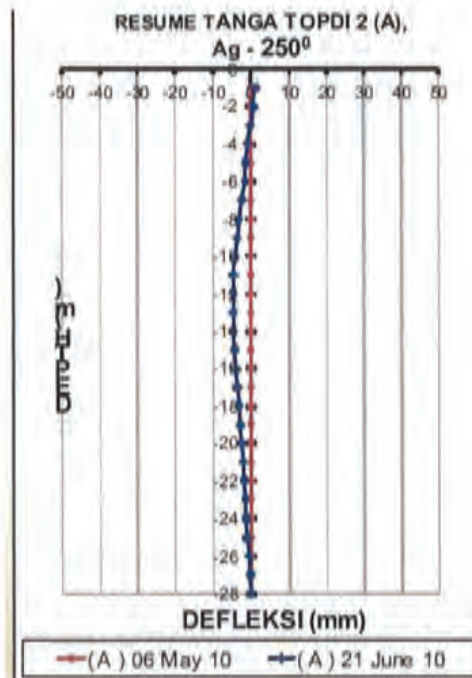
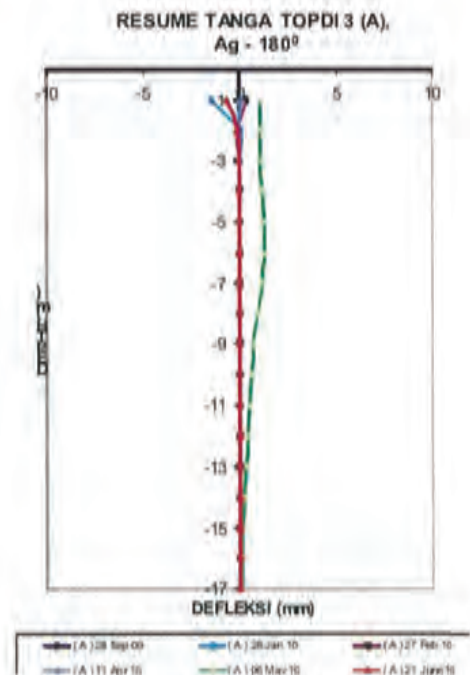
Borehole №1. Locates in the upper part of the landslide (upper than landslide scarp). The borehole was drilled on 09 of June 2010. The borehole depth is 4 m, 6 cycle measurements were implemented. Based on last measurements insignificant change is observed.

Borehole №2. Locates in the central part of the landslide. The borehole was drilled on 23 of April 2010. The borehole depth is 28,5 m, 2 cycle measurements were implemented. The changes from 4 m to 26 m in depth are observed.

Borehole №3. Locates in the low part of the landslide. The borehole was drilled on 09 of June 2010. The borehole depth is 17 m, 6 cycle measurements were implemented. On the graph the changes are observed in May, in other cycles no changes observed.

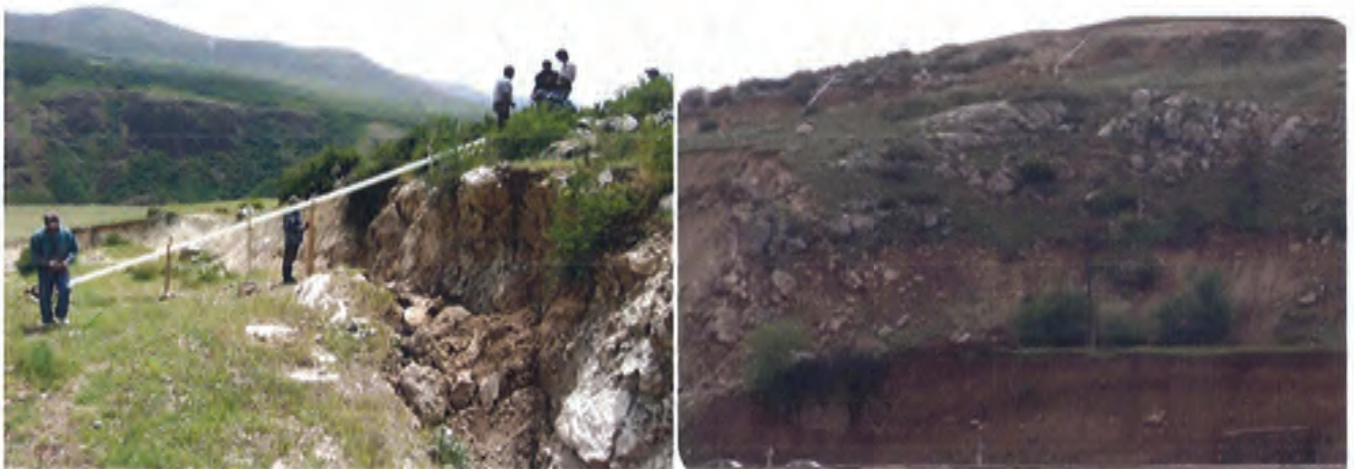
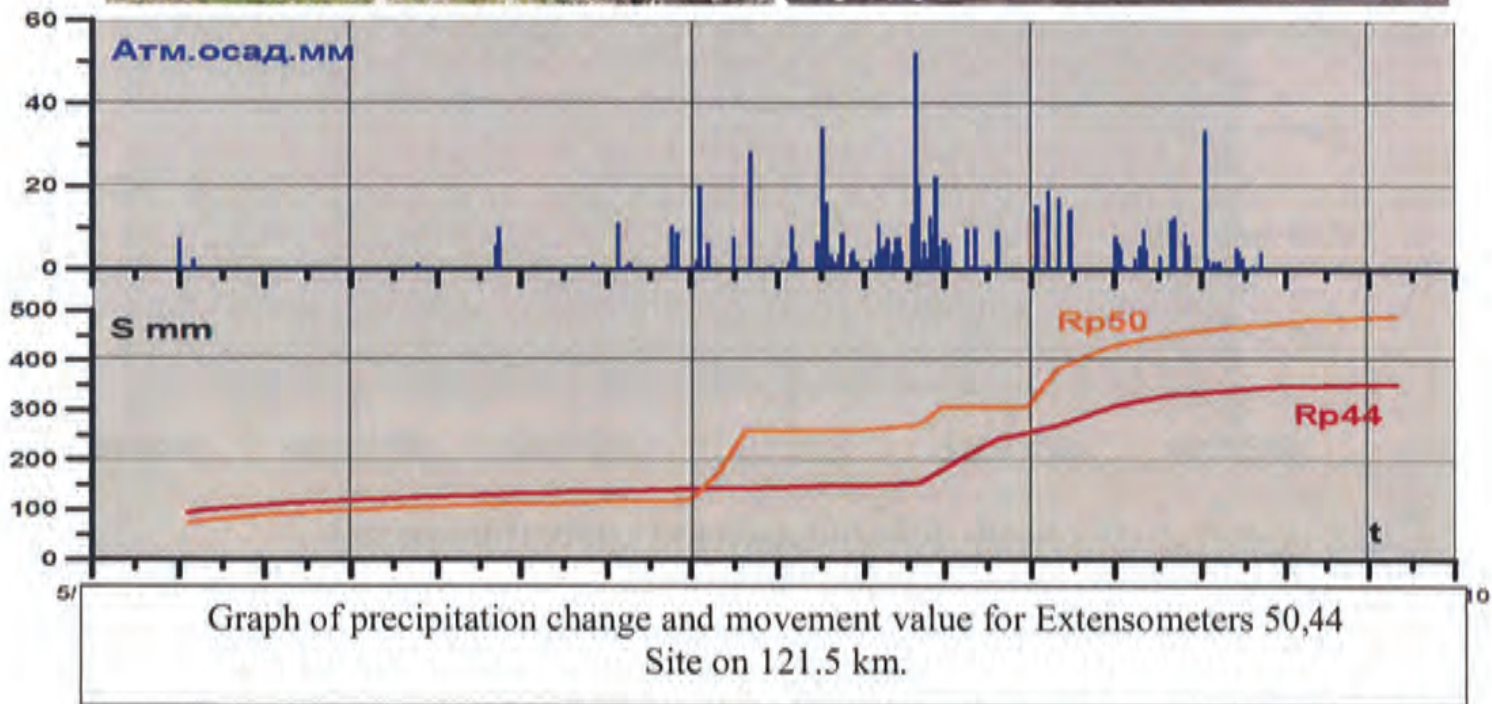
slope has been collapsed. Meanwhile, upper blocks settled deeper and new cracks appeared uphill. At present time, the crack elongated up to 90 – 100 m, with altitude up to 0,5 – 0,7 m, remaining landslide volume is 25,0 t. m<sup>3</sup>. To control the cracks expansion, considering hazard for Tashkent – Osh highway, on 04 of June 2009 two Extensometers 44,50 were installed. Extensometer results for 14 month showed that total movement for Ext. 44 is 257 mm, for Ext. 50 is 415 mm. The biggest movements occurred in spring period from February to April 2010. Movement graph is characterized by stepwise soil movement.

The biggest displacements related to rainfalls on 19 of February 2010 – 52,4 mm, 12 of April – 35 mm with intensity up to 30 mm/hour. The observations by Extensometers will be continued in the future, at the landslide site.

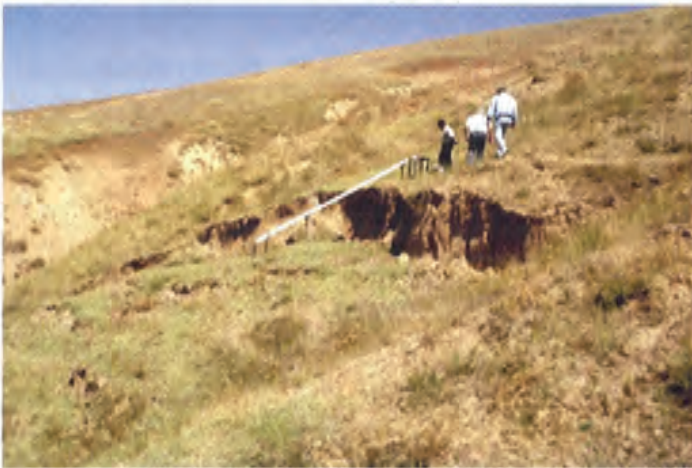
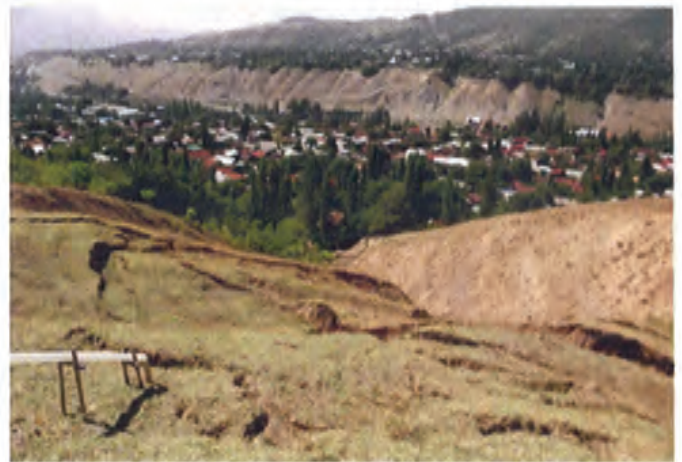
Graph of soil displacement in time (Humsan site)

At present time, there are 5 houses in landslide hazard. To control development of the crack the ground type Extensometer 42, was install at the site on 10 of June, 2010. For 75 day observations the displacements were just 2 – 3 mm, and it also has stepwise movement. In the future it is planned to install long span Extensometer through graben dips, on its terraces.

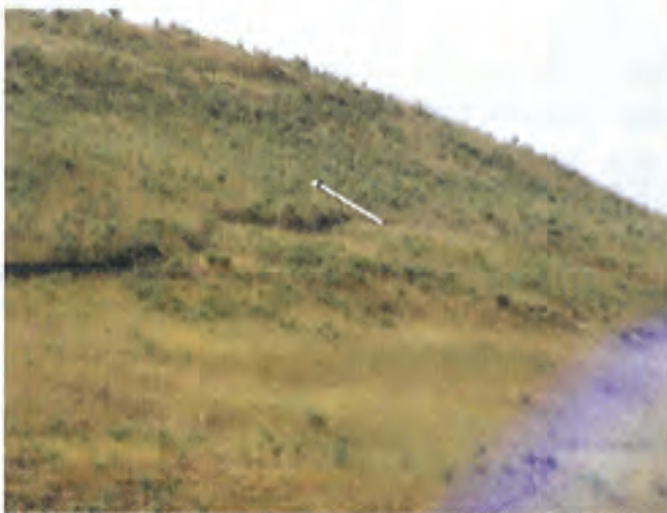
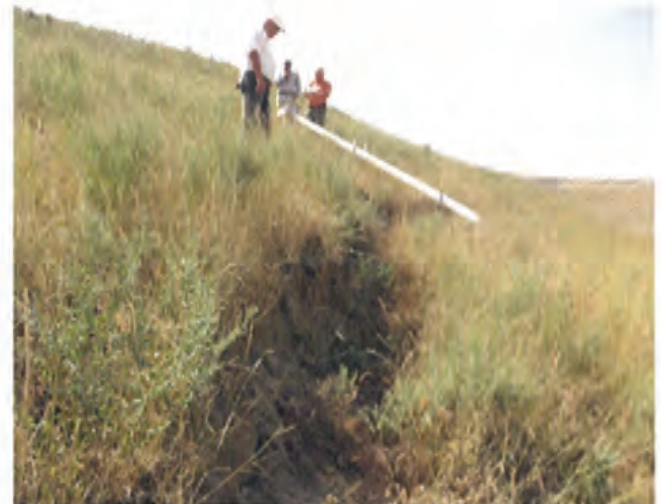
Graph of soil displacement on the Semgran landslide crack.

In order to determine cracks development dynamic, at the section formed in 2003 above the saw bench, on 5 of June 2010, the Extensometer 43 was installed.

First observation results for three months in summer time showed insignificant cracks expansion 5 – 9 mm. Theses have stepwise movement. In the future it is planned to continue Extensometer observations at the site.

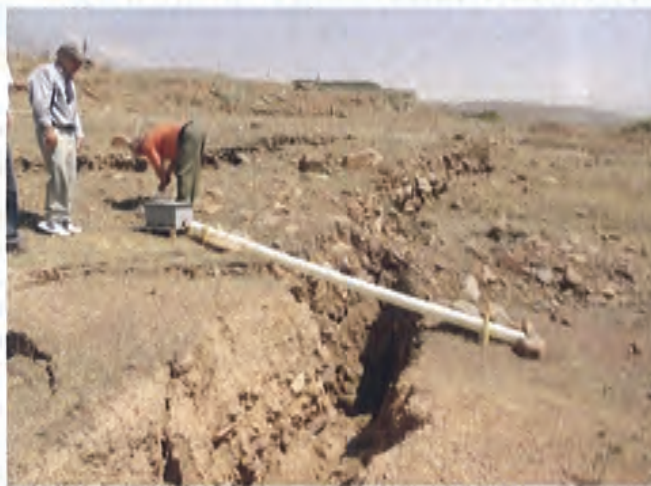
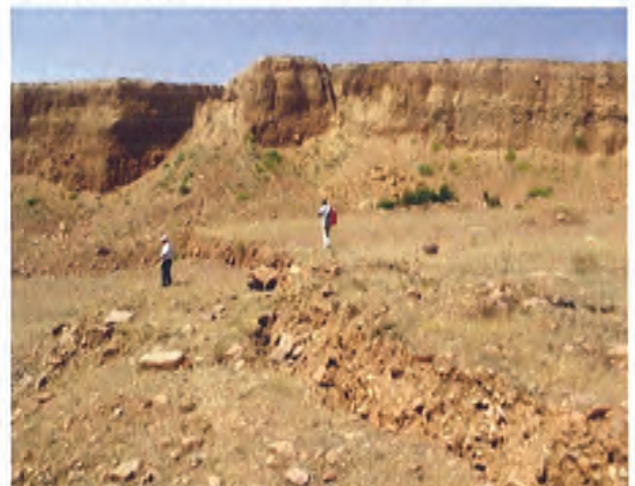
Graph of soil displacement in time for Substation landslide.

To determine movement mechanism on the left flank of the crack on 15 of June 2010 the Extensometer 45 was installed.

Measurement results from 15.06 to 10.08 showed insignificant soil movement – 11 mm in summer time.
