### 6.4.3 Evaluation

**6.5.1 Profile and Objectives**

## 6.6 Process and Evaluation of Project Component: Leaching of Salt Damaged Farm

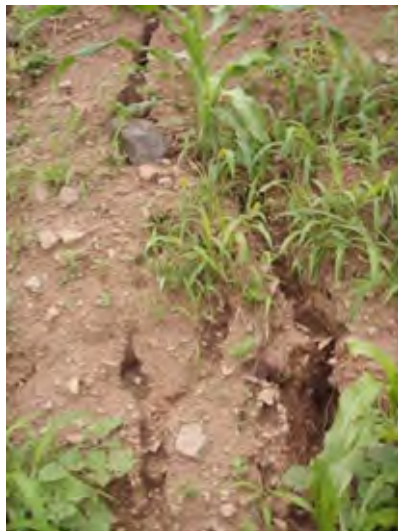
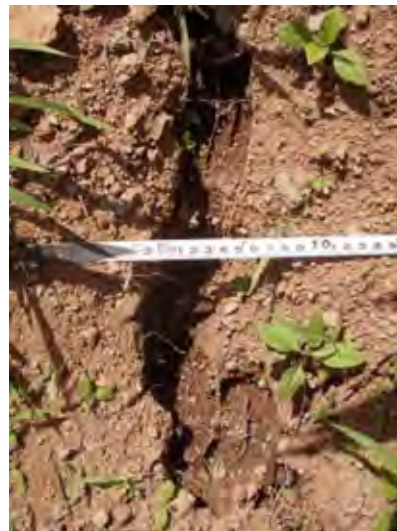
**Damage Caused by Erosion in Furrows  
(Upside of the pictures correspond to upstream)**

The results of the observation showed that clear rill erosion (clear gully with 5 cm in width and 5 cm in depth) was observed in the area where crescent filling works had not been installed. In some places, networks of some 12 cm of rill erosion were observed. On the other hand, although small-scale erosion was observed sporadically in the area where crescent filling works had been set up, there were no spots where rill erosion advanced in larger area. This was reflected to the value of vane shear test. In the slopes where the rill erosion was advanced, surface soil lost its strength and showed lower values (6.79 kPa) than those (8.88 kPa) of the protected area around the crescent filling works. The following is the result of the project.

- Through observations made on the fields, the evolution of apparent erosion in furrows was observed at the points where no conservation works were installed. The results of tests also indicated the decline in resistance of the surface soil on the slopes where erosion is advanced into grooves: and low value (6.79 kPa) was marked compared to the area where crescent filling works are implemented (8.88 kPa). Therefore, the effect was recognized as soil and water conservation works.

The result of observation reveals that accurate rill erosion was observed in the area where soil and water conservation works did not exist. Value of shear test also indicates the decline in stress in the surface soil on the slopes where erosion grooves are advanced, showing the low value (6.79 kPa) compared to the area around the crescent filling works (8.88 kPa). Therefore, the functions of the soil and water conservation works are recognized in this study. However, it is required for ACBs to water fruit trees in the first dry season until the fruit plants take roots, which is one of the concerns for ACBs for sustainable use of conservation works.

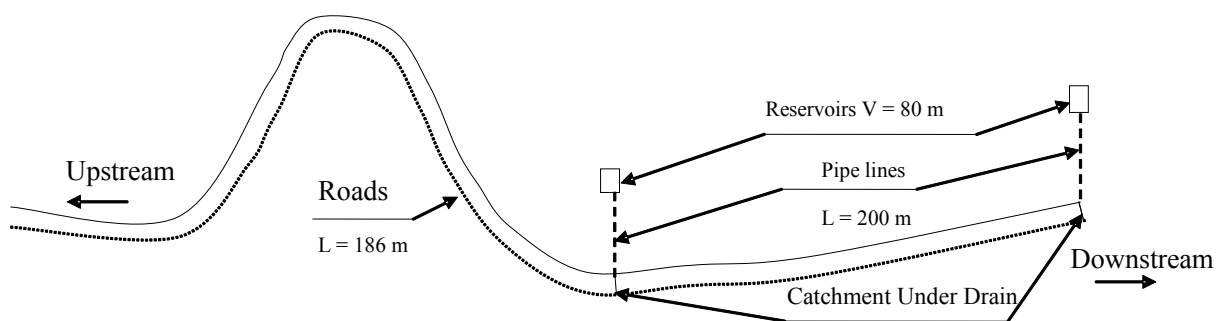
**Figure 6.5.1 Profile Água de Gato**

Reservoirs (Block wet masonry,  $V = 80 \text{ m}^3$ ): 2

Catchment Under Drain: 2

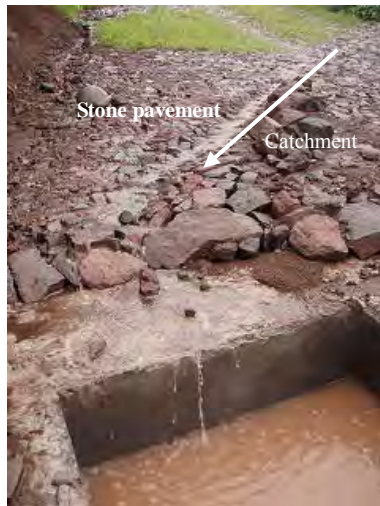
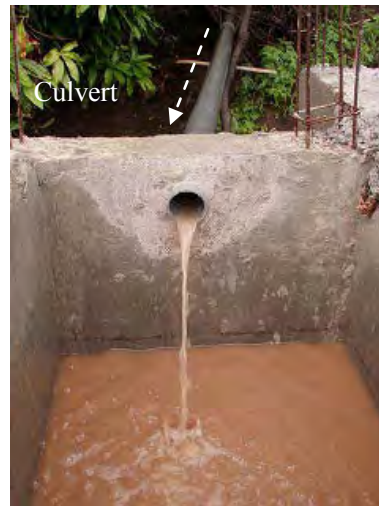
This study confirmed the functions of system in the upstream during the rainfall. Facilities were functioning in catching surface water, in making sand submerged and in conveying water to culverts. However, precipitation of sand was advanced in sand box at the end of September. The level of preserved water was  $50.2 \text{ m}^3$  at that moment.

Left: Conditions of the catchment on the surface roads

Right: Influent of water in the reservoirs (specifically into the sand box outside the reservoir)

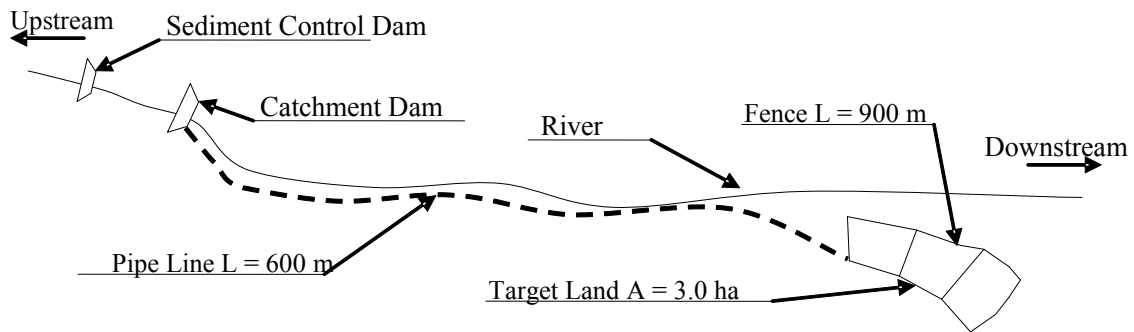
**Figure 6.5.2 Profile: Portal**

Installation of Pipe Lines:  $L = 600 \text{ m}$

Fence (Bar-bed Wire):  $L = 900 \text{ m}$

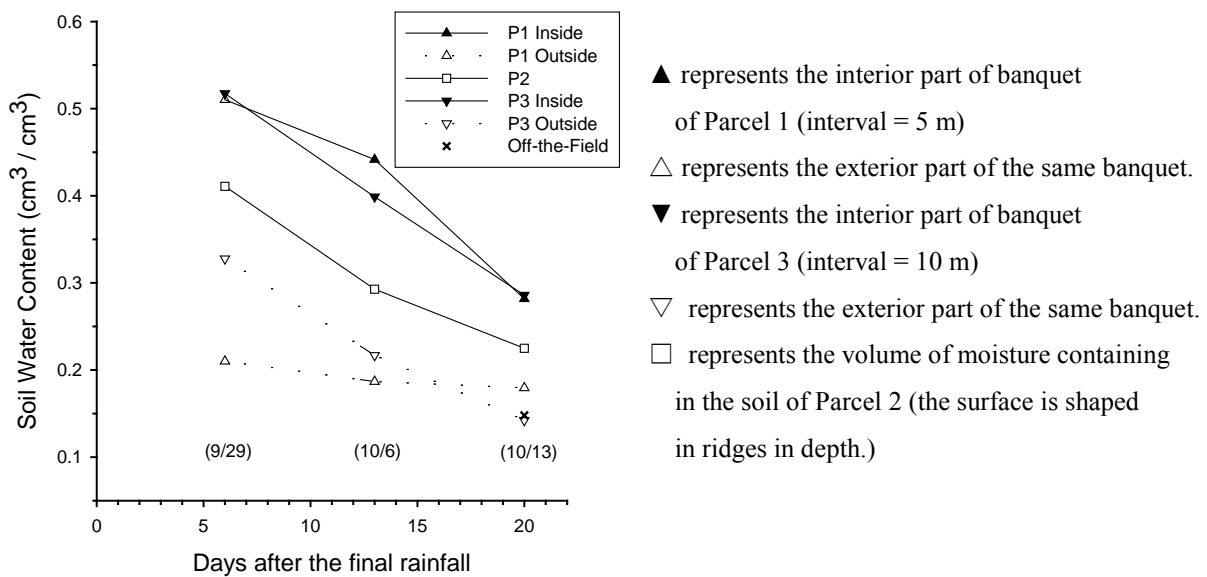
**Figure 6.5.3 Volume of Residual Soil Moisture in Each Experimental Field**

Variations in the soil moisture (in percentage of moisture content) in the areas with and without banquet (P1-P3) (See details of the P1 and P3 in the figure below) after the last rainfall are laid down below.

From the beginning of the evaluation, relatively high humidity in the interior of the banquettes was observed. By contrast, lower values of moisture than in the interior of banquettes were observed in Parcel 2 during the whole period of evaluation.

Functions of catchment and cultivation of water were observed in the banquettes, although the study was conducted within a limited period of three weeks.

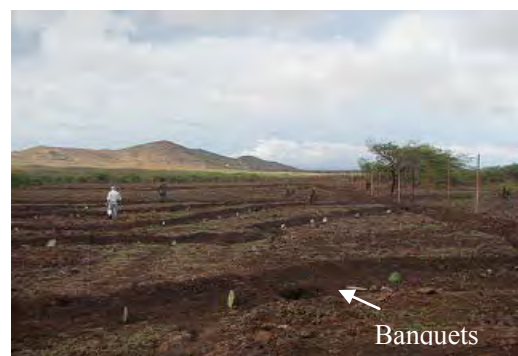
Two forage crops (cactus and parkinsonia) were planted in the two fields with the banquettes. Cacti, whose depth of planting was not enough, showed difficulty in consolidating; therefore some of the cacti fell down, and others had partial dieback. Hence, some cacti were replanted. In consequence, some sprouts were observed from planted cacti, and its roots

started to grow in the soil. Growth condition seemed to be good, regarding the parkinsonias as well. However, as for cacti, which appeared to grow in good condition at the end of November 2009, died out due to the diseases caused by germs and dry damage in the beginning of

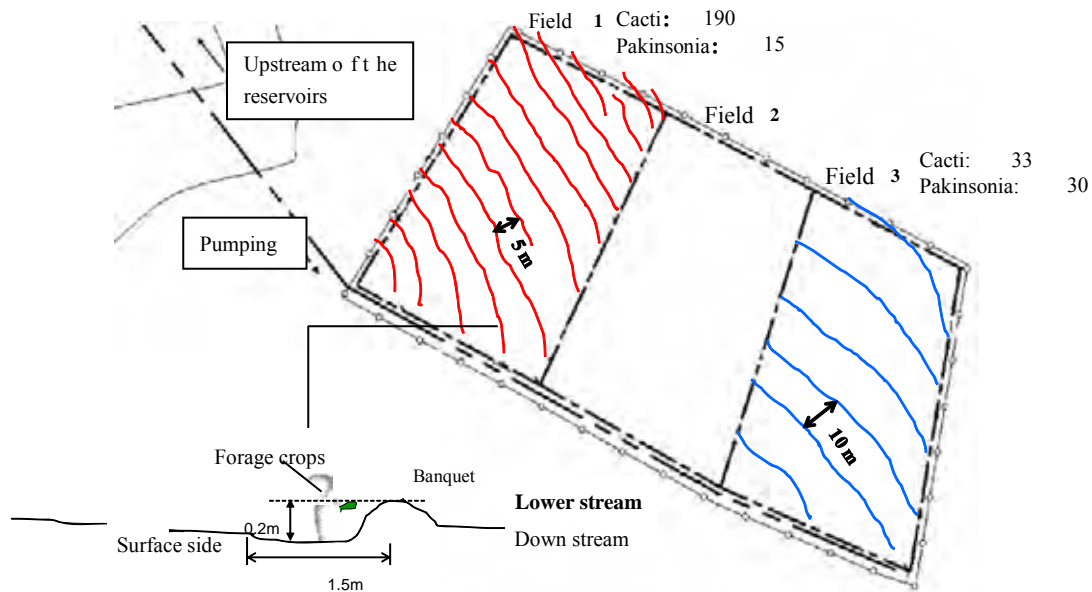
**Figure 6.5.4 Profile of Portal Site**

January 2010. Dry damage prevented parkinsonias from proper growing as well. The profile of Portal Site and the summary of growth conditions of forage crops in Parcel 1 and 3 are shown as follows.

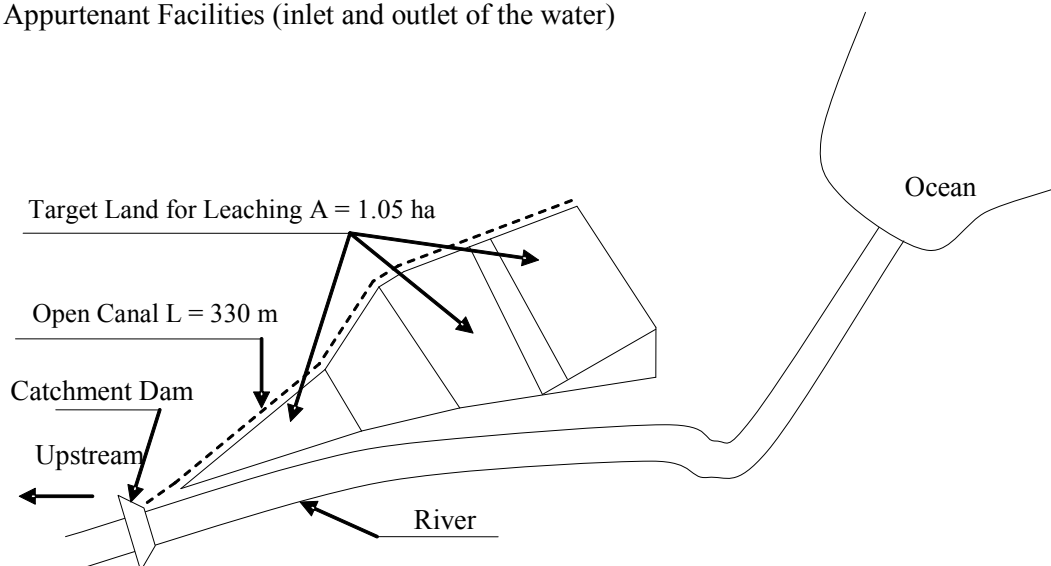
**Figure 6.6.1 Profile Baía**

Target Surface Area: A = 1.05 ha

Appurtenant Facilities (inlet and outlet of the water)

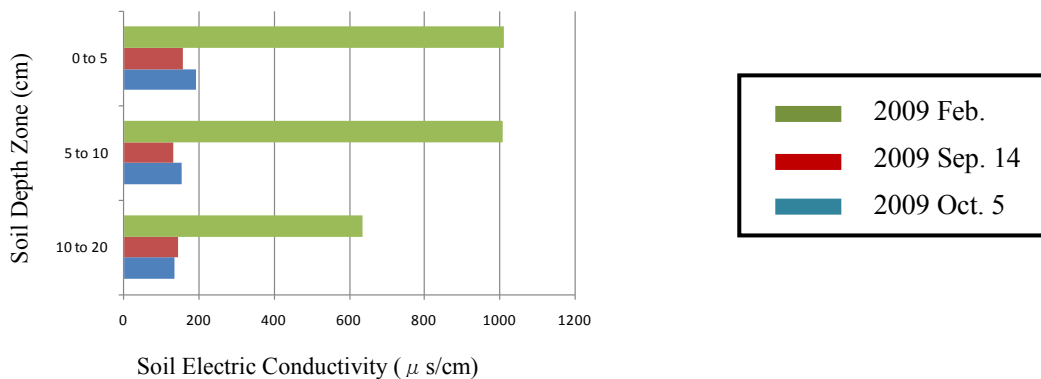
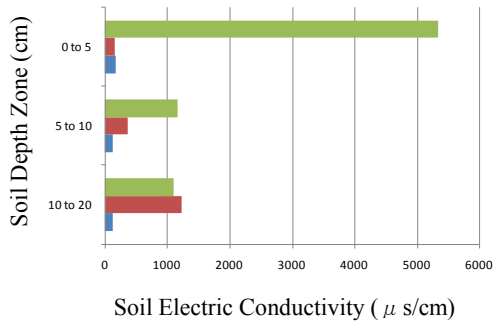
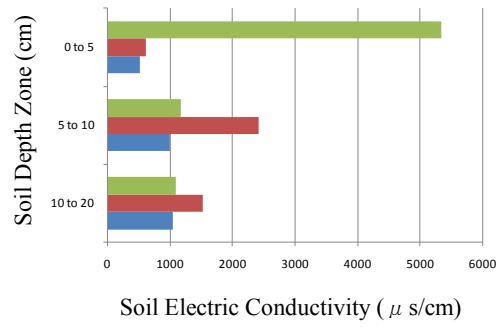
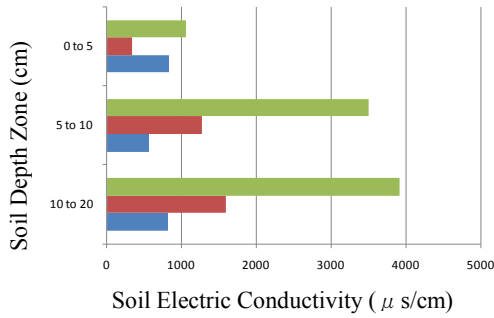
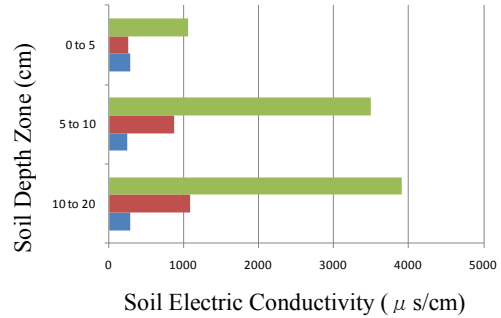
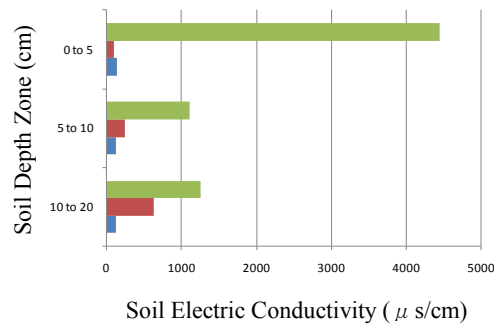
**Figure 6.6.4 Values of Electrical Conductivity**

The chart below shows the result of EC on the soil sampling extracted from the field of leaching project. The level of layer for sampling is indicated on the axis line (0 ~ 5 cm, 5 ~ 10 cm, 10 ~ 20 cm). In terms of the legend, the values of "Feb. 2009" are obtained in the baseline study before this project in the experimental field (x in the profile of leaching experimental field indicates the collection sight). Similarly, the sample values of "Sep 2009. 14" are collected after the floods, and the sample values of "2009 Oct. 5" indicates the value in response to the floods on the 24<sup>th</sup> of September.

The result shows that the values of EC decreased in almost all points (No. 1 ~ No. 8) in the field. The tendency of the decrease in the EC can be observed in all level of the layers in the soils. This infers that soil water including the sodium, such as NaCl, has moved and melted into the deeper layer (lower part than 20 cm layer) by several times of percolation within the field. As for the field where leaching was conducted, compared to the value of EC before the wet season, it was found that the value lowered to 1,000  $\mu\text{s}/\text{m}$ , which was 4,000  $\mu\text{s}/\text{m}$  on average originally. This confirms the effectiveness of the leaching facilities. (Less than 1,000  $\mu\text{s}/\text{m}$  is ideal for the vegetable cultivation, and more than 2,000  $\mu\text{s}/\text{m}$  can harm the growth of the crops.) Condition of inundation in the field of leaching project is shown below (observed on the 9<sup>th</sup> of September).

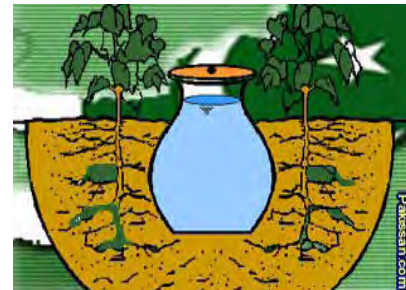
- Drip Irrigation (without mulch)
- Drip Irrigation (with mulch)
- Pitcher Irrigation (without mulch)
- Pitcher Irrigation (with mulch)
- Traditional Irrigation  
(basin irrigation, furrow irrigation: for comparison)
