**THE STUDY  
ON  
ENHANCING EFFICIENCY  
OF  
OPERATING  
THERMAL POWER PLANTS  
IN  
NTPC-INDIA**

**Final Report**

**Summary**

**November 2010**

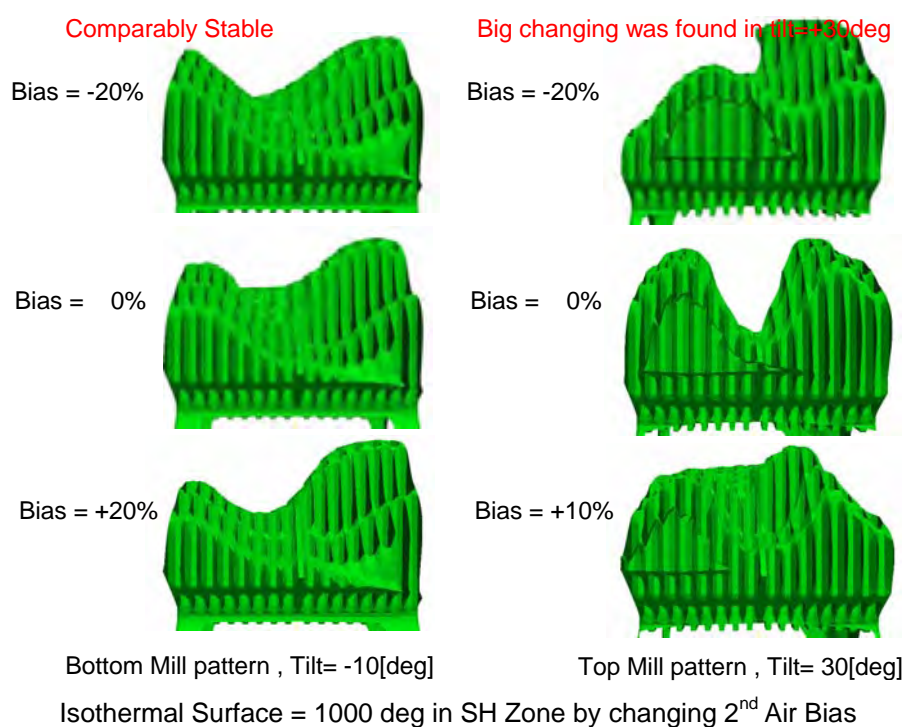
**Fig. 6.2-3 Isothermal Surface = 1000 deg in SH Zone by Changing 2nd Air Bias Results of the 2<sup>nd</sup> Air and/or Fuel Bias**

2<sup>nd</sup> air bias. However, it is clearly found that the right & left deflection profiles are greatly different by the tilt angle and the mill pattern. Thus, it would be difficult to always keep the small right & left deflection by this bias operation.

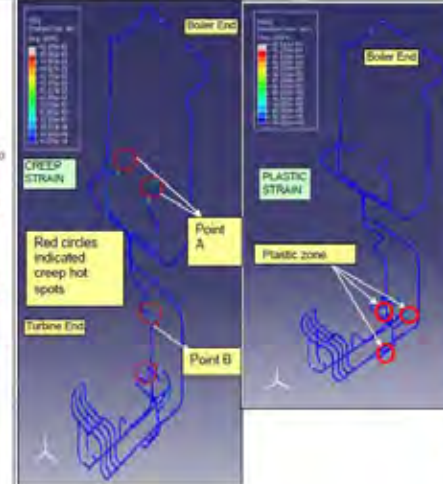
i) Evaluated Remaining Life through FEA & IM is >20 years (Lower amongst the two). ii) Evaluated Remaining Life through LMP is 5.91 years.  The wide difference between the evaluated remaining life as above is due to a conservative approach taken in LMP methodology. A safety factor of 1.25 upon operating pressure is taken - to cover the probability of variation in operation, under stresses due to change in loading pattern & spent life of the pipe. It may be noted that probability of failure is generally located in the hot spot zone as identified in FEA analysis. However, evaluated life changes drastically to 25 yrs if 50% safety factor is taken or in other words if pressure does not rise above design pressure.  Based upon above result, we conclude that the expected remaining life could be prolonged up to 20 years under strict compliance of the following: 1) Operating pressure will not exceed design pressure 2) Corrective action of resetting the hangers and supports are taken 3) Close monitoring of weak zones are carried out as recommended.  Please note that CRH & HPBP line is evaluated that the remaining life is >20 years.	It is suggested that the critical locations identified be subjected to the following tests in every annual overhauling, mandatory at next annual overhauling: 1. In situ Metallurgy (IM) to know the material degradation level. 2. Thickness Survey. 3. Online line monitoring systems using the installation of the High temperature strain gauges at identified hot spot locations & thus the real time strain data will be acquired and used for further life estimations. 4. EMAT - Electromagnetic acoustic transducer test / high frequency (20MHz) small diameter probe UT, can be implemented to check the state of steam side surface corrosion, / pitting of the main steam pipe in the critical locations. 5. Indicated hangers required to be corrected.

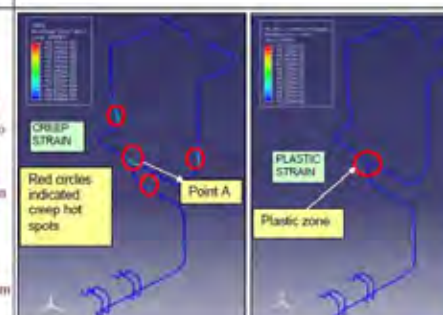
Based on the overall analysis, the condition of piping system is satisfactory. Remaining life is evaluated to 13.6 years.	Run-Component fit for further operation and re-inspection of the component is recommended after 5 years of further operation to monitor the extent and trend in service induced damage and assess its fitness for further service.  Repair / Replace: Indicated hangers required to be corrected.

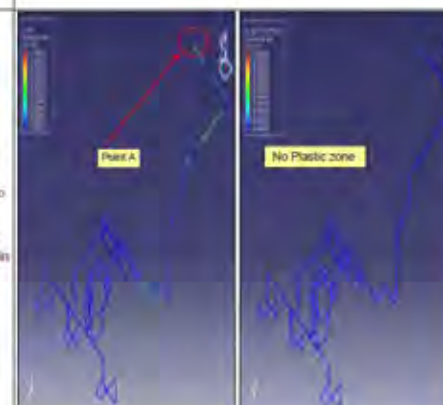
Not considered	Not considered	Remaining Life of Piping System based on FEA is > 20 Years.	<div>1) Maximum Stress due thermo mechanical load is 142 MPa (localised Point A) average stress value is 60 to 70 MPa which is within allowable limit &amp; strain observed is 0.00066. (Elastic Strain 0.00066 + Plastic Strain 0.0)</div>

Based on the overall analysis, the condition of piping system is satisfactory. Remaining life may be concluded > 20 years.	Run-Component fit for further operation and re-inspection of the component is recommended after 5 years of further operation to monitor the extent and trend in service induced damage and assess its fitness for further service.

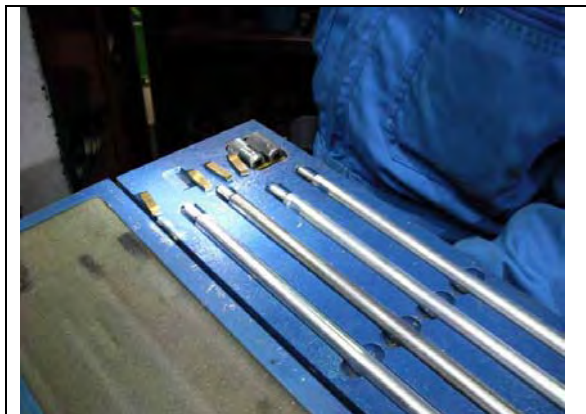
- 1) At periodical maintenance, only measurement of gap is carried out, and no adjustment is carried out. If the gap is bigger than OEM's limitation, seal fins must be replaced with new one.
- 2) Other work than measurement of gap, burr at fin tip part or cracked part should be cut, and tip part should be smoothed by special tool, for example, shown below.

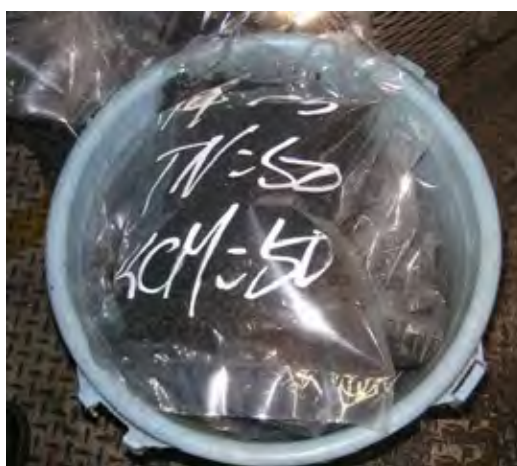
**Fig. 6.13-1 Coal Sampling Plastic Bag**

In accordance with Study team's procedure, the sampled coal is sealed in a plastic bag so that the moisture content in the coal does not vary, and then it is carried to the laboratory.

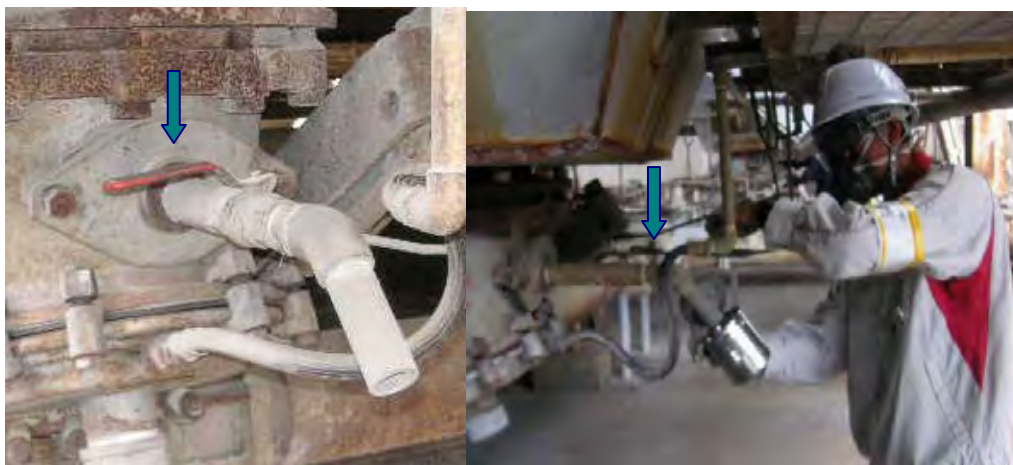
**Fig. 6.13-2 Fly Ash Extraction Valve for Sampling**

In accordance with Study team's procedure, a fly ash extraction valve is installed, and a fly ash sampling storage bin is used to sample a constant amount of fly ash.
