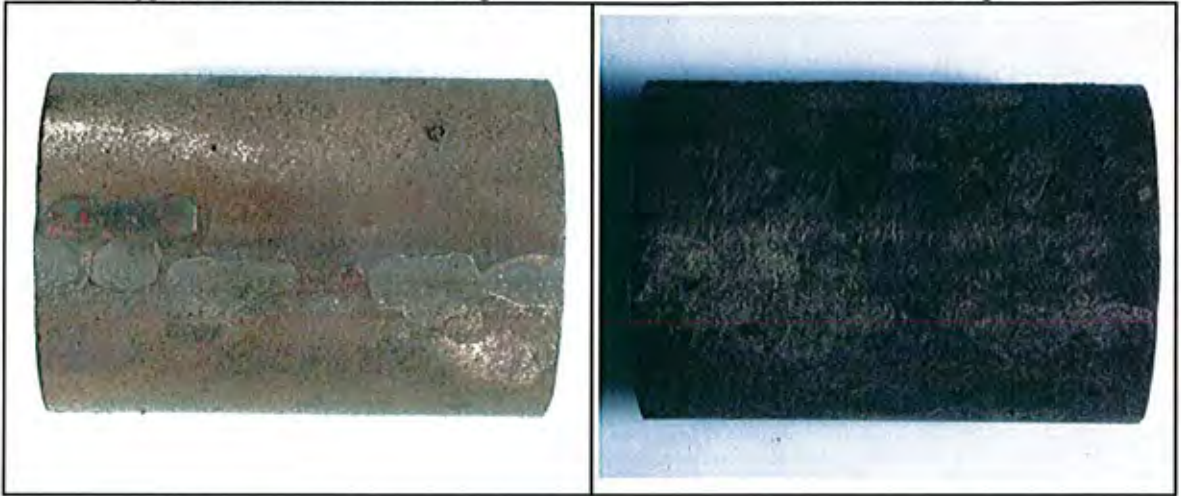
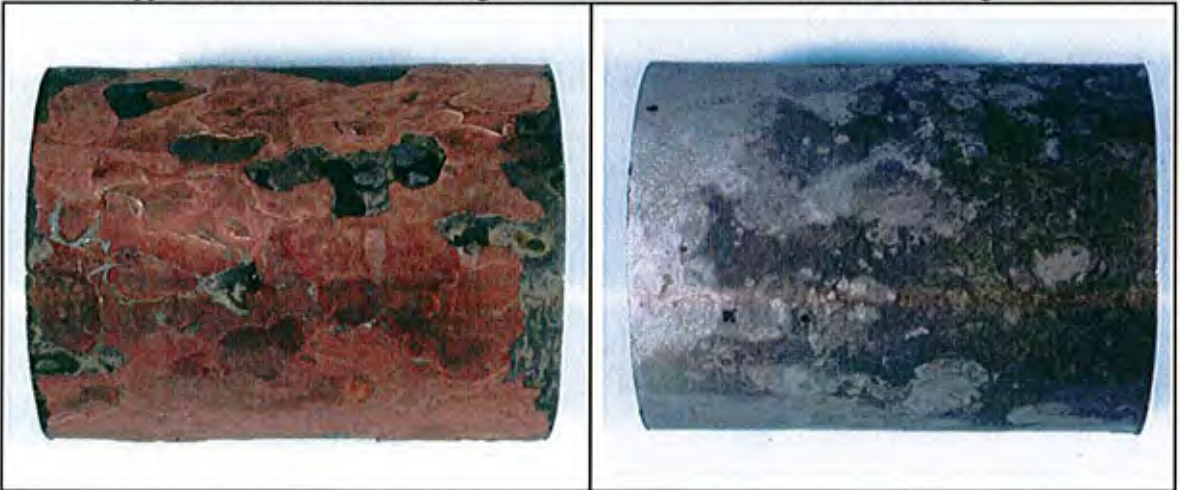
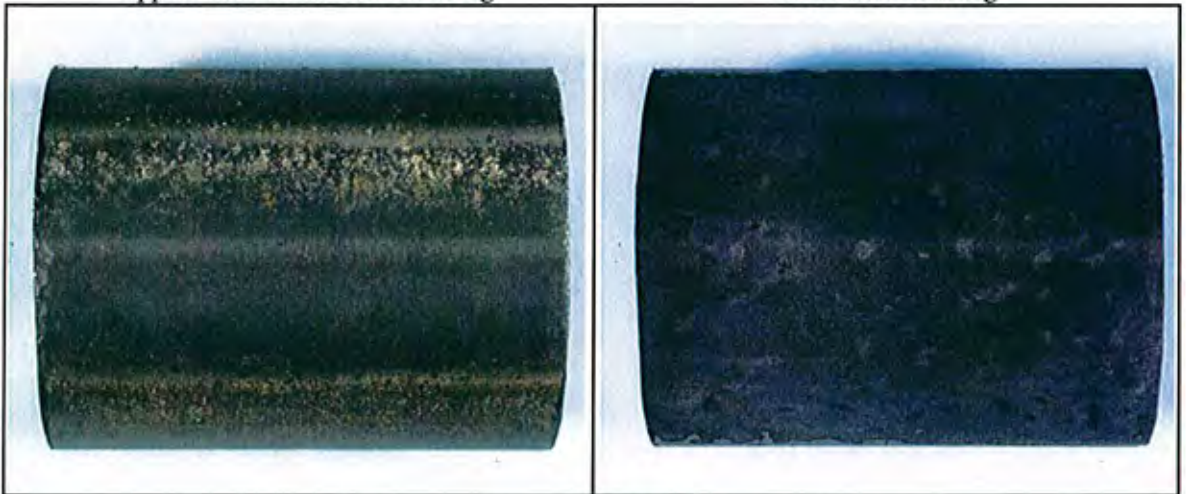
Photo I -12 Tube appearance from outside (boiler front side)

Appearance before acid cleaning

After acid cleaning

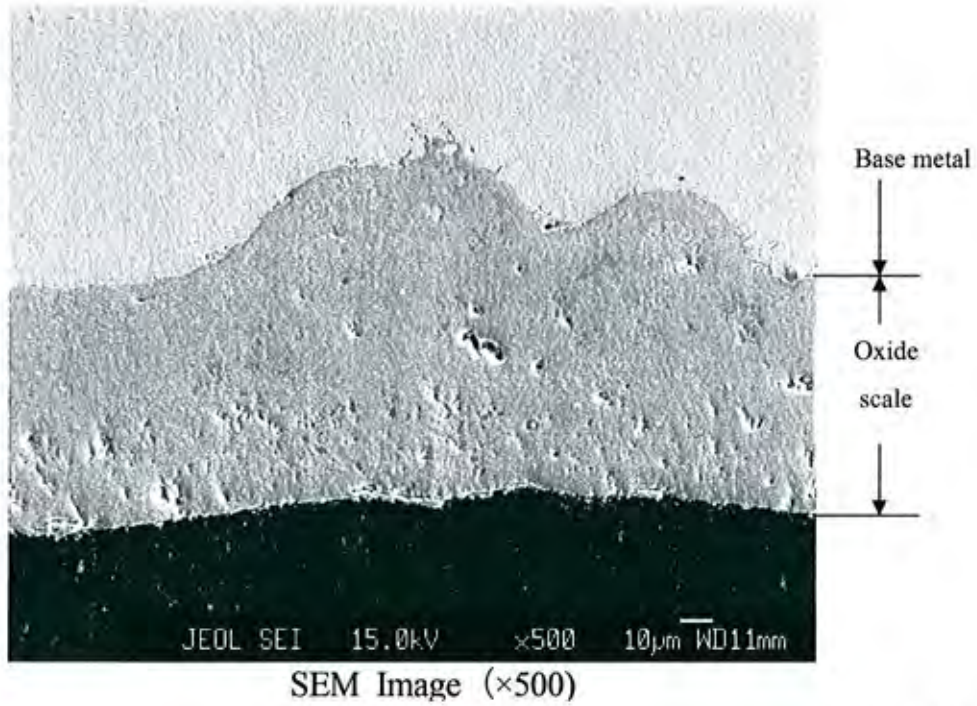
Fig I-13. EPMA analysis results

Singrauli Platen-SH [Front]

Element Mapping Image (brighter color indicates higher concentration)

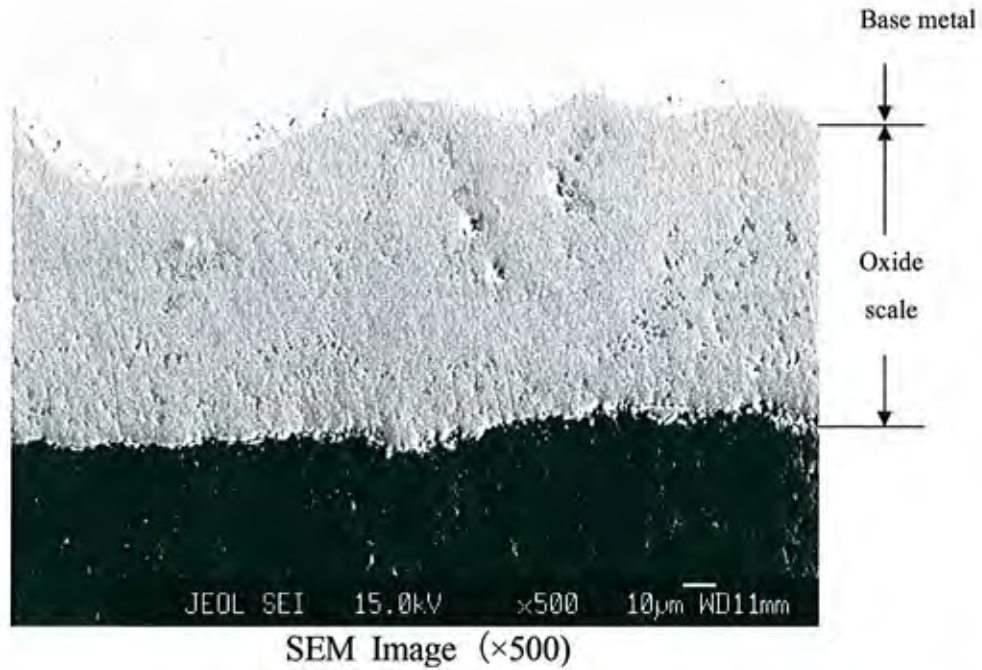
Fig I -14. E PMA analysis results

Singrauli Platen-SH [Right]

Element Mapping Image (brighter color indicates higher concentration)

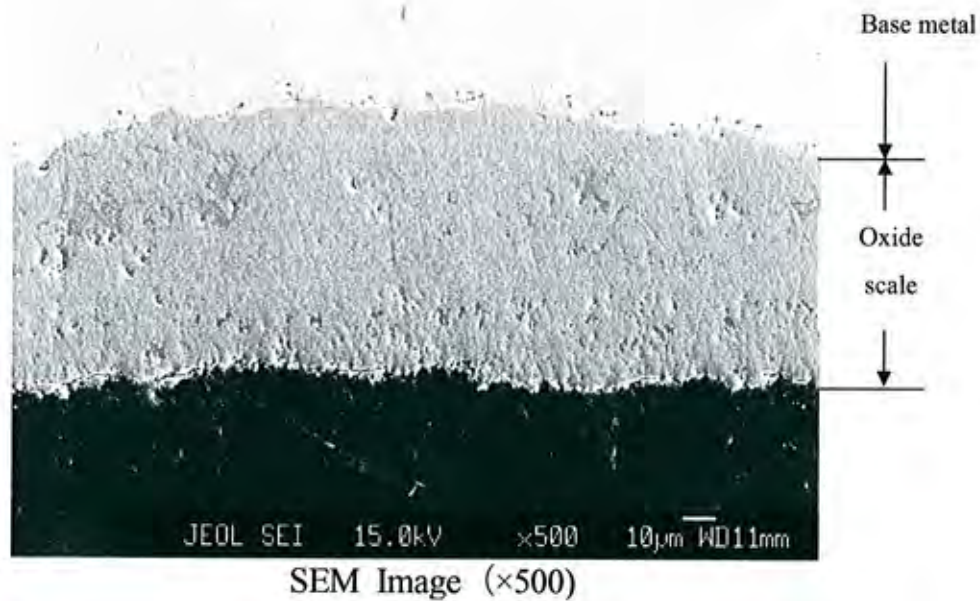
Fig I -15. E PMA analysis results

Singrauli Platen-SH [Rear]

Element Mapping Image (brighter color indicates higher concentration)

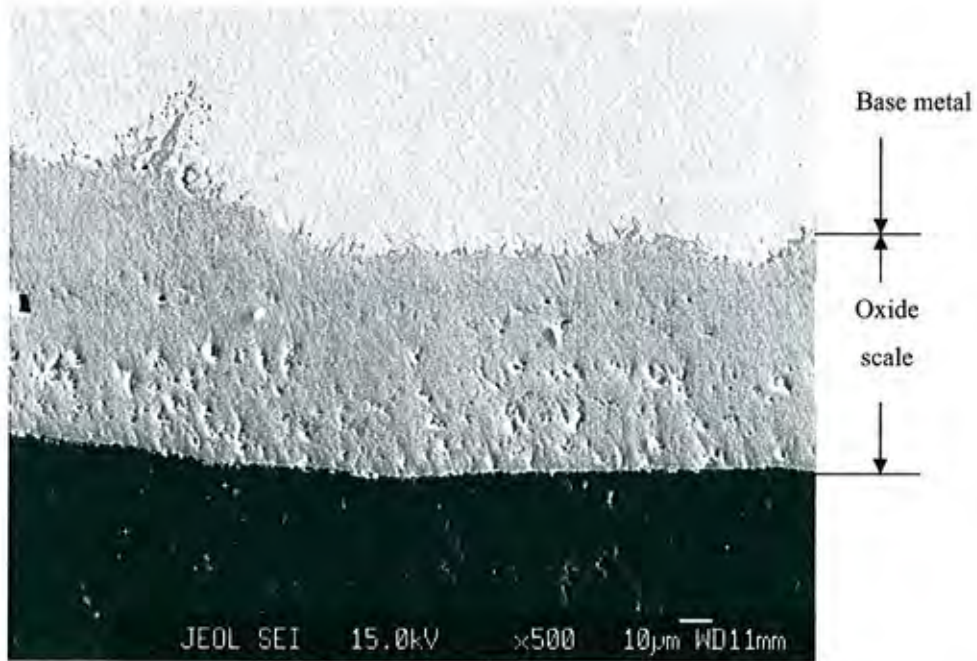
Fig I -16. E PMA analysis results

Singrauli Platen-SH [Left]

SEM Image (x500)

Element Mapping Image (brighter color indicates higher concentration)

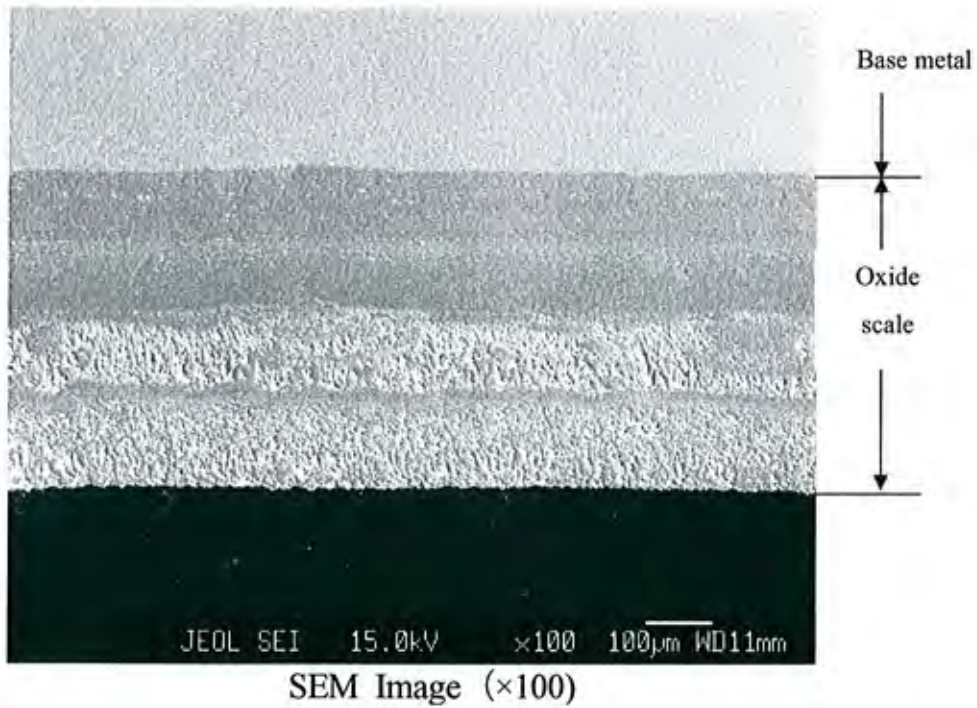
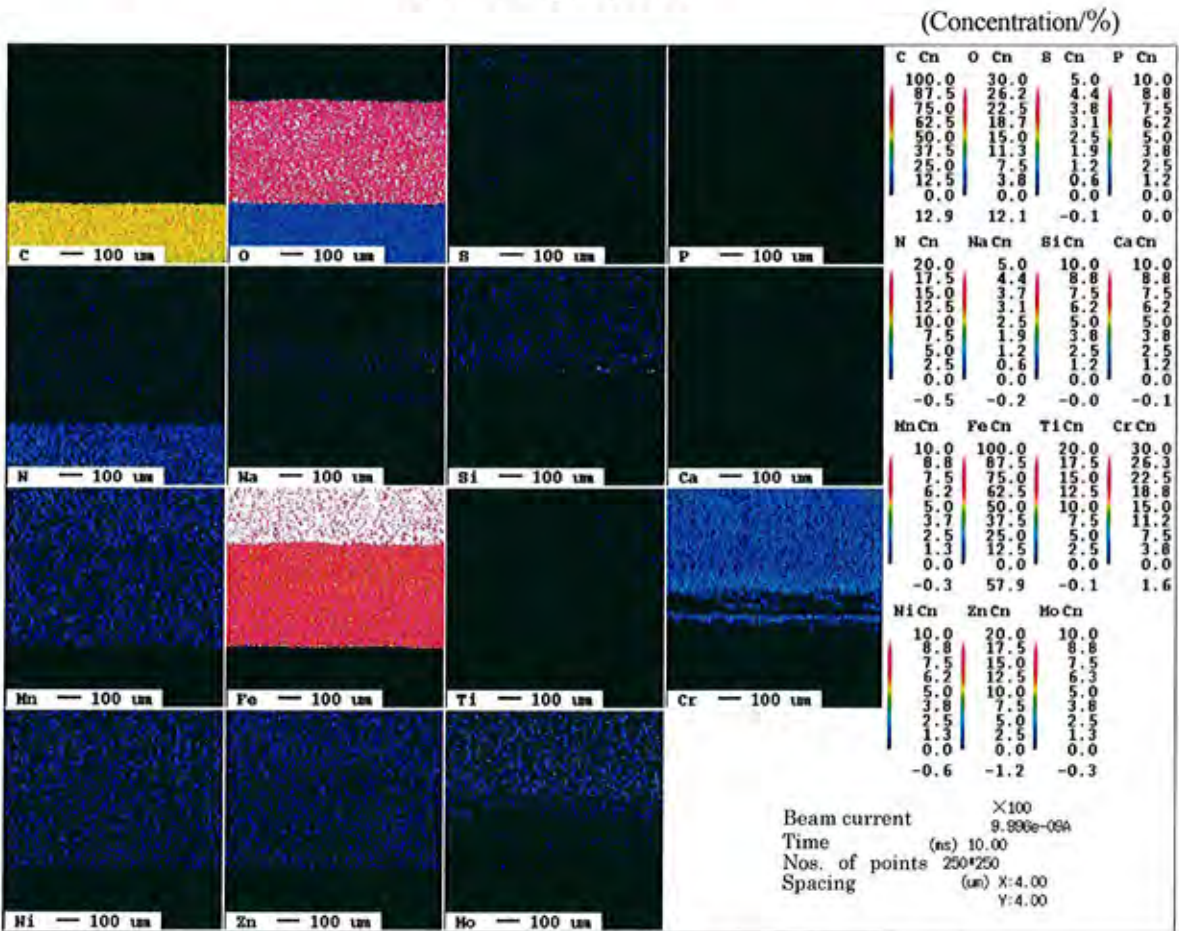
Fig I -17. E PMA analysis results

Singrauli RH(in penthouse) [Front]

Element Mapping Image (brighter color indicates higher concentration)

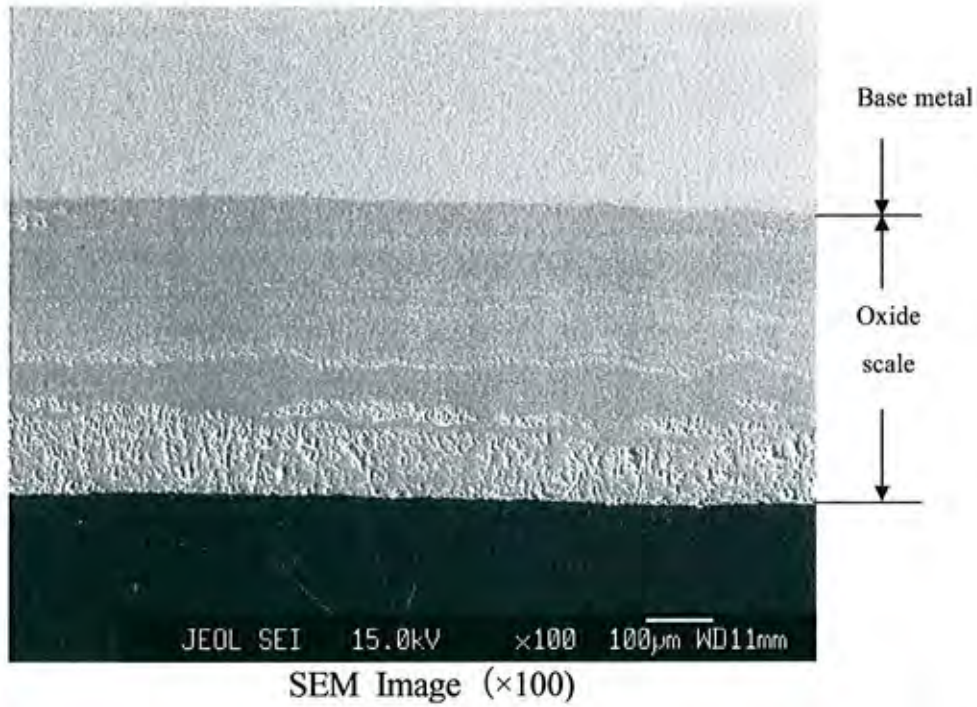
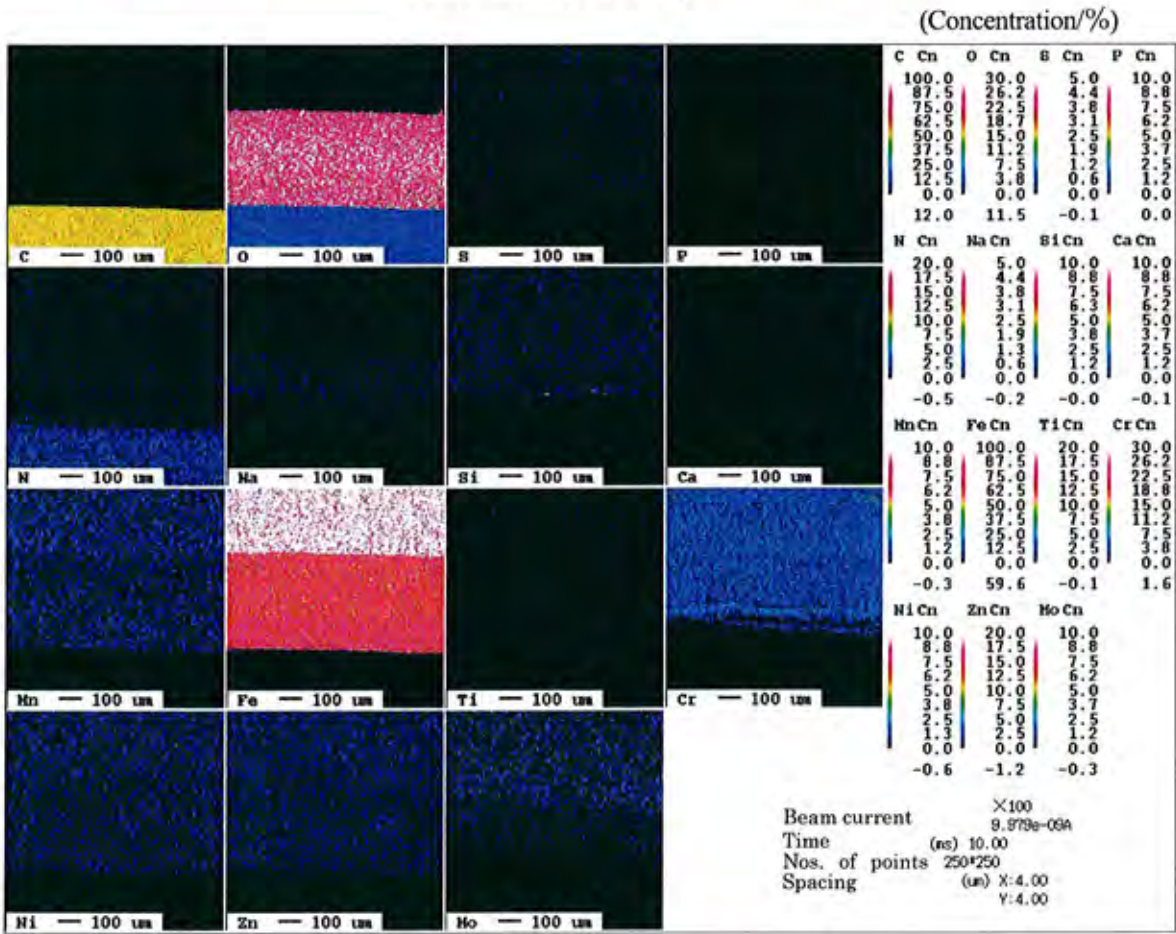
Fig I -18. E PMA analysis results

Singrauli RH(in penthouse) [Right]

Element Mapping Image (brighter color indicates higher concentration)

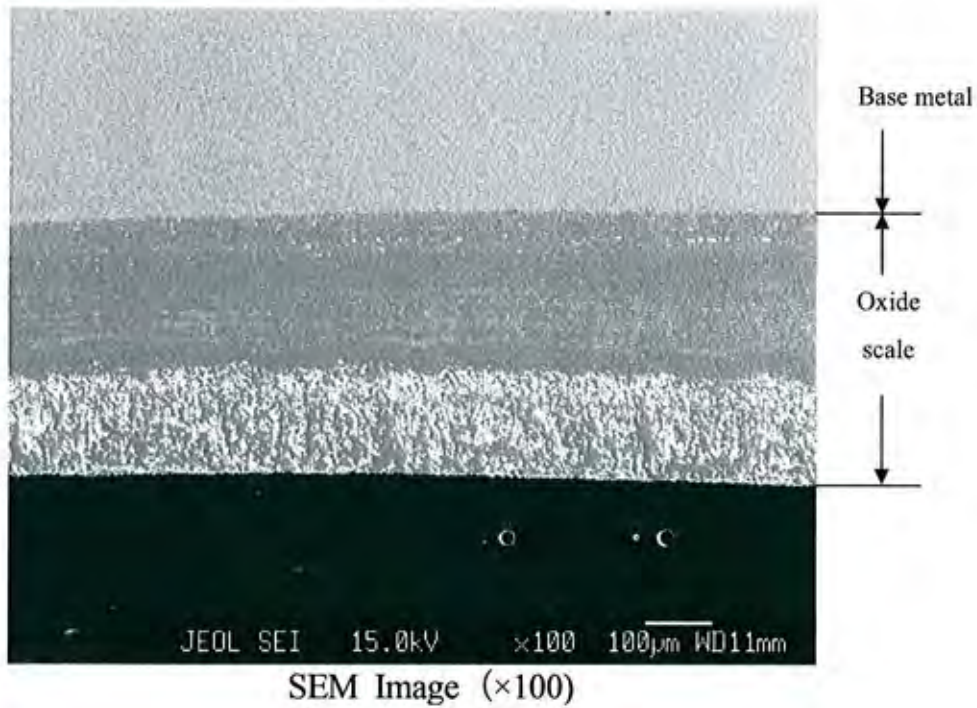
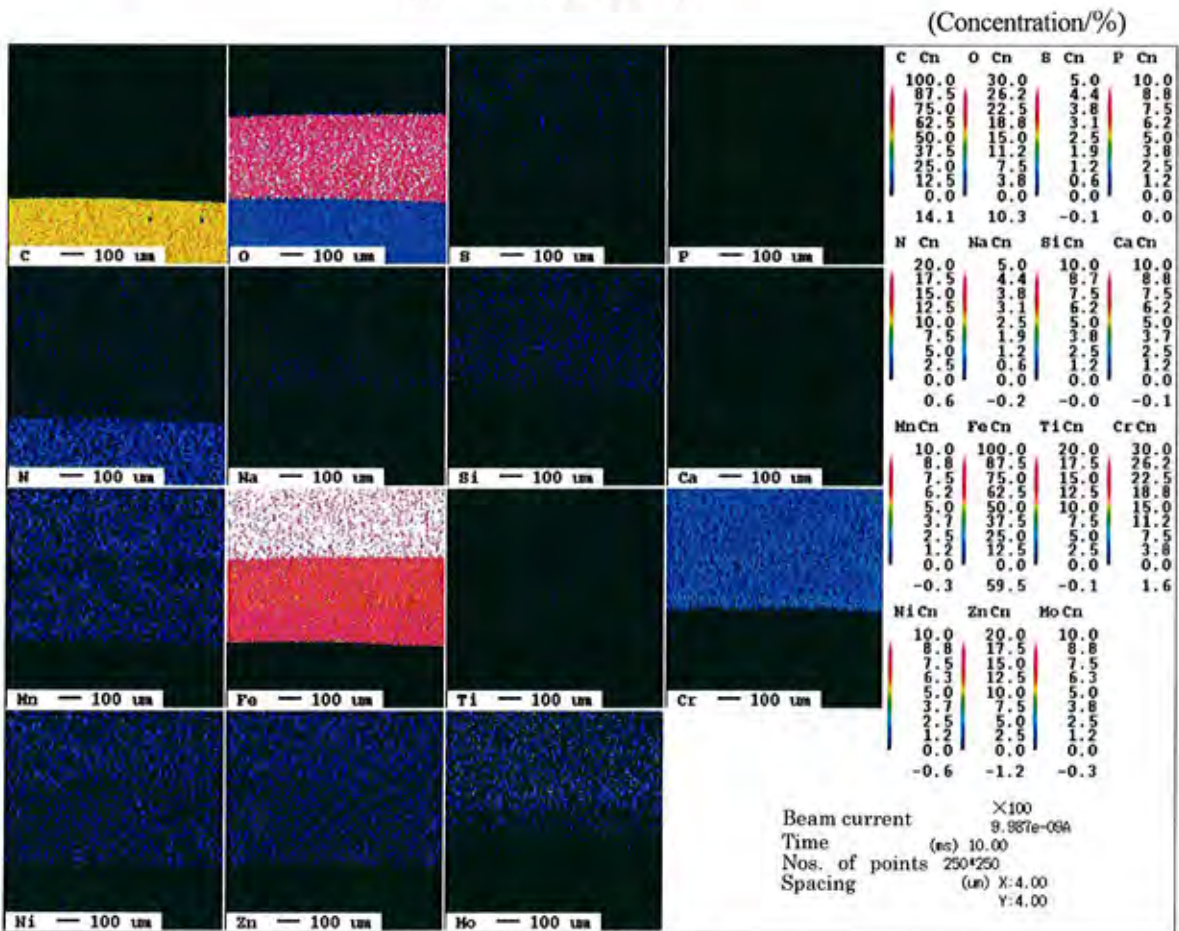
Fig I -19. E PMA analysis results

Singrauli RH(in penthouse) [Rear]

Element Mapping Image (brighter color indicates higher concentration)

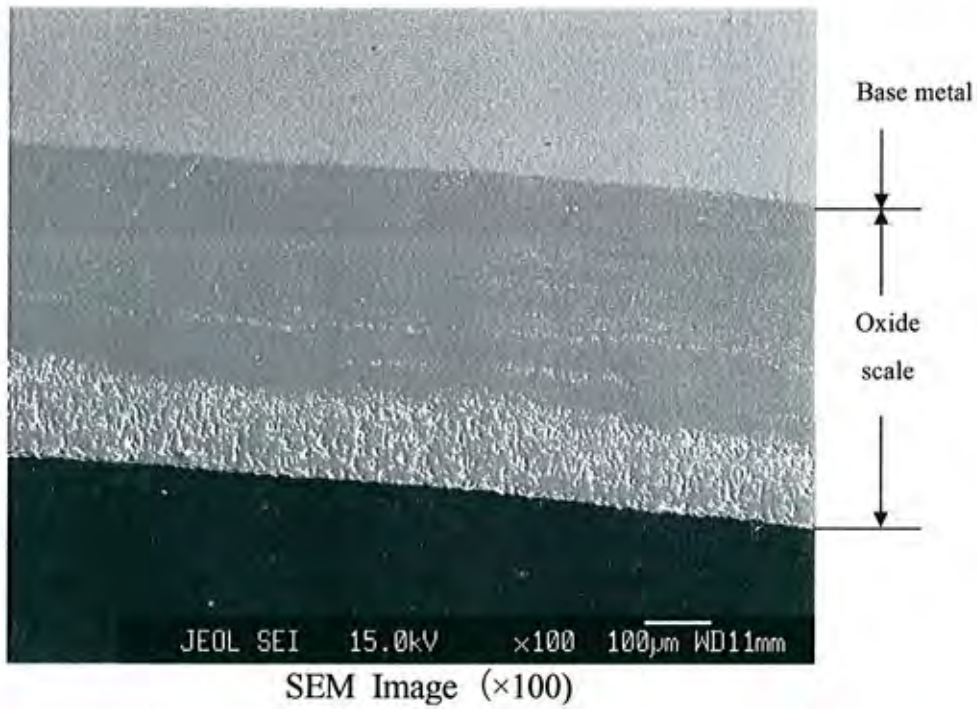
Fig I -20. E PMA analysis results

Singrauli RH(in penthouse) [Left]

Element Mapping Image (brighter color indicates higher concentration)

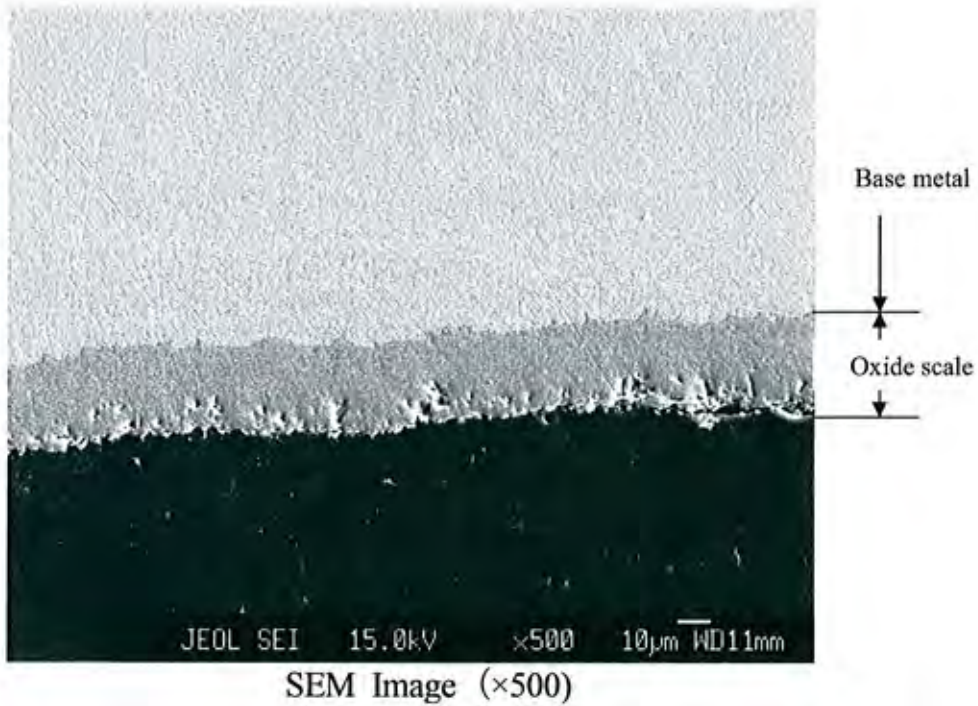
Fig I -21. E PMA analysis results

Singrauli RH(in furnace) [Front]

Element Mapping Image (brighter color indicates higher concentration)

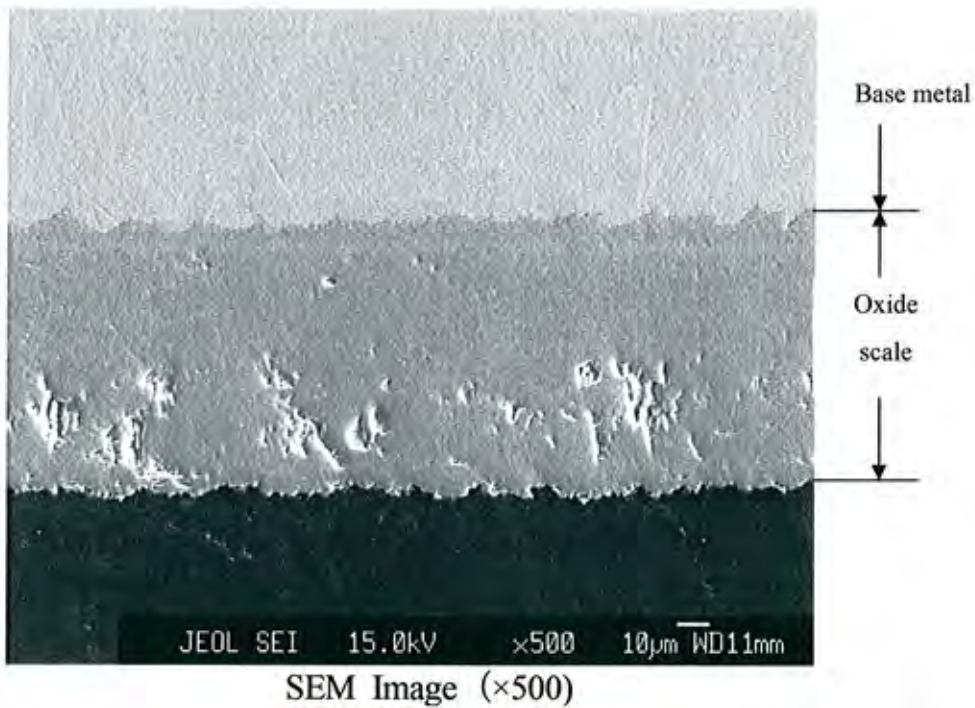
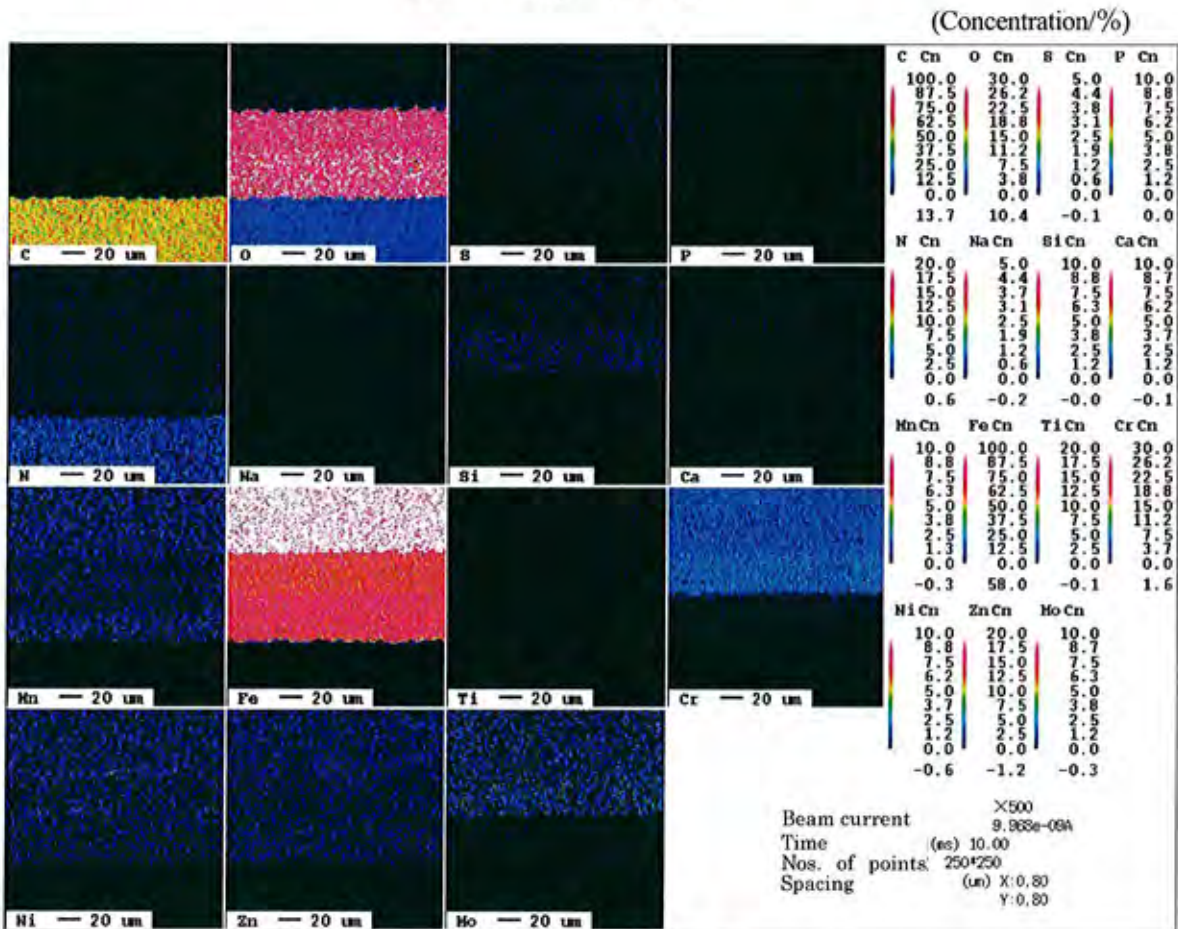
Fig I -22. E PMA analysis results

Singrauli RH(in furnace) [Right]

Element Mapping Image (brighter color indicates higher concentration)

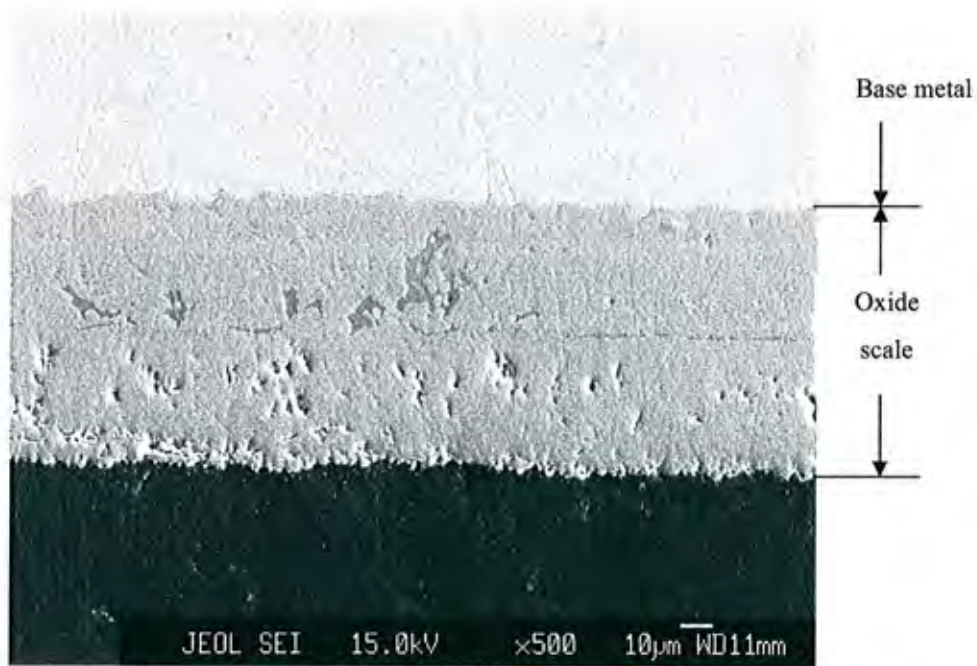
Fig I -23. E PMA analysis results

Singrauli RH(in furnace) [Rear]

SEM Image (×500)

Element Mapping Image (brighter color indicates higher concentration)

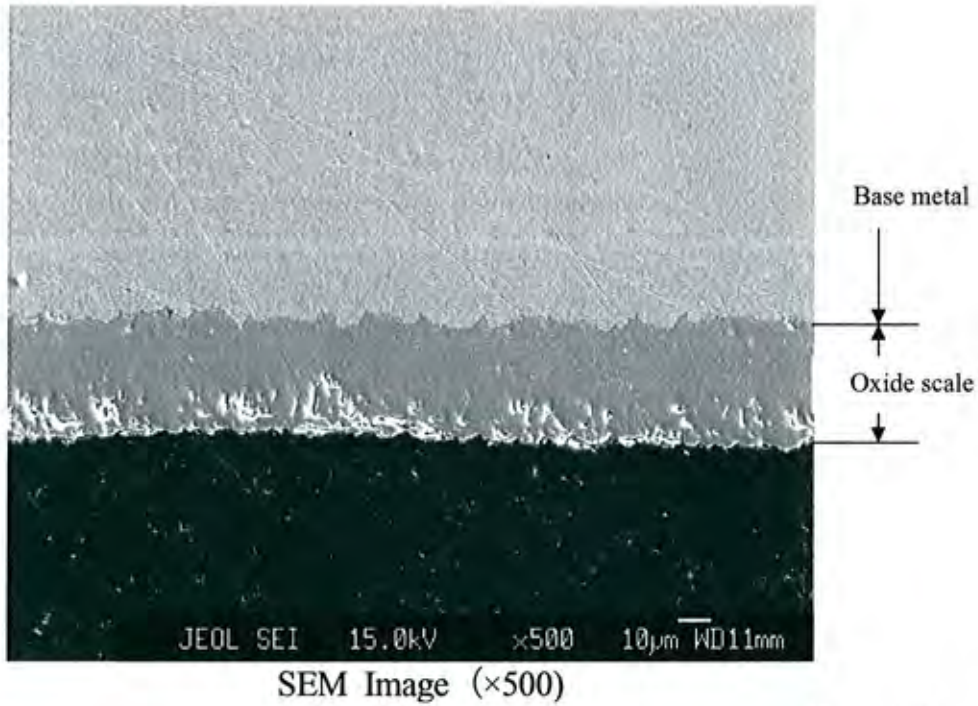
Fig I -24. E PMA analysis results

Singrauli RH(in furnace) [Left]

Element Mapping Image (brighter color indicates higher concentration)
