Sample tube inspection [Unchahar #2]

Sample tube inspection and creep rupture test were carried out as one of the boiler residual life assessment items for Unchahar Super Thermal Power Station #2 unit. The results are reported as follows.

Unchahar Super Thermal Power Station #2 unit

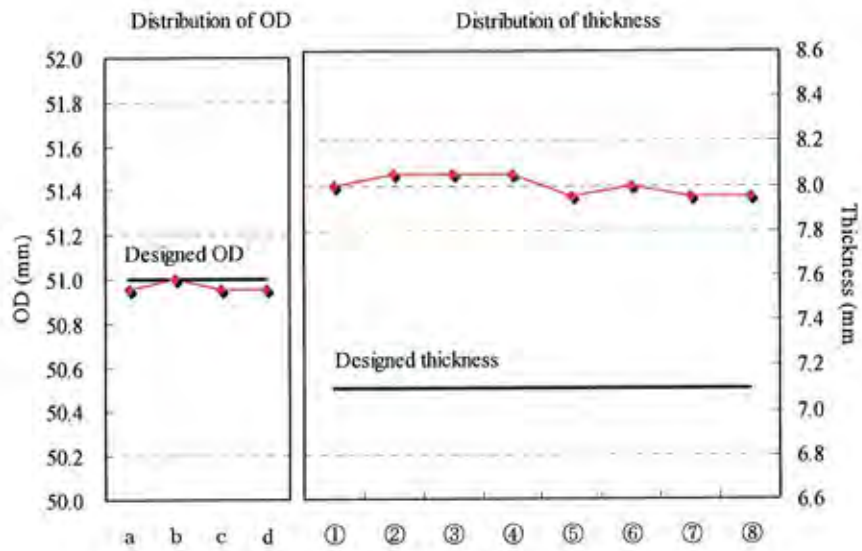
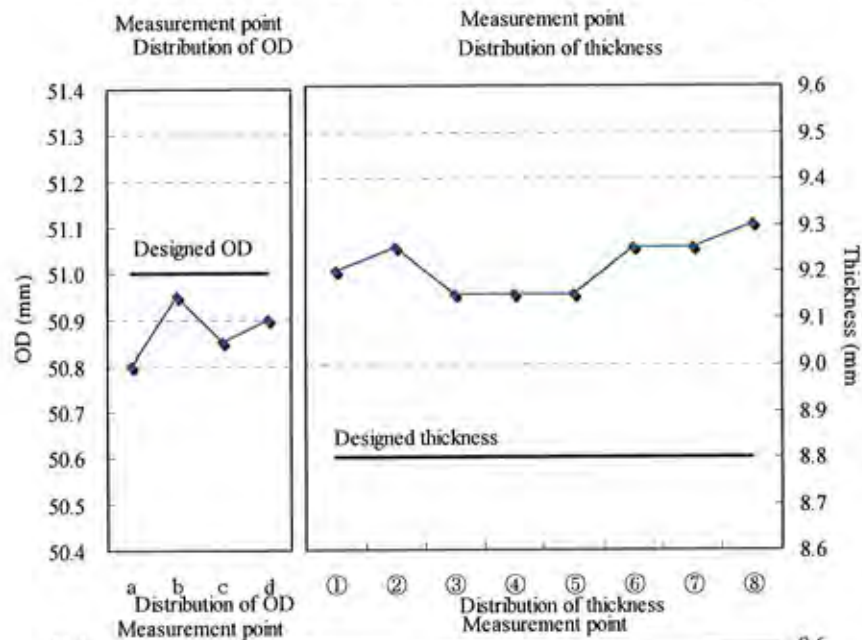
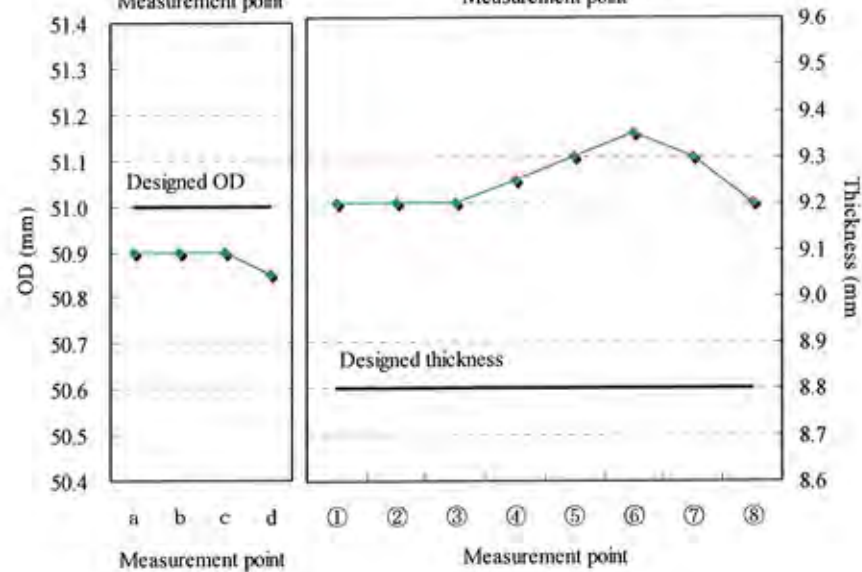
Fig II -12 Tube dimension measurement results

a. OD measurement

OD of each tube was measured to be less than designed values.

b. Thickness measurement

Thickness of each tube was measured to be larger than designed value.

(2) Tube dimension measurement (Table II -32, Fig II -12)

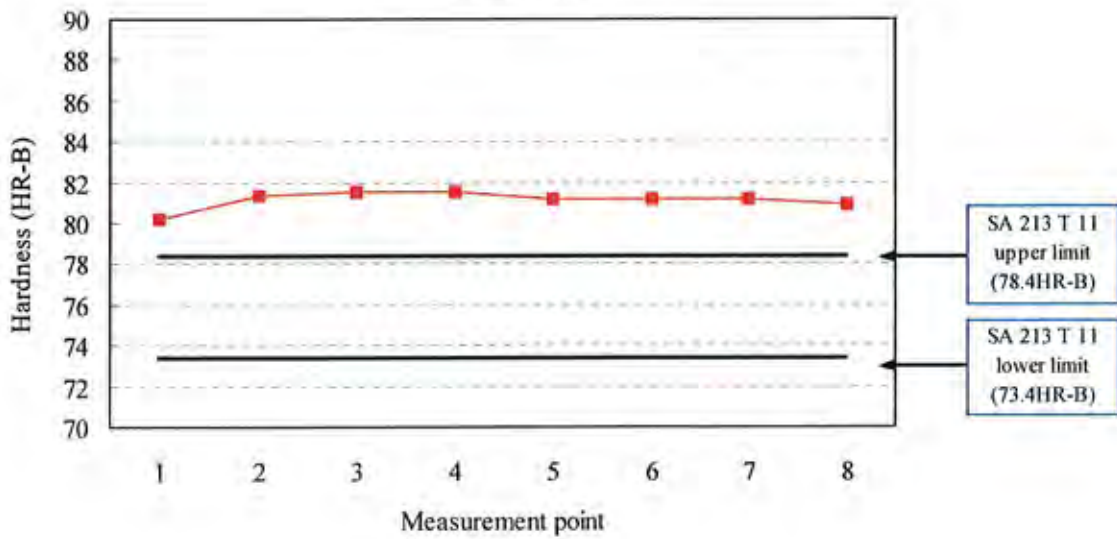
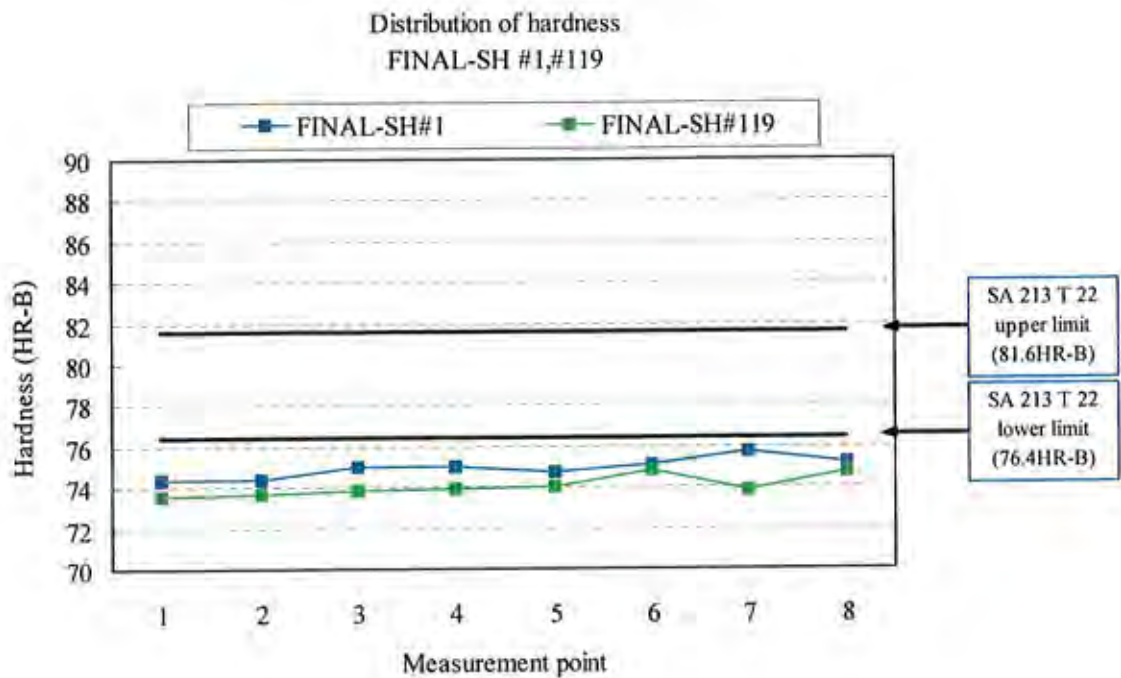
Fig II -25 Hardness measurement results

- The hardness of Platen-SH tube (SA213T11) was higher than the normal value of virgin material by Japanese steel manufacturer.
- The hardness of Final-SH#1, #119 tube (SA213T22) were lower than the normal value of virgin material by Japanese steel manufacturer.

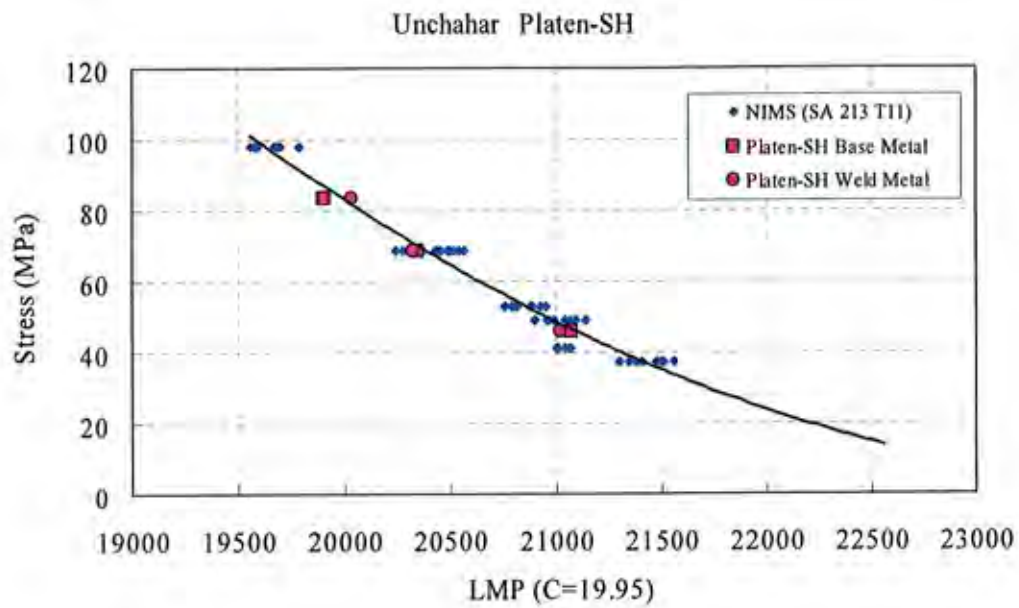
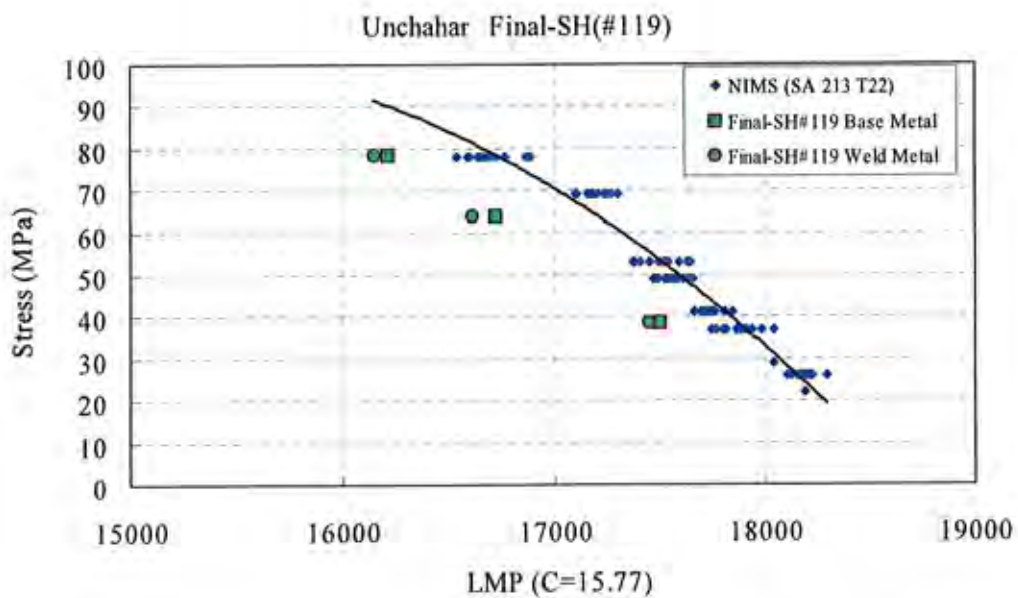
Fig II-27 The comparison of the test results and the creep rupture data of virgin materials by NIMS (National Institute for Materials science).

- The test results for base metal and weld joint in Platen-SH tube indicate almost same creep rupture strength as NIMS data.
- The test results for base metal and weld joint in Final-SH#119 tube indicate the lower creep rupture strength than NIMS data.

The comparison of the test results and the creep rupture data of virgin materials by NIMS (National Institute for Materials Science) is shown in Fig. II -27 .

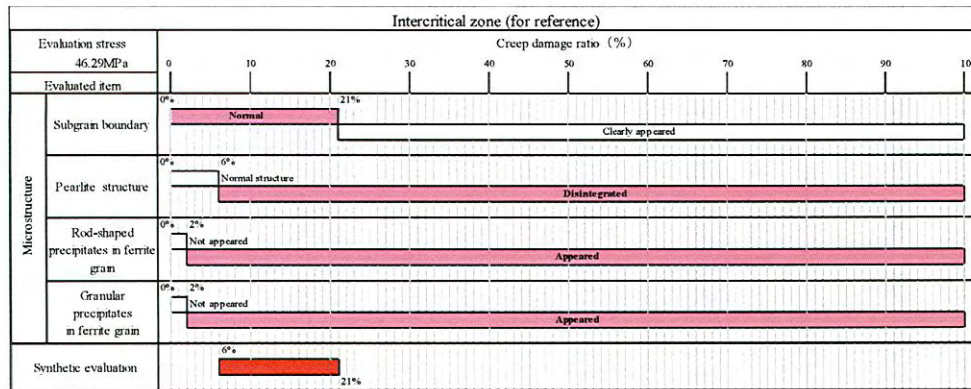
Fig II-28 Evaluation Results Platen SH

- The highest creep life consumption ratio was evaluated at Final-SH #1 tube with 36% and evaluated residual creep life (half of residual life evaluated microstructure comparison method) was 120,000 hours.

Evaluation figures of residual life assessment for each components by microstructural comparison method are shown in Fig. II-28~30 and evaluation results are shown in Table II-44.
