SCALA PENETROMETER LOG

Job No: **750725**  
 Project: **Solomons Radio**  
 Location: **Henderson Airport, Honiara**  
 RL: **5.73m**

CLIENT: Yachiyo Engineering Co Ltd  
 TITLE: Honaris Radio Mast  
 REFERENCE No. 750725

**Appendix D: Geotechnical Laboratory Testing**

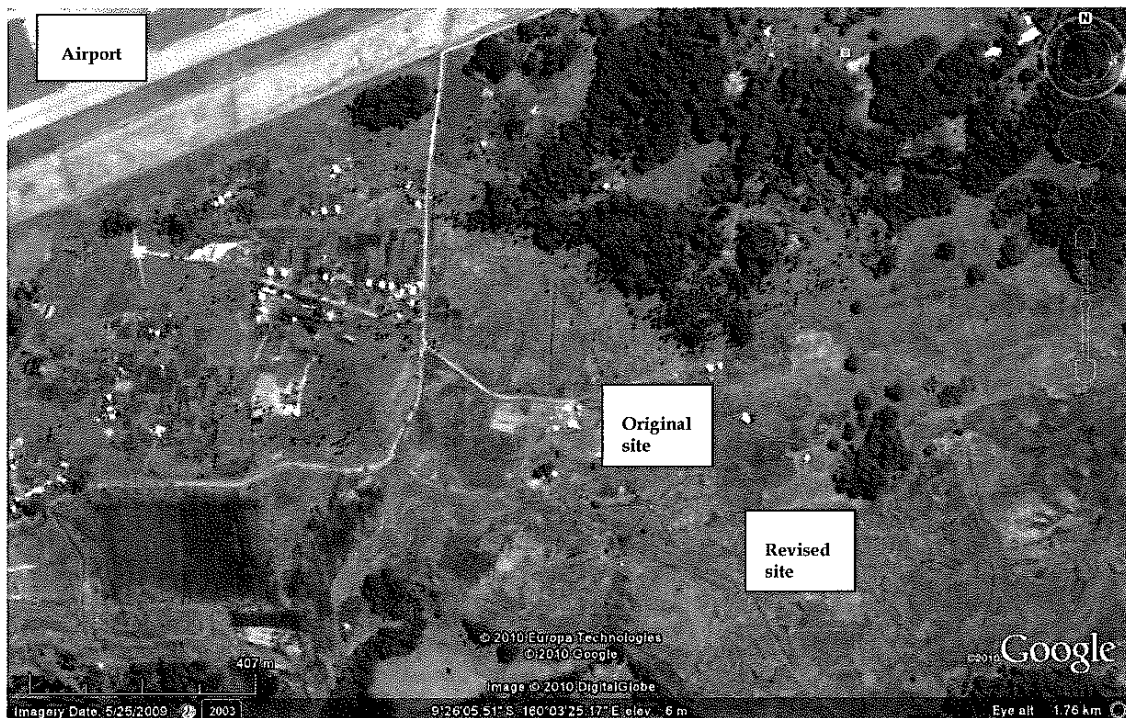
Figure 1: Site location plan

The location of the proposed antenna site in relation to the airport is shown in Figure 1 below and on the photographs in Appendix E.

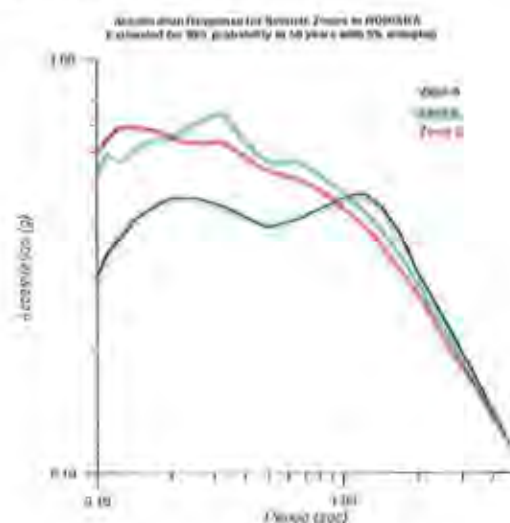
Figure 2. 1 in 500 year earthquake acceleration response curves for Honiara (SOPAC)

The Solomon Islands is situated near the active seismic zone along the boundary of the Indo-Australian and Pacific tectonic plates and, as such, is vulnerable to strong earthquakes. The SOPAC Technical Report 300 “Site-Specific Earthquake Hazard Determinations in Capital Cities in the South Pacific” (February 2001) discusses the seismic potential in the Honiara city centre. This report estimates a peak ground acceleration of 0.5 g for Honiara and provides 1 in 500 year earthquake acceleration response curves for three ground models (Figure 2). Of the three zones, the SIBC site is considered to be most similar to Zone A, which comprises 35 m of weak alluvial sediments overlying Honiara reef and bed limestone.
