Improvement of Radio
Broadcasting Network for
Disaster Prevention in the
Solomon Islands
Site Survey and Soil
Investigation Report

TONKIN & TAYLOR INTERNATIONAL LTD

October 2009

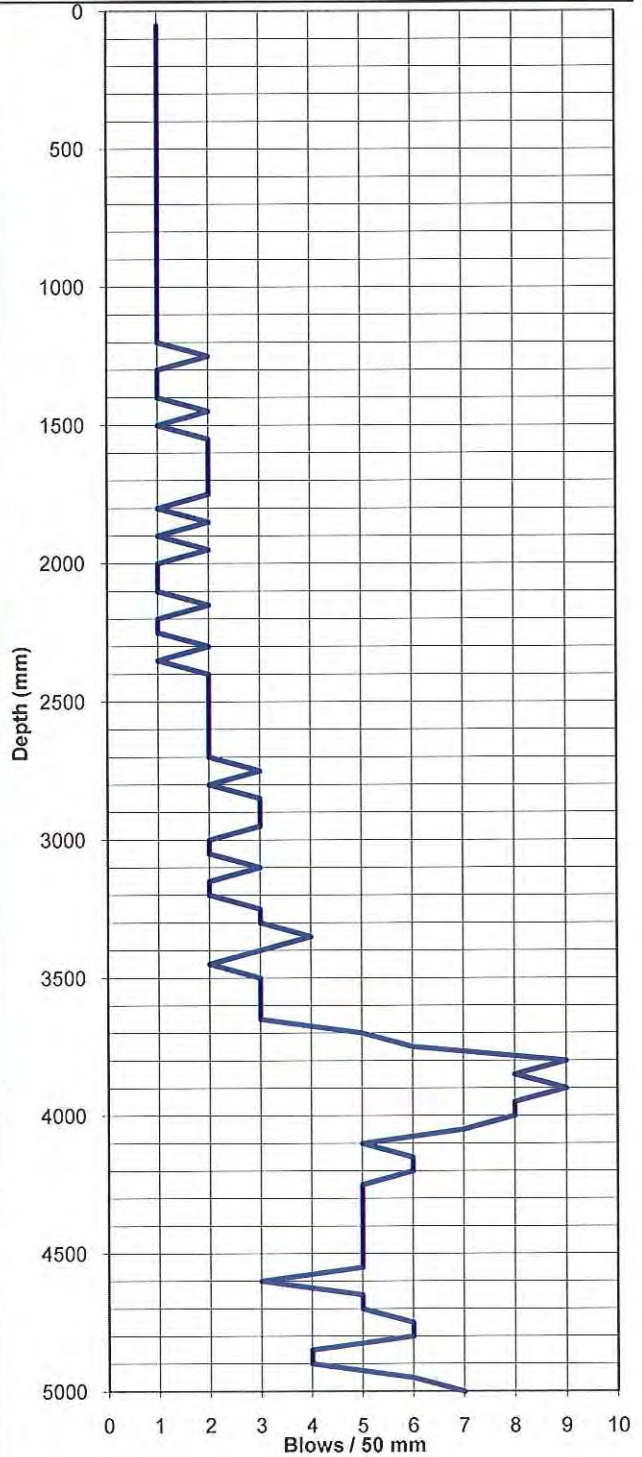
Test No. **SC 2**
 Sheet **1**
 of **2**

mm Driven	No. of Blows	mm Driven	No. of Blows
50	1	2550	2
100	1	2600	2
150	1	2650	2
200	1	2700	2
250	1	2750	3
300	1	2800	2
350	1	2850	3
400	1	2900	3
450	1	2950	3
500	1	3000	2
550	1	3050	2
600	1	3100	3
650	1	3150	2
700	1	3200	2
750	1	3250	3
800	1	3300	3
850	1	3350	4
900	1	3400	3
950	1	3450	2
1000	1	3500	3
1050	1	3550	3
1100	1	3600	3
1150	1	3650	3
1200	1	3700	5
1250	2	3750	6
1300	1	3800	9
1350	1	3850	8
1400	1	3900	9
1450	2	3950	8
1500	1	4000	8
1550	2	4050	7
1600	2	4100	5
1650	2	4150	6
1700	2	4200	6
1750	2	4250	5
1800	1	4300	5
1850	2	4350	5
1900	1	4400	5
1950	2	4450	5
2000	1	4500	5
2050	1	4550	5
2100	1	4600	3
2150	2	4650	5
2200	1	4700	5
2250	1	4750	6
2300	2	4800	6
2350	1	4850	4
2400	2	4900	4
2450	2	4950	6
2500	2	5000	7

Test Method Used: NZS 4402:1988 Test 6.5.2 Dynamic Cone Penetrometer

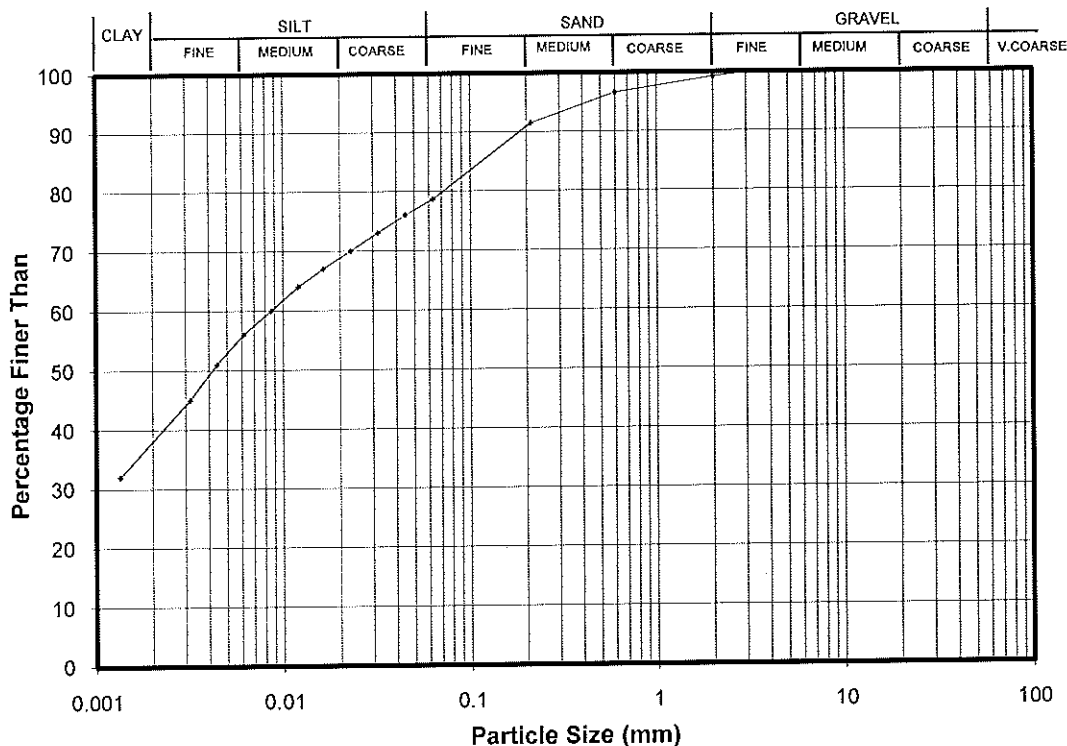
Your Job No.: **750725**
Our Job No.: **615120.000**
Depth: **1.0-1.5 (m)**

PARTICLE SIZE ANALYSIS

Sieve (mm)	Total % Passing	Sieve (mm)	Total % Passing
3.35	100		
2.000	99		
0.600	97		
0.212	91		
0.063	79

Equivalent Particle Diameter D (mm)	% of Particles Finer than D
0.0448	76
0.0319	73
0.0228	70
0.0163	67
0.0120	64
0.0086	60
0.0061	56
0.0044	51
0.0032	45
0.0013	32
