FINDINGS OF THE NATURAL CONDITIONS SURVEY

Improvement of Radio
Broadcasting Network for
Disaster Prevention in the
Solomon Islands
Site Survey and Soil
Investigation Report

TONKIN & TAYLOR INTERNATIONAL LTD

October 2009

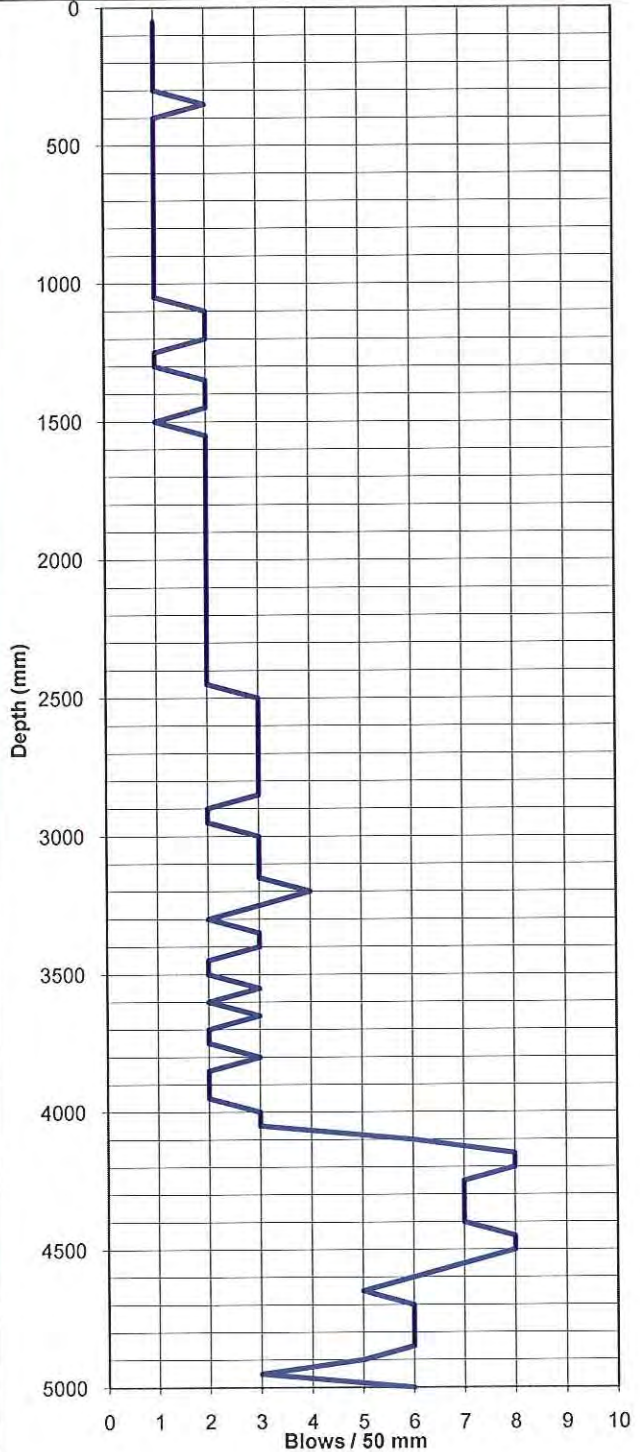
Test No. **SC 1**
 Sheet **1**
 of **2**

Test Method Used: NZS 4402:1988 Test 6.5.2 Dynamic Cone Penetrometer

The Scala penetrometer tests, SC1 and SC2 were terminated at depths of 8.3m and 8.8m, respectively. From this in-situ testing, we can assess the soil strengths at specific depths below the site. The Scala results and inferred soil strength are summarised in Table 3 below:

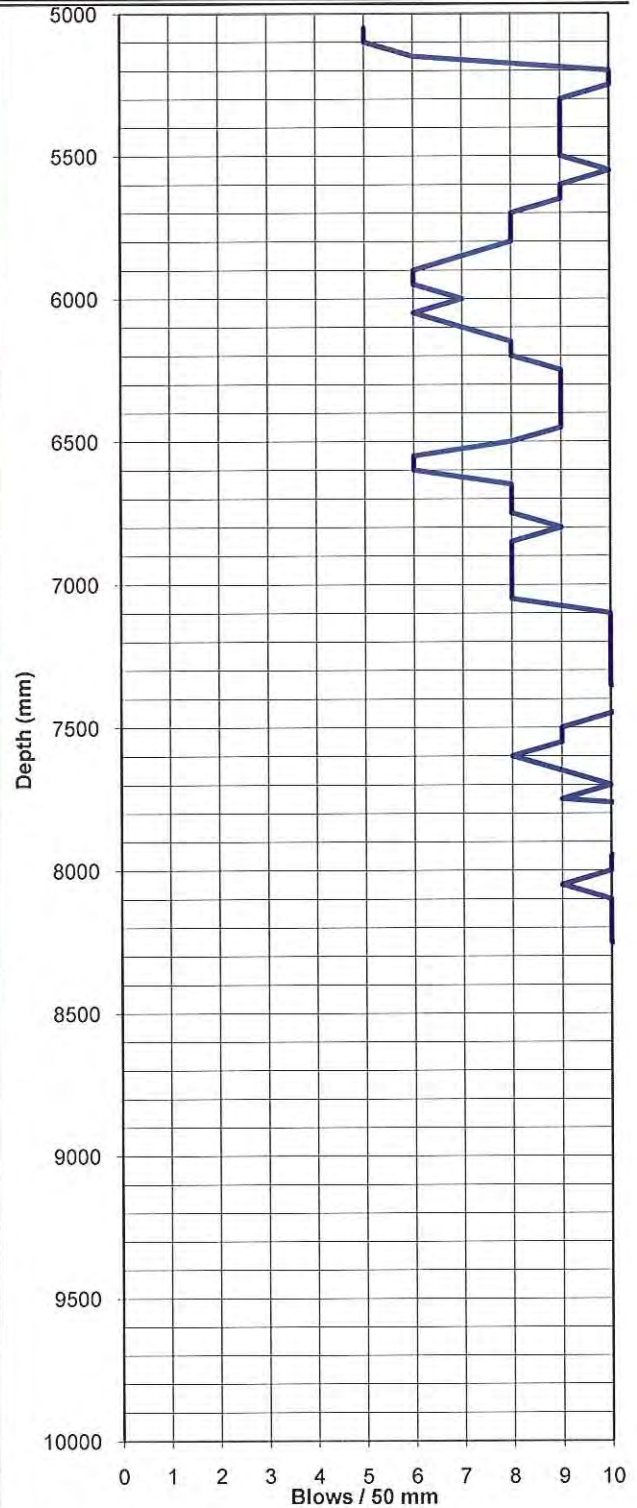
Test No.	SC 1
Sheet of	2 / 2

Test Method Used: NZS 4402:1988 Test 6.5.2 Dynamic Cone Penetrometer

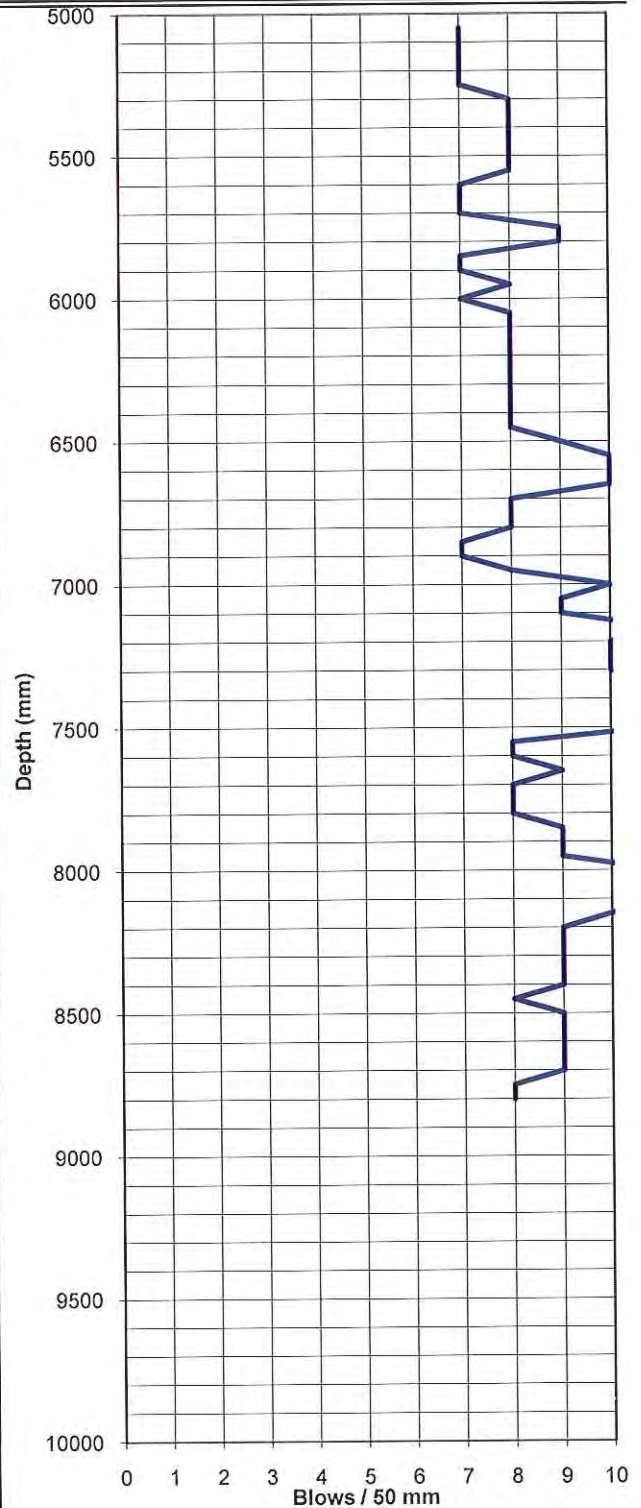
Test No. **SC 2**
 Sheet of **2**

Test Method Used: NZS 4402:1988 Test 6.5.2 Dynamic Cone Penetrometer

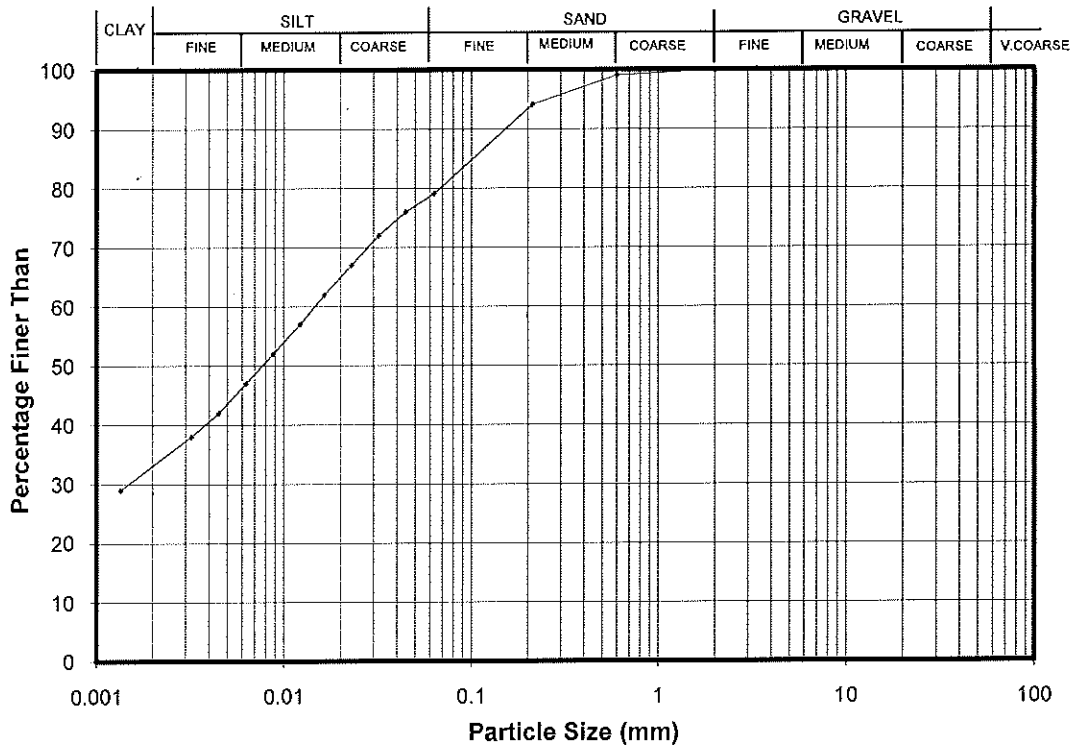
PARTICLE SIZE ANALYSIS

Sieve (mm)	Total % Passing	Sieve (mm)	Total % Passing
3.35	100		
2.00	100		
0.600	99		
0.212	94		
0.063	79

Equivalent Particle Diameter D (mm)	% of Particles Finer than D
0.0445	76
0.0319	72
0.0229	67
0.0165	62
0.0122	57
0.0088	52
0.0063	47
0.0045	42
0.0032	38
0.0013	29

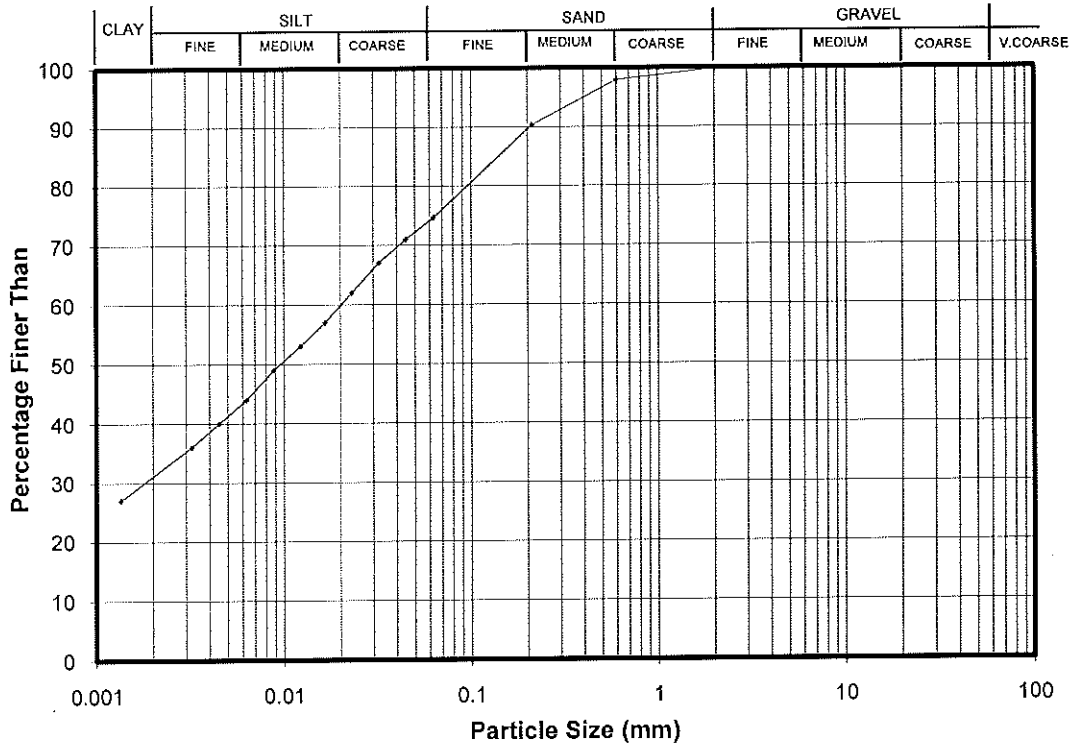
PARTICLE SIZE ANALYSIS

Sieve (mm)	Total % Passing	Sieve (mm)	Total % Passing
3.35	100		
2.00	100		
0.600	98		
0.212	90		
0.063	75

Equivalent Particle Diameter D (mm)	% of Particles Finer than D
0.0448	71
0.0321	67
0.0230	62
0.0166	57
0.0122	53
0.0088	49
0.0063	44
0.0045	40
0.0032	36
0.0013	27

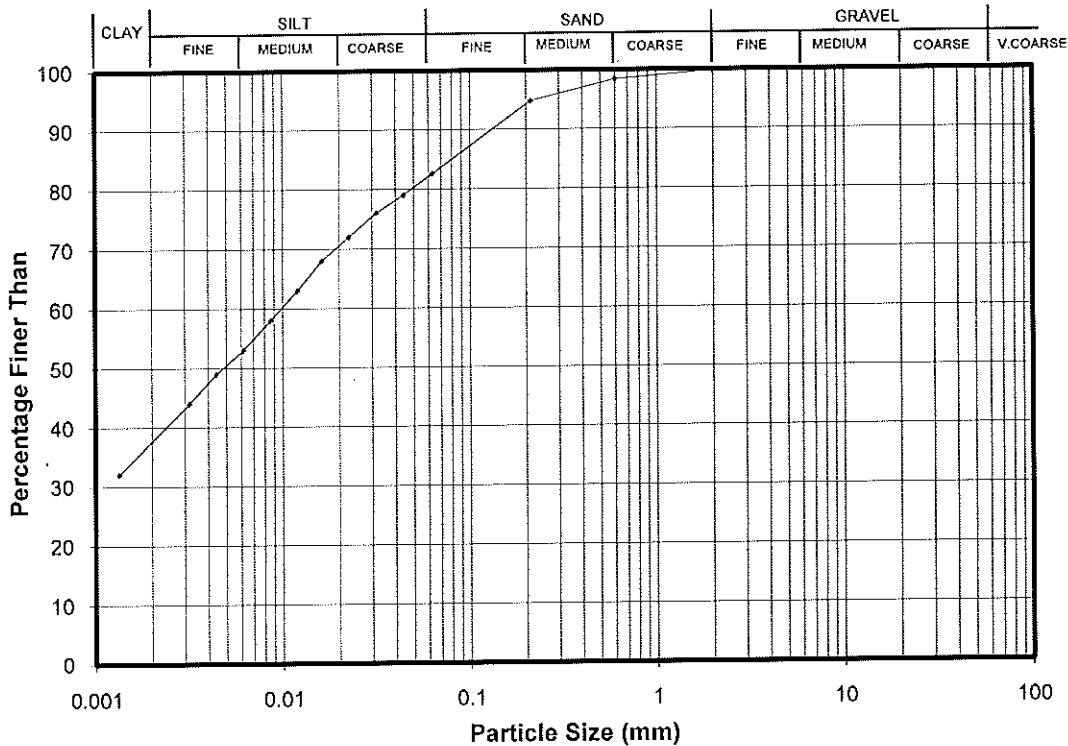
PARTICLE SIZE ANALYSIS

Sieve (mm)	Total % Passing	Sieve (mm)	Total % Passing
3.35	100		
2.000	100		
0.600	98		
0.212	95		
0.063	83

Equivalent Particle Diameter D (mm)	% of Particles Finer than D
0.0441	79
0.0315	76
0.0225	72
0.0161	68
0.0120	63
0.0086	58
0.0062	53
0.0044	49
0.0032	44
0.0013	32
