FINDINGS OF THE NATURAL CONDITIONS SURVEY

REPORT

**Improvement of Radio
Broadcasting Network for
Disaster Prevention in the
Solomon Islands
Site Survey and Soil
Investigation Report - Revised
Site**

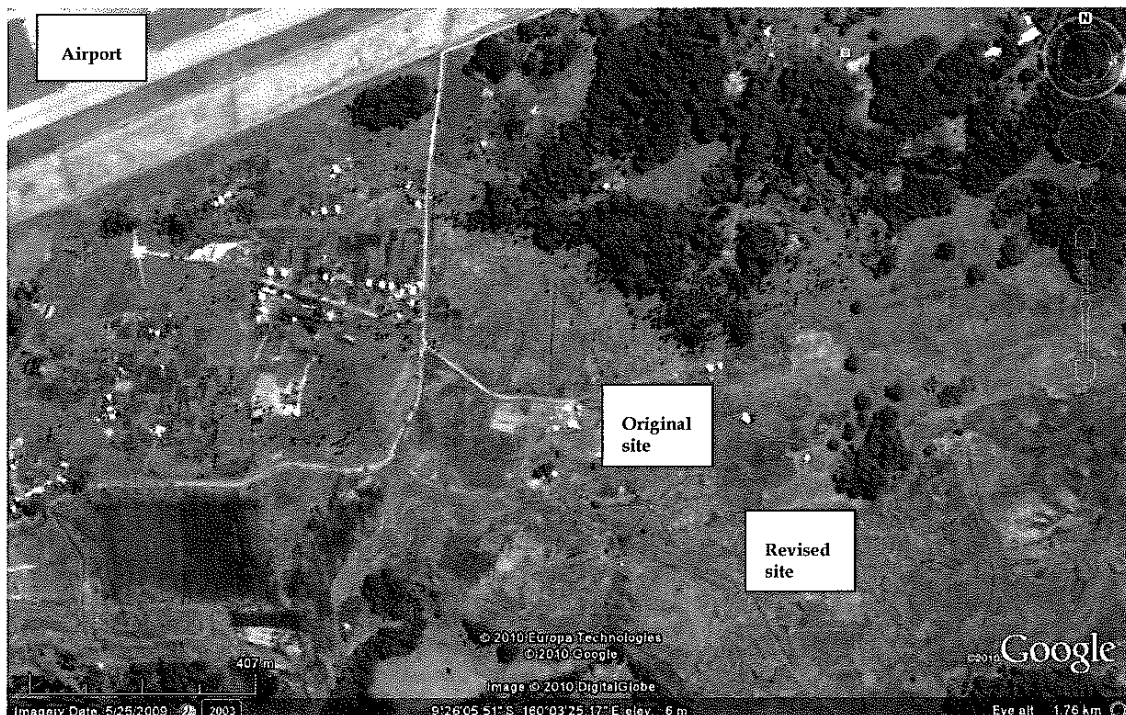
Figure 1: Site location plan

The location of the proposed antenna site in relation to the airport is shown in Figure 1 below and on the photographs in Appendix E.

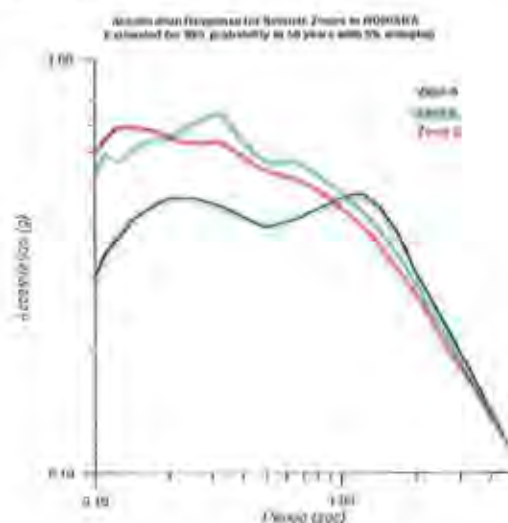
Figure 2. 1 in 500 year earthquake acceleration response curves for Honiara (SOPAC)

The Solomon Islands is situated near the active seismic zone along the boundary of the Indo-Australian and Pacific tectonic plates and, as such, is vulnerable to strong earthquakes. The SOPAC Technical Report 300 “Site-Specific Earthquake Hazard Determinations in Capital Cities in the South Pacific” (February 2001) discusses the seismic potential in the Honiara city centre. This report estimates a peak ground acceleration of 0.5 g for Honiara and provides 1 in 500 year earthquake acceleration response curves for three ground models (Figure 2). Of the three zones, the SIBC site is considered to be most similar to Zone A, which comprises 35 m of weak alluvial sediments overlying Honiara reef and bed limestone.

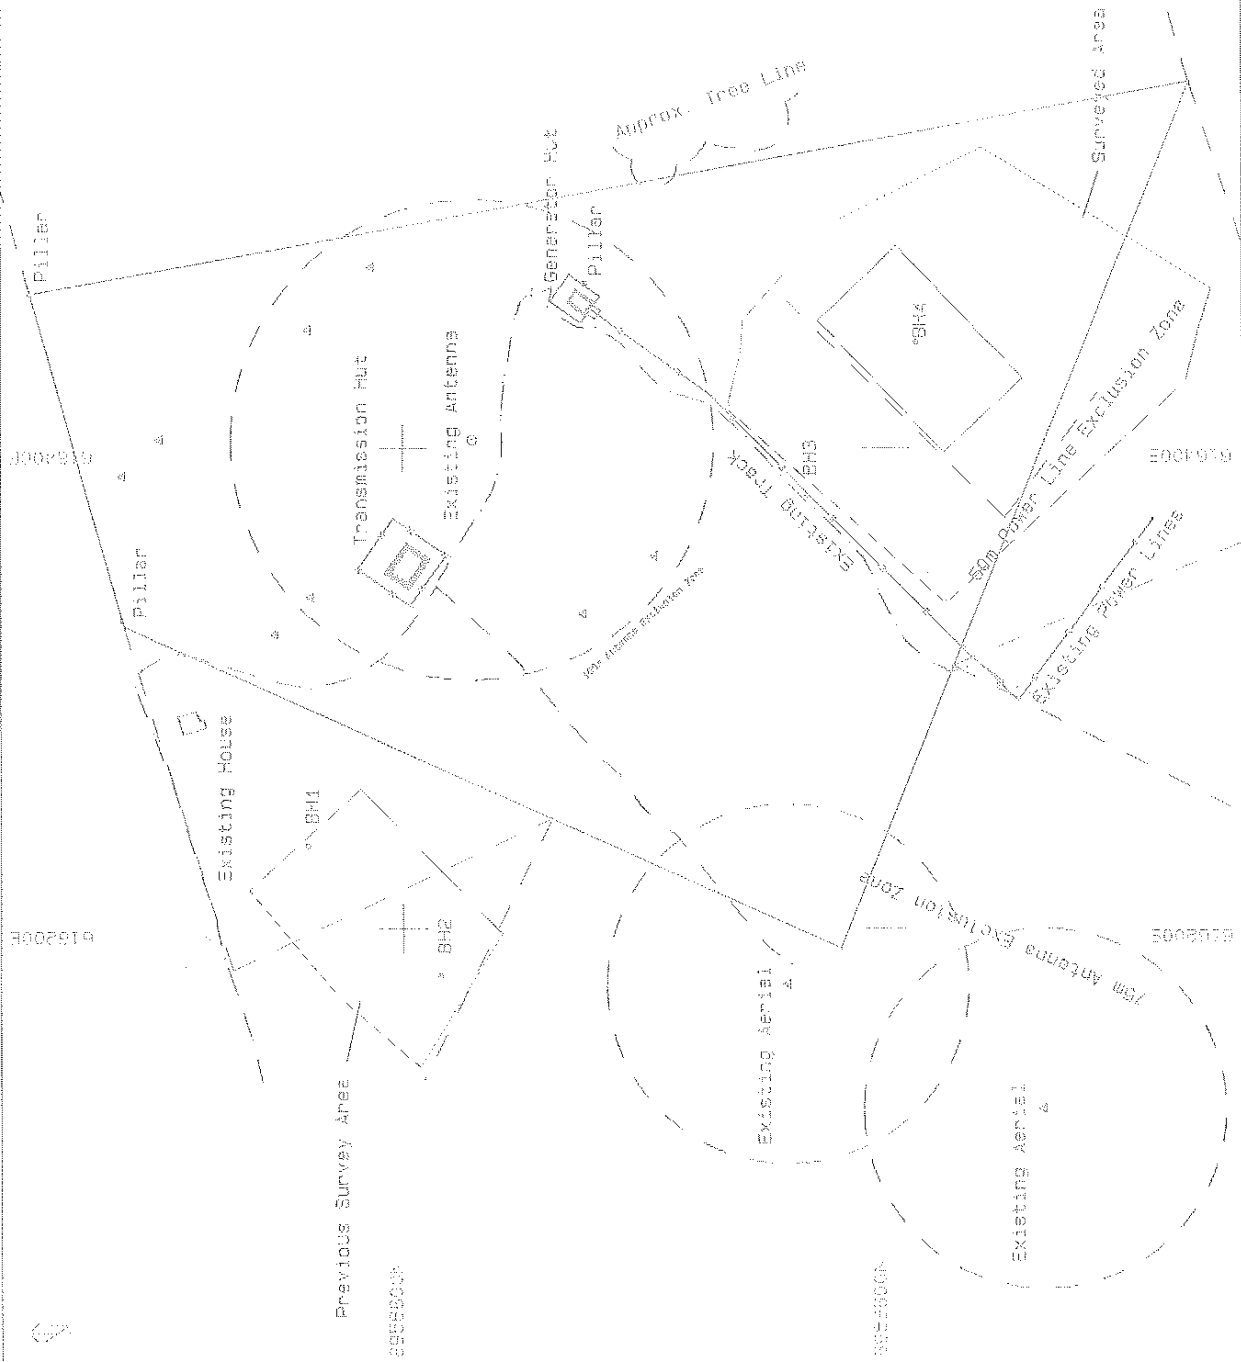
SITE PLAN

- BH1 - Bore Hole 1
- BH2 - Bore Hole 2
- BH3 - Bore Hole 3
- BH4 - Bore Hole 4

○ - Depression Contours
Boreholes are Indicative Only

Date: 12 - 13 Dec 2010
Datum: MSL 1984
CRS: UTM ZONE 57 South
Scale: 1:1000
Contours: 0.1m
Elevations Above MSL
Coordinate Offset: 5093 687500, 704N
514121.30ME
19.50m HEIGHT

In general, the site is located between 4 m and 7 m above mean sea level, with the majority of the project site between 5.0 and 6 m above mean sea level. A copy of the full survey report and topographical plans are presented in Appendix B.

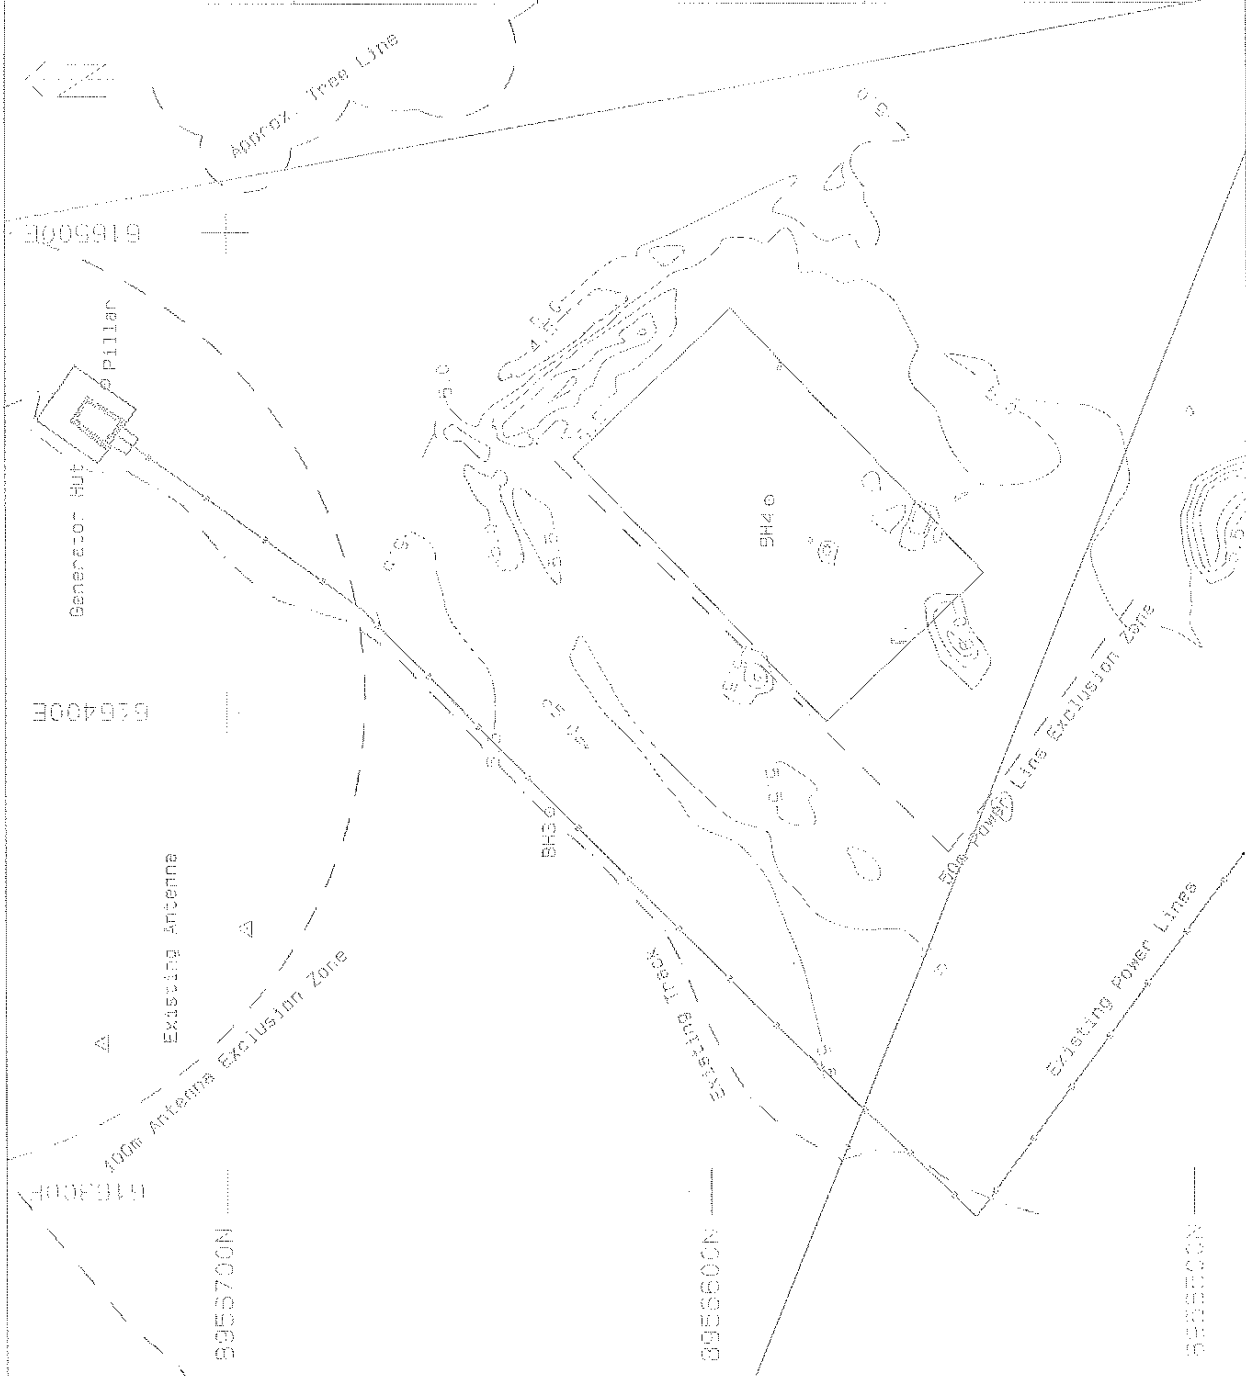
PROPOSED SITE PLAN

B43 Bore Hole 2
B44 Bore Hole 1
○ - Depression Contours
Boundaries are Indicative Only

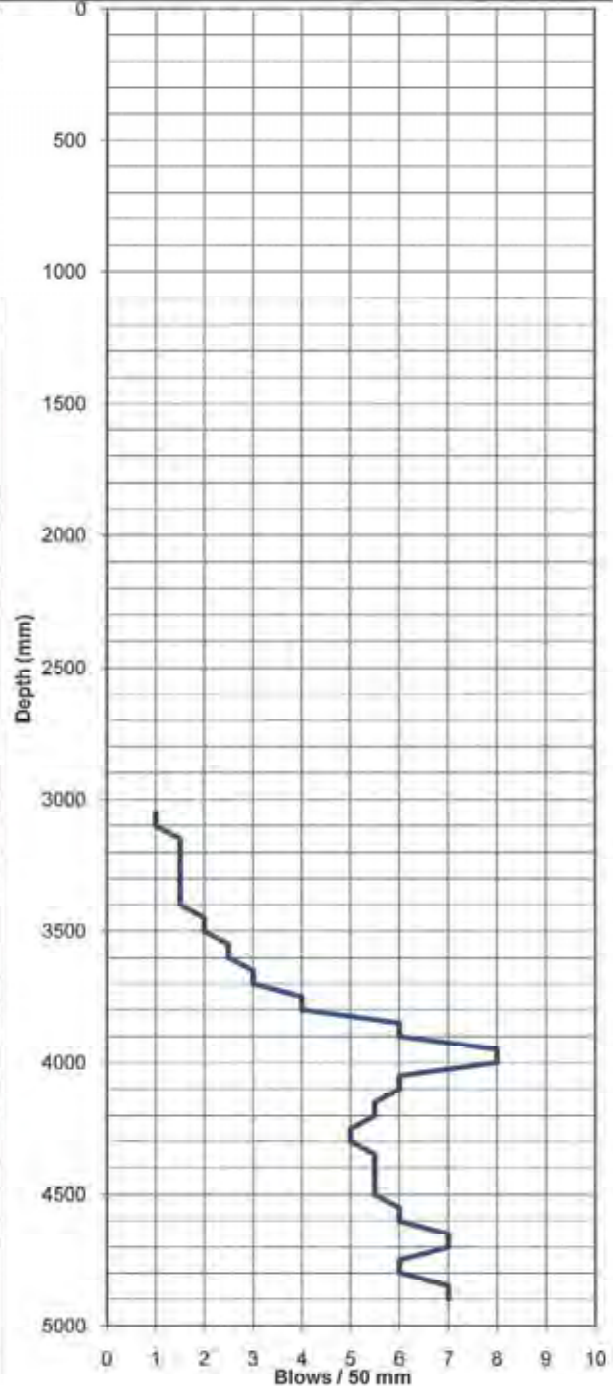
Test No.	SC 3
Sheet of	1 / 1

mm Driven	No. of Blows	mm Driven	No. of Blows
50		2550	
100		2600	
150		2650	
200		2700	
250		2750	
300		2800	
350		2850	
400		2900	
450		2950	
500		3000	
550		3050	1
600		3100	1
650		3150	1.5
700		3200	1.5
750		3250	1.5
800		3300	1.5
850		3350	1.5
900		3400	1.5
950		3450	2
1000		3500	2
1050		3550	2.5
1100		3600	2.5
1150		3650	3
1200		3700	3
1250		3750	4
1300		3800	4
1350		3850	6
1400		3900	6
1450		3950	8
1500		4000	8
1550		4050	6
1600		4100	6
1650		4150	5.5
1700		4200	5.5
1750		4250	5
1800		4300	5
1850		4350	5.5
1900		4400	5.5
1950		4450	5.5
2000		4500	5.5
2050		4550	6
2100		4600	6
2150		4650	7
2200		4700	7
2250		4750	6
2300		4800	6
2350		4850	7
2400		4900	7
2450		4950	
2500		5000

Test Method Used: NZS 4402:1988 Test 6.5.2 Dynamic Cone Penetrometer

Depths (Below Ground level)	Average Scala Blows per 50 mm		Inferred Soil Strength (cohesive/granular)
	SC3	SC4	
0.5m	-	-	-
1.0m	-	-	-
1.5m	-	1	Soft-firm/loose
2.0m	-	1	Soft-firm/loose
2.5m	-	2.5	Firm-stiff/medium dense
3.0m	1	2.5	Firm-stiff/loose-medium dense
3.5m	2	8.5	Firm-very stiff/medium dense to dense
4.0m	8	8	Very stiff/dense
4.5m	5.5	-	Very stiff/dense
5.0m	7	-	Very stiff/dense

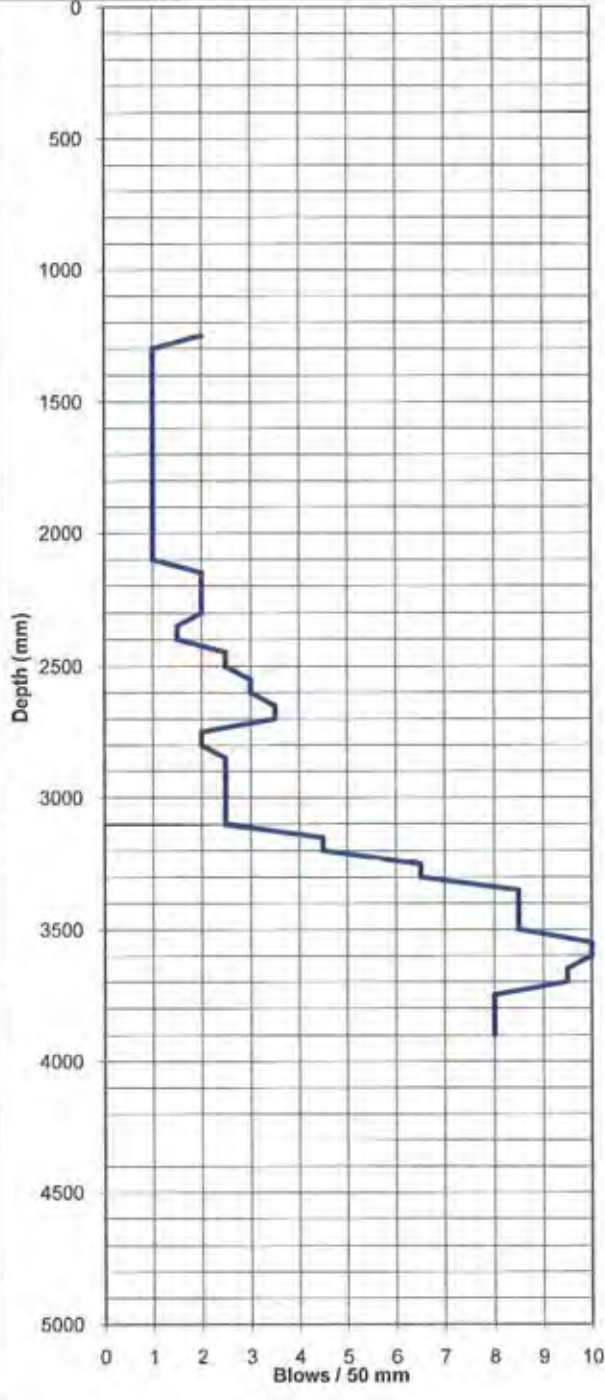
Test No.	SC 4
Sheet of	1 / 1

mm Driven	No. of Blows	mm Driven	No. of Blows
50		2550	3
100		2600	3
150		2650	3.5
200		2700	3.5
250		2750	2
300		2800	2
350		2850	2.5
400		2900	2.5
450		2950	2.5
500		3000	2.5
550		3050	2.5
600		3100	2.5
650		3150	4.5
700		3200	4.5
750		3250	6.5
800		3300	6.5
850		3350	8.5
900		3400	8.5
950		3450	8.5
1000		3500	8.5
1050		3550	10
1100		3600	10
1150		3650	9.5
1200		3700	9.5
1250	2	3750	8
1300	1	3800	8
1350	1	3850	8
1400	1	3900	8
1450	1	3950	
1500	1	4000	
1550	1	4050	
1600	1	4100	
1650	1	4150	
1700	1	4200	
1750	1	4250	
1800	1	4300	
1850	1	4350	
1900	1	4400	
1950	1	4450	
2000	1	4500	
2050	1	4550	
2100	1	4600	
2150	2	4650	
2200	2	4700	
2250	2	4750	
2300	2	4800	
2350	1.5	4850	
2400	1.5	4900	
2450	2.5	4950	
2500	2.5	5000

Test Method Used: NZS 4402:1988 Test 6.5.2 Dynamic Cone Penetrometer

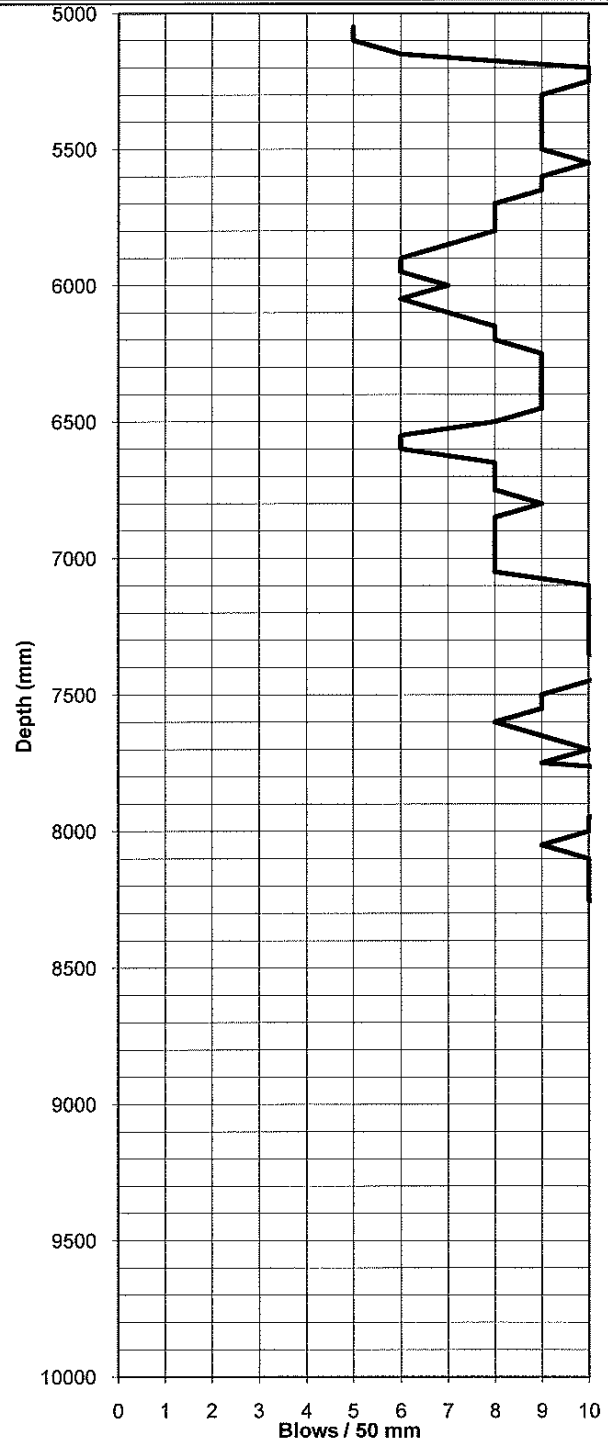
Test No.	SC 1
Sheet of	2 / 2

mm Driven	No. of Blows	mm Driven	No. of Blows
5050	5	7550	9
5100	5	7600	8
5150	6	7650	9
5200	10	7700	10
5250	10	7750	9
5300	9	7800	13
5350	9	7850	14
5400	9	7900	11
5450	9	7950	10
5500	9	8000	10
5550	10	8050	9
5600	9	8100	10
5650	9	8150	10
5700	8	8200	10
5750	8	8250	10
5800	8	8300	11
5850	7	8350	
5900	6	8400	
5950	6	8450	
6000	7	8500	
6050	6	8550	
6100	7	8600	
6150	8	8650	
6200	8	8700	
6250	9	8750	
6300	9	8800	
6350	9	8850	
6400	9	8900	
6450	9	8950	
6500	8	9000	
6550	6	9050	
6600	6	9100	
6650	8	9150	
6700	8	9200	
6750	8	9250	
6800	9	9300	
6850	8	9350	
6900	8	9400	
6950	8	9450	
7000	8	9500	
7050	8	9550	
7100	10	9600	
7150	10	9650	
7200	10	9700	
7250	10	9750	
7300	10	9800	
7350	10	9850	
7400	11	9900	
7450	10	9950	
7500	9	10000

Test Method Used: NZS 4402:1988 Test 6.5.2 Dynamic Cone Penetrometer

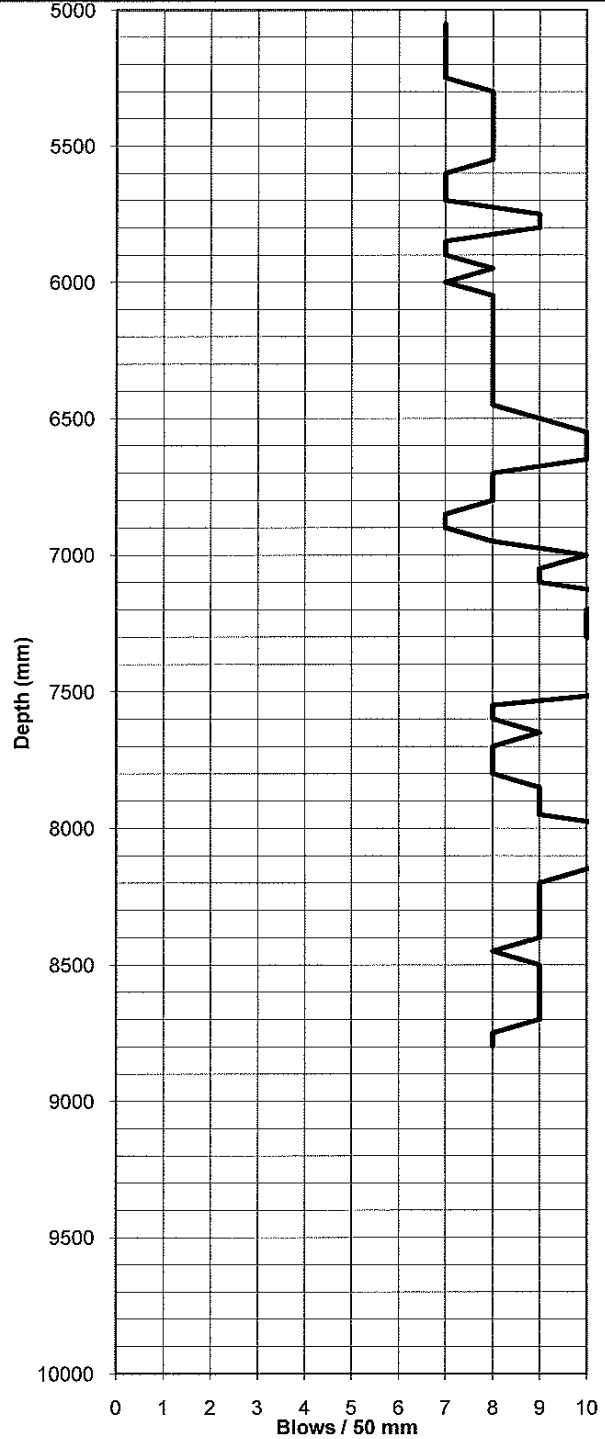
Test No.	SC 2
Sheet of	2 2

mm Driven	No. of Blows	mm Driven	No. of Blows
5050	7	7550	8
5100	7	7600	8
5150	7	7650	9
5200	7	7700	8
5250	7	7750	8
5300	8	7800	8
5350	8	7850	9
5400	8	7900	9
5450	8	7950	9
5500	8	8000	11
5550	8	8050	11
5600	7	8100	11
5650	7	8150	10
5700	7	8200	9
5750	9	8250	9
5800	9	8300	9
5850	7	8350	9
5900	7	8400	9
5950	8	8450	8
6000	7	8500	9
6050	8	8550	9
6100	8	8600	9
6150	8	8650	9
6200	8	8700	9
6250	8	8750	8
6300	8	8800	8
6350	8	8850	
6400	8	8900	
6450	8	8950	
6500	9	9000	
6550	10	9050	
6600	10	9100	
6650	10	9150	
6700	8	9200	
6750	8	9250	
6800	8	9300	
6850	7	9350	
6900	7	9400	
6950	8	9450	
7000	10	9500	
7050	9	9550	
7100	9	9600	
7150	11	9650	
7200	10	9700	
7250	10	9750	
7300	10	9800	
7350	11	9850	
7400	12	9900	
7450	11	9950	
7500	11	10000

Test Method Used: NZS 4402:1988 Test 6.5.2 Dynamic Cone Penetrometer

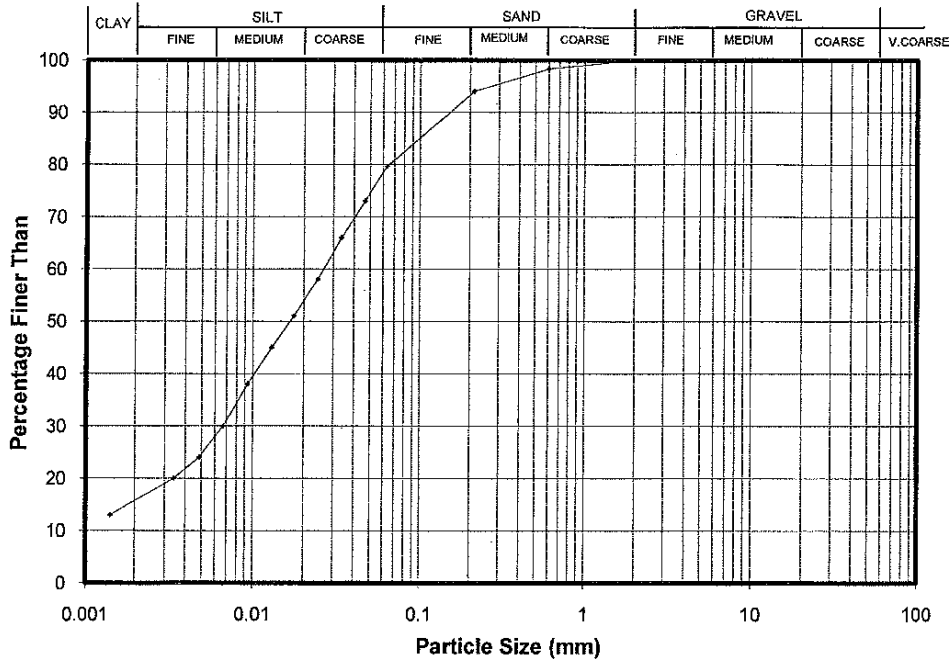
PARTICLE SIZE ANALYSIS

Test Method Used : NZS 4402:1986 Test 2.8.4 Hydrometer

Sieve (mm)	Total % Passing	Sieve (mm)	Total % Passing
2.00	100		
0.600	98		
0.212	94		
0.063	80

Equivalent Particle Diameter D (mm)	% of Particles Finer than D
0.0466	73
0.0336	66
0.0243	58
0.0175	51
0.0129	45
0.0093	38
0.0067	30
0.0048	24
0.0034	20
0.0014	13

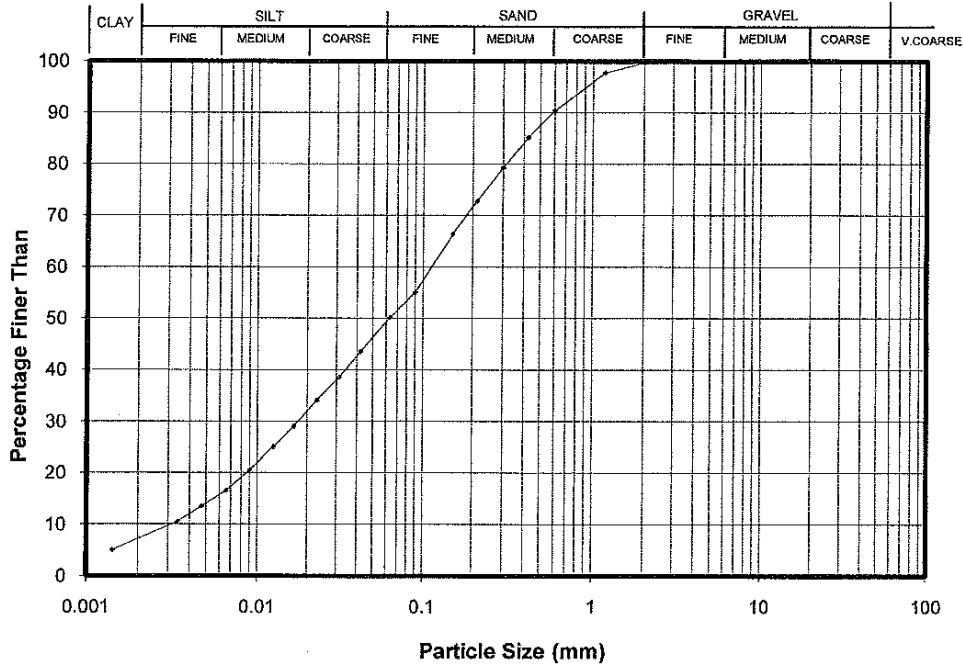
PARTICLE SIZE ANALYSIS

Plate No.: _____ Page of _____ Your Job No.: **750725.100**
 Site : **Honiara Airport, Solomon Islands** Our Job No.: **615474.000**
 HA No.: **3** Sample ID.: **5** Depth (m): **2.7-2.8**
 Test Method Used : NZS 4402:1986 Test 2.8.1 Wet Sieve Test 2.8.4 Hydrometer

Sieve (mm)	Total % Passing	Sieve (mm)	Total % Passing
6.70	---	0.090	55
4.75	---	0.063	50
3.35	100		
2.00	100		
1.18	98		
0.600	90		
0.425	85		
0.300	79		
0.212	73		
0.150	66

Equivalent Particle Diameter D (mm)	% of Particles Finer than D
0.0421	44
0.0311	39
0.0227	34
0.0166	29
0.0125	25
0.0091	21
0.0066	17
0.0047	14
0.0034	11
0.0014	5

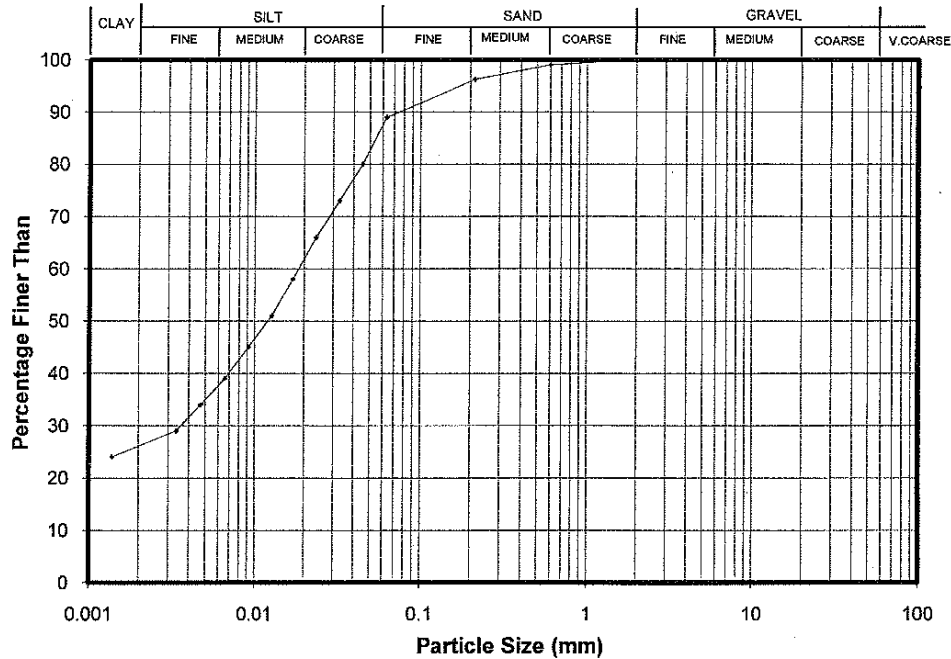
PARTICLE SIZE ANALYSIS

Sieve (mm)	Total % Passing	Sieve (mm)	Total % Passing
2.00	100		
0.600	99		
0.212	96		
0.063	89

Equivalent Particle Diameter D (mm)	% of Particles Finer than D
0.0453	80
0.0328	73
0.0237	66
0.0171	58
0.0127	51
0.0091	45
0.0066	39
0.0047	34
0.0034	29
0.0014	24

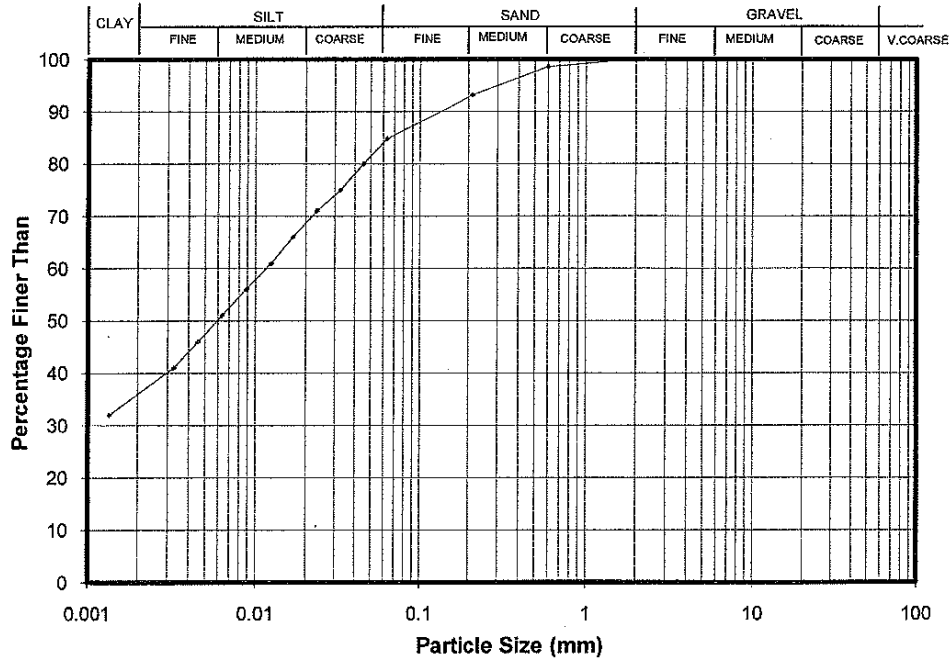
PARTICLE SIZE ANALYSIS

Test Method Used : NZS 4402:1986 Test 2.8.4 Hydrometer

Sieve (mm)	Total % Passing	Sieve (mm)	Total % Passing
2.00	100		
0.600	99		
0.212	93		
0.063	85

Equivalent Particle Diameter D (mm)	% of Particles Finer than D
0.0452	80
0.0325	75
0.0233	71
0.0167	66
0.0124	61
0.0089	56
0.0063	51
0.0045	46
0.0033	41
0.0014	32

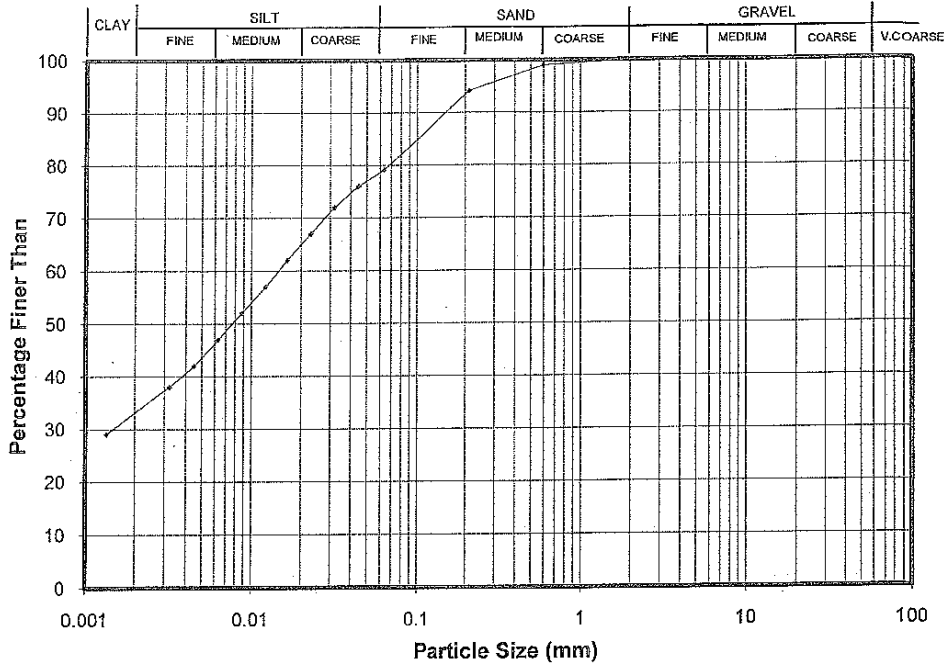
PARTICLE SIZE ANALYSIS

Sieve (mm)	Total % Passing	Sieve (mm)	Total % Passing
3.35	100		
2.00	100		
0.600	99		
0.212	94		
0.063	79

Equivalent Particle Diameter D (mm)	% of Particles Finer than D
0.0445	76
0.0319	72
0.0229	67
0.0165	62
0.0122	57
0.0088	52
0.0063	47
0.0045	42
0.0032	38
0.0013	29

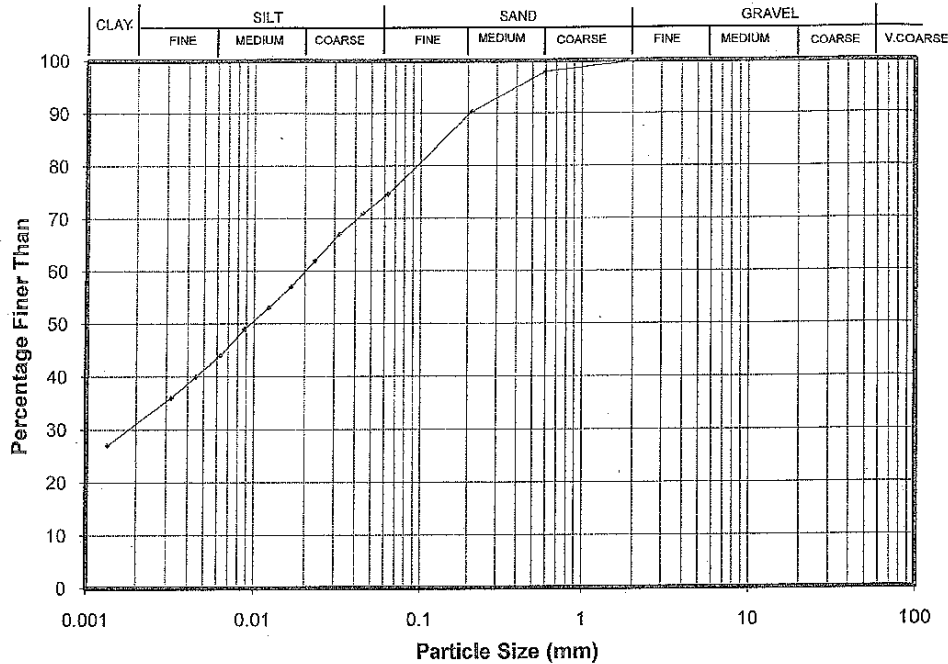
PARTICLE SIZE ANALYSIS

Sieve (mm)	Total % Passing	Sieve (mm)	Total % Passing
3.35	100		
2.00	100		
0.600	98		
0.212	90		
0.063	75

Equivalent Particle Diameter D (mm)	% of Particles Finer than D
0.0448	71
0.0321	67
0.0230	62
0.0166	57
0.0122	53
0.0088	49
0.0063	44
0.0045	40
0.0032	36
0.0013	27

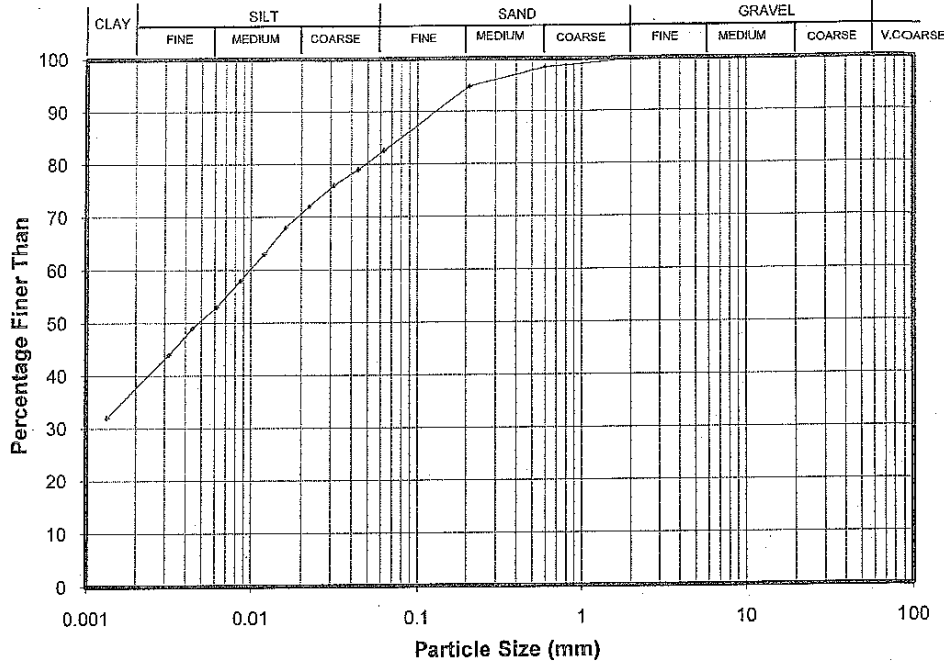
PARTICLE SIZE ANALYSIS

Sieve (mm)	Total % Passing	Sieve (mm)	Total % Passing
3.35	100		
2.000	100		
0.600	98		
0.212	95		
0.063	83

Equivalent Particle Diameter D (mm)	% of Particles Finer than D
0.0441	79
0.0315	76
0.0225	72
0.0161	68
0.0120	63
0.0086	58
0.0062	53
0.0044	49
0.0032	44
0.0013	32

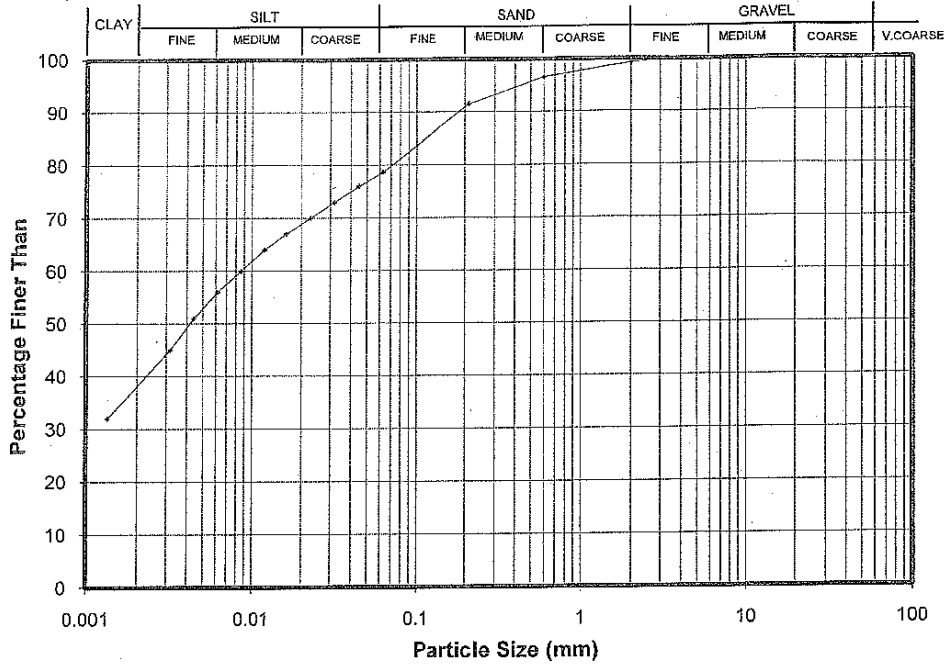
PARTICLE SIZE ANALYSIS

Sieve (mm)	Total % Passing	Sieve (mm)	Total % Passing
3.35	100		
2.000	99		
0.600	97		
0.212	91		
0.063	79

Equivalent Particle Diameter D (mm)	% of Particles Finer than D
0.0448	76
0.0319	73
0.0228	70
0.0163	67
0.0120	64
0.0086	60
0.0061	56
0.0044	51
0.0032	45
0.0013	32

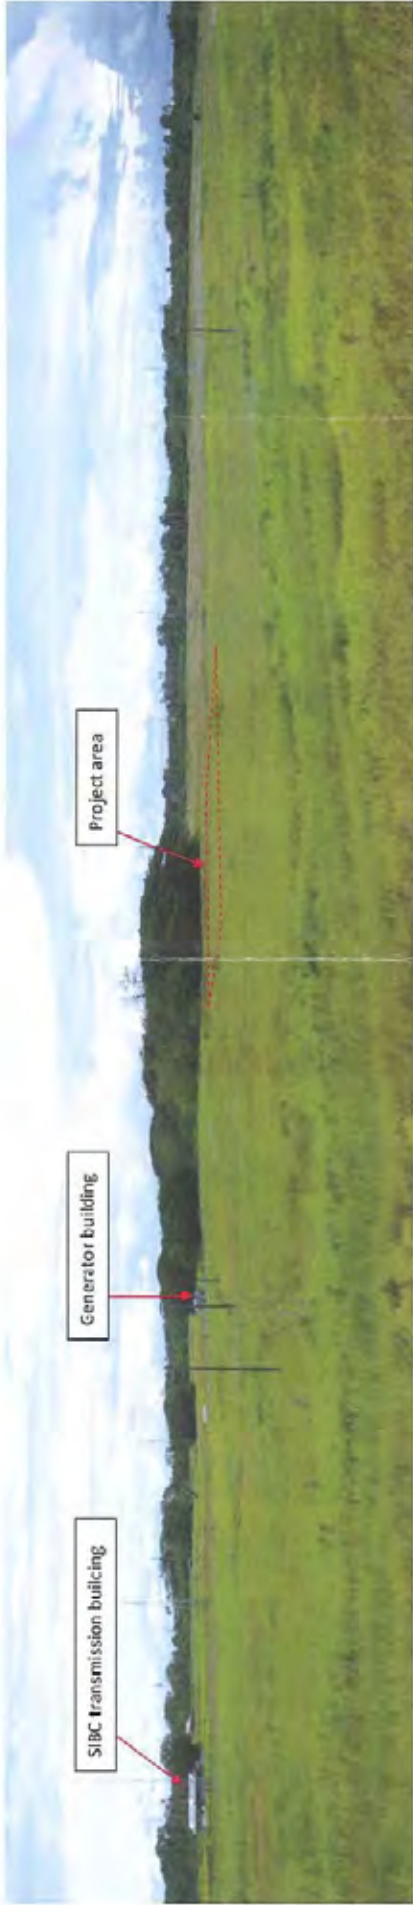
Photograph 1. General site area (pink flags mark four corners of the project area)

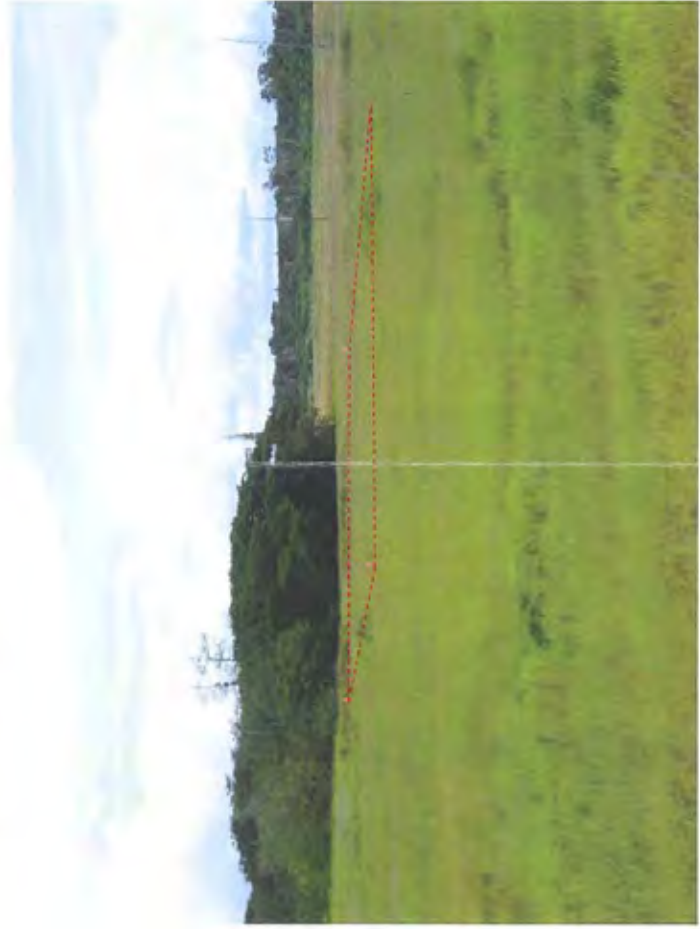
Photograph 2. Project site area (pink flags mark four corners of the project area)
