PART II: FIELD RECONNAISSANCE AND FIELD SERVEY IN SEA AND COASTAL AREAS FOR BASIC STUDY

Section 1: Supporting Report

1. Field Reconnaissance

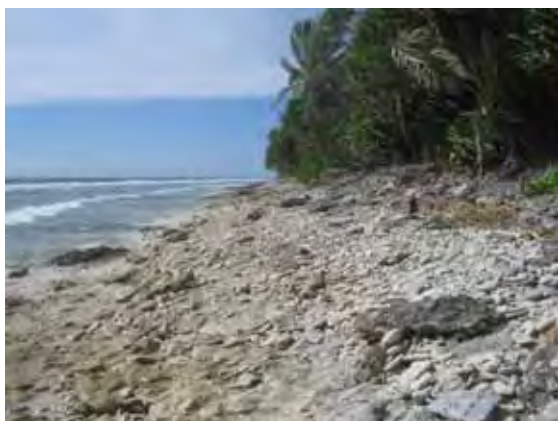
Photo 1.1

Like on Tengako Islet, the north side of the beach ridge consists only of gravel (Photo 1.1), containing no sand and forms a steep slope with an approximate gradient of 1 in 3. Going southward, houses have been built closer to the coast, and vegetation has been felled for the sake of development in some areas (Photo 1.2).

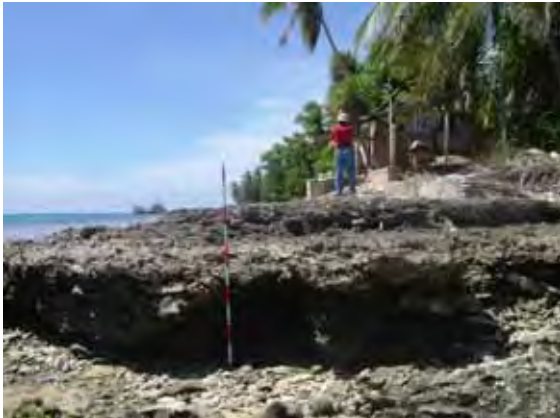
Photo 1.3

On the south, beach rocks are formed (Photo 1.3). On the north of Funafuti Port, on the other hand, beaches are scattered (Photo 1.4). The conditions of the shoreline connecting the new and old jetties of Funafuti port are shown in Photos 1.5 (left bank of the new jetty), 1.6 (right bank of the new jetty), 1.7 (left bank of the old jetty), and 1.8 (right bank of the old jetty), in this order. The new jetty is adjacent to the south side of the old jetty. On the new jetty where sand has been deposited on both sides, there is more sand on the southwestern side (left-bank side) when judged by comparison of the photos. This is considered to be because, despite a permeable type on the front side, the sand was influenced by the jetty that runs in parallel to the coast. On the old jetty, sand has been deposited on the southwestern side (left-bank side) but not on the northeastern side (right-bank side). Whereas these photos were taken in October 2009 in the dry season, the ones taken in January 2010 in the rainy season are shown in Photos 1.9 to 1.12. On the new jetty, unlike in the dry season, more sand is found on the northwestern side (right-bank side). On the old jetty, no significant difference is found between the dry and rainy seasons. From these facts, it is deduced that the direction of the predominant littoral drift is approximately neutral in the dry season and southwest in the rainy season, and that its amount is small.

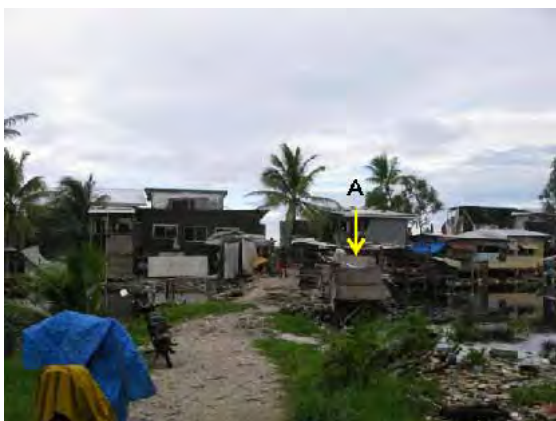
Photo 1.13

A north-south road is connected to a residential district by a narrow path shown in Photo 1.13. A small hut indicated by arrow A on the right side of the path is a pigpen. On the right and left sides of Photo 1.13, there are big ponds (Photos 1.14 and 1.15) around which there are numerous such pigpens. The pig waste flows untreated into these ponds. Although these ponds are not directly connected to the ocean, the beach ridge consisting of gravel is highly permeable so that seawater flows into these ponds due to changes in the tide level of the ocean. On the beach ridge between these ponds and the ocean, houses stand side-by-side as shown in Photos 1.14 and 1.15. Most of the houses are high-floored, but some of them are not high enough.

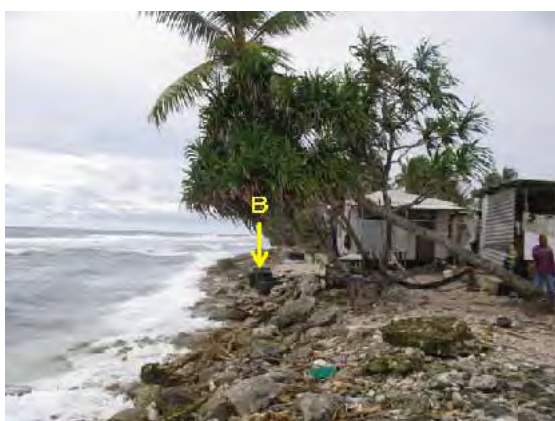
developed depression. The conditions shown in the photos, therefore, indicate that this neighborhood is susceptible to wave run-ups and overtopping waves. A picture taken facing forward near the tires indicated by arrow B in Photo 1.16 is shown in Photo 1.17. The tires for preventing overtopping waves were placed on a masonry seawall consisting of stacked beach rocks. On the ocean side, the beach rock surface was exposed, showing no sign of the usual gravel slope formed by beach rocks deposited by wave actions. This shows that the masonry seawall was made by collecting and stacking stones that had been scattered in front of it and, additionally, setting out the normal of the seawall further toward the ocean in order to expand the planation surface on the land side of the seawall. A picture taken under the masonry seawall, facing north, is shown in Photo 1.18. The stone masonry consists of heavy stones stacked on a slanting slope of gravel, and the seawall height is 1.2 m. Arrow C in Photos 1.18 and 1.19 points to the same rock. The part of the masonry seawall shown in Photo 1.19 consists of smaller stones than those in the southern-side seawall and cannot avoid being washed away by even low waves. Photo 1.20 shows the conditions of the part of the coast located immediately north of the place shown in Photo 1.19, where a saddle is formed due to the lack of a masonry seawall in the vicinity. The beach ridge has been mostly dug away and is low.

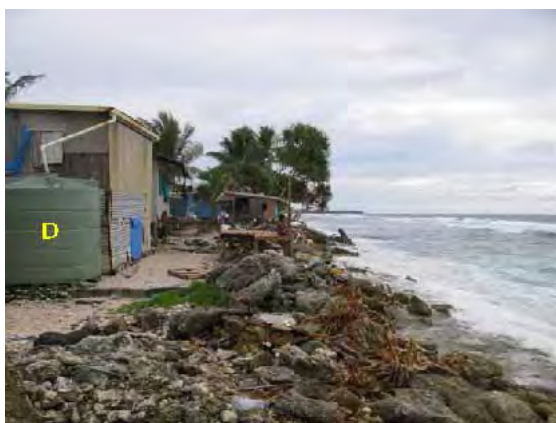
Photo 1.21

A rainwater catchment tank (D) is shown a little to the left of the center of Photo 1.20. The conditions near this tank are shown in Photo 1.21. At this place, the ground level is still lower than an altitude of 1.2 m shown in Photo 1.15. According to an interview survey, overtopping waves flow into the other side in the high-tide season in February and March every year. Large rocks shown in the center of this photo are viewed from the land side in Photo 1.22. According to the interview survey, these rocks were not carried by wave actions but lined up by the residents to deal with terrible overtopping waves. Similarly, the adjacent area to the north of the rocks had just one row of rocks as shown in Photo 1.23, which served as a seawall. A scene viewed from the central path of the settlement toward the ocean is shown in Photo 1.24. In the center, stacked rocks observed in Photo 1.22 can be seen. There is no other protective facility, and the path is inclined toward the land side. When overtopping waves come, a fairly strong current flows down this narrow path. One item of evidence of such a phenomenon can be seen in a concrete facility shown on the other side (south) of the rainwater catchment tank in Photo 1.24. The ocean-side foundation of this facility (probably also a catchment tank) has been broken mainly by wave action as shown in Photo 1.25.

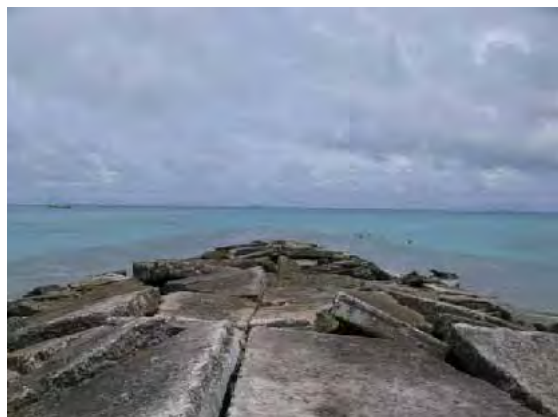
Photo 1.26

A little to the north of the central part of the western coast, there is a ramp constructed as a base for flying boats of the American troops during the Pacific war (Photo 1.26). In an adjacent area to the north of this ramp, concrete blocks shown in Photo 1.27 have been installed. These blocks, measuring about 30 cm on a side, are nearly regular hexahedrons intended to be carried manually while weighing as much as possible. A common use for them is to line them up and use them as a seawall.

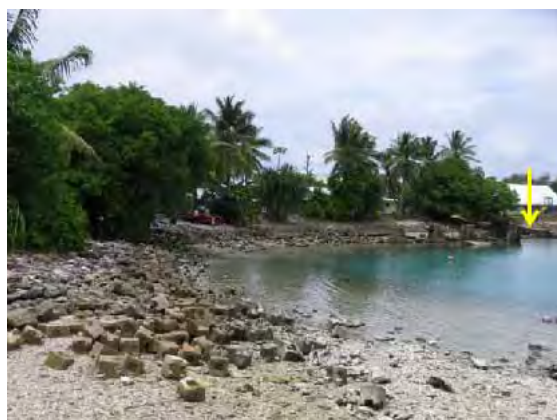
Photo1.28

The conditions of the adjacent area to the south of the ramp are shown in Photo 1.28. The left end of this photo shows that many of the above-mentioned blocks are scattered. On the other hand, the water area shown in the right and center of this photo is deep even at low tide because the American troops dug the reef surface to create a passage for boats.

To the south of the groin, many blocks and waste rocks are lined up in the same way as in Photo 1.28, providing very poor access to the shoreline. An area further to the south is under similar conditions as shown in Photo 1.29 but forms a ramp to allow a small boat to be carried down from the front of the house behind it onto the sea.

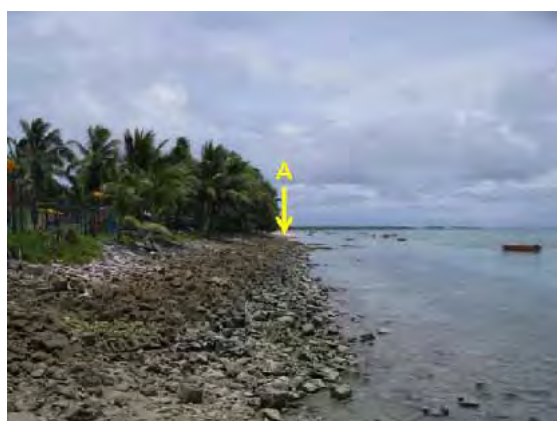
Photo 1.30

Going further to the south, there is a beach indicated by arrow A in Photo 1.30. This beach consists of sand that has been deposited stably by the wave-absorbing effect of an offshore reef adjacent to it. With gravel deposited on the land-side edge of the sand beach, the deposition area is clearly divided into sand and gravel areas. Simple measurement conducted on the day of field reconnaissance using a pole found that the sand beach had a gradient of 1 in 12 and that the gravel beach on the shore side had a gradient of 1 in 6. The beach had a composite cross section with well-sorted gravel deposited on the shore side and sand offshore from it. It is noteworthy that the gradient of 1 in 6 of the gravel slope on the shore side is equal to that of the above-mentioned ramp for small boats. This is a point to be considered for future improvements. Furthermore, gravel deposited on the shore side is useful from the viewpoint of shore protection because they have a characteristic of being carried up to the land side when high waves hit the shore (Matsuura et al., 2009).

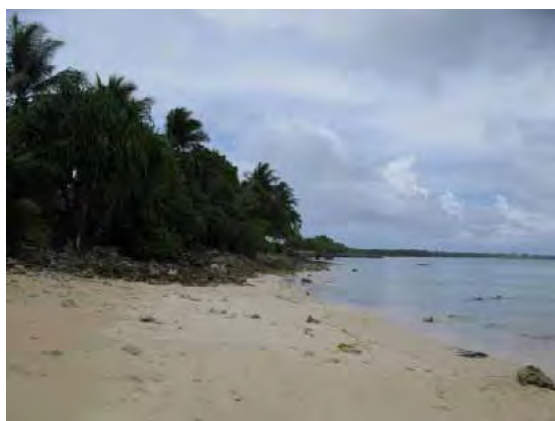
Photo 1.31

The sand beach of the study area ends at a certain length, and to the south of it, there is an area where concrete chips and large-sized gravel are scattered once again (Photo 1.31). Although a masonry seawall has been installed here, strong wave actions have bored cavities near the

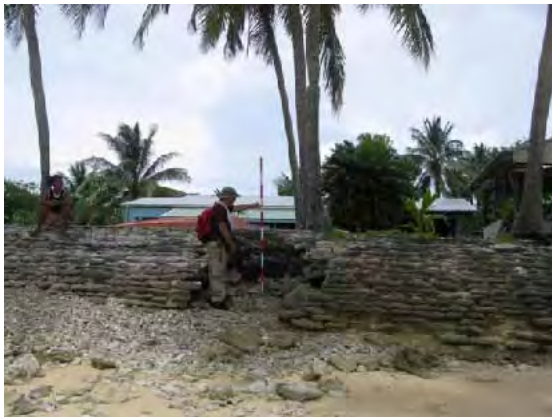
Photo 1.32

high-tide shoreline on the seawall, causing the destruction to progress on it (Photo 1.32).

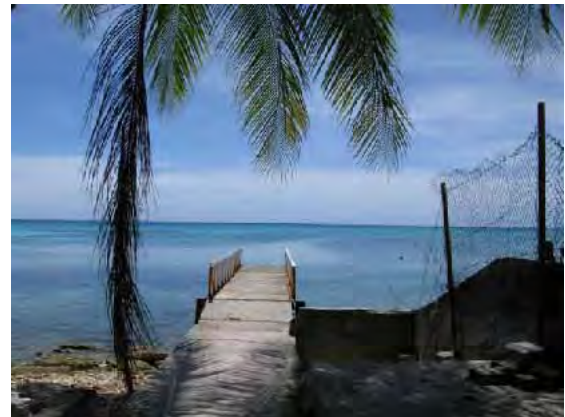
To the south of this place, there are several groins extending at right angles to the coastline. For example, Photo 1.33 shows a permeable jetty extending beside a hotel. Scenes viewed from this jetty to the north and south are shown in Photos 1.34 and 1.35, respectively. As shown in the northward scene in Photo 1.34, there is an upright bulkhead in front of the hotel, which is becoming old. To the south, the gravel beach continues.

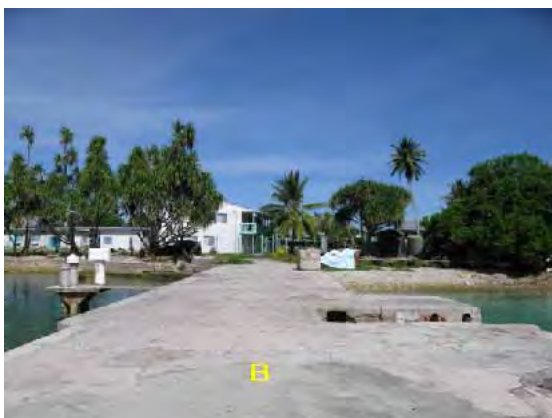
Photo 1.36

Further to the south of this jetty, there is groin B, which is shown in Photo 1.36. In Photo 1.37 that shows the north side of the groin, there is no gravel beach at all in front of the seawall. In Photo 1.38 that shows a scene to the south, a triangular-shaped gravel beach is formed toward the base of the groin. This asymmetry of the shoreline reveals that a northward littoral drift is predominant at this point. The conditions in the rainy season (January 2010) were the same as those shown in these photos taken in October 2009 in the dry season.

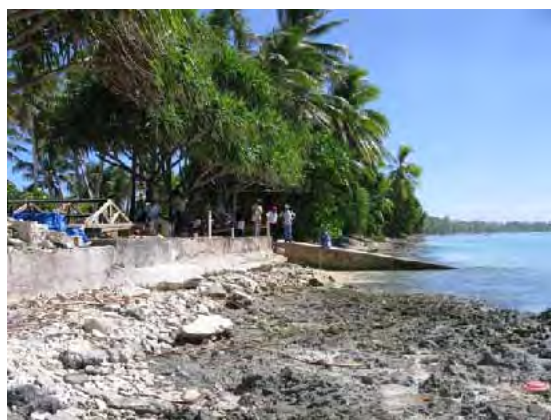
Photo 1.39

To the south of this groin, there is another small groin, on the northern side of which there are exposed beach rocks as shown in Photo 1.39, indicating a depletion of gravel that can be moved. On the southern side of the groin, however, a gravel beach has been formed in the same way as shown in Photo 1.40. This reveals the same characteristics as shown in Photos 1.37 and 1.38, i.e., a northward littoral drift is predominant around this place.

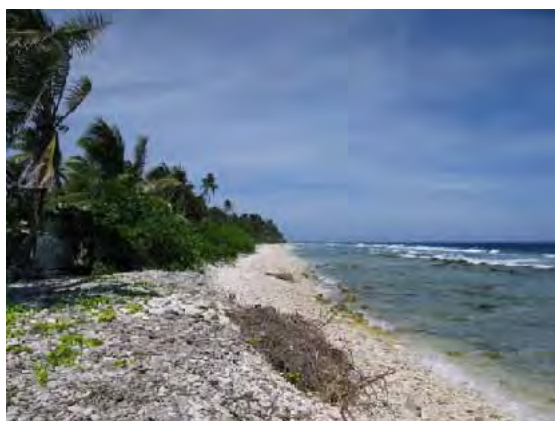
Photo 1.42

A picture taken of the ocean side of the islet looking toward east shows the formation of a slightly elevated beach ridge due to constant actions of overtopping waves from the South Pacific (Photo 1.42). The foreshore is a steep slope with a gradient of 1 in 3 and is connected offshore to the planation surface of the reef, from which a reef edge extends as can be seen in the conditions of white waves in the offing. A picture taken at the same position looking west is shown in Photo 1.43. The reef and the beach ridge are continuous, and vegetation such as screw pines has grown to the back of the berm on the ridge. The foreshore deposit, as shown in Photo 1.44, is gravel rounded to an approximate diameter of 3 to 10 cm, containing no sand. A close shot of the spit-shaped tip with another islet in the background is shown in Photo 1.45. Gravel is deposited here, too. Lastly, a picture taken of the beach ridge extending towards the Lagoon side of the islet is shown in Photo 1.46. On the southernmost tip of the islet, a large amount of gravel is deposited in a protruding spit shape but, going northward, the deposited area abruptly narrows down. Photo 1.46 taken in the dry season (October 2009) shows that the tip of the spit faced somewhat the lagoon side. In the rainy season, however, it faced the ocean side as shown in Photo 1.47.

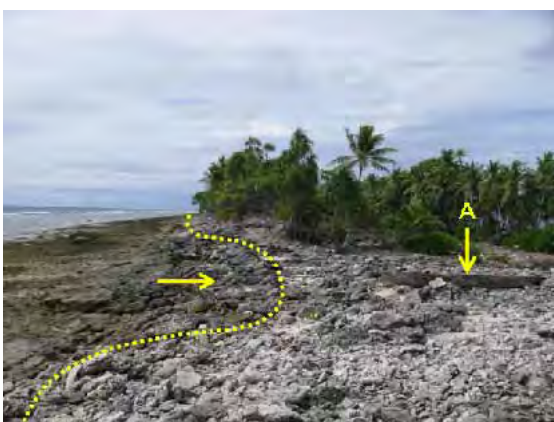
Photo 1.50

A picture taken at the position of Photo 1.49 facing south is shown in Photo 1.50. In this photo, the zone vegetated by palms, etc. abruptly disappears, and white gravel that constituted the ridge has been driven to the land side. This is where breaching occurred. The depression in the center of the deposition area of white gravel, shown by a dotted line in this photo, reveals that the gravel has been carried by wave actions in a direction indicated by an arrow in this photo. Driftwood A in the center, in view of its species and form, is not wood that grew on this islet but an exotic drift.

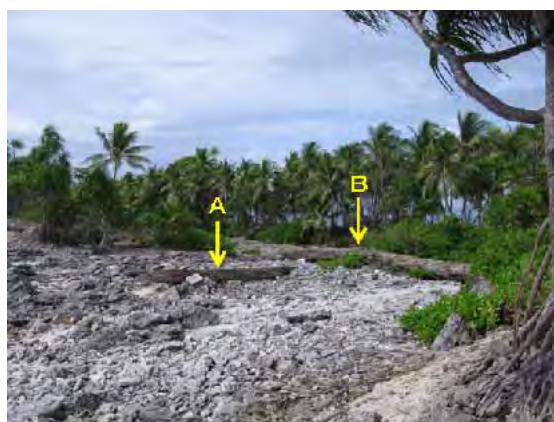
Photos 1.54 and 1.55 show a large amount of wastes washed ashore near the border line between a trench where breaching occurred and the western coast. Having low specific gravities, they were carried deep into the southern side of the trench (near the place indicated by an arrow in the photo). On the northern side, on the other hand, the driftwood shown in Photo 1.51 prevented many drifts from being carried in.

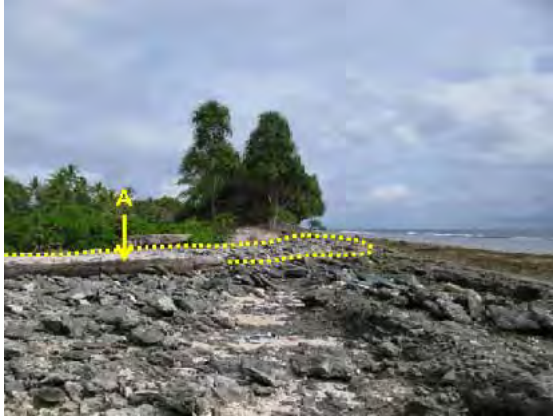
Photo 1.52

A picture showing both Driftwood A and the northernmost end of the cut ridge is Photo 1.52. The cross section of the cut beach ridge is clearly shown in the top of the belt-shaped deposition area of gravel. Photo 1.53 shows a scene looking toward the horizon from the land side of Driftwood B. It reveals that a funnel shape formed by a combination of Driftwood B and the southern beach ridge caused water current to be concentrated between these two elements, carrying in a large amount of gravel with it. In contrast, drifts were accumulated on the back of Driftwood B because water currents were weak there.

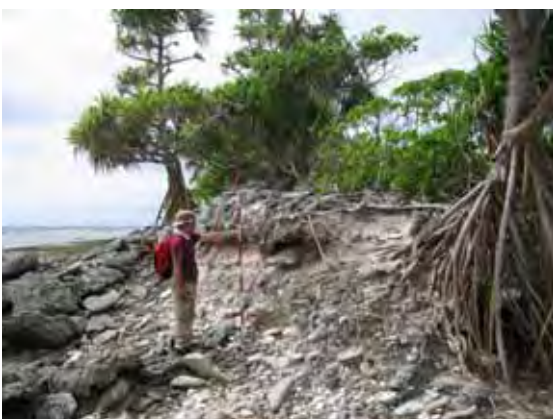
Photo 1.56 shows the cut part of the beach ridge. The root of a screw pine has been exposed due to erosion. To the south of this place, however, a stable beach ridge continues (Photo 1.57). Flat gravel derived from Acropora coral has been thickly deposited in layers, forming a typical beach ridge.

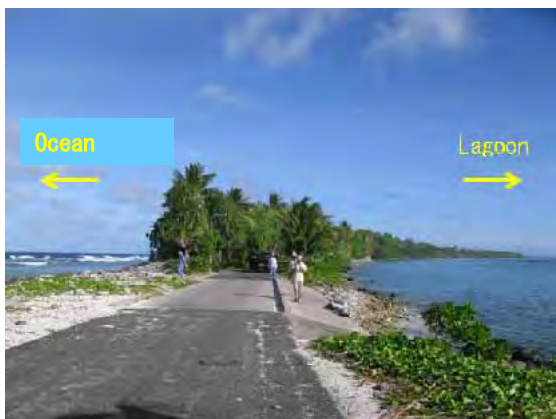
Photo 1.58

A scene of the causeway viewed from the north to the south is shown in Photo 1.58, showing the lagoon side on the right and the ocean side on the left. A scene of the causeway viewed from the northernmost tip, a little to the ocean side, facing south is shown in Photo 1.59. A large amount of gravel with large grain sizes has been deposited, forming a beach ridge. The ocean side of the central part of the causeway is a little elevated, where beach vegetation grows. In contrast, an area from this place to the camera position is free of vegetation but half covered with gravel that must have been carried there by waves. From this fact, it can be deduced that

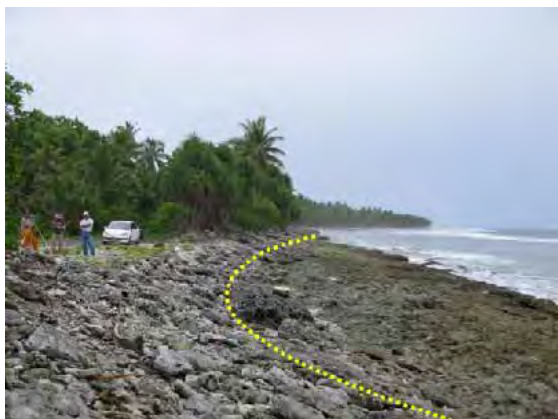
Photo 1.60

When viewing the coast facing north from the southernmost tip of the causeway, as shown in Photo 1.60, the beach ridge is covered with white gravel with large grain sizes, which has been deposited at a steep gradient. The ocean-side gravel in the deposition area has been consolidated and is covered with beach rocks with many protrusions. The border line between the gravel deposition area and the beach rocks is depressed toward the land side at the causeway. This corresponds to the inflow of gravel to the lagoon side when high waves hit. Moving to the ocean side shown in Photo 1.60, the beach rocks can be seen in the coastal direction as shown in Photo 1.61. On the offshore side, the beach rocks have less projections and depressions and continue to a planation surface. The shallow water area offshore from the planation surface is inhabited by foraminifera. The reasons why the beach rocks have less projections and depressions are considered to be that the further offshore, the more influenced by wave actions, and the faster the gravel carried onshore, resulting in stronger abrasive actions. A scene seen from the causeway toward the foraminifera habitation area is shown in Photo 1.62. In comparison with the gravel deposition area with significant projections and depressions near the beach ridge, the foraminifera habitation area is flat.

of the gravel deposition area. The deposition of gravel, as shown in Photo 1.60, moves mainly in the coastal direction along the beach ridge, facilitating the passage of gravel deposited in the same altitude zone through the causeway.

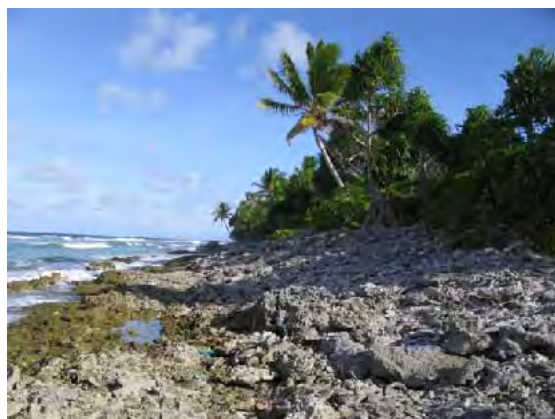
Photo 1.63 is a picture taken of the beach ridge from the southern side of the causeway facing south. Vegetation, including coconut palms, has grown on the ridge, in front of which gravel washed ashore has been deposited in bands. Photo 1.64 is taken at approximately the same position at low tide. This reveals that the gravel deposition area, beach rock area, and foraminifera habitation area further offshore are distributed in bands, the borders of which are classified by altitude, and gravel is deposited in the uppermost one.

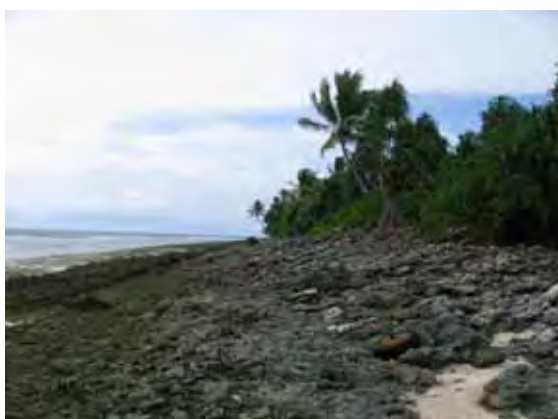
Since the causeway is located 1.3 m above the MSL, it is apparent by the comparison with Photo 1.64 that gravel deposited in the uppermost layer on the ocean side is carried to the lagoon side by overflows over the causeway depending on the wave conditions and tide levels. At the same time, the causeway is a steep slope toward the lagoon side, overflows run down in a jet flow, consequently carrying gravel with large grain sizes deep into the lagoon. The gravel deposition area shown on the right in Photo 1.65 is shown in Photo 1.66. It reveals that gravel is deposited in a semicircular shape on the planation surface of the lagoon. This is considered to correspond to the flow velocity distribution on the causeway. A scene of the causeway viewed from the rear side of it is shown in Photo 1.67. Since the level difference just below the concrete ramp becomes larger going northward, overflows are estimated to have larger flow rates in the north than in the center of the causeway.

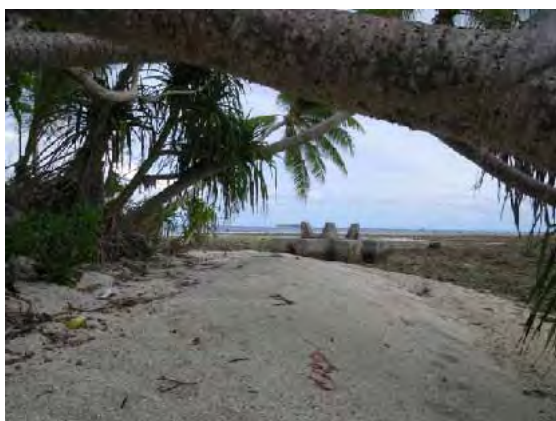
Photo 1.74

rocks with large grain sizes, a totally different material from white sand derived from the coral reef and gravel shown in Photo 1.74. The offing of the beach ridge is widely covered with beach rocks. From the above conditions, the following characteristics can be pointed out.

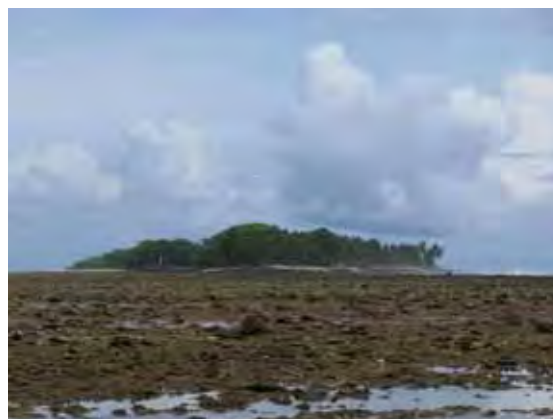
Photo 1.77 shows a distant view of Amatuku Islet, located to the north of Tengako Islet, with an expansion of a planation surface covered with beach rock and coral fragments. Similarly, Photo 1.78 shows Tengako Islet seen from the channel. In some parts of the center of the channel, not so much gravel is scattered, unlike near the shore. Photo 1.79 is a picture taken near its border facing the ocean. To the north (left) of the border line, there is an area with active currents from the ocean to the lagoon side. To the right, on the other hand, land continues to Tengako Islet, and there is significant deposition of gravel.

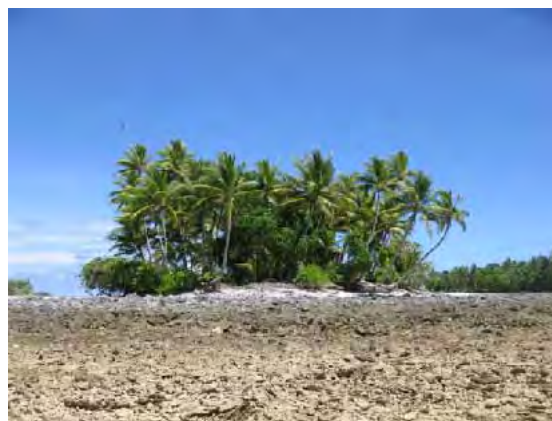
Photo 1.83 shows the southern side of islet A, which is surrounded by beach rocks washed ashore by waves and then covered with coral heads congealed on them. These beach rocks have many irregular projections and an exceedingly high degree of roughness. A distant view of the reef edge from islet A is shown in Photo 1.84. It can be seen that the reef edge has a slightly elevated gravel deposition area, and that this elevation extends completely in parallel with the horizon. Simple measurement using a pole found that the height was 1.1 m above the reef surface.

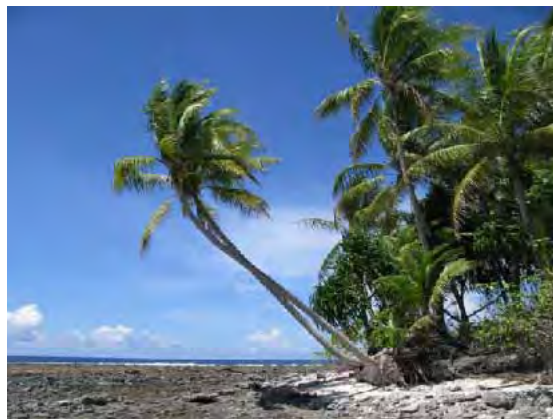
Photo 1.85 shows the conditions of the southeastern tip of islet A. Islet A, being protected by a large beach rock area and therefore free of strong wave actions, has a deposition of coral sand. In the southern area (side) of the islet, on the other hand, currents to the lagoon side are predominant so that any movable sand cannot remain on the coast, resulting in a gravel beach (Photo 1.86). A view of the comet tail in the back of islet A shown in Figure 1.4, seen from the base of islet A facing northwest, is shown in Photo 1.87. In the center of the wide deposition area of coral heads, sand is deposited in an approximately triangular shape. This reveals that, around islet A, sand can be deposited only where wave actions are blocked and, elsewhere, all the sand is carried away to the lagoon side.

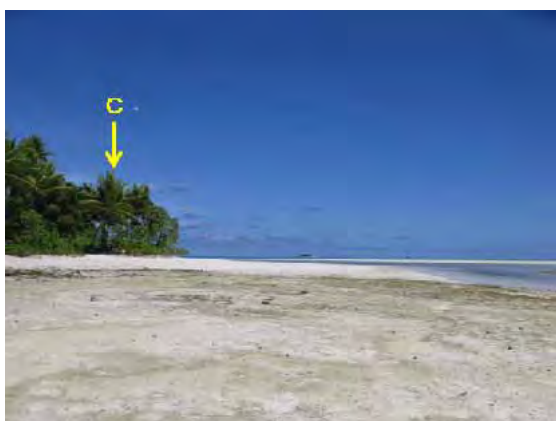
Photo 1.88 shows a distant view of a sandbar near C2, a tip of islet C, seen from the eastern side. The sand beach at C3 remains to have an approximate thickness of one meter over a congealed planation surface. Photo 1.89 is taken standing on sandbar C3, which shows a broad expanse of sand beach. The constituent materials of sandbar C3, shown in Photo 1.90, are red sand derived from foraminifera and well-sorted sand such as seashell chips. Although such sand is ideal as a beach nourishment material, the question is whether a sufficient amount of it is available. Therefore, a detailed survey was conducted near sandbar C3. Photo 1.91 shows a view of islet 3 seen from the center of C3, and Photo 1.92 shows a view of the tip of the sandbar in the opposite direction. It appears as if there is sufficient sand near this place. However, digging an area a little distant from sandbar C3 in the west that seemed to be covered with sand revealed that the thickness of deposited sand is only about 7 cm as shown in Photo 1.93, and that there is little available sand. In an area further to the east of it (Photo 1.94), the surface was white, appearing to have a deposition of sand, but was actually firm ground, having little sand unlike in Figure 1.89 and 1.91.

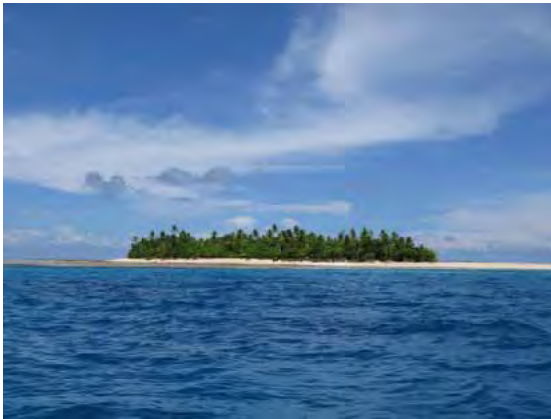
Photo 1.95

Fuagea Islet, located to the west of the atoll, is a beautiful cay that has been built up through accumulation of dead foraminifera. The altitude of this islet is high in the southernmost tip where coconut palms and screw pines grow thickly. Toward the north, a narrow sandbar has been developed (Photo 1.95). On the eastern side of the islet, there is an expanse of shallow reef covered with fine sand on the surface (Photo 1.96). The foreshore of the cay was measured to have an approximate gradient of 1 in 10 and consists of well-sorted sand (with grain sizes of few millimeters) (Photos 1.97 and 1.98). The red material forming the beach is sand derived from foraminifera.

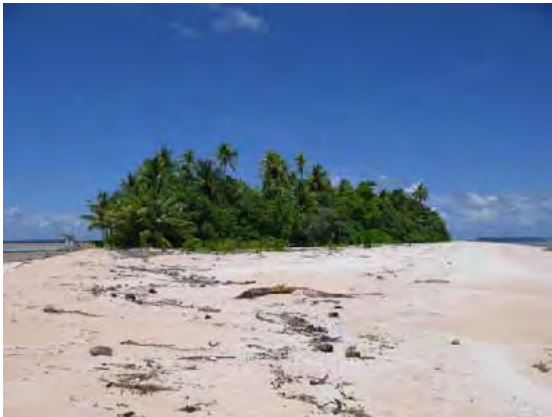
Photo 1.99

The center of the islet seen from the sandbar extending thinly to the north of the islet looking south is shown in Photo 1.99. Swash oscillations from both sides of the islet cause drifts to be washed ashore from both sides. This cay, as long as it is shown in this photo, looks stable. However, the conditions on the other side (southern side) of the islet were not clear. Therefore, the conditions of the beach were checked while we walked around this islet counterclockwise along the shoreline.

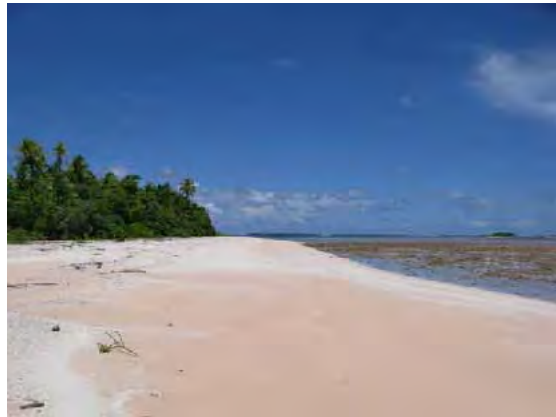
First, Photo 1.100 was taken of the islet from the western side of the islet looking south. The foreshore of the cay starts as a steep slope from the planation surface of the reef. Photo 1.101 was taken after moving further to south along the shoreline. There is a clear border between the zone of sand that constitutes the cay and the planation surface of the reef, at which the planation surface of the reef abruptly changes to a slope consisting of sand. This phenomenon is due to the following cause: Since the equilibrium gradient of sand is as high as about 1 in 10, any sand deposited on the reef planation surface is subject to strong onshore littoral drift. If there is an impermeable wall (an islet itself in this case) that blocks sand movement on the

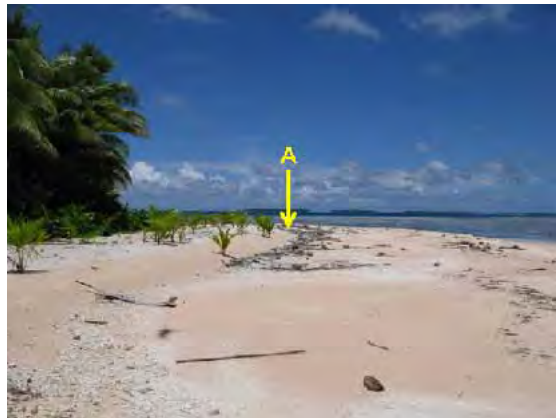
Photo 1.102

Near the southernmost tip of the islet, some coconuts drifted ashore and pushed out new shoots that were growing as shown in Photo 1.102. However, this area where coconuts were growing abruptly ends near arrow A. Near A, a small beach scarp has been formed, and a berm is being formed again on the ocean side of it. This status is considered to be due to the following cause: The cay was eroded once to form a beach scarp, on which sand was deposited to form a berm. Then, coconuts that drifted ashore before this temporary erosion pushed out new shoots.

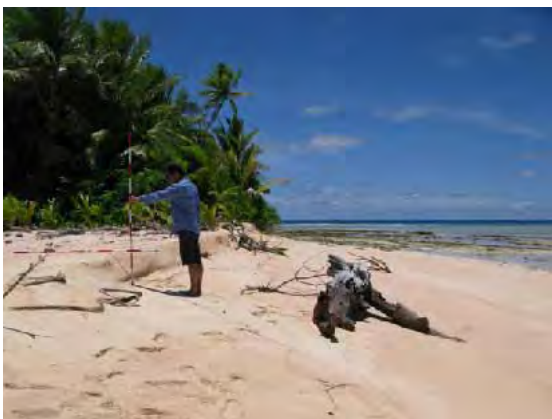
Going around the southernmost tip of the cay and reaching the eastern side of the islet, the beach conditions are completely different. First, Photo 1.103 shows a beach scarp that began to be observed near the southernmost tip of the cay. At this position, the beach scarp has an elevation difference of 0.4 m. Going along the eastern side of the islet, the erosion conditions were photographed as shown in Photos 1.104, 1.105 and 1.106. The vegetation fell due to the erosion, and the beach scarp has increasingly greater elevation differences of 0.8 m, 1.1 m and 1.2 m in Photos 1.104, 1.105 and 1.106, respectively. Going down from the position where Photo 1.106 was taken, Photo 1.107 was taken at the shoreline facing southeast. In this photo, many rows of beach rocks inclined toward the shore side are observed offshore from the present shoreline. Considering that beach rocks are formed in the sand beach, these conditions show that the beach rocks shown in Photo 1.107 were developed in an area that used to be covered with a sand beach in the past, and that erosion of the sand beach exposed the beach rocks. Near the place shown in Photo 1.106, the shoreline is estimated to have backed off for about 12 m based on the beach scarp's elevation difference of 1.2 m and an approximate foreshore gradient of 1 in 10. Therefore, it is understood that the area with beach rocks shown in Photo 1.107 was initially covered with sand, but was later exposed when the beach moved approximately in parallel and that erosion occurred on the eastern side of the cay in recent years. Going further, the beach scarp has smaller elevation differences of 1.1 m and 0.6 m as shown in Photos 1.108 and 1.109. Near the back (northern side) of the islet, there is almost no beach scarp as shown in Photo 1.110.

- In Fuagea Islet, erosion has been progressing on the eastern side of the cay in recent years, and a beach scarp with an elevation difference of 1.2 m at the maximum has been formed. At places with significant beach scarp formation, several rows of beach rocks were observed near the low-tide shoreline. It was concluded that these beach rocks were formed while the cay extended to the eastern side and got exposed due to erosion that occurred in recent years.

- In view of the beach scarp erosion and beach rock exposure conditions, waves that caused the erosion are considered to have come from the eastern to southeastern direction. In the atoll, there is a cut in the eastern to southeastern direction of this islet. Therefore, the entry of high waves from this direction is considered to be the cause of the erosion.

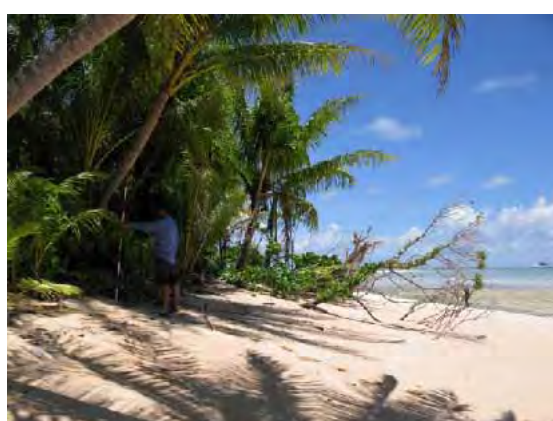
At the same time as the cay erosion described in the above, a narrow comet tail extended on the north of the cay. Photo 1.111 shows the comet tail seen from the northernmost tip of the cay facing north. The sprouting of many coconuts observed at the base of the comet tail shows that sand has just been accumulated at this place and that a stable comet tail has been formed. The comet tail is not straight but bends sharply to the east near the tip (Photo 1.112). Arriving at the tip of the comet tail, it was found to have a cut as indicated by an arrow in Photo 1.113, where a channel has been formed (Photo 1.114). On the lagoon side of this channel, a

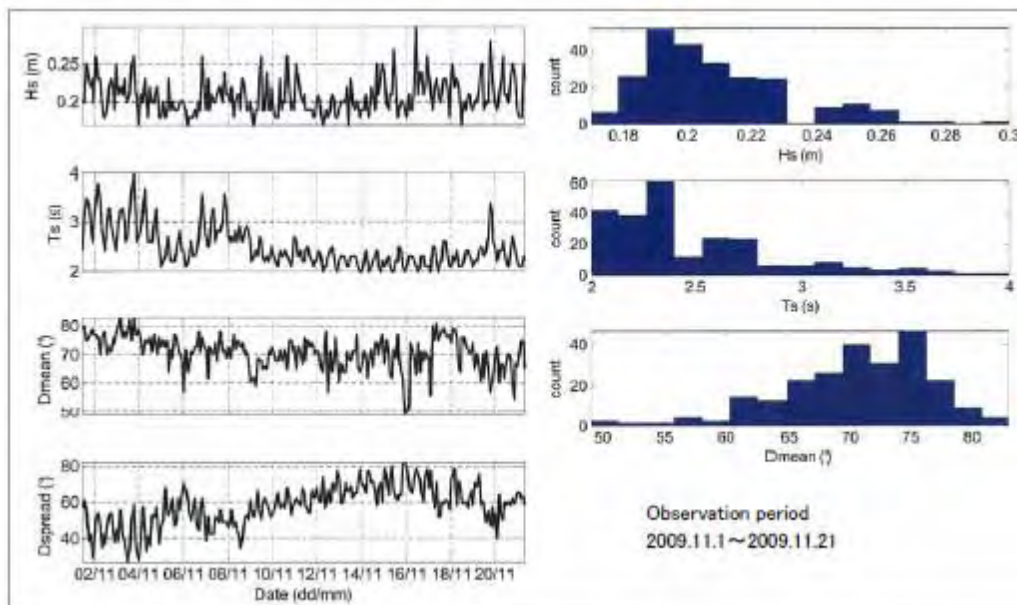
Figure 2.2 Time Series Plot of Wave and Occurrence Frequency Histograms
(WG-1: First Deployment)

Wave Dimension	First Deployment (Nov.1 to 21, 2009)	Second Deployment (Feb.2 to 19, 2010)	Third Deployment (Feb.20 to Mar.19, 2010)
Wave Height : Maximum	0.3 m	0.9 m	1.4 m
Mean	0.2 m	0.4 m	0.4 m
Minimum	0.2 m	0.2 m	0.2 m
Wave Period : Maximum	4.0 sec	4.5 sec	4.5 sec
Mean	2.5 sec	3.6 sec	3.1 sec
Minimum	2.0 sec	2.5 sec	2.1 sec
Wave Direction: Maximum	83.0°	89.0°	99.0°
Mean	70.7°	79.8°	76.8°
Minimum	49.0°	67.0°	51.0°

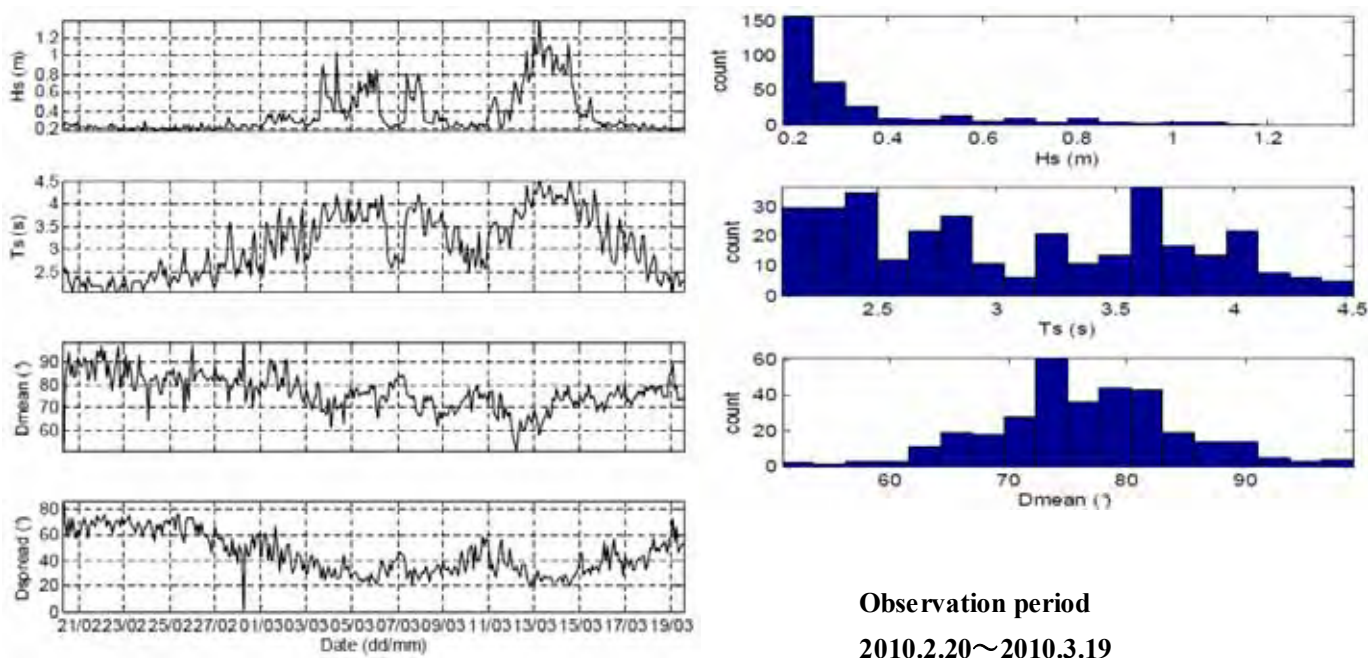
**Figure 2.4 Time Series Plot of Wave and Occurrence Frequency Histograms
(WG-1: Third Deployment)**

(Note) Hs : Significant Wave Height, Ts : Significant Wave Period
Dmean : Mean Wave Direction, Dspread : Wave Average Dispersion Angle

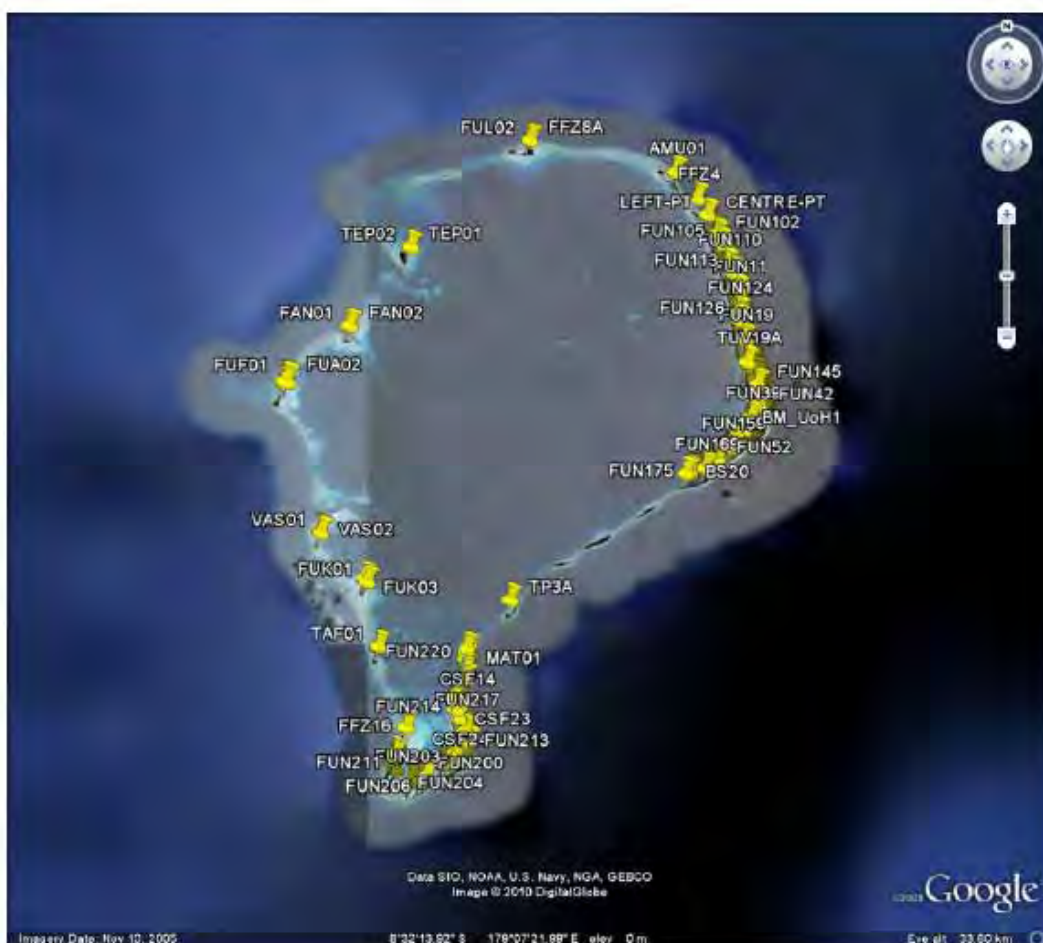
Figure 2.12 Ground Control Points Map in Google Earth

Figure 2.12 and Figure 2.13 show the ground control points map all over the Funafuti atoll and Figure 2.14 shows one sample of the detailed ground control points in satellite image as a reference.

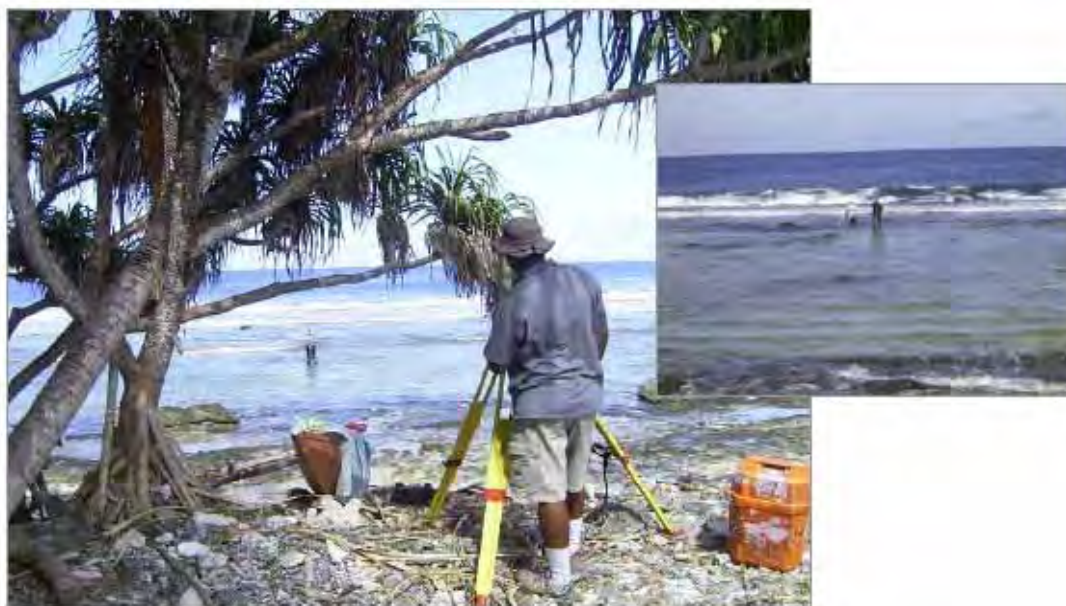
Photo 2.1 Scenes from Cross Sectional Survey using Total Station

The cross sectional survey was conducted on topographic features shallower than the depth of 1.2 meters from the supplementary control points along the survey cross sections from the ocean into the lagoon. The topographic features were measured through indirect leveling using a Total Station at an observation pitch of 10 meters or less and based on topographic feature change points in Fongafale islet. At the same time, surface geological conditions were also recorded.

The cross section lines were set in a direction roughly perpendicular to the coastline at a pitch of 100 meters in Fongafale islet and one line per islet was set on other islets than Fongafale, resulting more than 140 survey lines in the entire atoll of Funafuti.

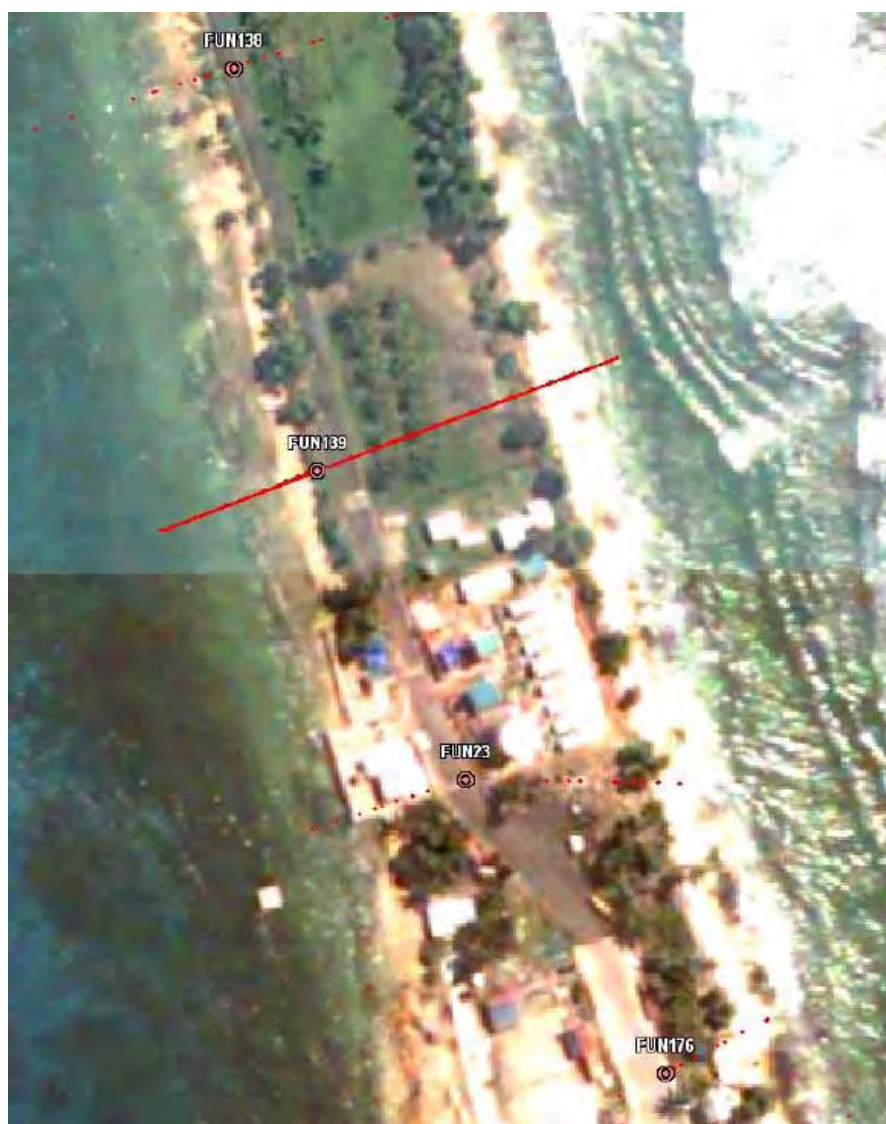
**Figure 2.15 Cross Sectional Survey Line in Satellite Image
(FUN-139 : North Side of BP Oil)**

Figure 2.15 and Figure 2.16 show one sample of the detailed cross sectional survey line in satellite image and a cross sectional profile along a ground control point (along the ground control point: FUN-139 near the BP Oil in the north part of Fongafale islet in this case).
