## 4. Geotechnical Classifications

JGS		0051		Geotechnical Classifications				
Project Title	THE STUDY FOR ASSESSMENT OF ECOSYSTEM, COASTAL EROSION AND PROTECTION/REHABILITATION OF DAMAGED AREA IN TUVALU			Date	September 22, 2010			
				Trier	Hideaki Tsuge			
Sample Number (Depth)	DS-1	DS-2	DS-3	DS-4	DS-5	DS-6		
Stone Fraction (more than 75mm)	%	0.0	0.0	0.0	0.0	0.0	0.0	
Gravel Fraction (2~75mm)	%	0.7	1.7	12.5	0.5	0.1	31.2	
Sand Fraction (0.075~2mm)	%	87.7	74.8	76.6	52.4	81.3	55.5	
Fine-Grained Fraction (less than 0.075mm)	%	11.6	23.5	10.9	47.1	18.6	13.3	
Silt Fraction (0.005~0.075mm)	%	7.7	18.4	8.5	36.2	12.6	9.9	
Clay Fraction (less than 0.005mm)	%	3.9	5.1	2.4	10.9	6.0	3.4	
Maximum Particle Size	mm	4.75	9.50	9.50	4.75	4.75	9.50	
Uniformity Coefficient $U_c$		8.74	17.12	12.53	30.81	27.58	51.20	
Liquid Limit $w_L$	%	NP	NP	NP	NP	NP	NP	
Plastic Limit $w_p$	%	NP	NP	NP	NP	NP	NP	
Plastic Index $I_p$		—	—	—	—	—	—	
Class Name of Ground Materials		Sand with some Fine fraction	Sand and Fine fraction	Sand with some Fine fraction and Gravel	Sand and Fine fraction	Sand and Fine fraction	Sand and Gravel with some Fine fraction

Passing Through Test for Geofabric (Spun bond fabric and Woven Texti

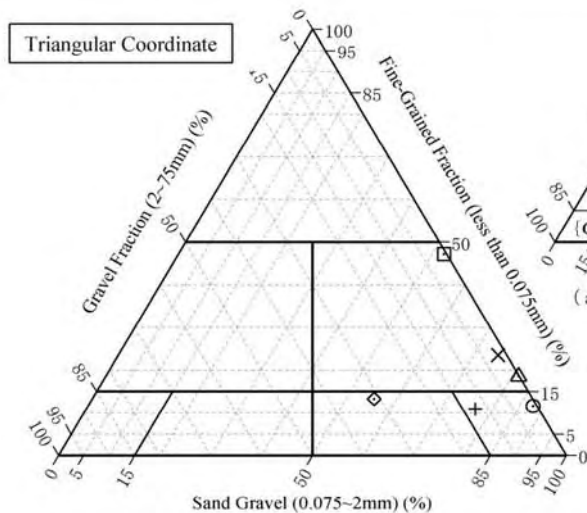
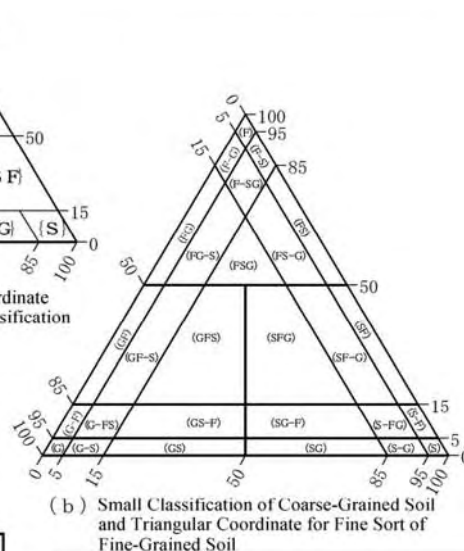
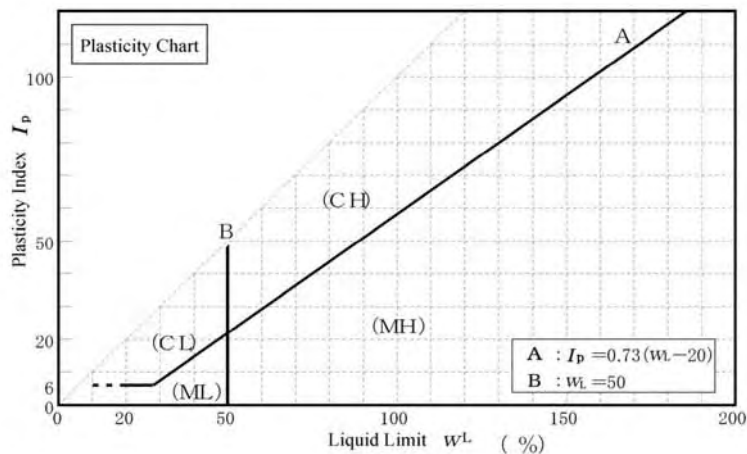
Class Symbol		(S-F)	(SF)	(S-FG)	(SF)	(SF)	(SG-F)	
Legend Symbol		○	×	+	□	△	◇

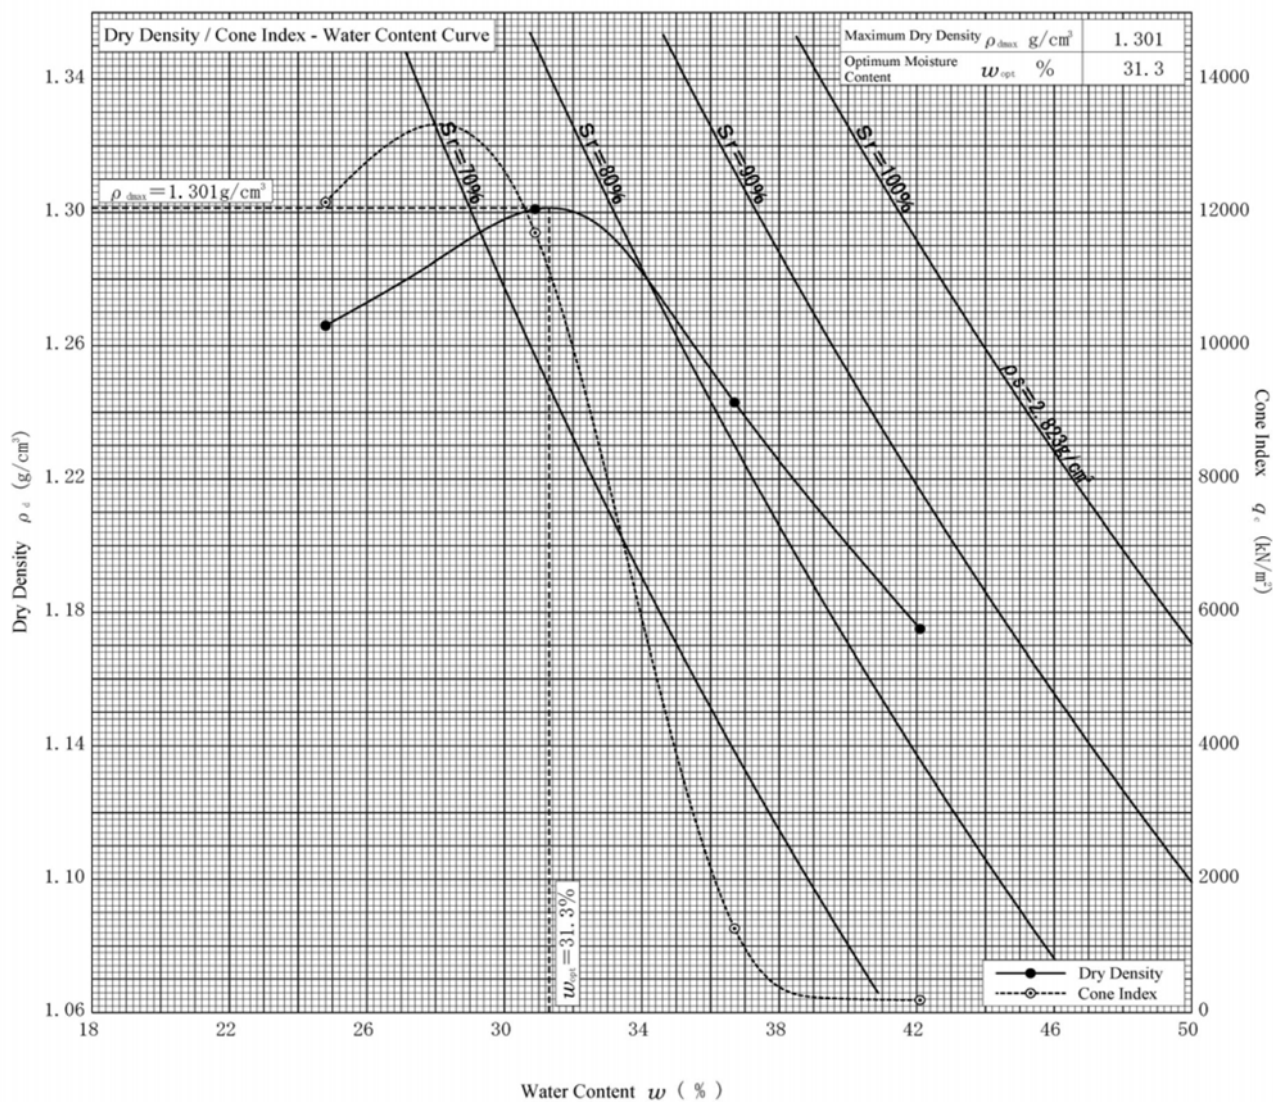
Soil Compaction Test and Cone Index Test										
Project Title		THE STUDY FOR ASSESSMENT OF ECOSYSTEM, COASTAL EROSION AND PROTECTION/REHABILITATION OF DAMAGED AREA IN TUVALU				Date		September 30, 2010		
Sample Number (Depth) DS-4						Trier		Minoru Sato		
Soil Style		A-c				Density of Soil Particle $\rho_s$ g/cm <sup>3</sup>		2.823		
Compaction Test	Test Method	A-c				Rammer Mass kg	2.5	Mold	Bore Diameter cm	10.00
	Preparation Method of Sample	Dry Method • Wet Method				Tamping Number of Times	25		Height cm	12.73
	Usage Method of Sample	Iterate Approach • Not Iterate Approach				Tamping Layer Number Layer	3		Area of Base of Cone cm <sup>2</sup>	3.24
Measurement No.		①	②	③	④	⑤	⑥	⑦	⑧	
Cone Index Test	Resistance Force	Penetration Amount	Penetration Resistance Force	Penetration Resistance Force	Penetration Resistance Force	Penetration Resistance Force	Penetration Resistance Force	Penetration Resistance Force	Penetration Resistance Force

5.0 cm	2867	2236	291	56				
		7.5 cm	4118	3865	421	62				
	N	10.0 cm	4828	5265	515	65				
Average Penetration Resistance Force		N	3938	3789	409	61				
Average Water Content w		%	24.8	30.9	36.7	42.1				
Dry Density $\rho_d$		g/cm <sup>3</sup>	1.266	1.301	1.243	1.175				
Cone Index $q_c$		kN/m <sup>2</sup>	12154	11694	1262	188

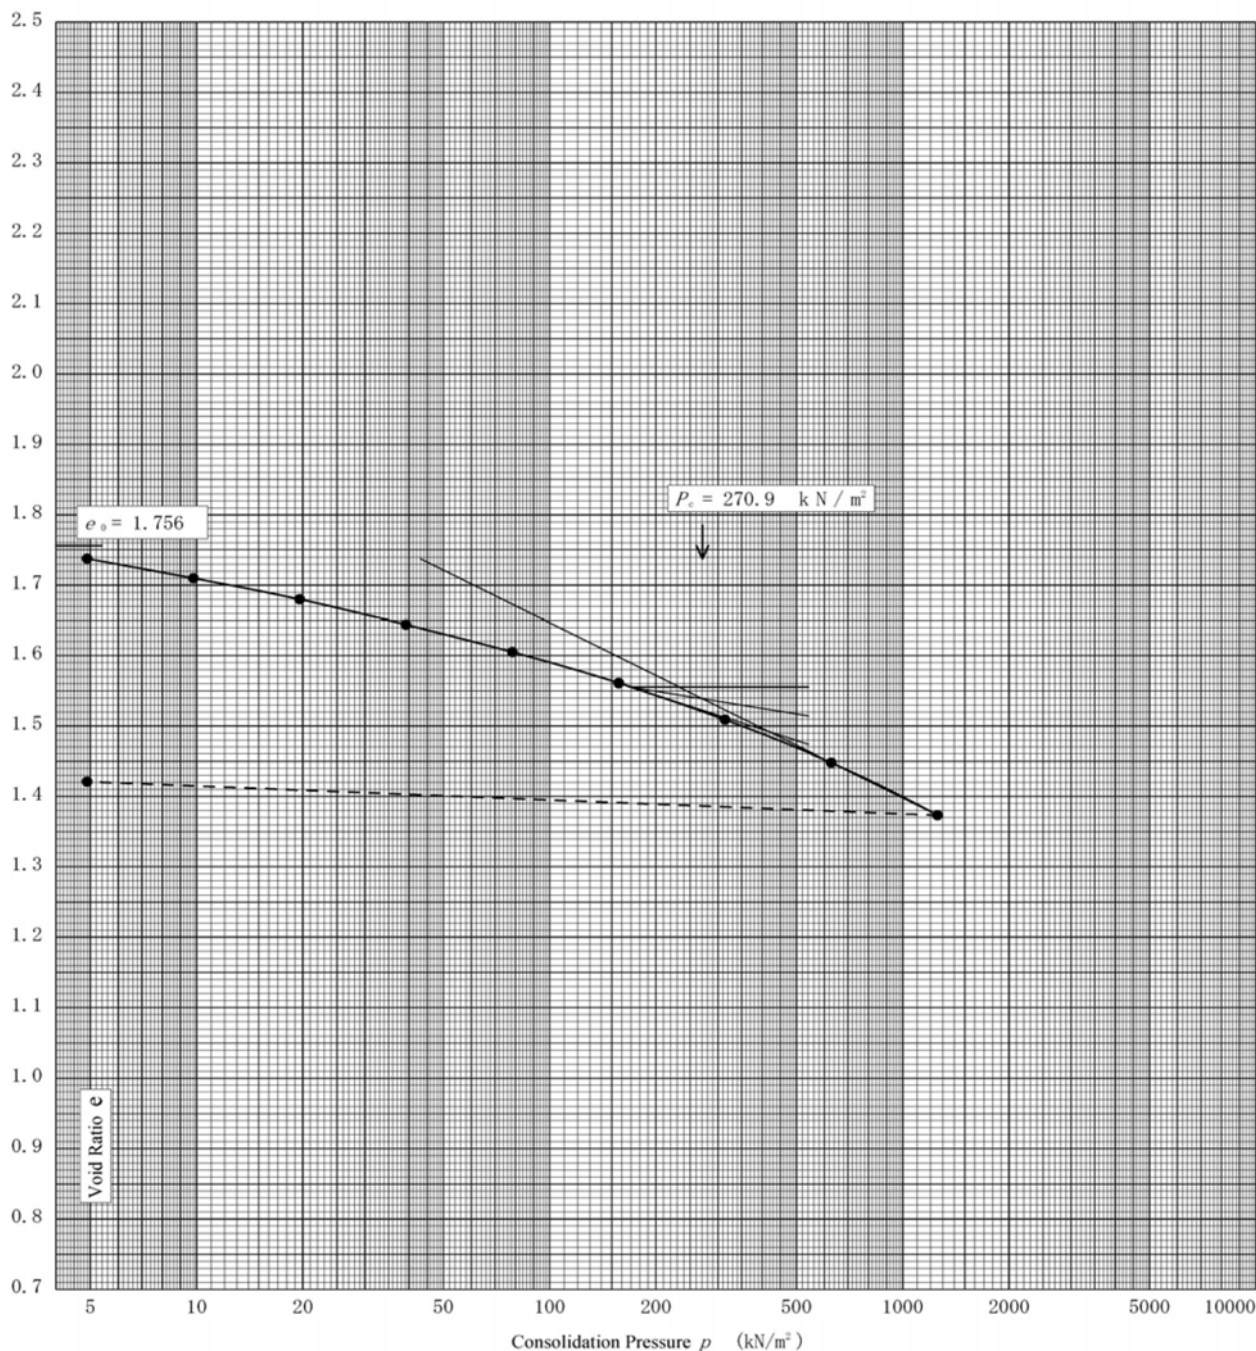
JIS A	1217	Consolidation Test by Stage Loading of Soil (Compression Curve)					
JGS	0411						
Project Title	THE STUDY FOR ASSESSMENT OF ECOSYSTEM, COASTAL EROSION AND PROTECTION/REHABILITATION OF DAMAGED AREA IN TUVALU		Date September 30, 2010				
Sample Number (Depth)	DS-4		Trier Mitsuaki Kondo				
Density of Soil Particle $\rho_s$ g/cm <sup>3</sup>	Liquid Limit $w_L$ %	Plastic Limit $w_P$ %	Initial Water Content $w_0$ %	Initial Void Ratio $e_0$ Initial Volume Ratio $f_0$	Compression Index $C_c$	Compressive Yield Stress $p_c$ kN/m <sup>2</sup>	Strain Speed <sup>1)</sup> %/min
2.823	NP	NP	40.6	1.756	0.249	270.9

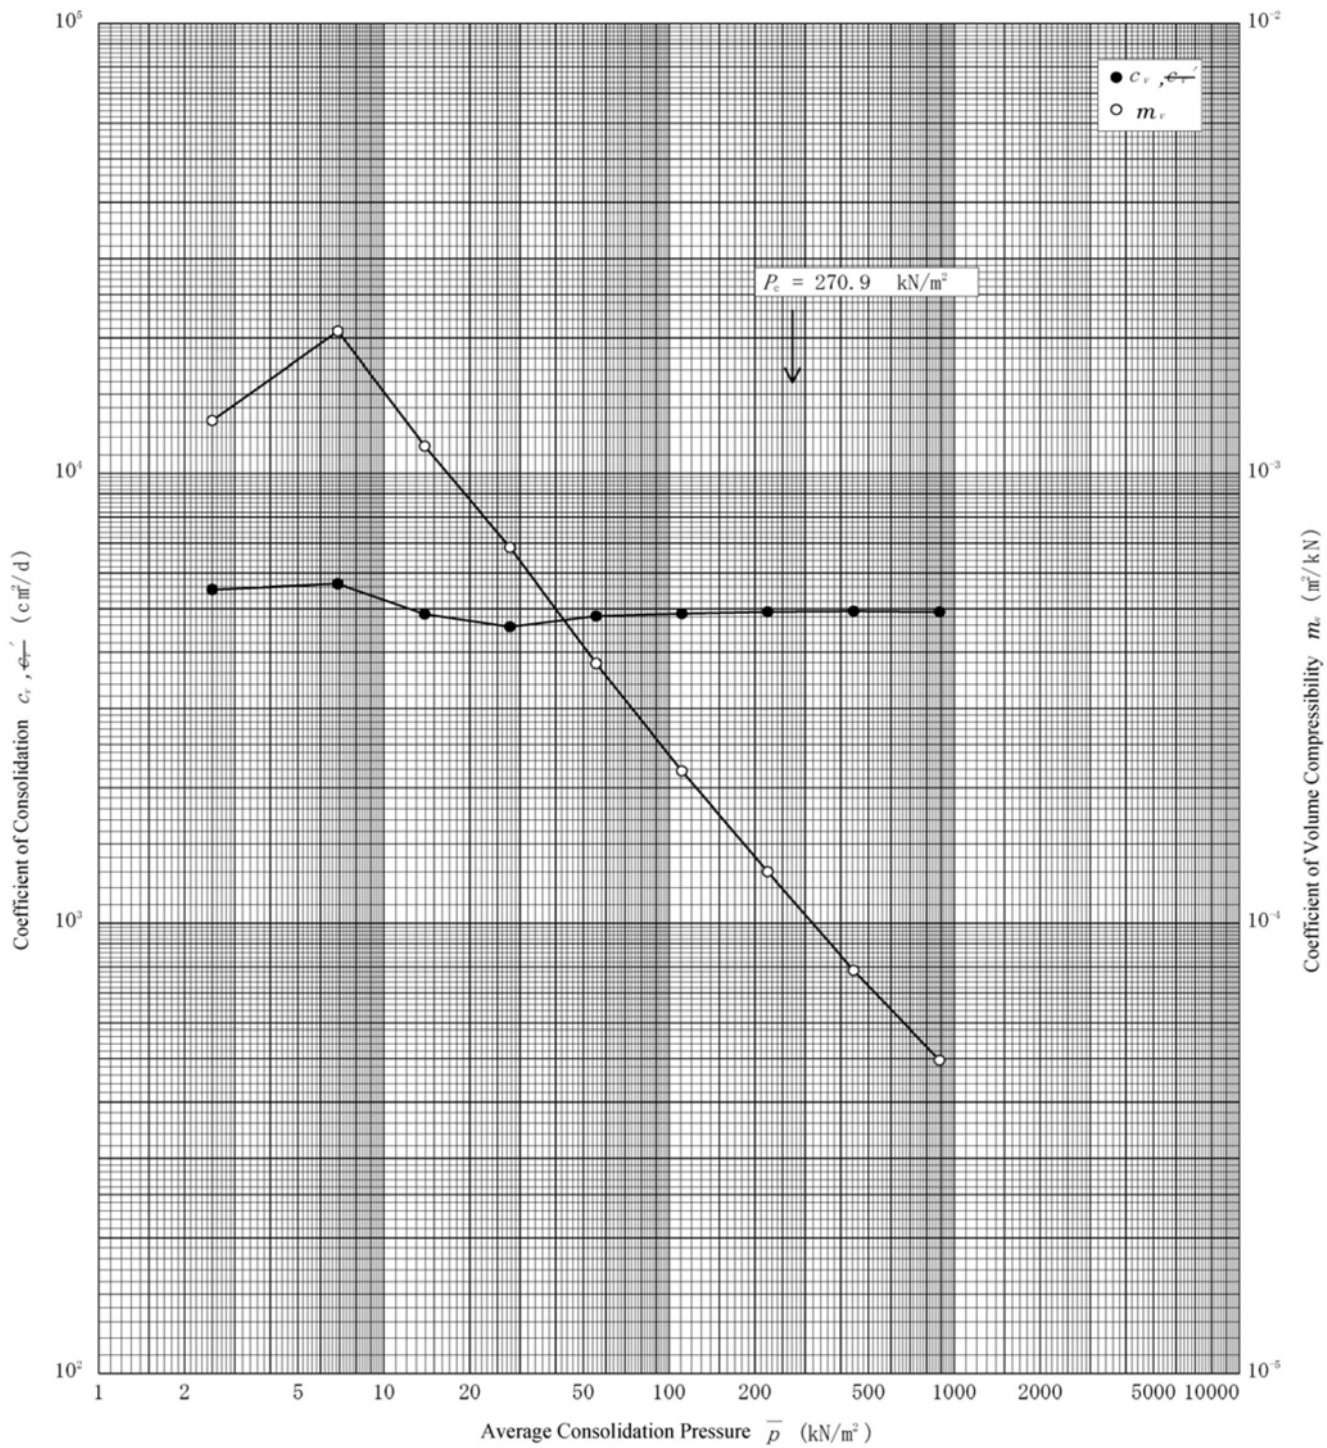
JIS A	1217	Consolidation Test by Stage Loading of Soil (Relation of $c_v, m_v - \bar{p}$ )	
JGS	0411		
Project Title	THE STUDY FOR ASSESSMENT OF ECOSYSTEM, COASTAL EROSION AND PROTECTION/REHABILITATION OF DAMAGED AREA IN TUVALU		Date September 30, 2010
Sample Number (Depth)	DS-4		Trier Mitsuaki Kondo

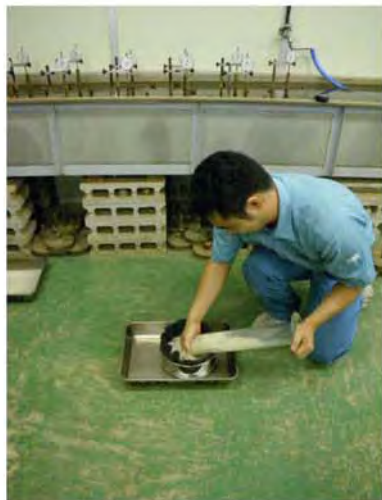
Photo-1 : Passing Through Test for Geofabric (5mm Thk. spun bond fabric) and Dredged Sand

Murky well mixed water consisting of one liter of water and dredged sand (100g) was spilled onto geofabric (5mm thickness) laid over 0.074mm test sieve.

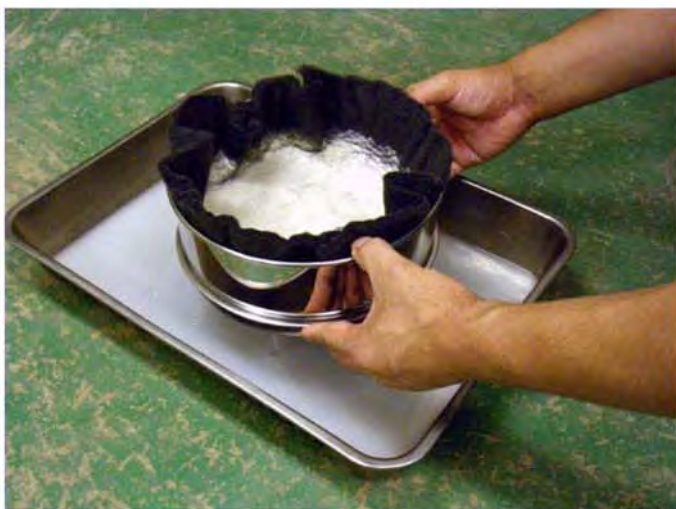
Photo-2 : Passing Through Test for Geofabric (5mm Thk. spun bond fabric) and Dredged Sand

Just after having spilled onto geofabric (5mm thickness) laid over 0.074mm test sieve. Water penetrated smoothly. It took 4 minutes until water disappeared from the surface.

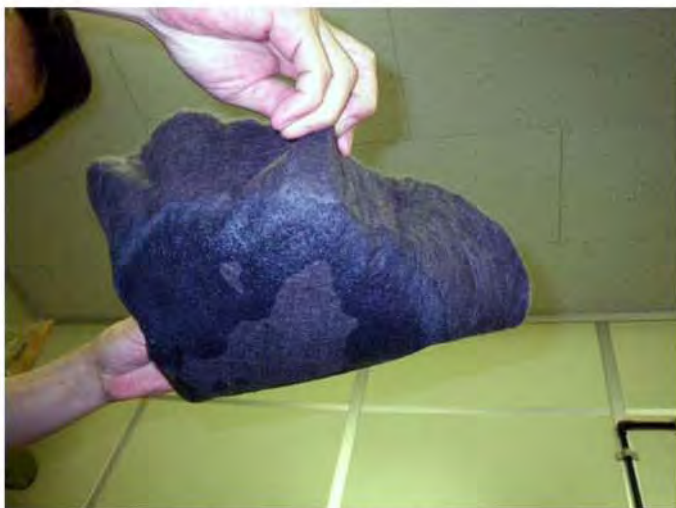
Photo-3 : Passing Through Test for Geofabric (5mm Thk. spun bond fabric) and Dredged Sand

No soil observed on the back of spun bond fabric after water penetrates. There was no remain on the 0.074mm test sieve

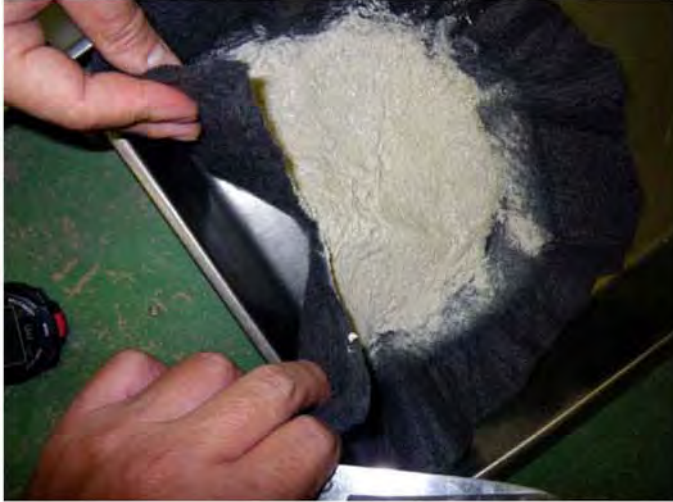
Photo-4 : Passing Through Test for Geofabric (5mm Thk. spun bond fabric) and Dredged Sand

The section was observed cutting the spun bond fabric after water had penetrated. The soil particle soaks only up to about 1mm of the surface.

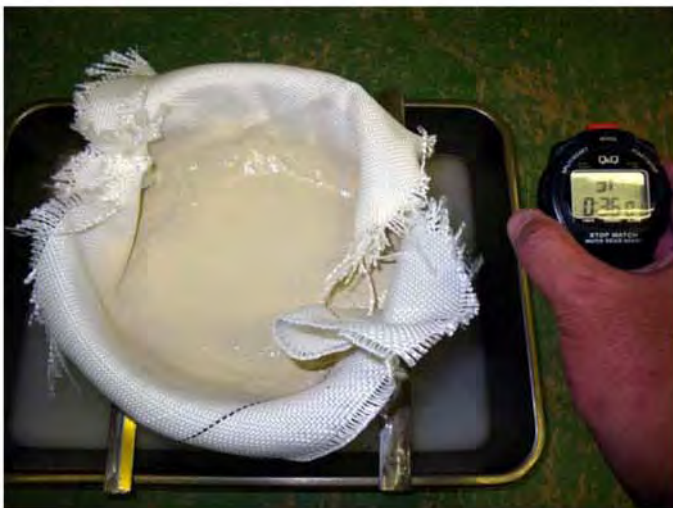
Photo-5 : Passing Through Test for Geofabric (1mm Thk. woven textile) and Dredged Sand

The same above-mentioned test was done with woven textile. Water doesn't penetrate easily. It took 40 minutes until water disappeared from the surface.

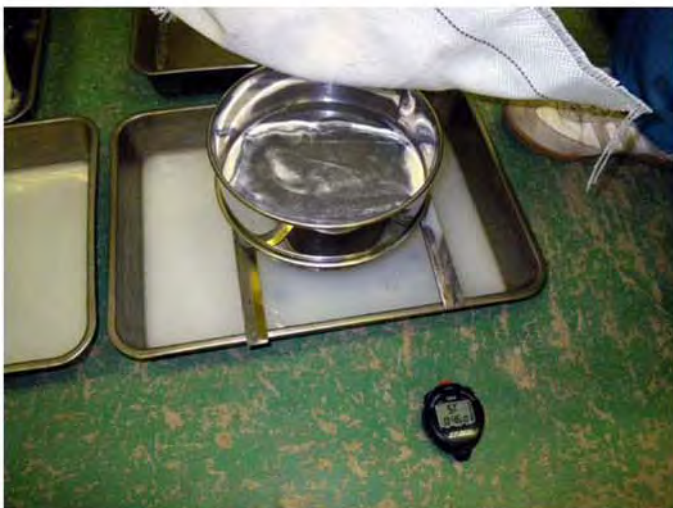
Photo-6 : Passing Through Test for Geofabric (1mm Thk. woven textile) and Dredged Sand

When the woven textile after water penetrated was raised, some soil particles remained in test sieve of 0.074mm.

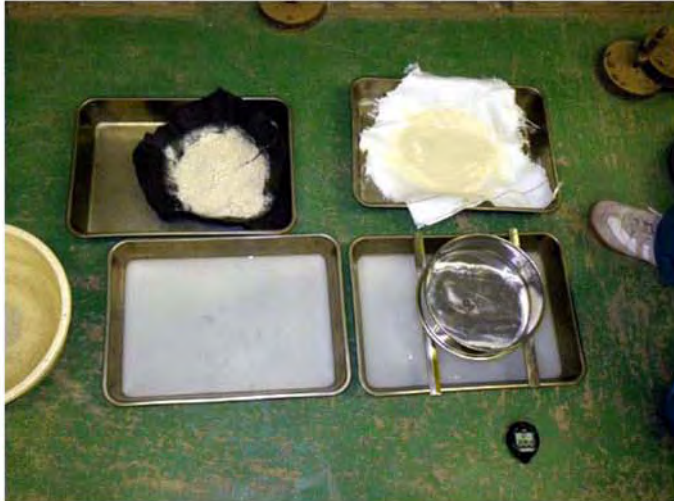
Photo-7 : Right: 5mm Thk. spun bond fabric, Left: 1mm Thk. woven textile

Test Result;  
Left: Spun Bond showed;  
- Excellent water permeability,  
- Excellent soil particle trapping performance  
Right: Woven Textile showed;  
- Very Poor water permeability,  
- Poor soil particle trapping performance
