**PREPARATORY SURVEY REPORT  
ON  
THE PROJECT FOR FLOOD PROTECTION  
AND DRAINAGE IMPROVEMENT  
IN THE PHNOM PENH CAPITAL CITY  
(PHASE III)  
IN THE KINGDOM OF CAMBODIA**

**March 2011**

**JAPAN INTERNATIONAL COOPERATION AGENCY**

**CTI ENGINEERING INTERNATIONAL CO., LTD.**

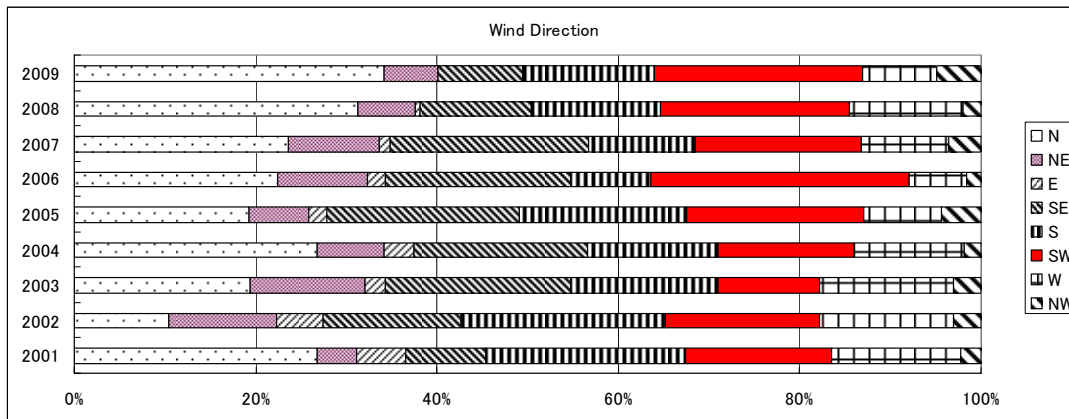
**Fig. R 1.3.3 Wind Speed and Wind Direction Data at Pochentong Station (2001-2009)**

The maximum wind speed is 21 m/s recorded in 2006. In general, high wind speed is recorded in the dry season. Wind direction varies with the season: northerly from October to January, south-easterly from February to April, and south-westerly from May to September.

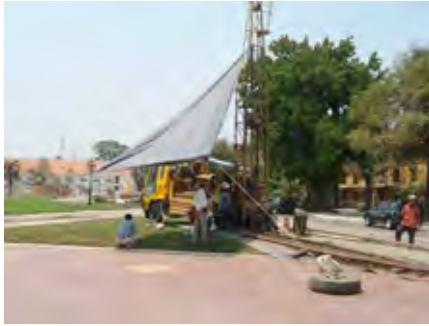
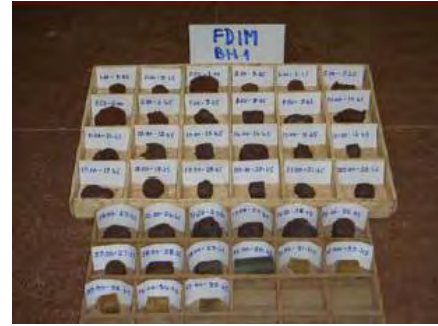
The condition during the survey is shown in Photo R 1.3.2.

(At Boring Works)

(Samples taken from Borehole)
