## **CHAPTER 8 PRESENT SITUATIONS OF WATER AND SANITATION SECTOR AND OPERATION AND MANAGEMENT**

### **8.1 Long Term Plan of Water and Sanitation Sector**

In this chapter, the first section describes general matters of existing conditions regarding watershed management and flood control in Lake Kyoga Basin, which includes conditions of past disasters, land cover and vegetation conditions, surface water use facilities, flood control facilities, and sharing of water resources with neighboring countries. Then, subsequent sections mention two topics considered to be particularly important for formulating the basic plan, which are runoff characteristic of the basin and characteristic of past flood, and deforestation condition and characteristic of disasters in hilly and mountainous area of the upstream of the basin.

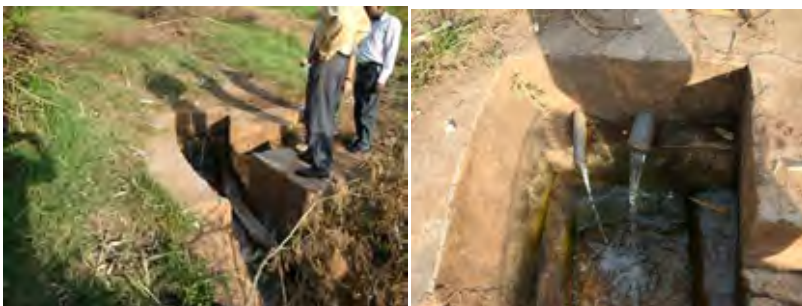
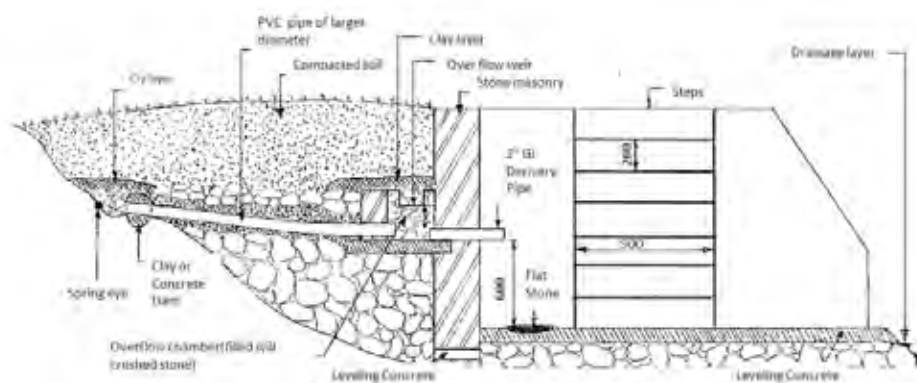
Most of spring water supply facilities are small-scaled and their performance deeply depends on the natural condition of rainy and dry seasons. Some of the facilities are not always

safety because no protection fences are installed for animals' intrusion or rainwater pouring into the upper intake of the facilities. However, a large number of piped water supply facilities are provided in the neighborhoods of the Mt. Elgon because of rich yields of such spring resources therein.

Figure 8-2 Typical Spring Water Supply Facility

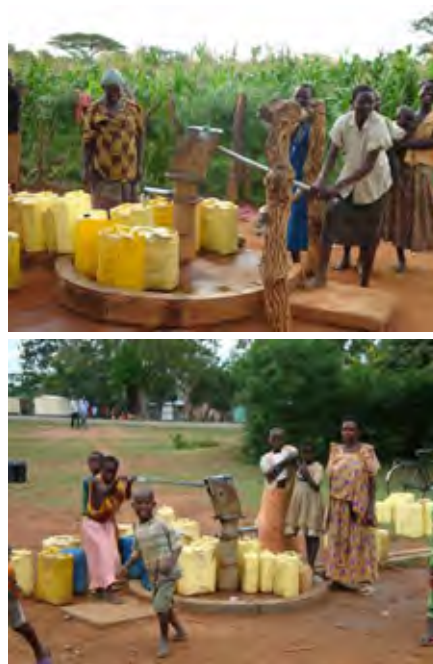
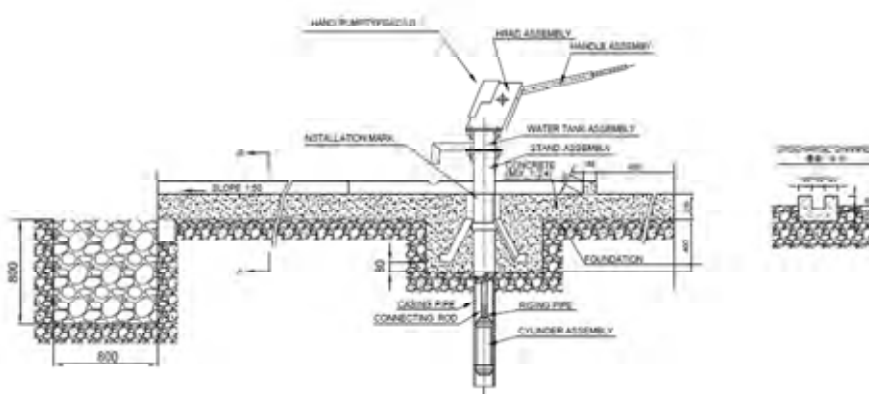
The facilities are furnished with a hand pump, an apron and a soak pit. U2 and U3 type hand pumps, remodeled type of Indian Mark II, are popular and widely utilized in Uganda. Spare parts for maintenance are easily procured because they are manufactured in Uganda, and the supply chains are also provided widely to cover district capitals. Hand pump platforms are constructed in accordance with the standard specification of DWD, and wooden fences are required to be constructed by the respective communities, but there are many wells operated without no such fences.

Figure 8-3 Typical Groundwater Supply Facility (Hand Pump)

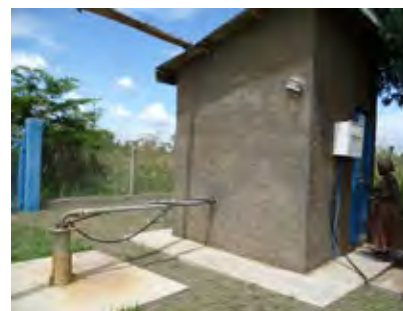
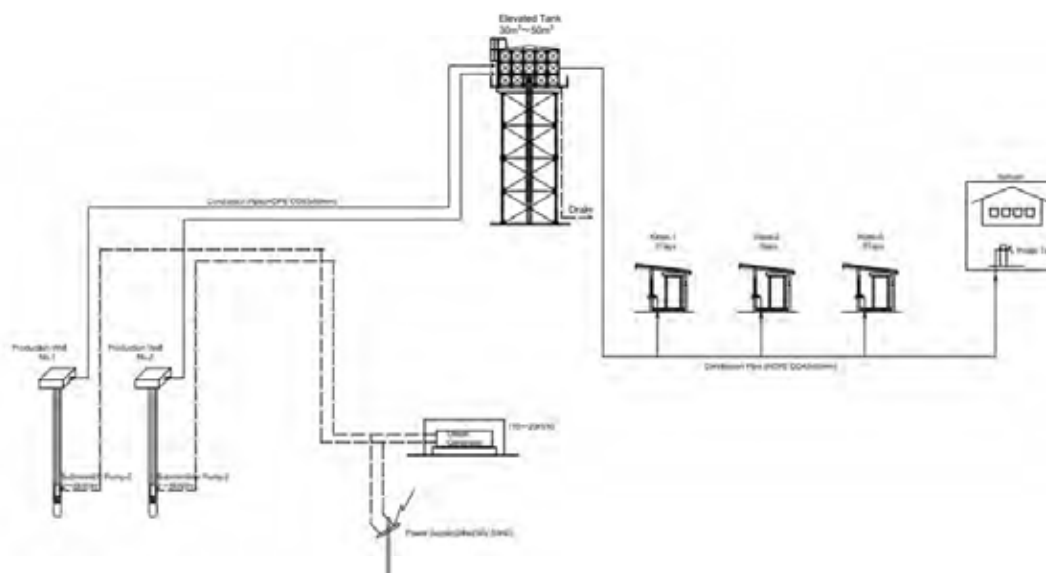
Most of water intakes use submersible motor pumps with protection fence and utilize commercial electricity of 415V, 3-phases, because RGC usually install electricity distribution systems. However, the electricity distribution system produces frequent electricity failure and voltage fluctuation of approximately 10 percent. Some of piped water supply facilities are not constant operated due to stoppage of electricity supply because of no electricity bills payment. In planning of piped water supply system, it should be into consideration whether the revenue from water sold is able to cover operation cost. In Long-term Strategy for Investment Planning, Implementation and Operation & Management of Water Supply and Sanitation in Rural Growth Centers, it is recommended to apply the most suitable power sources through the comparison among commercial electricity, diesel generation, solar power, and wind power considering the characteristics of the target water supply areas.

**Figure 8-4 Typical Piped Water Supply Facility (Groundwater)**

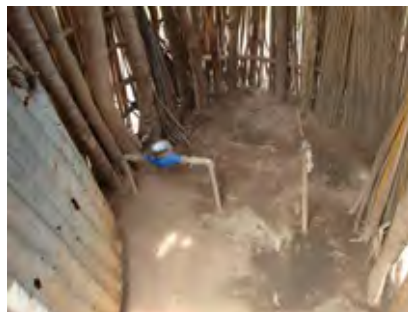
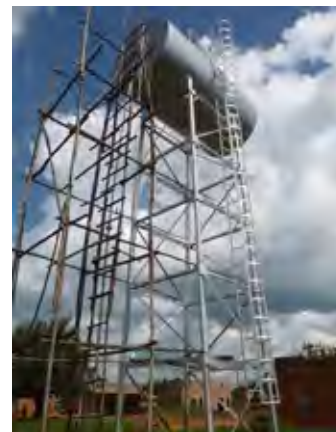
Water service facilities usually apply kiosk type, but some of houses utilize yard taps by which the water is distributed into the house inside. The kiosk has usually 3 taps, and the water bill is collected on the basis of water supply amount. The yard tap and the kiosk install flow meters, with which the water supply amount is recorded.

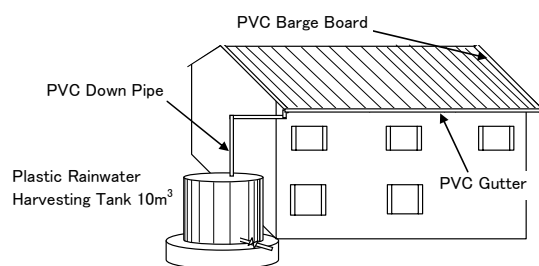
Small scale facilities of rainwater harvesting are widely applied in the communities because of their low costs required, but they are considered as the facilities supplementing the other main facilities since rainwater is not considered as stable seasonally.

**Figure 8-5 Rainwater Harvesting Facility**

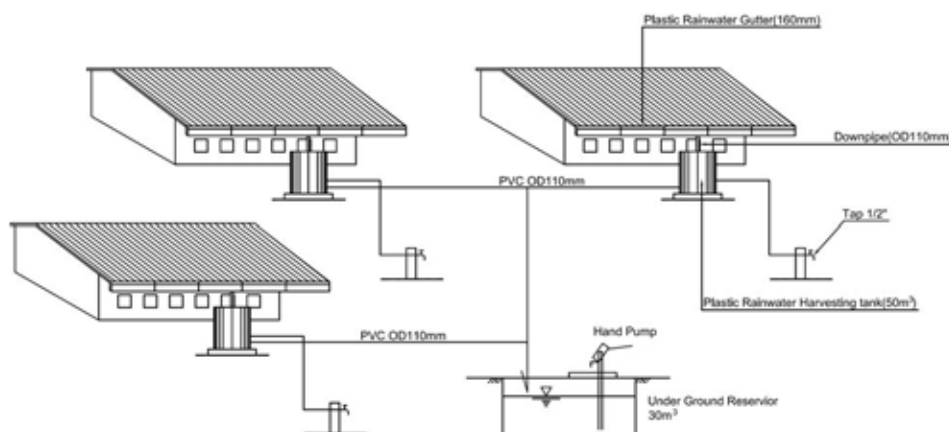
In case of primary schools, the facility collects the rainwater with 10m<sup>2</sup> plastic tank, and then conveys and stocks it to the underground reservoir with capacity of 30m<sup>2</sup> in the school ground. The underground reservoir installs the hand pump at the upper slab for use as needed.

**Figure 8-6 Typical Rain Water Harvesting Facility (Large Scale)**

The photos show the rainwater supply facility of the primary school in Soroti area, which was constructed in the Amret Soroti Phase Project, but the facility does

not work at present due to damaged connection pipe line fabricated with low-quality pipes. The rainwater collecting system comes to be utilized in many households because improved PVC collectors and plastic tanks are easily procured.

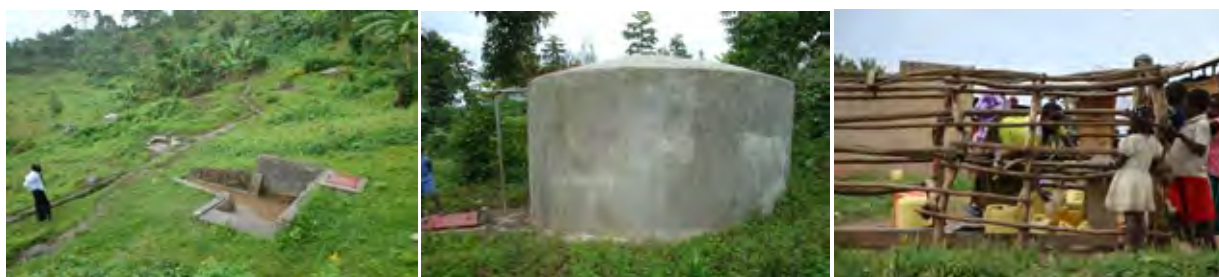
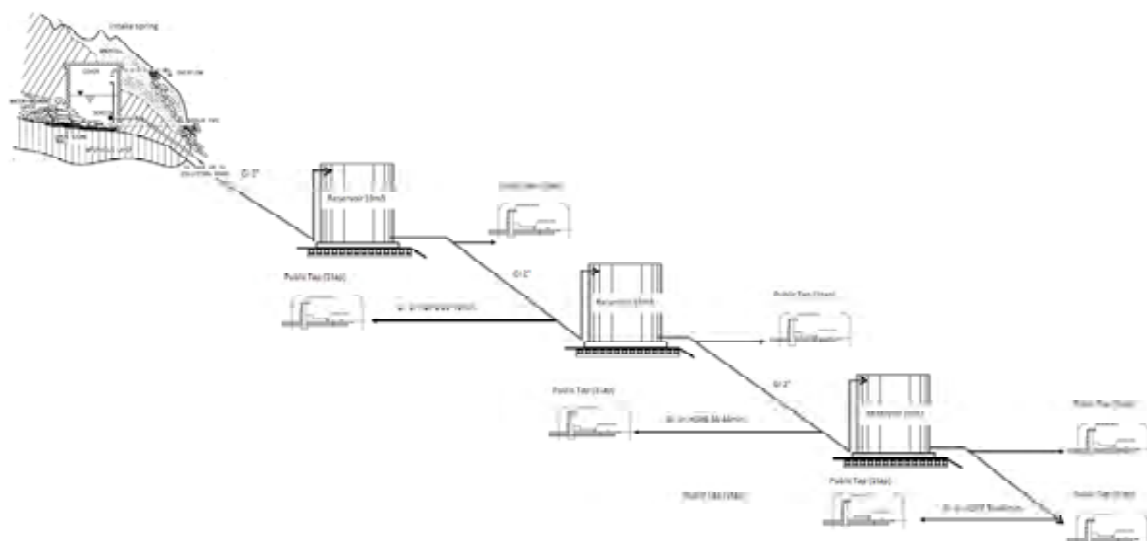
In the middle of Mt. Elgon, a large number of piped water facilities are installed, collecting surface and/or spring waters, and distributing them to the villages. The facility allows steady and constant water supply through a year without water pollution influenced by animals and people’s activities, but the water does not reach to some areas because the service area has been expanded. Since the level difference between water supply and water service facilities is approximately 500m in height, the water is depressurized by means of several concrete pressure-reduced tanks and distributed to each village with GI (galvanized iron) pipes of 50mm in diameter. The water service facilities with one public fountain are protected with the wooden fence for animals not to enter and to protect the public fountain.

**Figure 8-7 Typical Gravity Flow System**

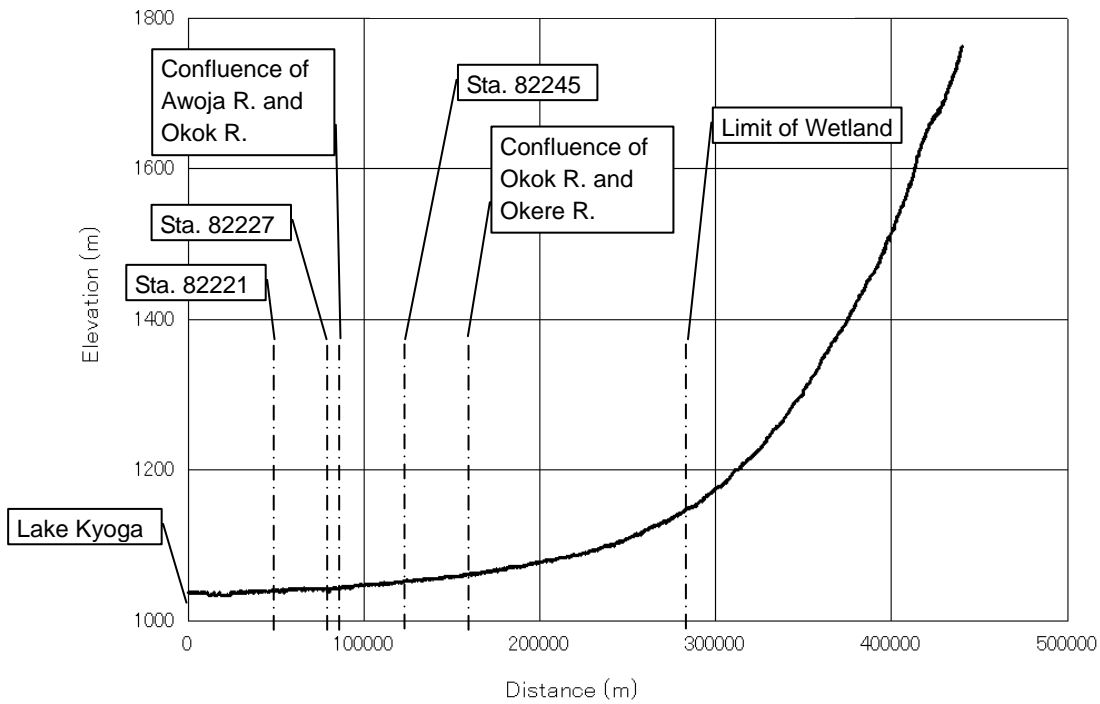
All rivers have quite gentle slope around Lake Kyoga.

**Figure 9-7 Longitudinal Profile of Awoja and Okok River (from Lake Kyoga to Confluence of Awoja and Okok River, and to Uppermost Stream of Okok River)**

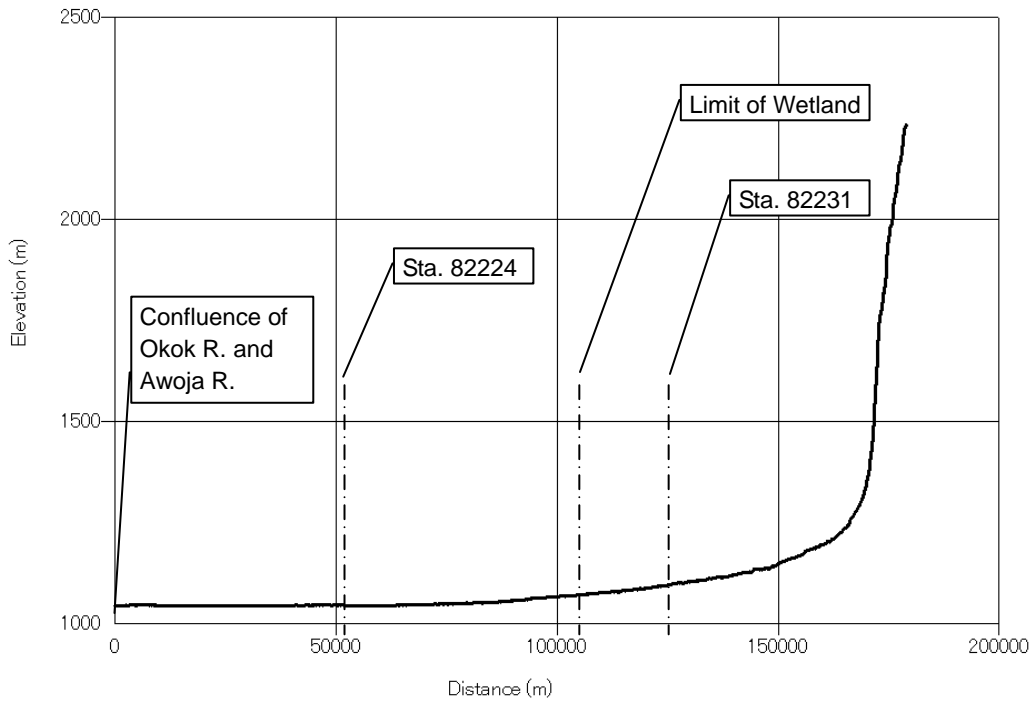
**Figure 9-8 Longitudinal Profile of Awoja River (from Confluence of Okok River to Uppermost Stream of Awoja River)**

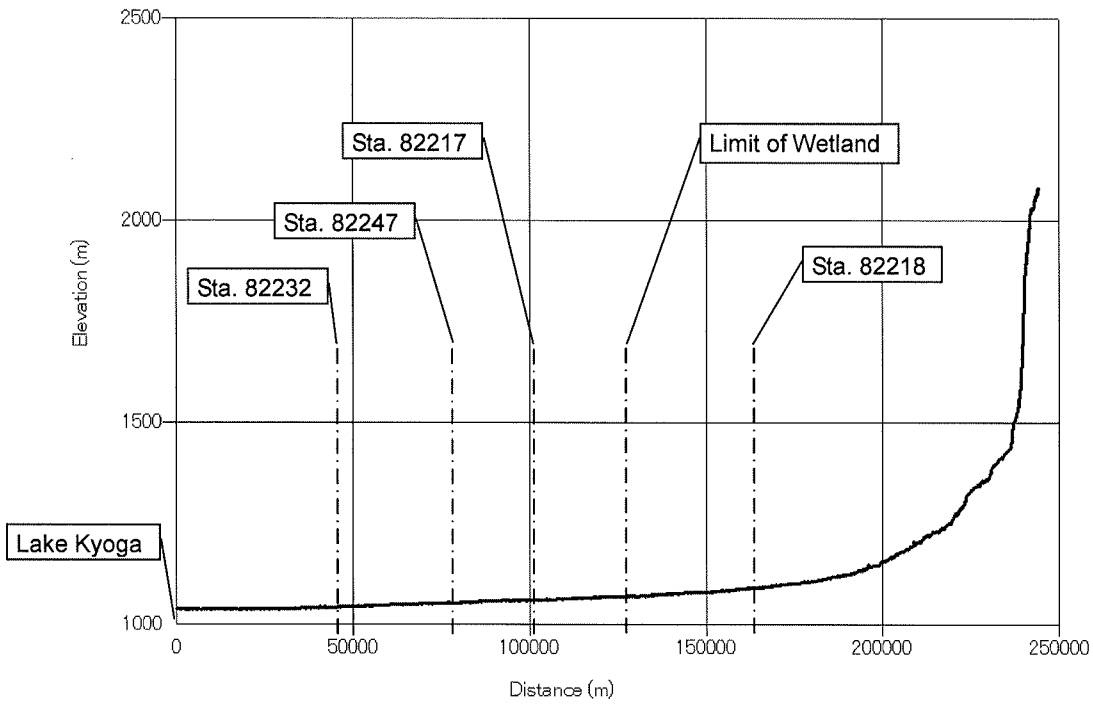
**Figure 9-9 Longitudinal Profile of Mpologoma River (from Lake Kyoga to Uppermost Stream of Mpologoma River)**

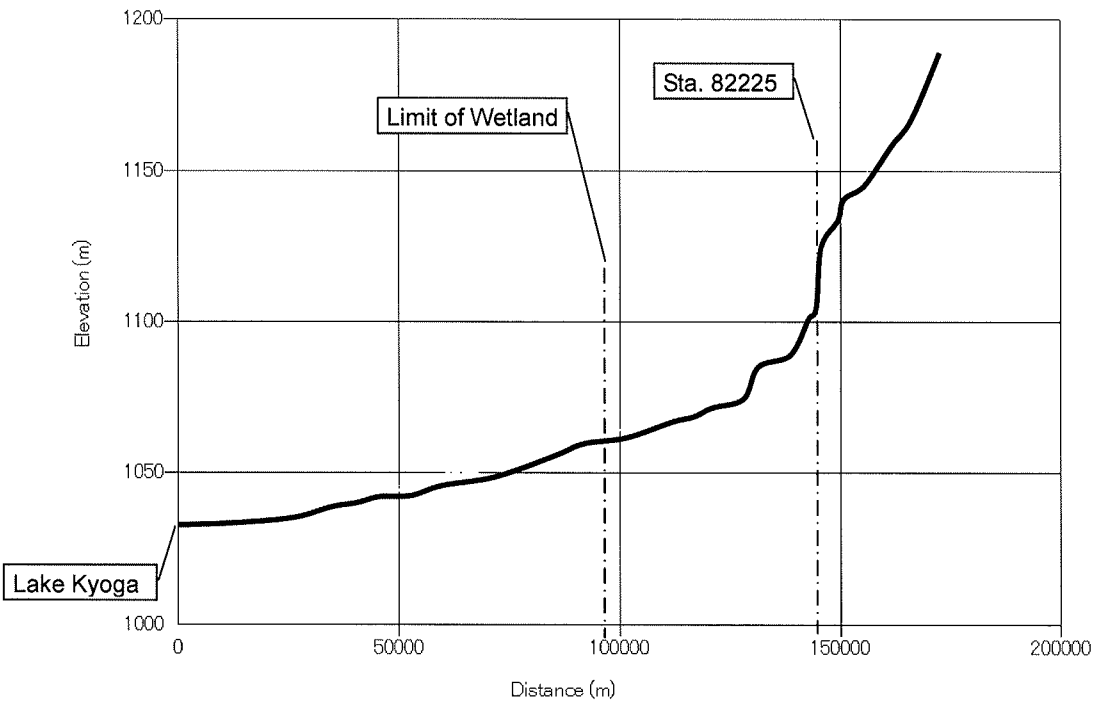
**Figure 9-10 Longitudinal Profile of Sezibwa River (from Lake Kyoga to Uppermost Stream of Sezibwa River)**

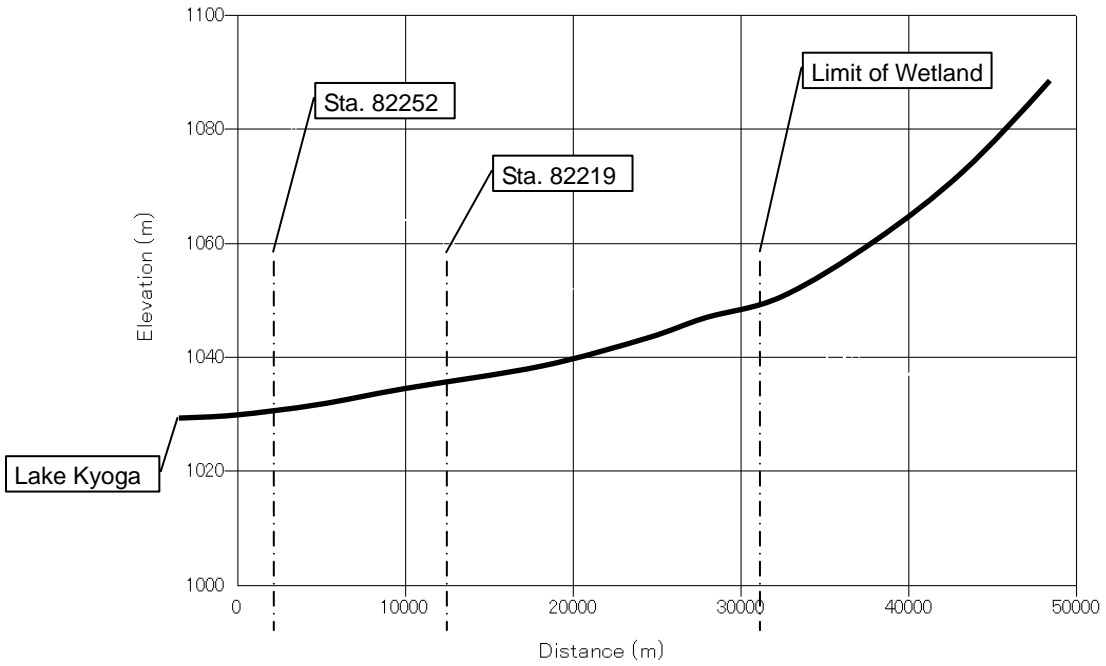
**Figure 9-11 Longitudinal Profile of Akweng River (from Lake Kyoga to Uppermost Stream of Akweng River)**

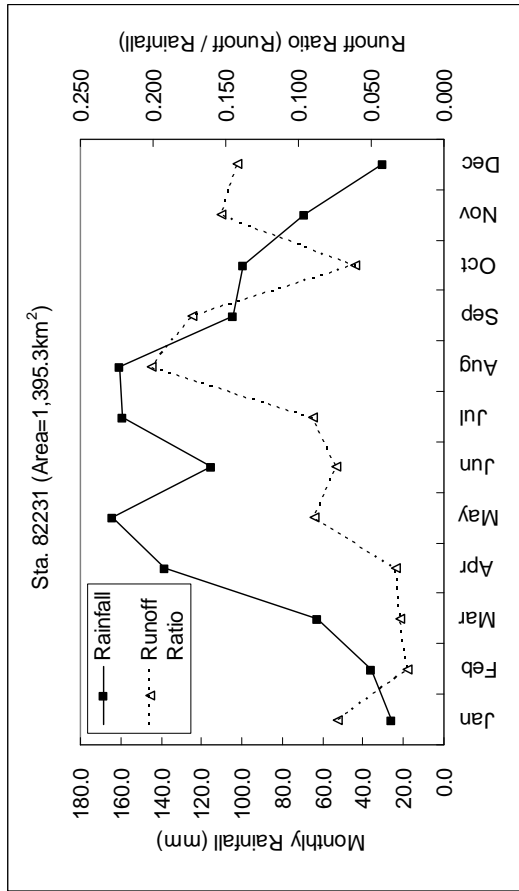
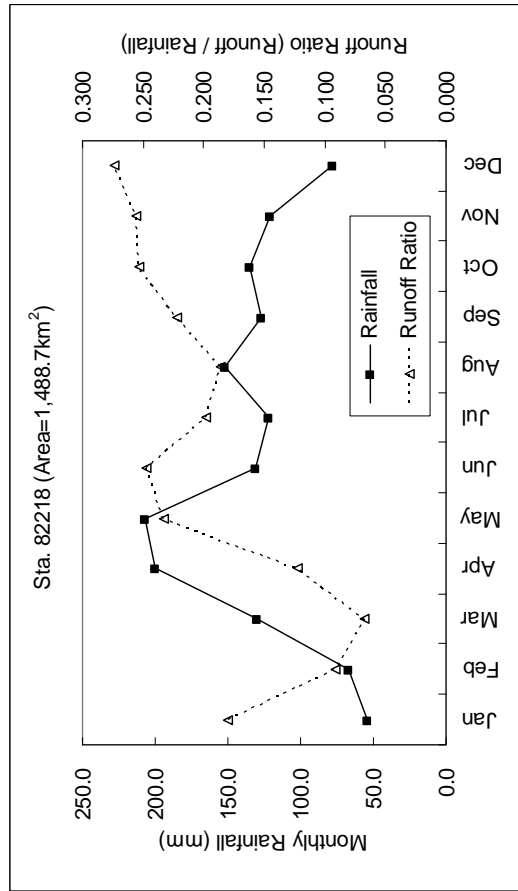
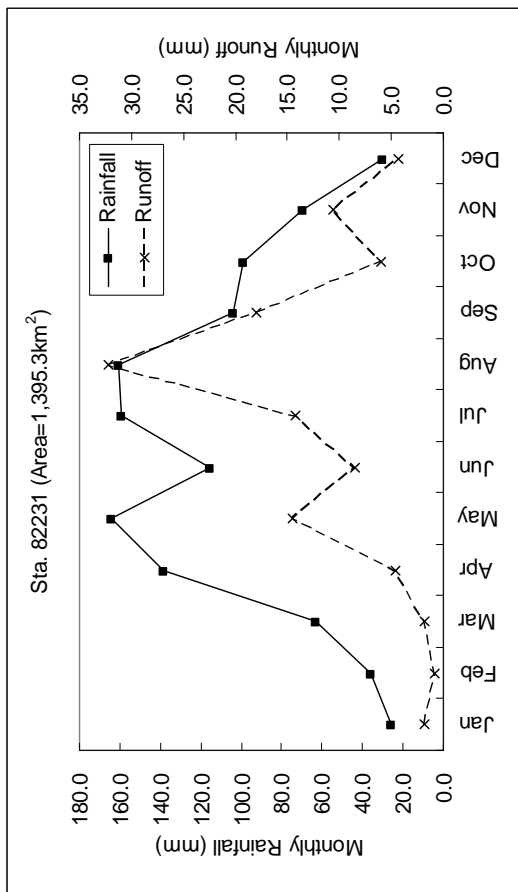
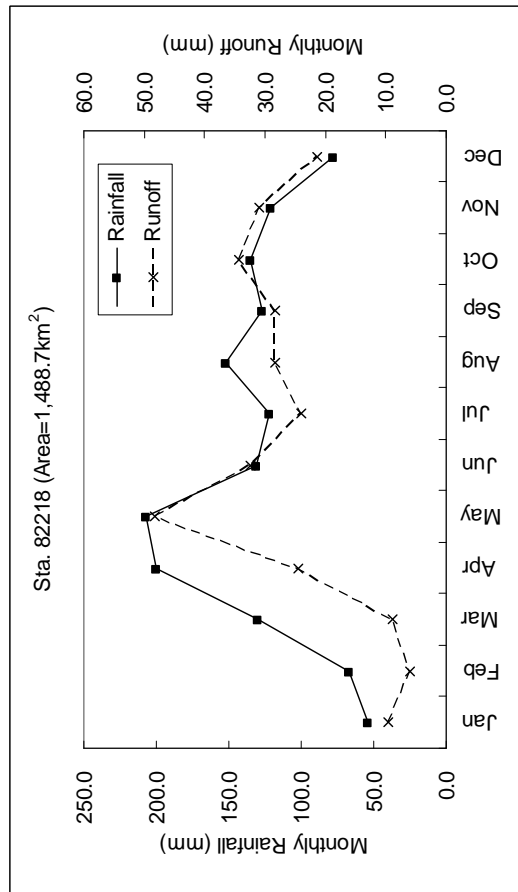
Figure 9-14 Rainfall, Runoff and Runoff Ratio of Selected Stations (2/2)

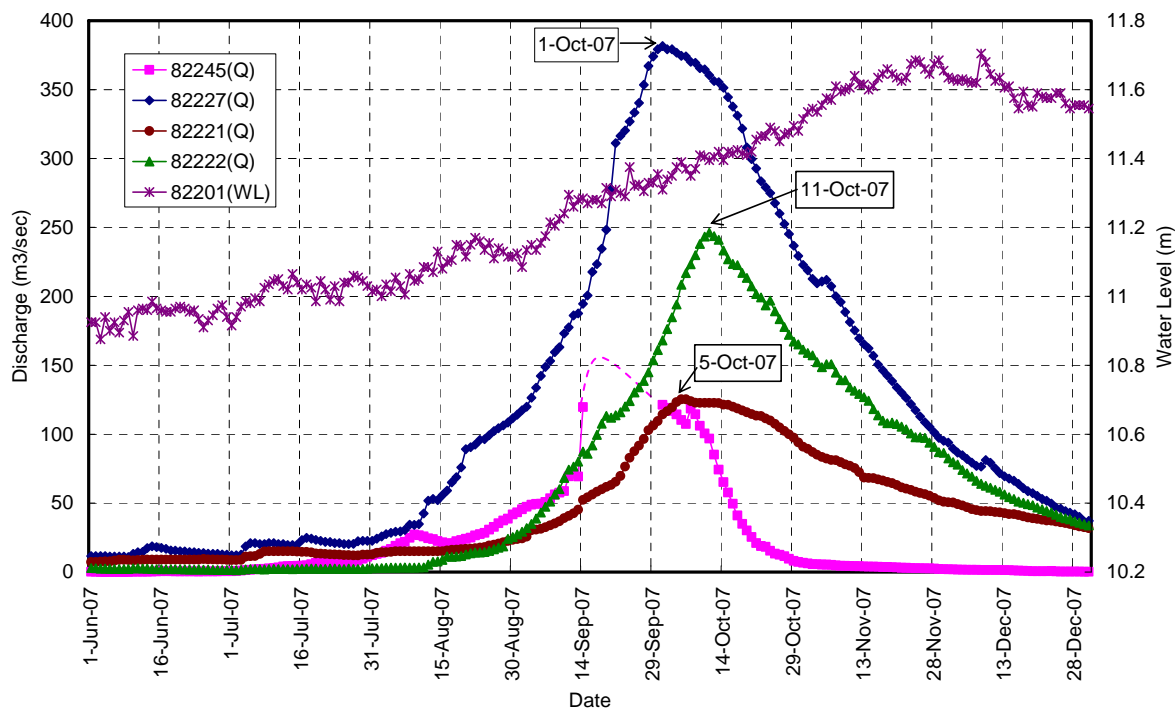
**Figure 9-17 Comparison of Peak Discharge**

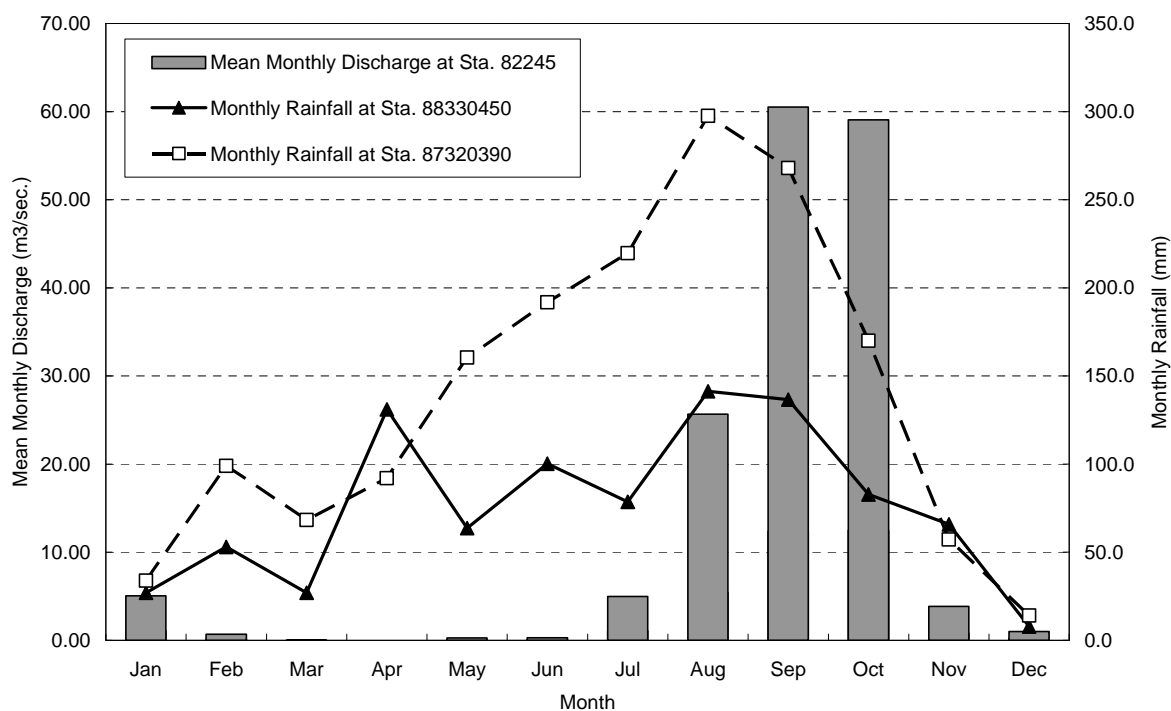
From the figure below, it can be said that there is time lag of peaks of rainfall and discharge as is the case with characteristic of long term mean of rainfall and runoff in sub-basins, and the time lag was about one month in 2007 flood.

Figure 9-19 Monthly Rainfall and Mean Monthly Discharge in 2007

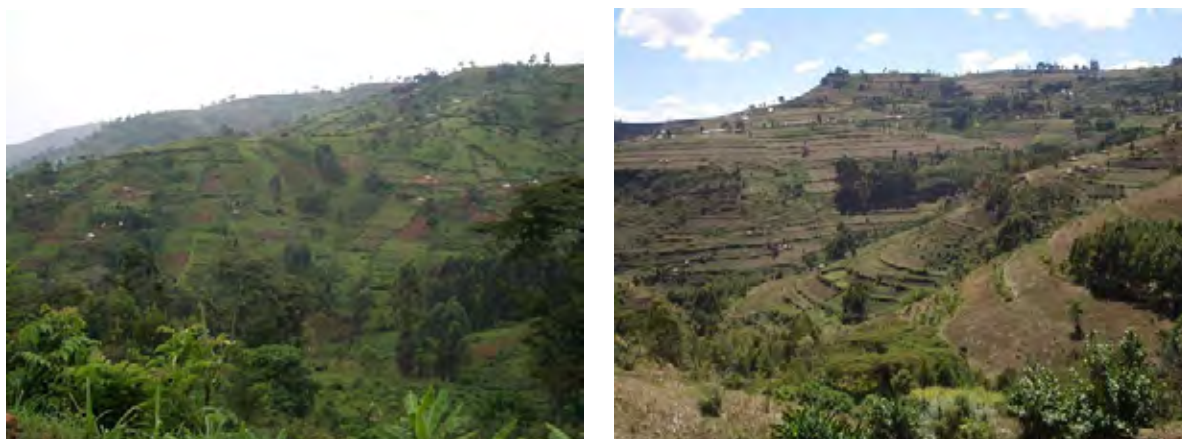
**Photo 9-1 Cultivation in Mountainous Area (Right: Bududa District, Left: Bukwa District)**

Photo 9-1 is mountainous area from Bududa district to Mbale district and mountainous area in Bukwa district. It clearly shows that forest was logged and cultivated even in such mountainous area. Such cultivated slopes were observed in every mountainous area around Mt. Elgon through the field reconnaissance and most slopes were cultivated up to very narrow boundary with National Park.

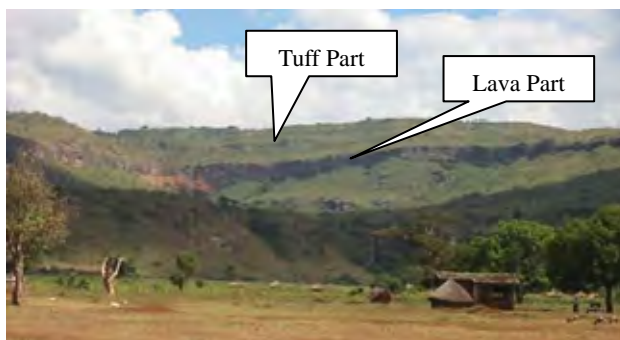
Mt. Elgon is above sea level 4,310m and is considered as a composite volcano in Cenozoic, of which original magma is lava by alkali basalt. The mountain body has a sandwich structure that lava and tuff made by pyroclastic flow and volcanic ash alternately repeat. The tuff occupies thickness about 5-10 time to Lava=1 (Photo 9-3)).

**Photo 9-3 Sandwich Structure of Lava and Tuff**

Collapse of rock slope is controlled in collapse pattern by topple that foreface of slope unsticks by vertical crack and corrupts like falling as shown in Figure 9-26. Lava is strong in weathering of the rock itself, however, the lava unsticks, falls and corrupts from the foreface by erosion of lower tuff since the lava has developed vertical cracks due to fast cooling in the process of flowing on the surface. Slopes formed by this phenomenon have been observed through the field reconnaissance, lava part exposes near-vertical sheer surface (Photo 9-3).

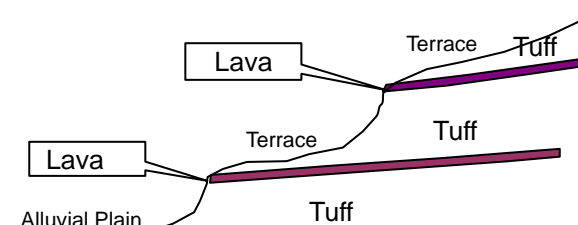
Since the lava is strong in weathering because it is dense and rigid but the tuff is weak to weathering and erosion, the lava protects progression of weathering of the tuff in the lower part of the lava in the place where lava remains, and terraced geographical features are formed in the upper part of the lava as shown in Figure 9-25. On the other hand, the tuff which is early to weathering is exposed and remarkably eroded in the place where the lava collapsed, and a terrace low by one step is formed.

**Figure 9-25 Geological Structure around Foot of Mt. Elgon**

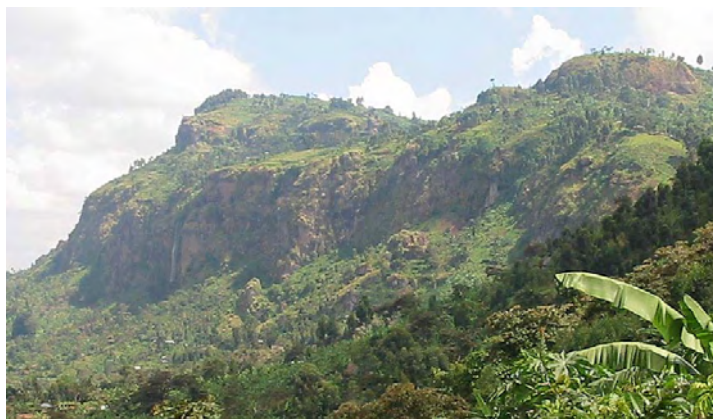
heavy rainfall on September 2007, rock collapse as well as collapse of unsteady talus cone deposited below the rock have occurred and have caused damage to houses and roads by mountain.

**Photo 9-4 Collapsed Slope by Topple**

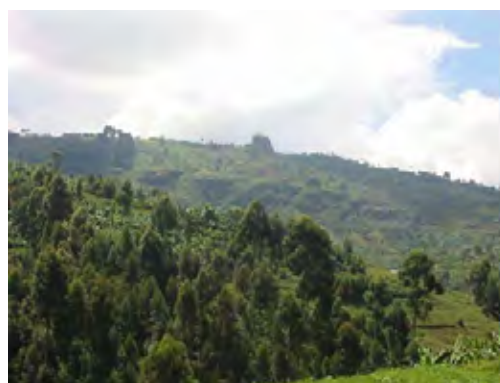
On the other hand, tuff located in a terrace in the upper part of lava is considered that the part made brittle by weathering has been gradually eroded by rain and forms rounded hillside (Photo 9-5). The danger of collapse and slope failure is a little in such an area.

**Photo 9-5 Hillside (Terrace)**

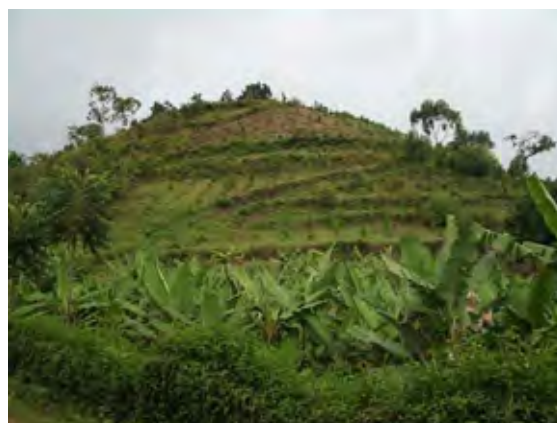
**Photo 9-6 Tree Planting (Mbale)**

The right photo 9-6 is a tree planting site of the project in Mbale district. Tree species for planting are determined taking consideration of regional characteristics such as soil conservation, profitability, indigenous species and slope. The examples of recommendable species are pine and grevillea.
