Appendix 5 Transmission and Distribution Line Facilities

Project for Operation and Maintenance of the Rural Electrification on Micro-hydropower in Mondul Kiri, Cambodia (2nd Period Work: 2010/4 to 2011/3)

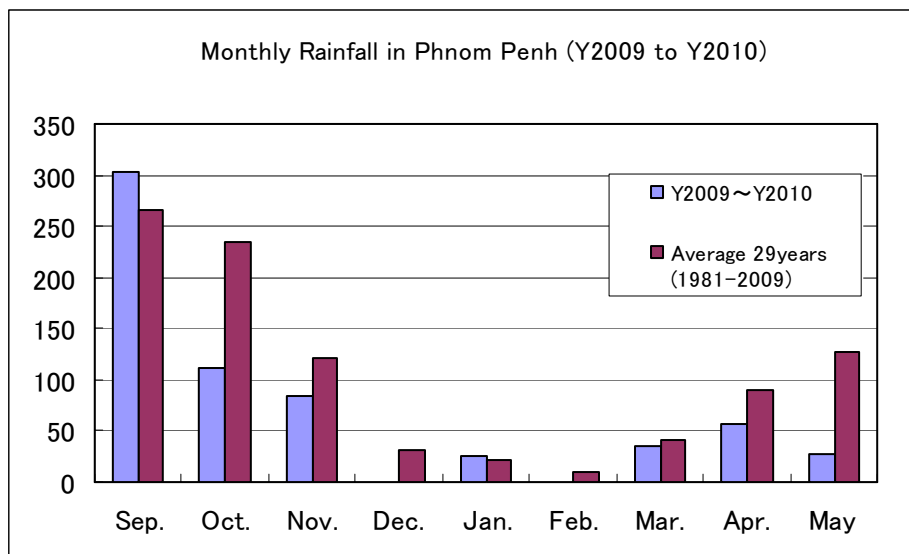
Data of monthly rainfall from 1981 to the present of Phnom Penh meteorological station were gathered. The figure below shows monthly rainfall for the period of rainy season to dry season to rainy season.

In usual years, rainfall gradually decreases from September, peak month of the rainy season, to reach the bottom in January or February of the next year and to increase little by little from March, which is the usual pattern of rainfall. Contrary to that pattern, from 2009 to 2010 (shown in light-blue line), rainfall drastically decreased from October to almost none from December through February. Usual years see rainfall from April but no rainfall until May this year.

That graph illustrates a delay of commencement of the rainy season this year.

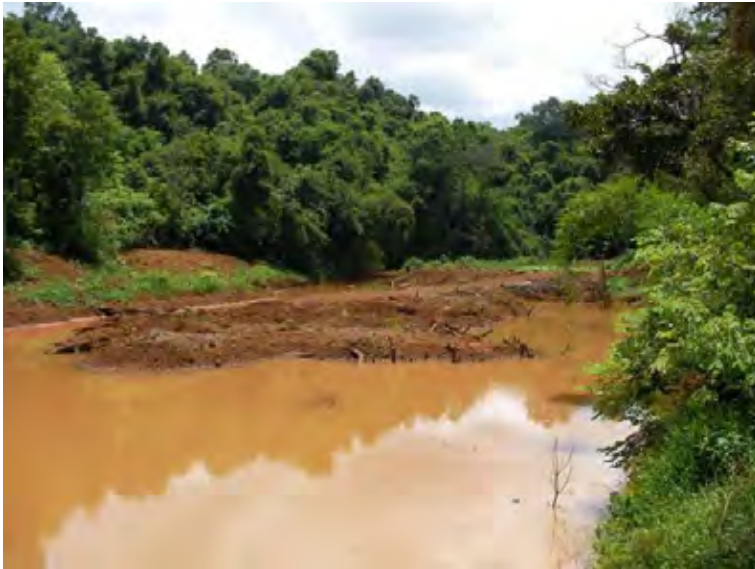
Temporary road left in the reservoir
(Looking upstream from the diversion weir)

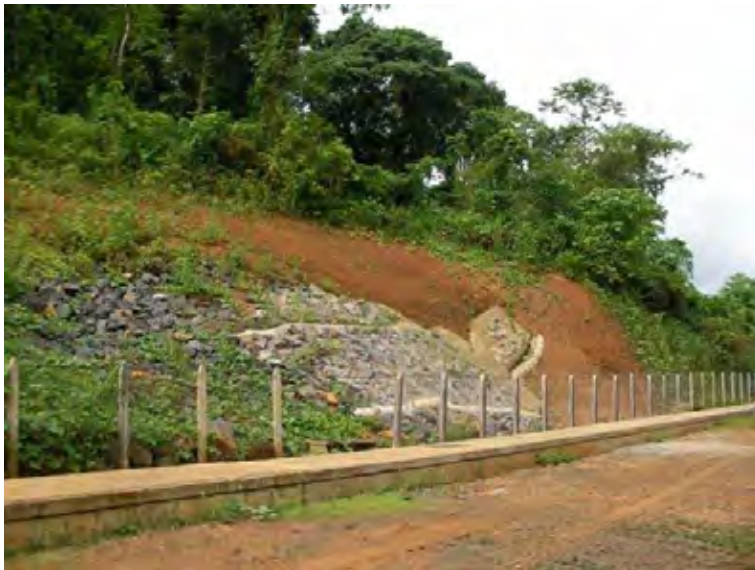
Repaired slope alongside the
O'Romis Power Station access
path

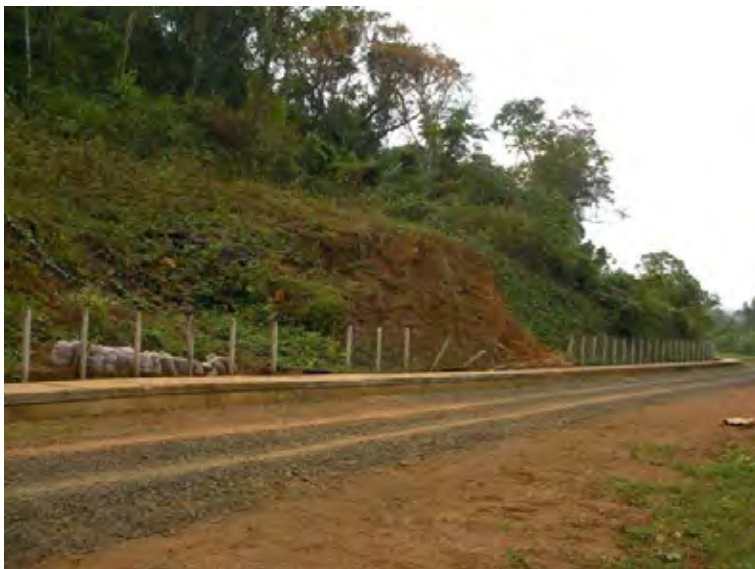
[For reference]
State of the slope before the repair
(December 2009)

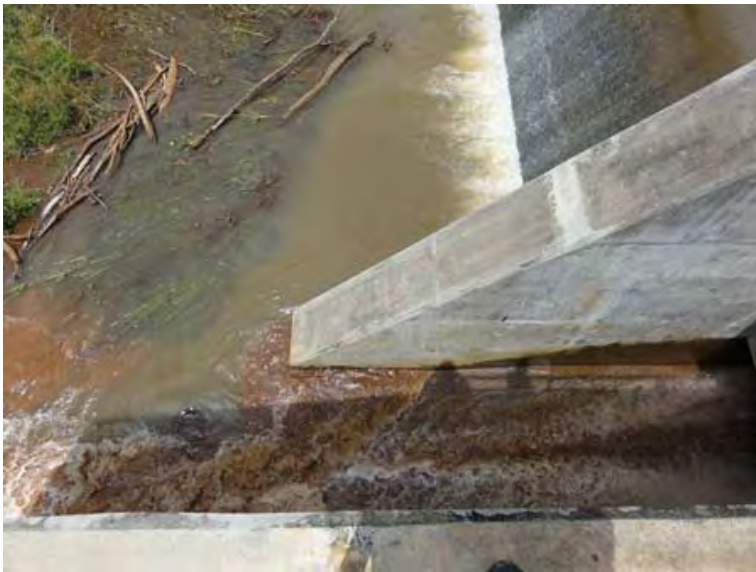
○ Sand removal

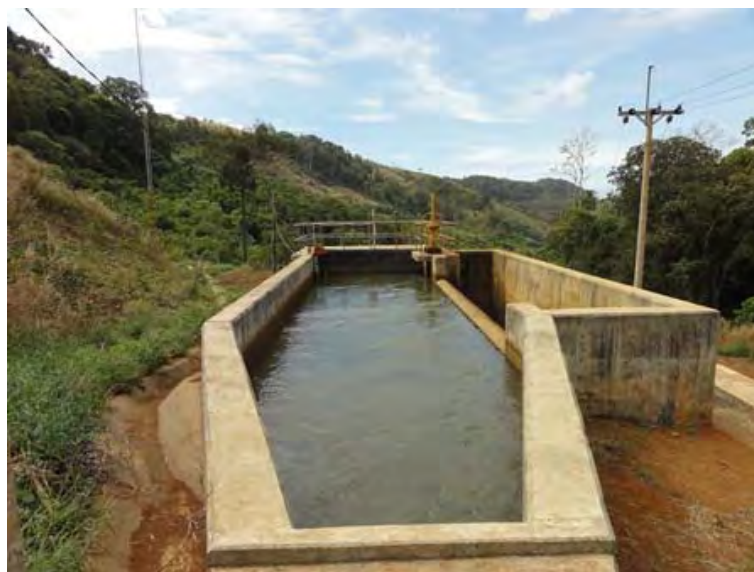
○ O'Romis Power Station
Present state of water tank. There was no overflow into the effluent outlet.
Hydropower when photograph taken: 140 kW.

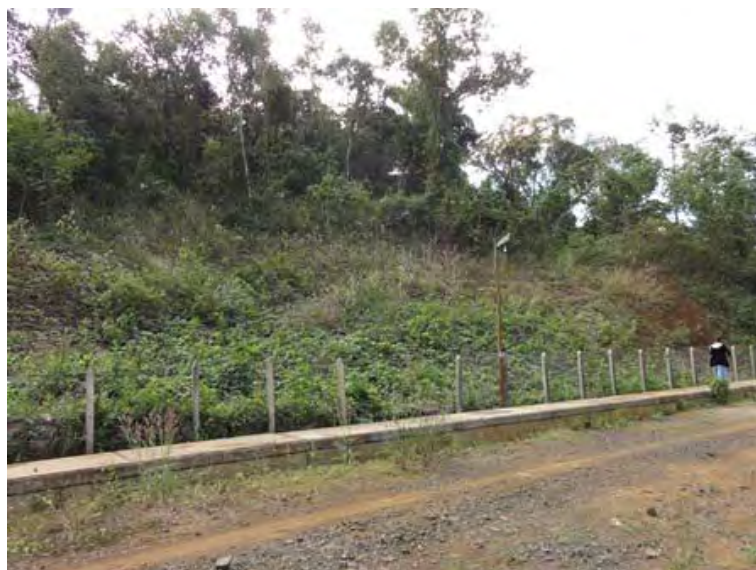
○ O’Romis Power Station
Slope repaired last year.
Currently stable.

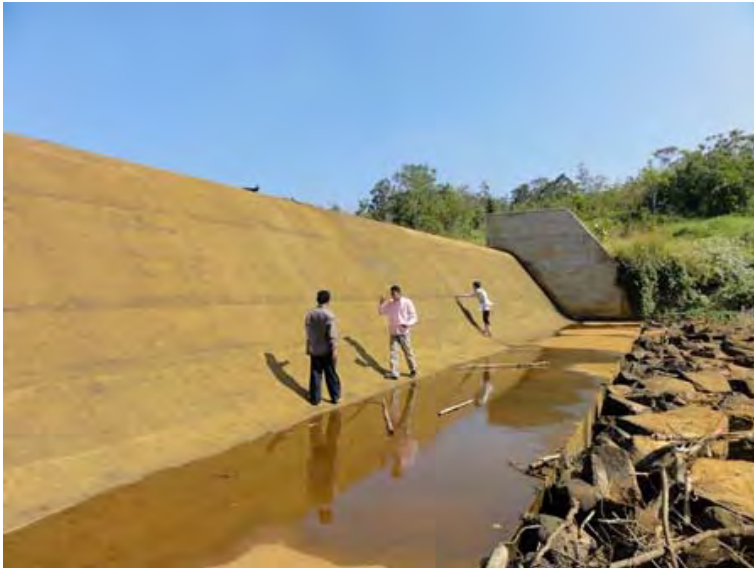
○ Guidance in patrolling
(O'Moleng Power Station)
Seepage at the diversion weir joint
portion.

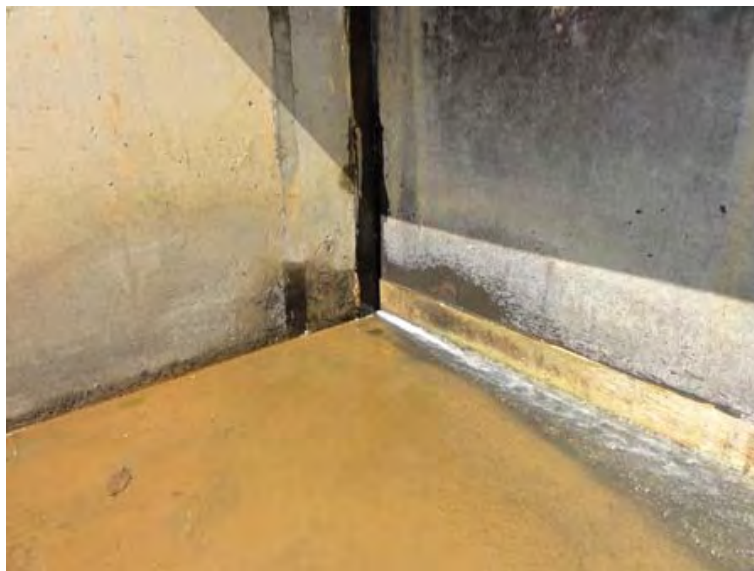
○ Guidance in patrolling
(O'Moleng Power Station)
Leakage from the sand removal
gate

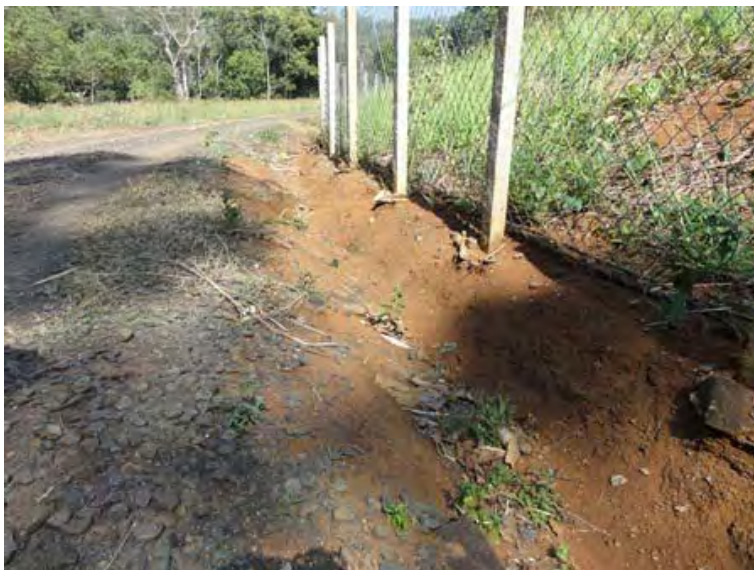
○ Guidance in patrolling
(O'Moleng Power Station)
Base portions of posts in rockfall
protection fence along access path

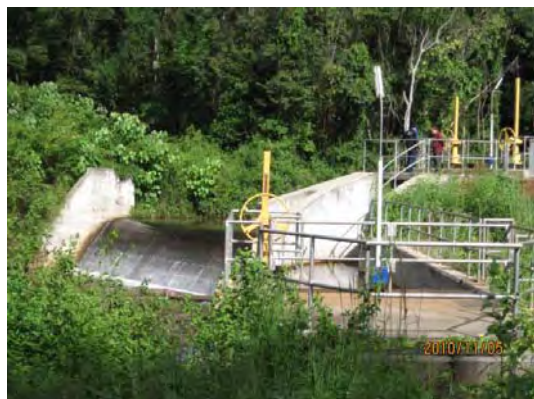
The year 2010 saw unusual dry condition for hydropower stations, the river inflow delayed around for 3 months. As of November 2010, hydropower station was operable at rated out put (185kW), furthermore, river water was overflowing from dam crest, so that EUMP operated to open the gate for flushing.

(Left)
Over flow at O’Romis dam
(Left-bottom)
Overflow at O’Moleng dam
(Right-bottom)
Sand flushing at O’Moleng

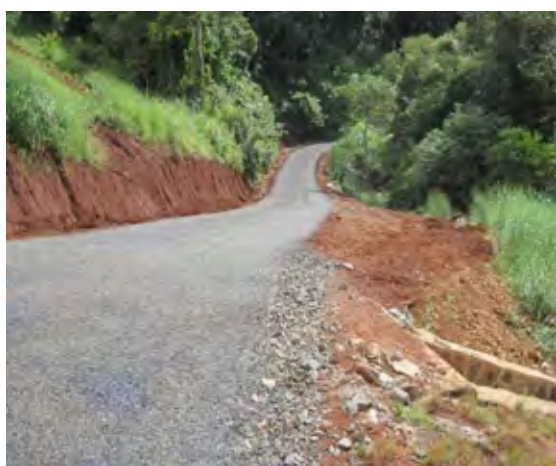
After new construction of national road route 76, access road of O’Romis was repaired and inspected by EUMP/EDC in 4th October 2010. The final arrangement and repairing work would be completed by coming dry season.

Access road to O’Romis (before)

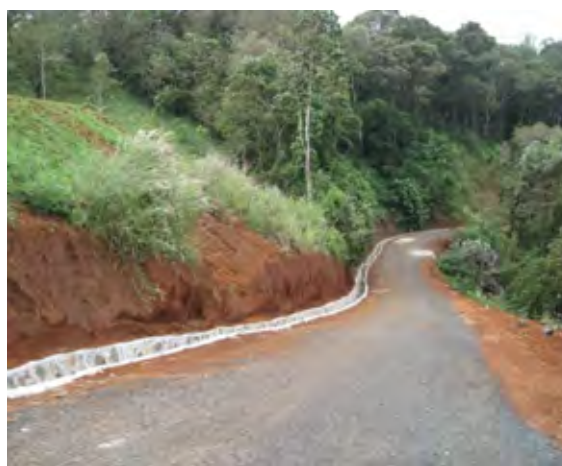
After repairing and pavement road

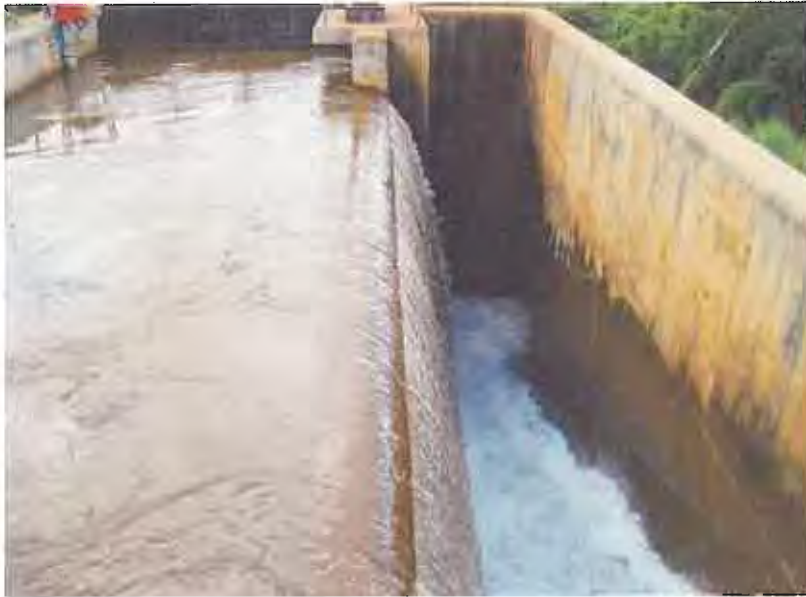
Overflow from Head Tank

2010/10/7
Overflow due to increasing river
water inflow at O' Romis
(generation output: rated185kW)

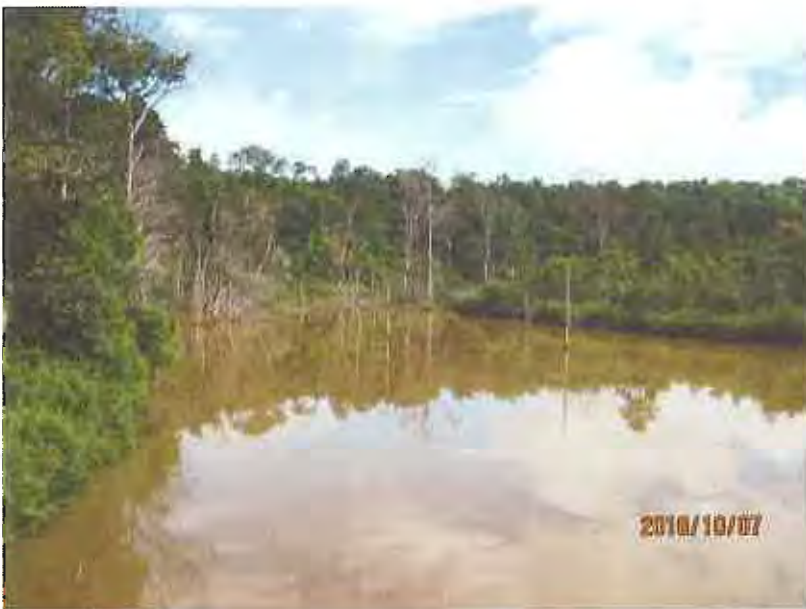
Reservoir at O' Moleng Dam

2010/10/7
Full reservoir level due to
increasing river water
(generation output: rated185kW)

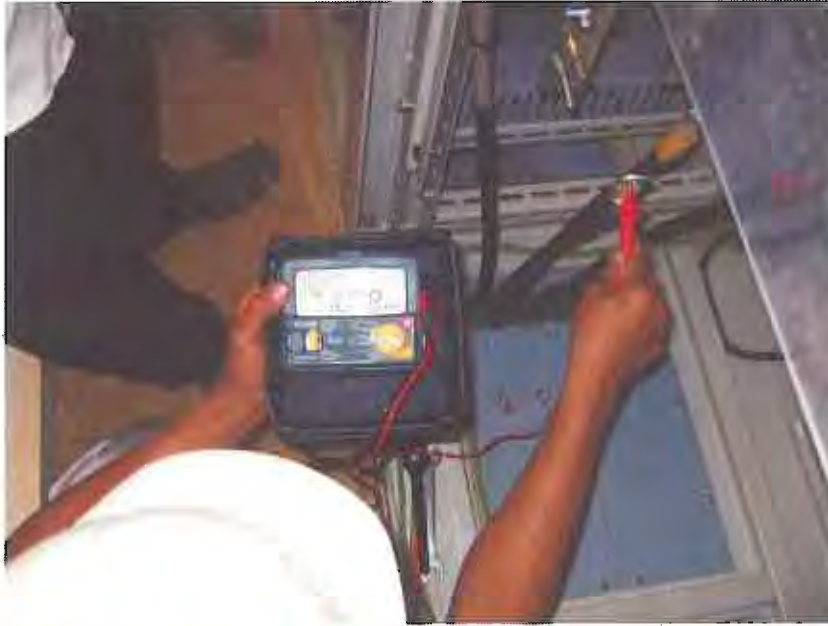
3rd Periodic Inspection

2010/6/3
Measuring Insulation
resistance of Generator

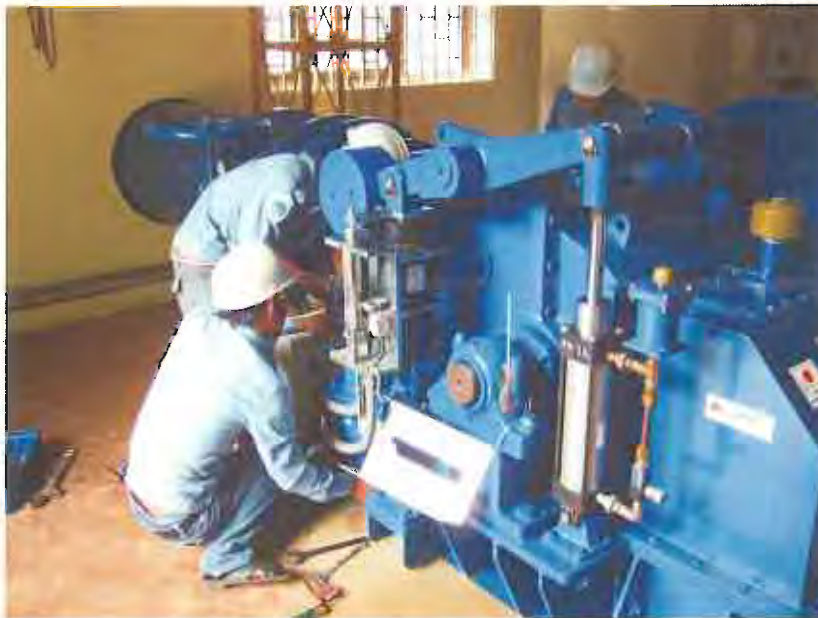
3rd Periodic Inspection

2010/6/2
Adjustment of Servo-motor
stroke for Guide-vane

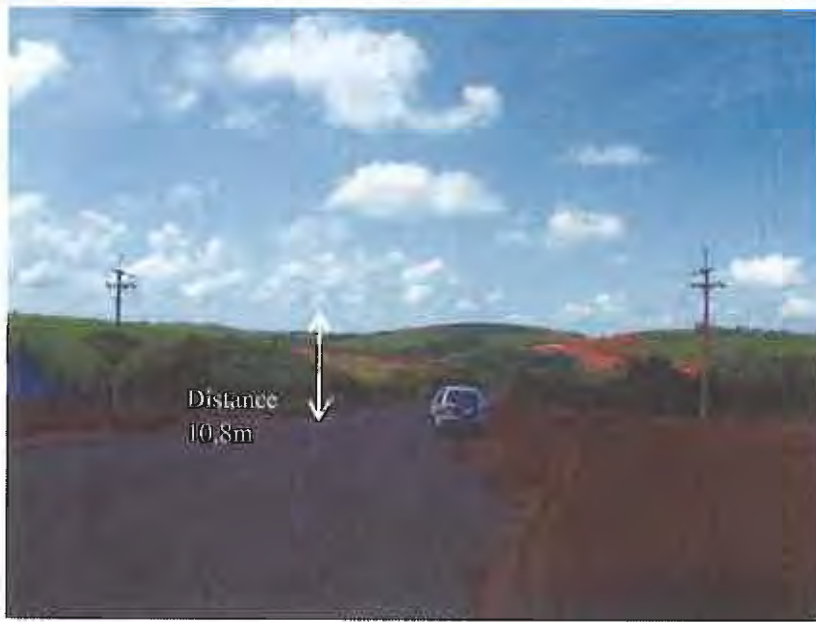
Patrol for 22kV T/L

Patrol for Checking Ground Height of Medium Voltage Conductor, crossing line near O' Romis road
